SERIOUS INCIDENT

Aircraft Type and Registration:	Boeing 757-3CQ, G-JMAB	
No & Type of Engines:	2 Rolls-Royce RB211-535E4-B-37 turbofan engines	
Year of Manufacture:	2001 (Serial no: 32242)	
Date & Time (UTC):	31 October 2014 at 1130 hrs	
Location:	During takeoff from London Gatwick	
Type of Flight:	Commercial Air Transport (Passenger)	
Persons on Board:	Crew - 10	Passengers - 239
Injuries:	Crew - None	Passengers - None
Nature of Damage:	Slide carrier, pivot forging and actuator deformed, slide loss and fuselage scuff marks	
Commander's Licence:	Airline transport pilot's licence	
Commander's Age:	50 years	
Commander's Flying Experience:	15,300 hours (of which 8,765 were on type) Last 90 days - 196 hours Last 28 days - 57 hours	
Information Source:	AAIB Field Investigation

Synopsis

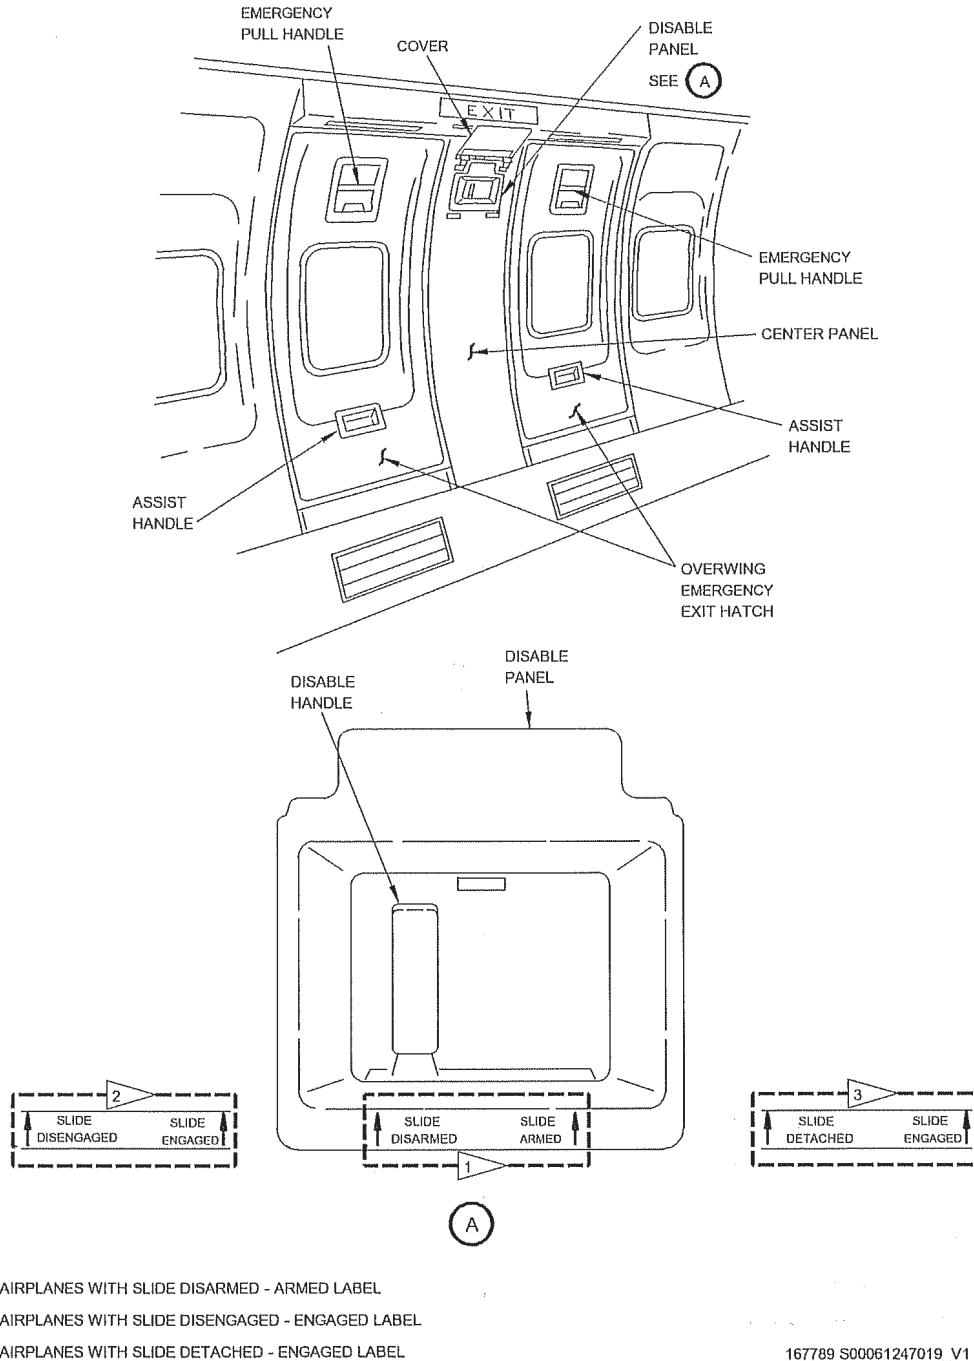
Over-wing escape hatches general arrangement within the cabin
 (Boeing Proprietary. Copyright © Boeing
 Reprinted with permission of The Boeing Company)

Figure 1 shows the general arrangement of the over-wing escape hatches. For safety the system is fitted with a several interlocks to prevent unwanted slide deployment during maintenance. The electrical input to the squib is isolated by a SLIDE ENGAGED and SLIDE DISENGAGED lever situated between the two escape hatches behind a plastic trim cover on the cabin sidewall.

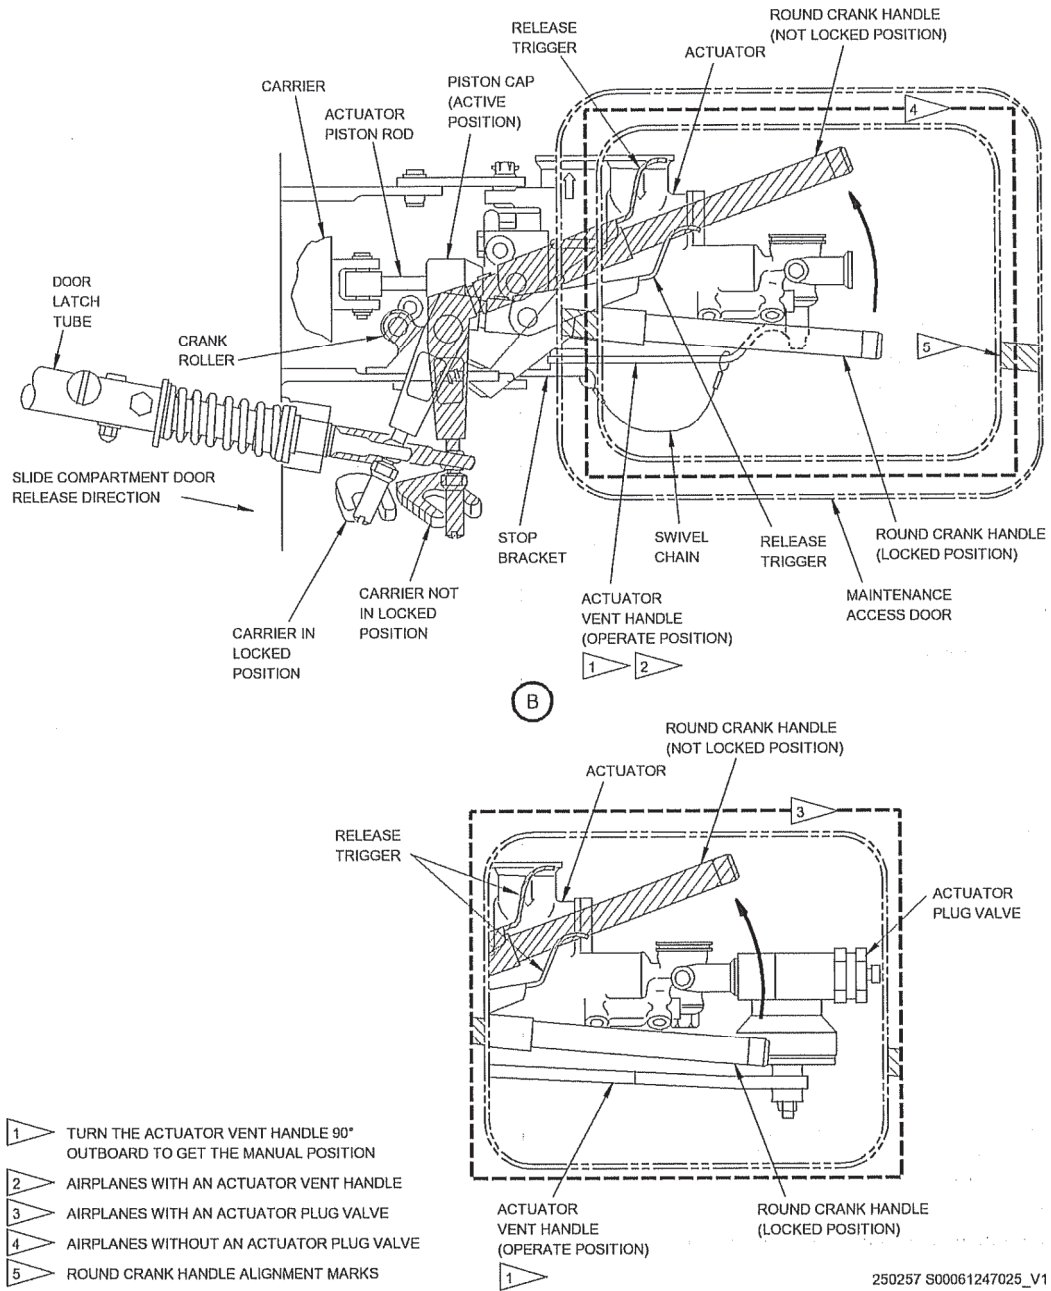
The actuator (Figure 2) is fitted with a vent lever, coloured red, which when rotated outwards to the 'manual' position allows the actuator piston to be moved manually and prevents gas pressure acting on the actuator. When the vent lever is in the manual position its handle protrudes outside the fuselage and its access panel cannot be closed.

In addition to the vent lever there is also a yellow crank handle fitted alongside the actuator. It is normally in the down, just below horizontal, position. When it is moved upwards, to approximately 30° above the horizontal, it releases the slide door, by retracting the door latch tube, and withdraws the slide carrier restraint device. Its purpose is to replicate the unlocking actions of the actuator to allow maintenance and inspection of the slide and its carrier without having to operate the actuator using gas pressure. The crank handle has a secondary function whereby the lifting of a trigger assembly on the handle and rotating it back down engages a hook on the slide carrier with the door latch tube to lock the slide carrier in the deployed position. To enable maintenance staff to check for the correct orientation of the crank handle, yellow paint marks are specified on the doubler plate, known as the land, surrounding the access hole on the inside, which abuts against and supports the back of the access panel when it is closed. The marks align with the lever when it is correctly positioned with the slide carrier locked and the slide panel closed. Figure 2 shows the slide actuator and crank handle assembly.

Figure 2
 Slide carrier actuator assembly (left side shown)
 (Boeing Proprietary. Copyright © Boeing
 Reprinted with permission of The Boeing Company)

The slide gas bottle was fully charged and none of the initiation devices had activated. The actuator access panel was found closed. The vent lever was found positioned in the 'operate' position. However, the yellow crank lever was in the slide panel OPEN AND CARRIER RELEASE position. The lever and its trigger assembly were undamaged.
