Rail Accident Investigation Branch

# Rail Accident Report

**Runaway of 'ironmen' trolleys and subsequent  
near miss at Raven level crossing, Garnant,  
Carmarthenshire  
1 November 2014**

Report 13/2015  
August 2015

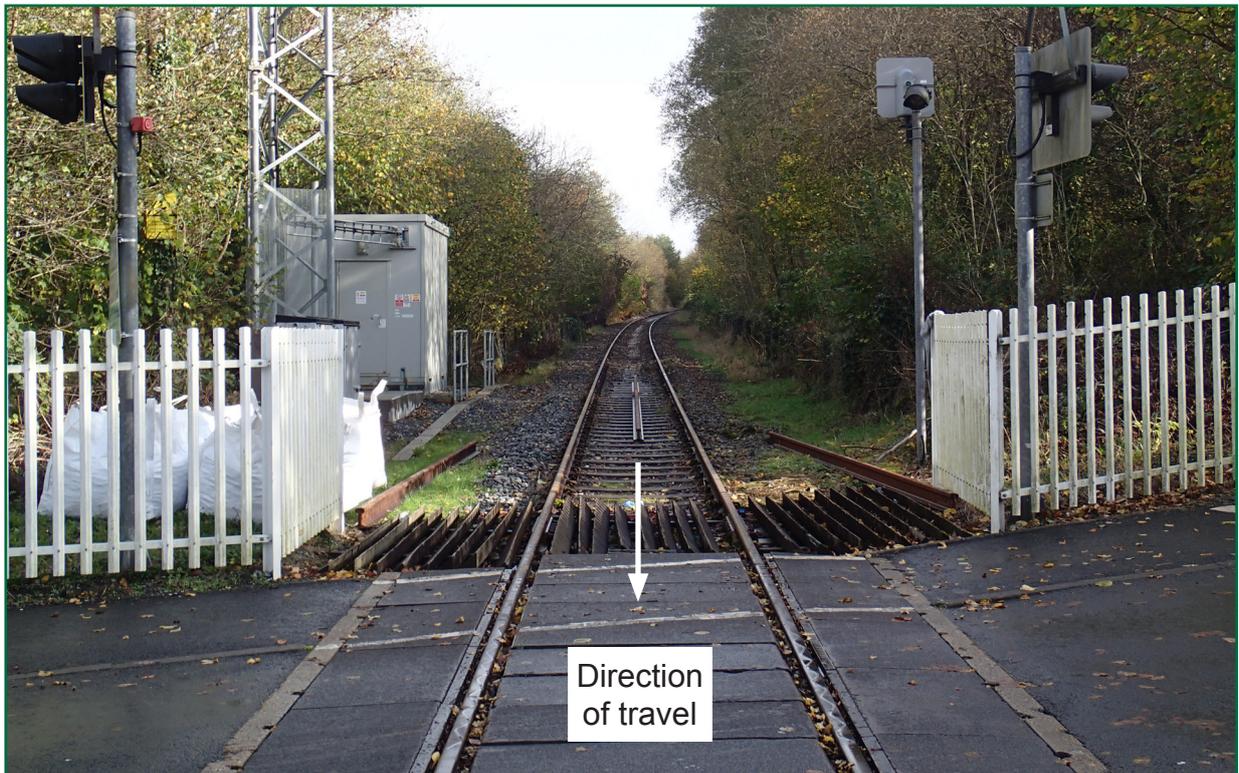
- 5 Following the loss of control of the rig, the two track workers rode on the ironmen in order to shout a warning to colleagues who were working in the *four foot* at Raven level crossing (figure 3). The warning provided just enough time for their colleagues to get clear of the line. The two track workers then jumped off the ironmen just before the crossing, receiving minor injuries; one was taken to hospital and was later discharged.

Figure 3: Raven level crossing looking towards GCG

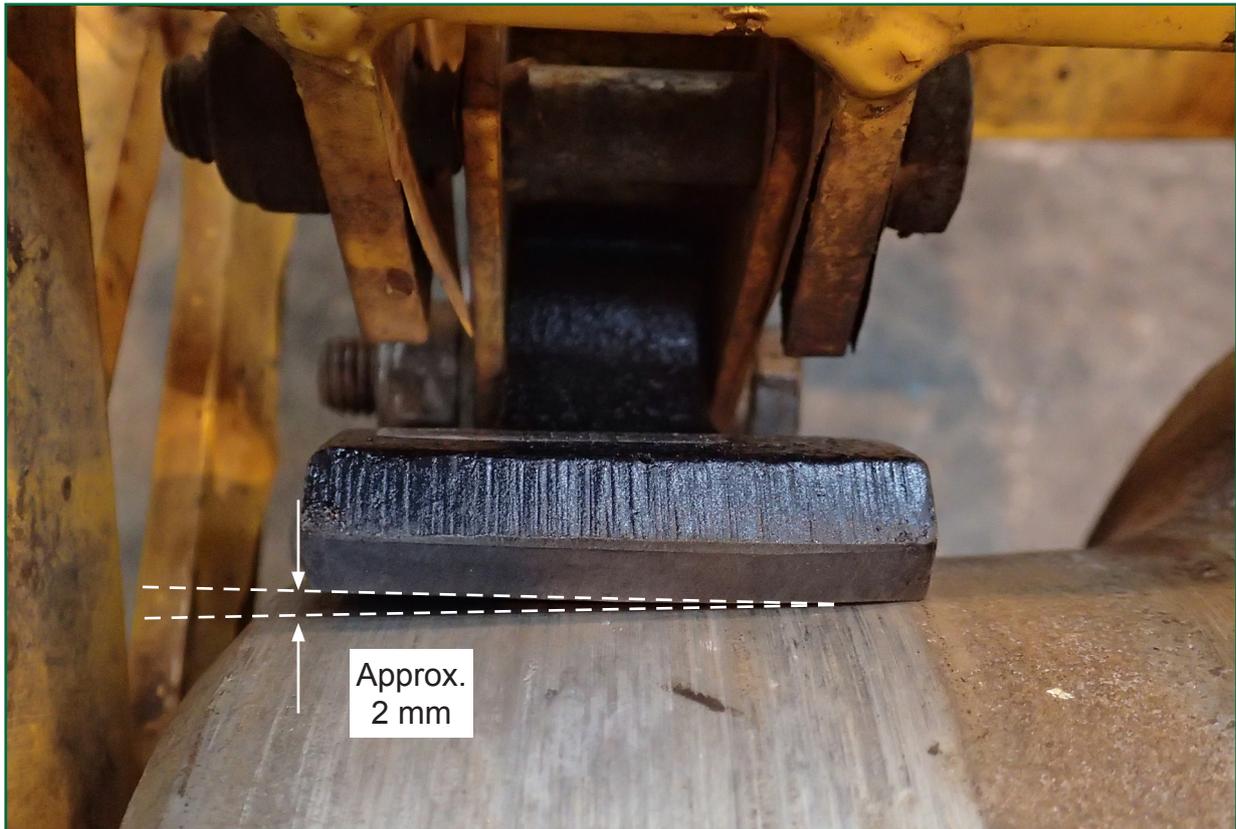
G3 Permaquip’s user guide MAN/M/O/105 sets out the requirements for maintenance of the braking system. These include a requirement that the brake pads should be completely clear of the wheels when the brake handle is held fully down, and in full contact with the wheels when the brake handle is released. However, with new brake pads fitted, there is a gap of typically 2 mm at the outside edge of the brake pad (figure G4) because the wheel is tapered and the brake pad is not. Permaquip has been unable to explain why the pad is not designed to sit flush against the wheel tread.

Figure G4: Alignment of new brake pad with wheel tread

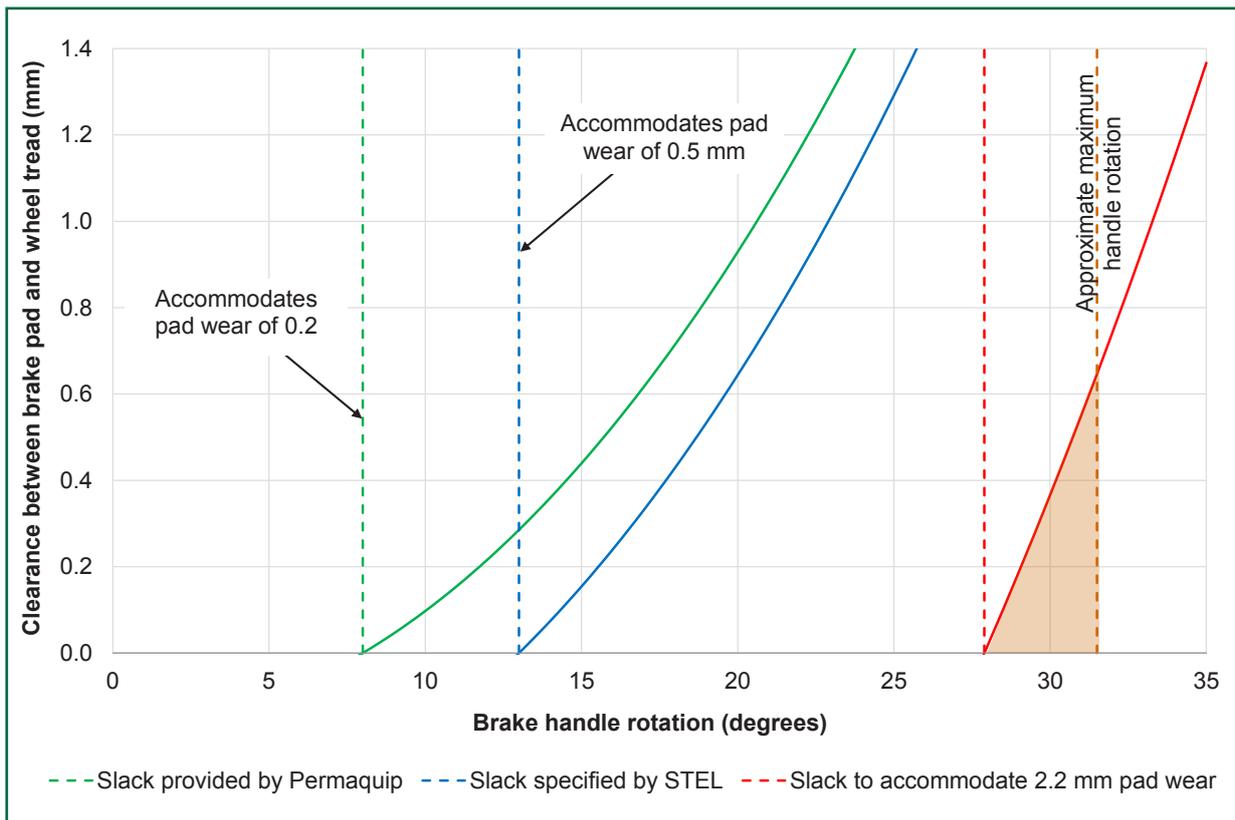
- G8 The relationship between the rotation of the handle and the position of the brake pads is shown at figure G6. The amount of free rotation of the handle when it is released corresponds to the slack in the vertical brake cable. As the brake pads wear, the amount of slack reduces; this is equivalent to moving the X axis downwards.

Figure G6: Relationship between brake handle rotation and pad position

G9 The slack normally provided by Permaquip on an ironman leaving the factory is sufficient to accommodate 0.2 mm of pad wear before the cable will remain in tension when the handle is released. The amount of slack specified in the STEL User and Maintenance Guide will accommodate approximately 0.5 mm of pad wear. However, the wear limit before brake pads should be changed during maintenance is 2.2 mm<sup>13</sup> (in practice, the brakes could be adjusted to compensate for wear in service at successive maintenance intervals before reaching this limit). If sufficient slack was provided to compensate for 2.2 mm of pad wear with new pads fitted, it might not be possible to release the brakes when the handle is depressed fully due to the tolerances and play in the various linkages of the braking system. The limited operating range with this amount of slack is represented by the shaded area in figure G6.
