AIRCRAFT ACCIDENT REPORT 2/2015

Report on the serious incident to Boeing B787-8, ET-AOP London Heathrow Airport on 12 July 2013

Air Accidents Investigation Branch

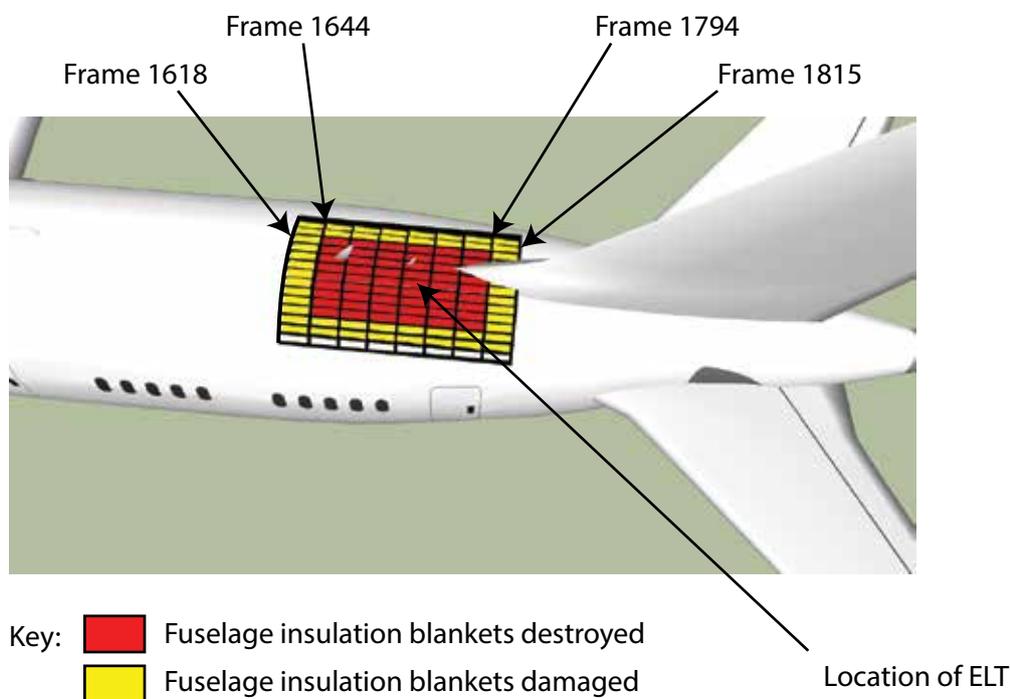
Figure 8
Fuselage frame diagram

After removal of the aisle ceiling panels, a visual examination of the interior of the rear fuselage crown skin was carried out. All the bay blankets and over-blankets between frames 1644 and 1794, and stringers 2R and 7L, had been severely damaged or destroyed (Figure 8). The remaining blankets between frames 1605 and 1835 showed varying degrees of thermal exposure and damage but had remained attached to the crown skin.

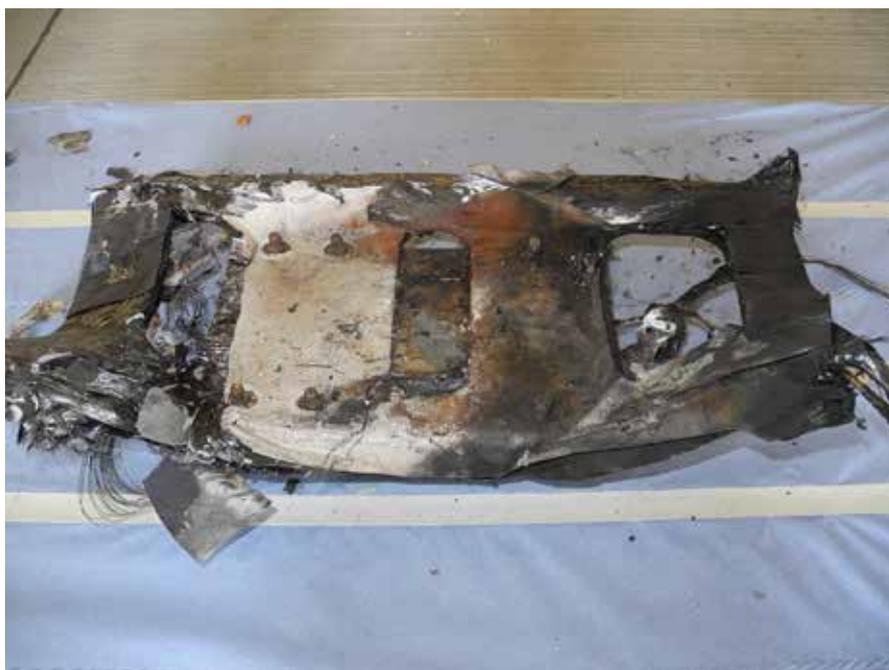
Figure 11

The ELT was removed from the aircraft for examination, together with its mounting plate and the sections of frames 1719 and 1744 to which it was attached. When the mounting plate was separated from the ELT it was found to have suffered almost total resin loss, with all the carbon fibre laminations separating readily (Figure 11). Both frame sections had also suffered from resin loss but remained substantially intact.

ELT composite mounting plate

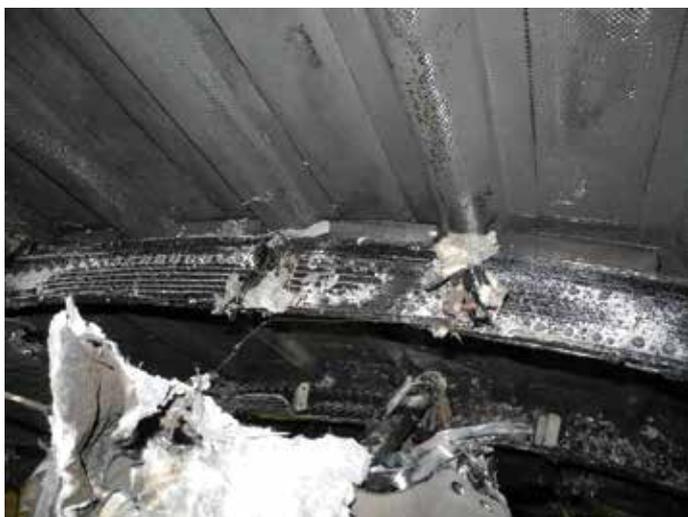
Figure 13

Examination of the removed skin confirmed that the areas showing large amounts of resin damage had lost a significant amount of rigidity and the exposed layers of carbon fibres readily separated. The frames exhibited varying degrees of damage. There was evidence of significant loss of resin to frames 1719, 1744 and 1769 between stringers 2R and 6L which resulted in a loss of rigidity in the affected areas. Additionally, the carbon fibre layers had begun to separate at the edges of the frame (Figure 13).

The sections of frame 1719 and 1744, which had been removed with the ELT mounting plate, were subject to laboratory analysis, to determine the temperature to which they had been exposed. The examination confirmed that all the resin had been lost from the frame sections closest to the ELT and that significant resin loss had occurred in the surrounding sections of the frame. However, it was not possible to determine the maximum temperature or duration of heat exposure.

Damage to frame 1719 in the region of the ELT mounting plate (looking aft)

During the course of the aircraft repair, a large section of the rear crown skin was replaced, together with all the damaged frame sections. This included all the areas identified as being damaged or discoloured in Figure 12. To facilitate removal the damaged section was cut into six pieces which, together with the damaged frame sections and the remains of the insulation blankets, were transported to the AAIB headquarters for further investigation.

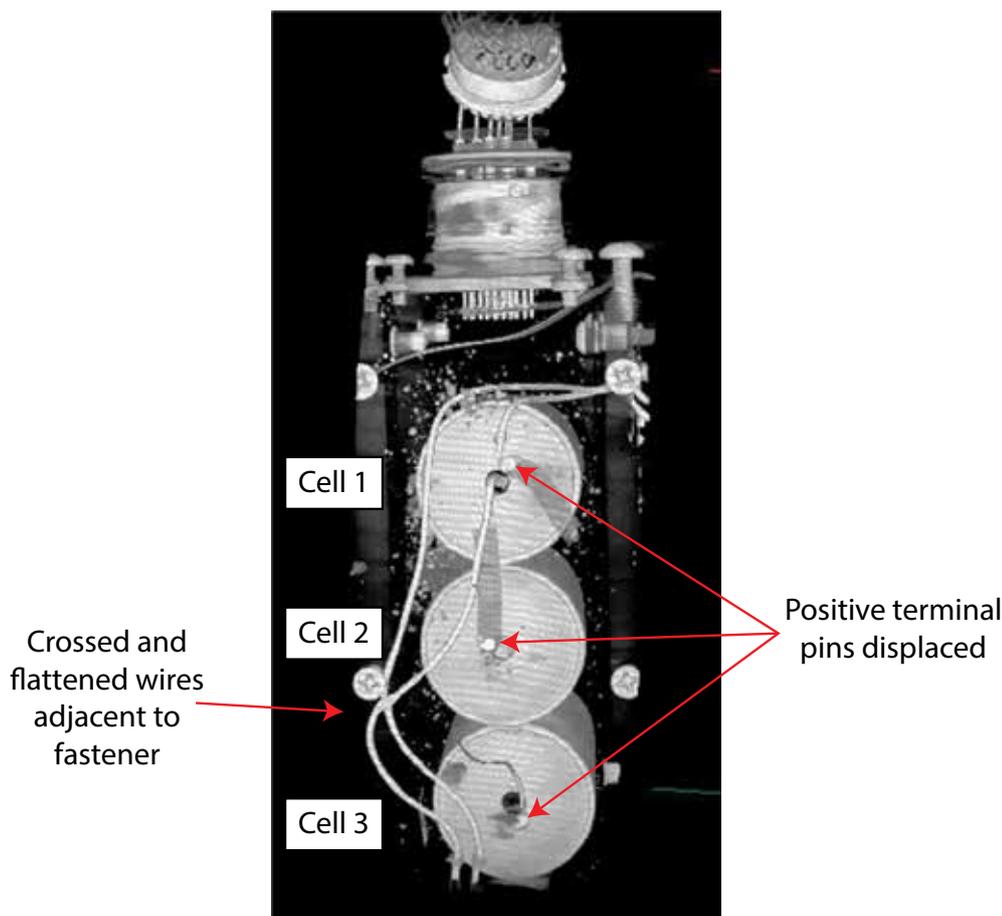
Figure 15

The CT images of the ELT showed large breaches in the cell walls of Cells 1 and 2, on the outboard side, and ruptures in the base of Cells 1, 3, 4 and 5. The CT scans also showed that the positive terminal pins on all five cells had been displaced from the cell headers, and that there was a substantial amount of debris in the ELT battery compartment. Significantly, as shown in Figure 15, the ELT battery wires appeared to be crossed and flattened, adjacent to one of the fasteners for the battery cover-plate. The scans also showed that this fastener was not fully inserted in its fastener hole.

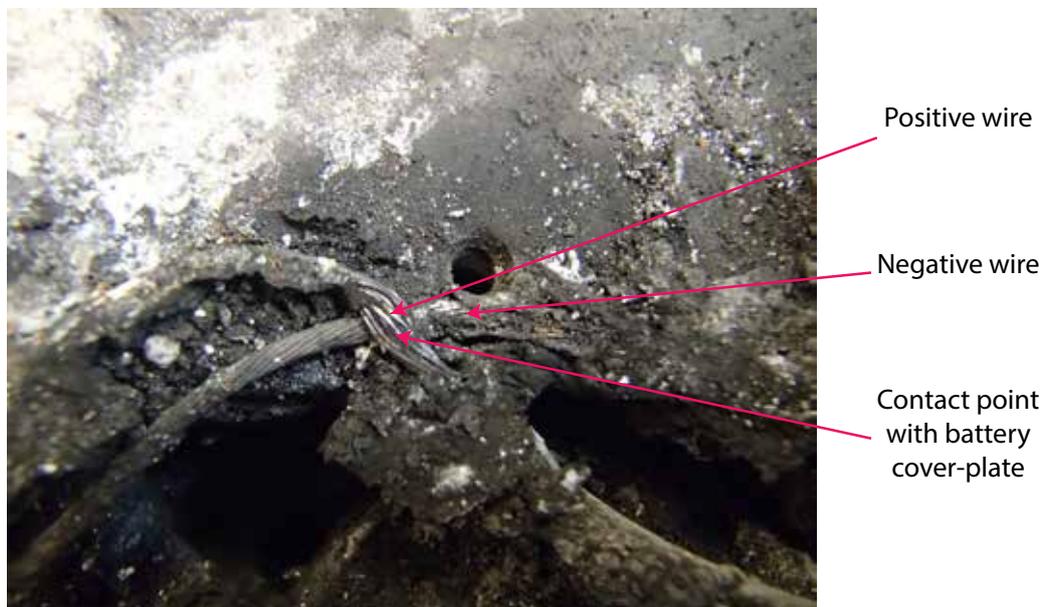
Figure 17

The battery cover-plate was bulged in one location. On removing the cover-plate it was evident that the ELT battery wires were crossed and trapped under the cover-plate in this location (Figures 16 and 17). The battery had experienced severe disruption, exhibiting evidence of a high-energy thermal event, consistent with the cell's having experienced a thermal runaway¹⁰.

Zoomed-in view of crossed ELT battery wires, identified in Figure 16

The cross-over of the wires was on the ELT side of the electrical connector, rather than the battery side. The positive (upper) wire exhibited some untwisting of the strands at the wire cross-over location and two strands of the wire exhibited visible flattening (Figure 17). Some transfer of aluminium cover-plate material onto the wires had occurred at the contact location, as well as localised removal of the silver coating, exposing the copper wire. The size, shape and alignment of the features on the positive wire corresponded with those on the cover-plate. No evidence of melting was observed.

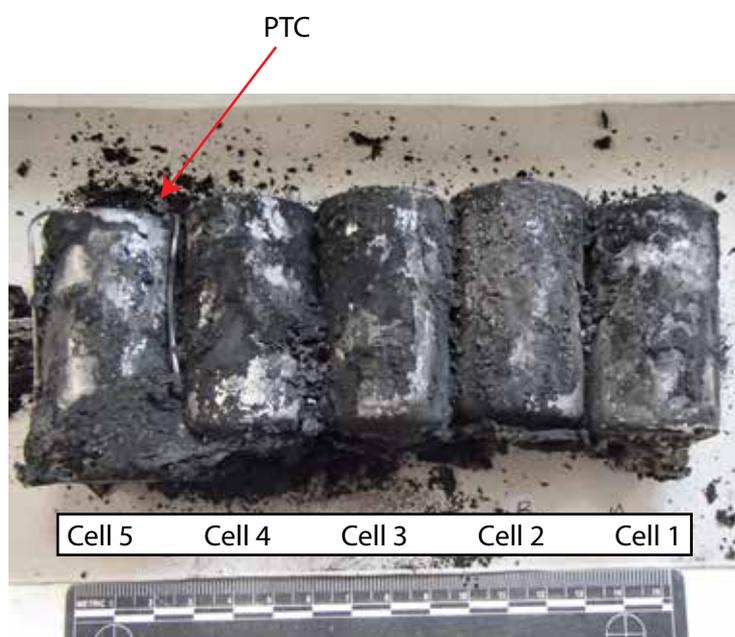
Figure 18

Upon removal of the battery it was confirmed that all five cell cases had been breached and battery material had been ejected into the battery compartment. The cells were burnt and blackened and encrusted in charred debris (Figure 18). The remains of the PTC were evident on the negative wire, where it normally terminates on the Cell 5 header, but due to thermal damage it was not possible to determine its pre-incident condition or electrical connection.

View on inboard side of ELT battery, immediately after removal from ELT

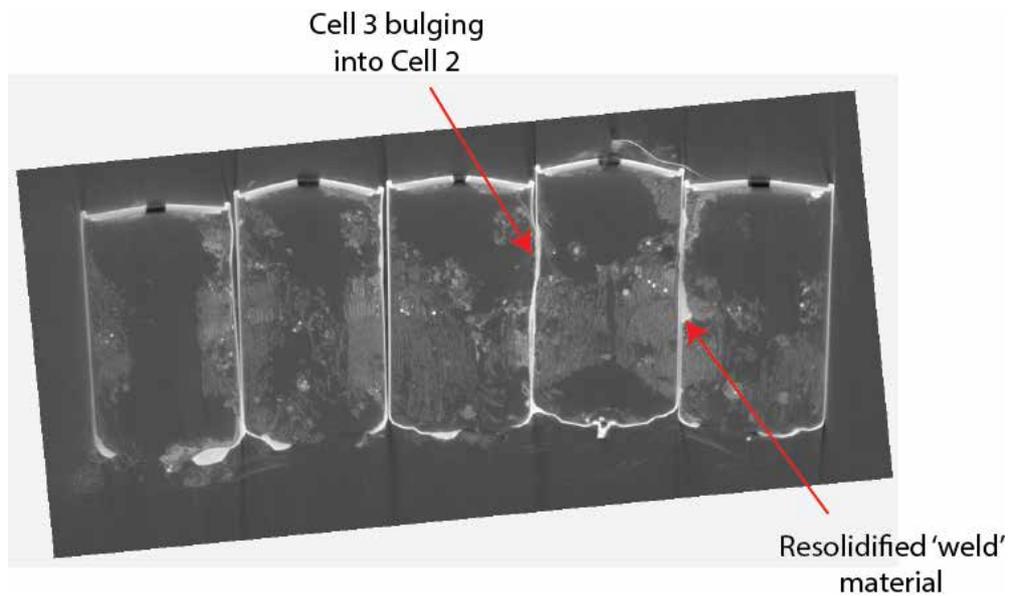
Figure 21

Examination of the CT scans showed that the cell walls in the vicinity of the large sidewall ruptures on Cell 1 and 2, had melted and re-solidified, fusing the two cells together (Figure 20). The melting point of the steel cell-can material is approximately 1,500°C. Solidified debris had accumulated around the sidewall ruptures between Cells 1 and 2, both inside and outside the cells. Smaller ruptures in the sidewalls of Cells 2 and 3 were evident and these had caused localised fusing of the cell walls in two locations. A bulge in the upper half of Cell 3 protruded into Cell 2, causing deformation of the Cell 2 sidewall (Figure 21). The cells were not vertically aligned, particularly Cell 2, which had shifted upwards from the rest of the pack. This suggested some relative movement between the cells during the battery fire. Some horizontal misalignment between the cells was also evident.

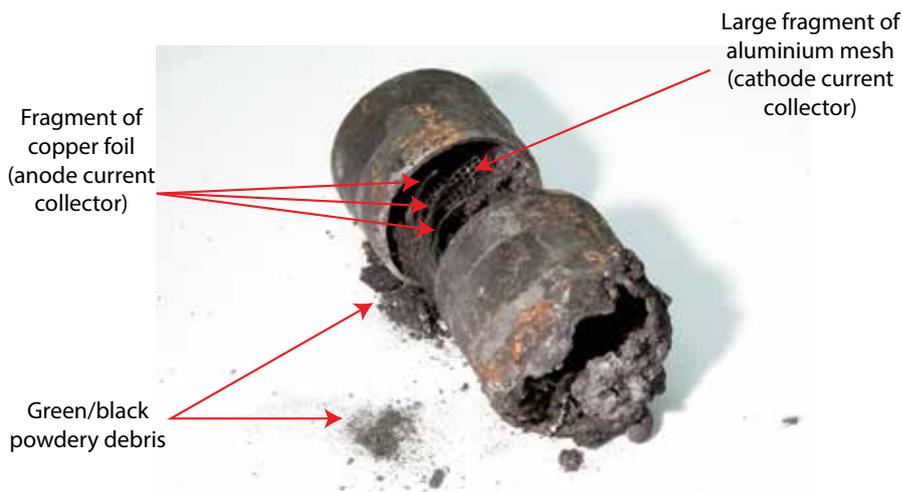
Figure 22

Removal of external debris revealed that there were, in fact, two separate apertures in the base of Cell 5. A pipe-cutter was used to open the cell, with some difficulty as the cell was no longer perfectly cylindrical. Large fragments of aluminium mesh (cathode current collector) were present in the upper half of the cell. A few coils of copper foil (anode current collector) were present at the expected position, around the 'equator' of the cell, but they were in a fragile condition (Figure 22). The lower half of the cell contained debris, some of which was solidified.

Cell 5 disassembly showing remaining cell winding components

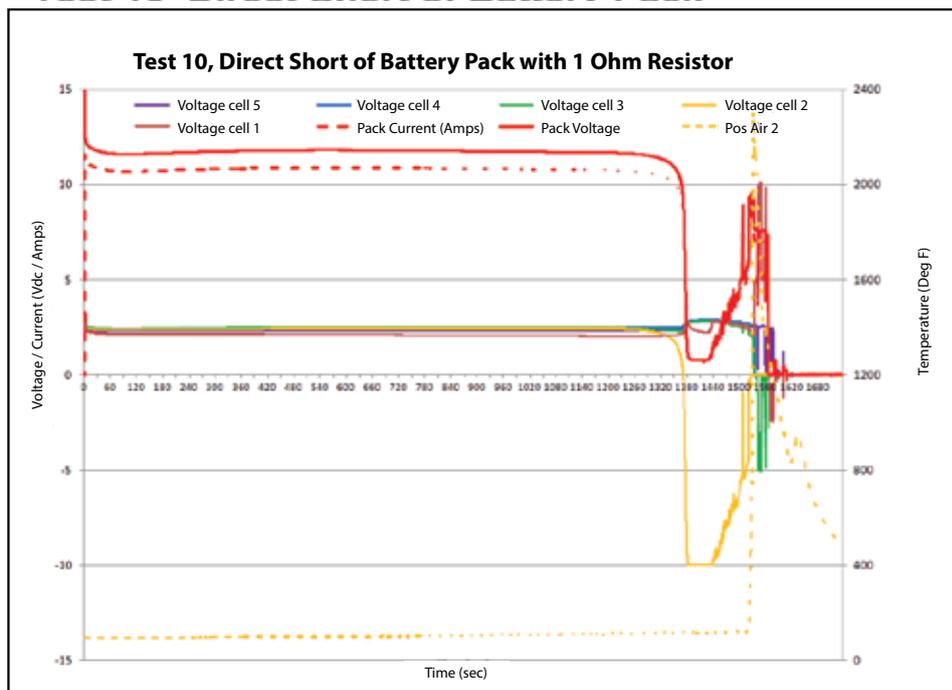
Figure 26

Twenty three minutes after the battery pack was shorted, Cell 2 experienced a 'voltage reversal'¹⁹ to -10V, becoming resistive (Figure 26). Approximately 2½ minutes later, Cell 2 experienced a rapid rise in temperature and decomposed under thermal runaway, exhibiting violent venting of gas, sparks and flames. The failure propagated to the remaining four cells, which all failed in a similar manner.

Post-test examination of the cells revealed they were burned and blackened and a number of the cells had been breached at the base of the cells. The maximum cell temperature was approximately 1,300°F (704°C), while the air temperature above Cell 2 peaked at approximately 2,300°F (1,260°C).

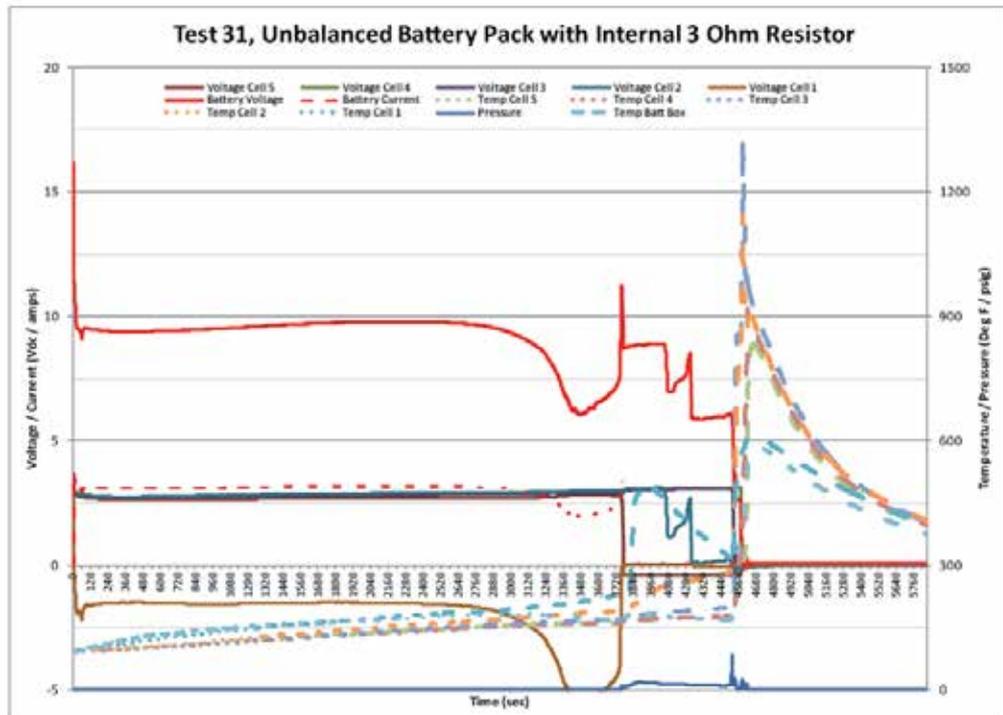
Figure 28

Immediately after initiating the short, the depleted Cell 1 voltage reversed to -2V. One hour later, Cell 1 voltage dropped further to -5.5V and it then experienced a significant thermal event, which cascaded to the other cells over a 15 minute period (Figure 28). Cell 1's maximum temperature at failure (260°C) was noticeably lower than the temperature of the remaining four cells during their subsequent failures (426 – 649°C), most likely because it had been depleted prior to the test.

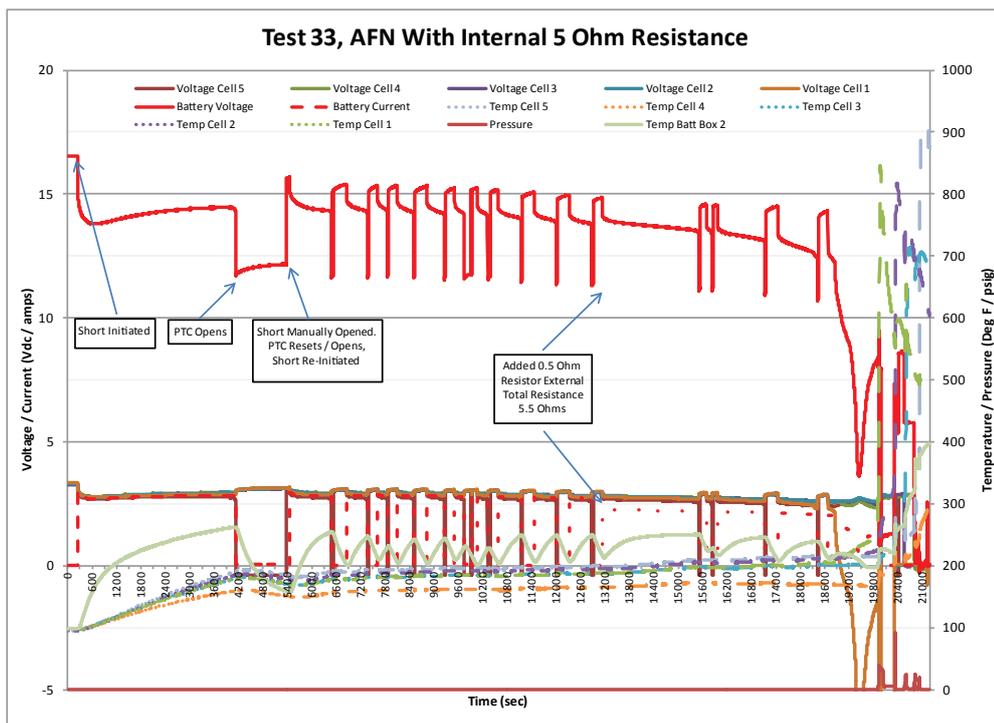
Figure 29

With the high resistance of the tripped PTC in the circuit, the battery pack voltage dropped to approximately 12V (Figure 29). 22 minutes after the PTC tripped the circuit was manually opened, resetting the PTC to its low resistance state. The circuit was then reconnected to re-create the short circuit. After a short period the PTC tripped again. This process of opening and closing the circuit was repeated; the time required to trip the PTC decreased with each cycle.

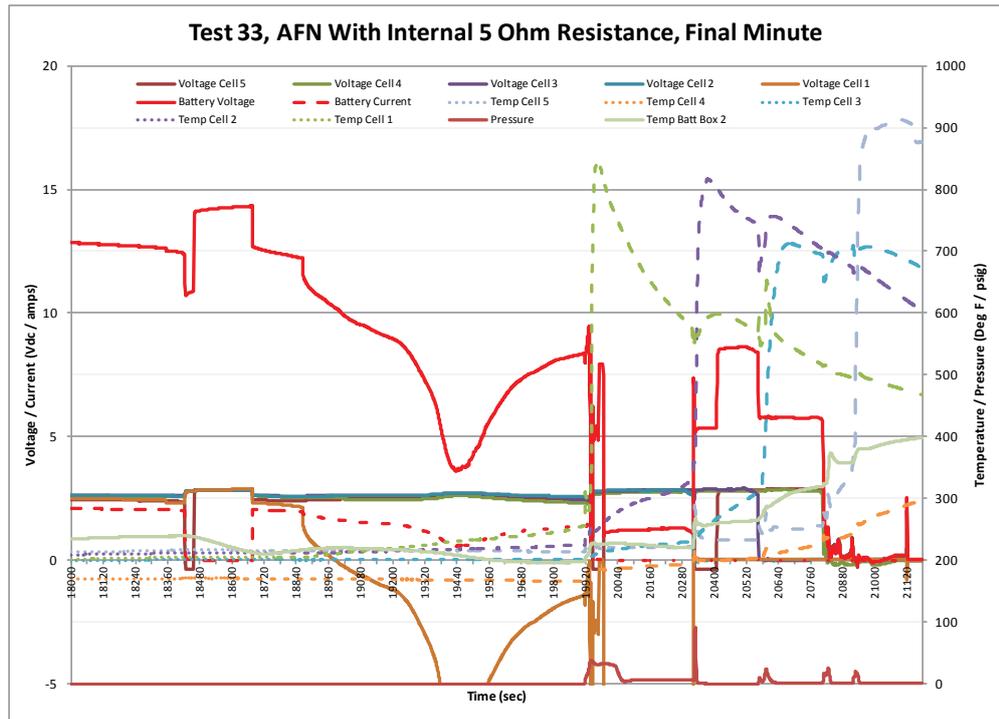
Figure 30

After 11 cycles of opening and closing the circuit as a means of getting the PTC to reset, an additional 0.5 ohm resistor was added, outside the test chamber. This reduced the current to 2.2A and increased the time between PTC trips. After a total of 16 cycles, Cell 1 experienced a voltage reversal (Figure 30) and decomposed under thermal runaway. This propagated to the neighbouring cells in a cascading thermal runaway, over the next 19 minutes.

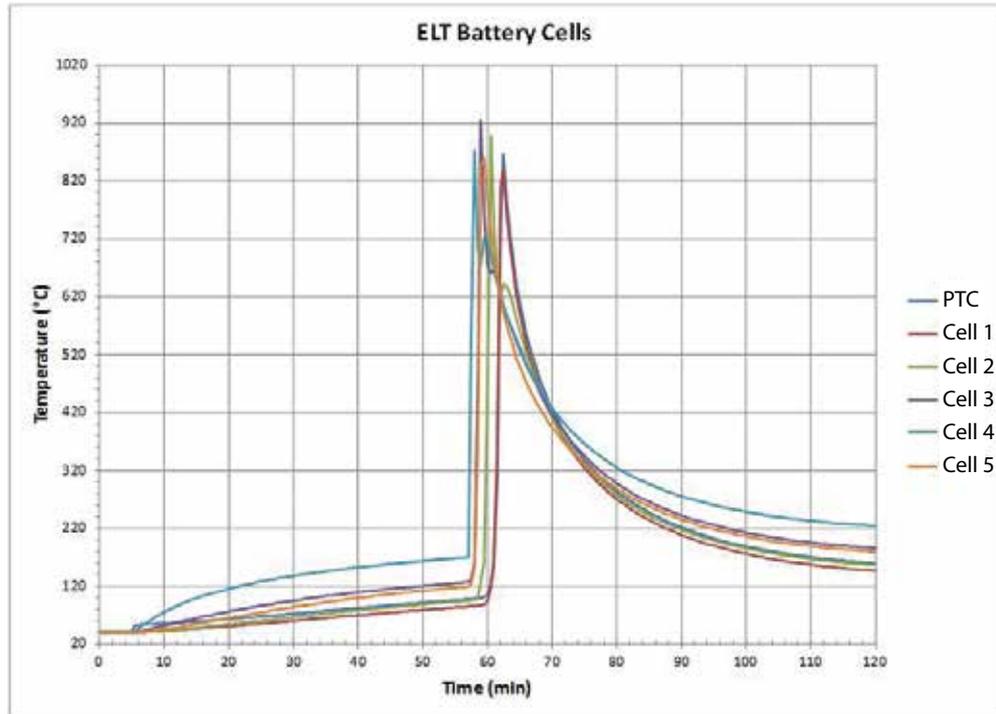
Figure 36

The high concentration of computational nodes on the battery cover plate was intended to allow simulation of the heat energy released from a short-circuit at the location of the pinched wires. The model assumed that this heat was dissipated in the cover-plate, in order to determine whether this heat load could cause failure of Cell 2 or 3 (closest to the pinched wires), before the PTC reached its trigger temperature of 118°C.

The model was run, and following the Cell 2 failure, it predicted a propagating thermal failure through the cell stack, with cell temperatures peaking at 920°C (Figure 36). The time from the initial cell failure to that of the last cell was 5 minutes. The model provided good correlation with the test results from the Root Cause testing.

Thermal model prediction of an event initiated by a short-circuit at the location of the pinched wires

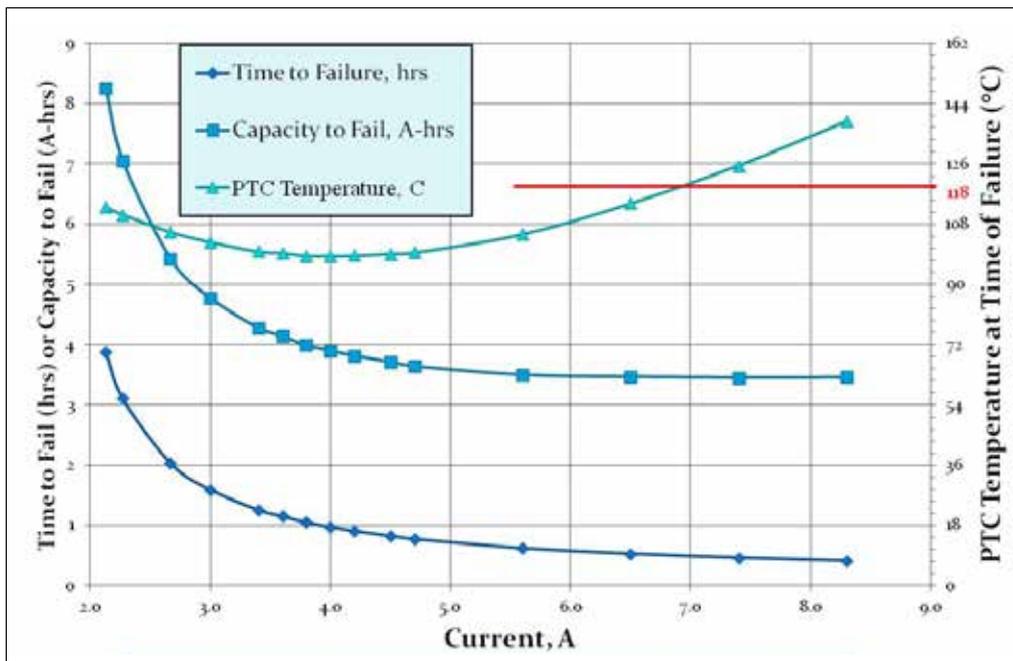
Further runs of the model were performed to estimate the possible range of short-circuit resistance values that could lead to a cell failure, prior to the PTC tripping. The results, over a range of possible short currents from 2A to 8.3A (PTC minimum trip current), are shown in Figure 37.

The model predicted that if the short-circuit current was less than approximately 2A, the heat from the short-circuit can conduct through the cell stack and ELT chassis. This would cause the temperature to exceed the PTC switching temperature (118°C). The PTC would therefore trip and protect the battery. (Note: the Capacity and Time-to-fail curves in Figure 37 become asymptotic at 2A).

PTC and cell temperature thermal analysis

As the short-circuit current was increased above 2A, the model predicted that Cell 2 could fail when the PTC temperature was below the switching temperature. It showed that the time to failure would drop from 4 hours to 30 minutes as the current increased.

The model showed that the predicted PTC temperature at the time of Cell 2 failure would reach a minimum, at a short-circuit current of approximately 4A. The PTC temperature would then increase as the current increased, due to the dissipated power losses (I^2R) within the PTC.

In summary, a short-circuit current of between 2A and 7A could lead to a cell failure without activation of the PTC. The results of this modelling broadly matched the results of the Root Cause testing, which indicated that a short current below 2A would not result in the PTC tripping.

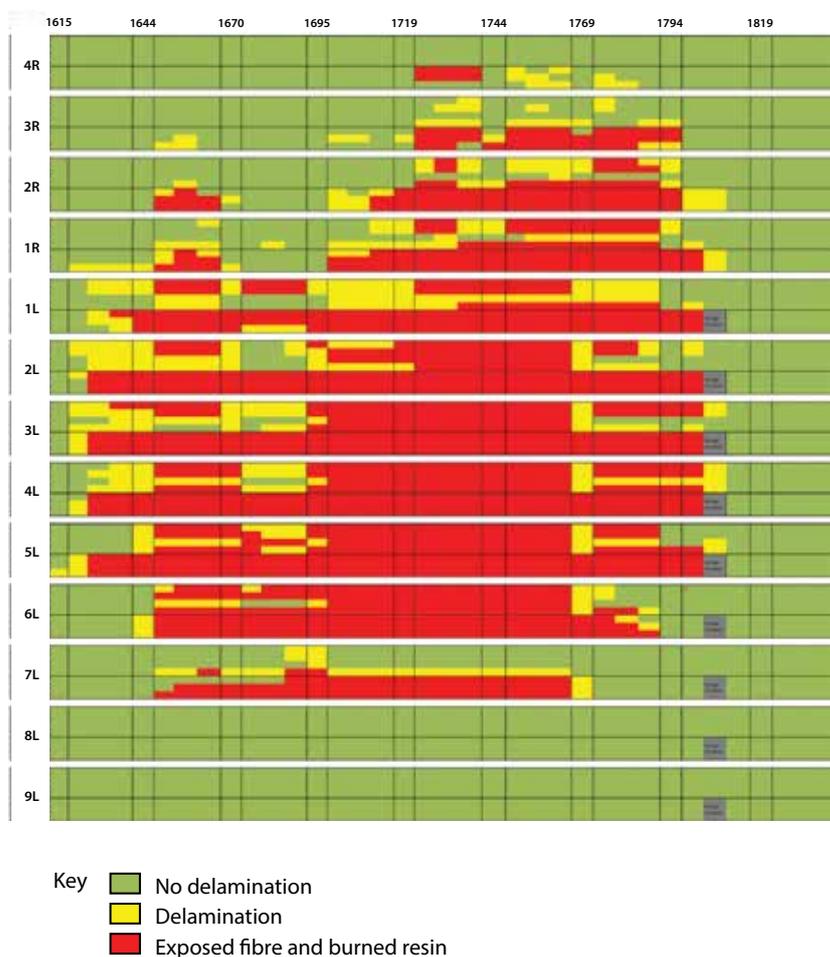
Figure 40

The two sets of results were combined to produce a composite picture of the condition of the crown skin and stringers (Figure 40).

Composite plot of crown skin-stringer ultrasonic test results

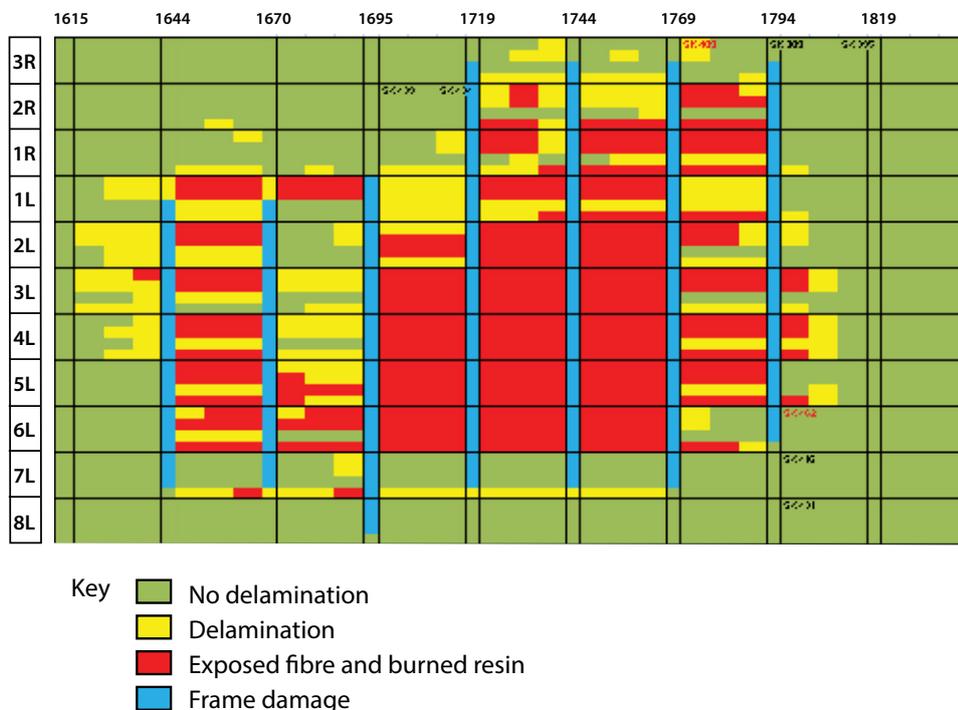
Figure 41

A number of frames exhibited evidence of burning on both sides of the frame, yet they still retained some structural integrity. This indicated that despite the visual damage, some resin was present within the CFRP. The use of X-ray examination confirmed that resin was present in the most damaged areas of all frames with the exception of frames 1719, 1744 and 1769, which were the closest frames to the ELT.

All the frames were manually scanned with ultrasonic probes and the damage boundary for each frame was identified. The transition area from heavily burnt sections of the frame to sections with no damage, was typically less than one to two inches.

The data provided by these tests was overlaid on the data obtained during the skin and stringer testing (Figure 40), to produce a combined representation of the delamination of the damaged fuselage structure (Figure 41).

Combined composite plot of skin and frame delamination

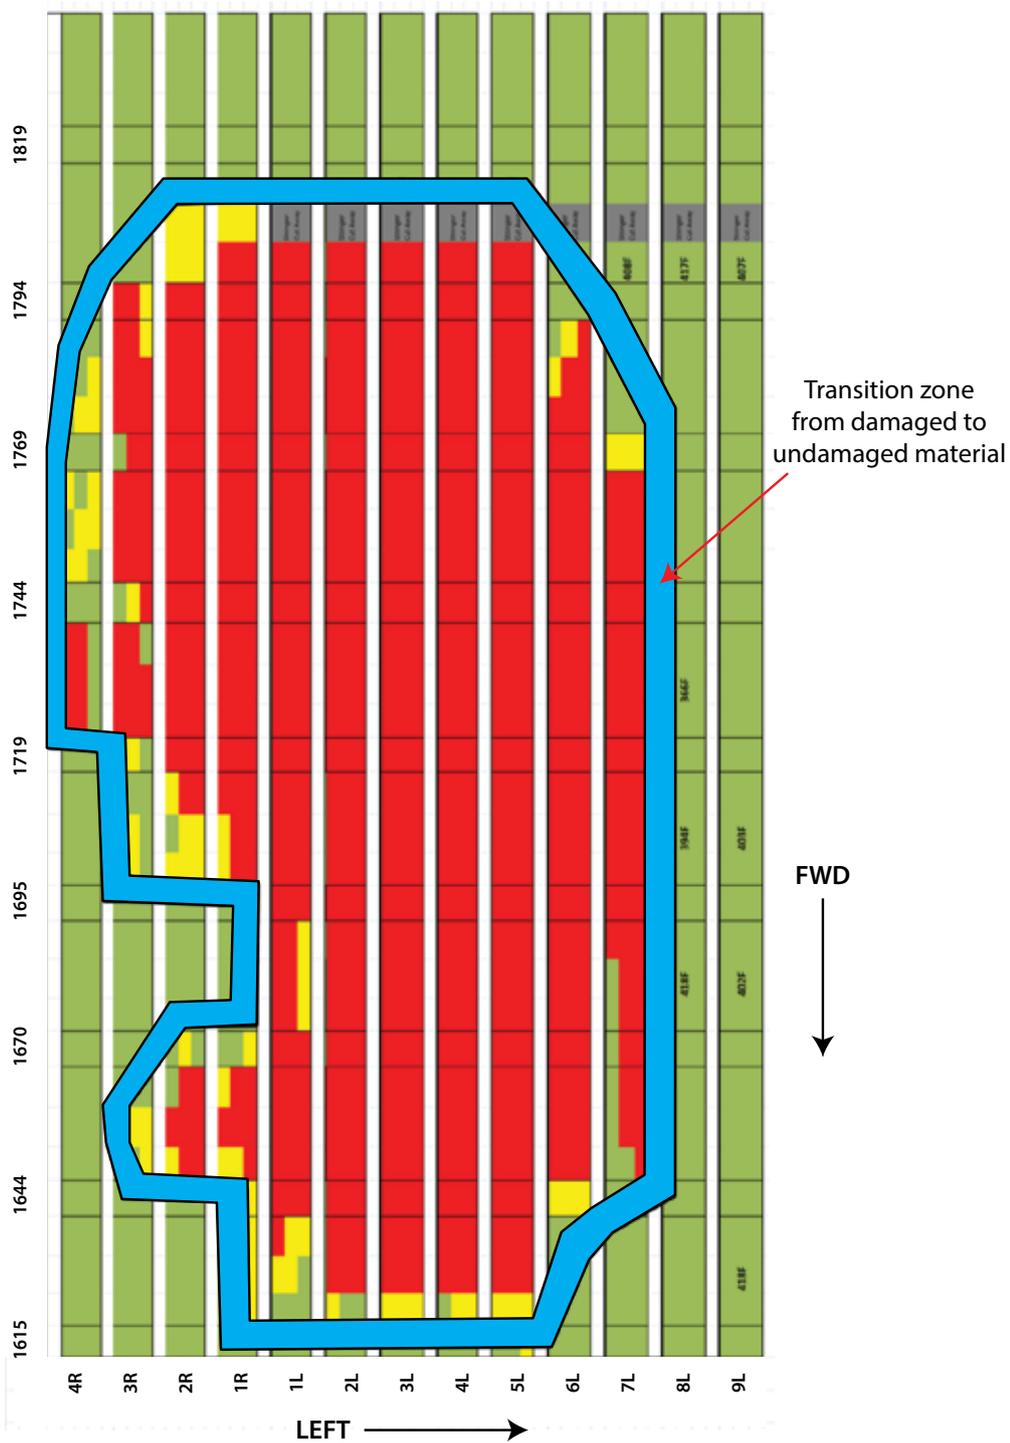
Figure 43

The FTIR technique was used to assess the condition of thermally degraded resin beyond the boundary of delamination. The results indicated that within the crown skin, the typical transition zone extended approximately six inches beyond the boundary of any delamination. The FTIR results were superimposed on the composite skin-stringer damage mosaic (Figure 42) to provide an overall image of the damage to the skin panels and the stringer webs (Figure 43).

Boundary of thermal damage on stringer webs

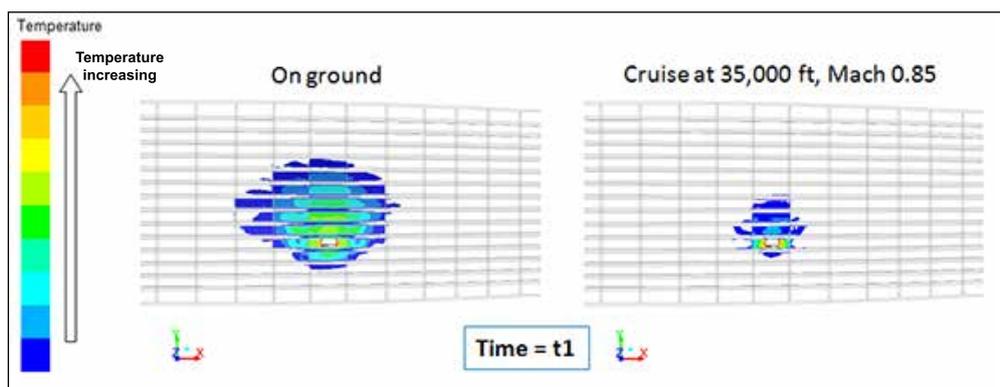
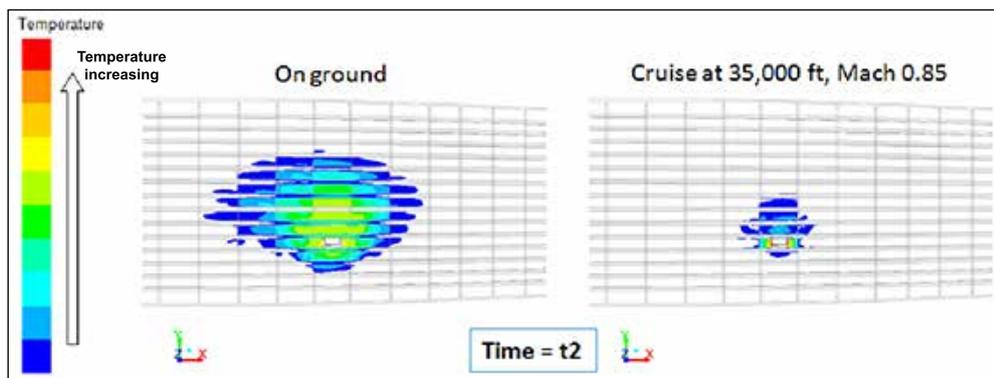
The FLUENT model was designed to replicate the thermal conditions on the ground during the incident and in cruising flight at an altitude of 35,000ft at Mach 0.85. In both cases a constant ELT heat source, a hot gas plume, was assumed. The results of the model are shown in Figures 44 and 45, which provide a side-by-side comparison for the on-ground and in-flight conditions at two arbitrary times, t1 and t2. Time t1 represents a point early in the heating process and t2 late in the process. The comparison between t1 and t2 is used to illustrate the trend in the temperature gradient between the on-ground and in-flight condition.

FLUENT model results at time t1

FLUENT model at time t2

The results of the FLUENT model illustrated that, using the on-ground conditions, the temperature of the fuselage skin would continue to increase with time and the heat-affected zone would grow; the in-flight case maintained a nearly constant skin temperature and the elevated temperatures remained local to the heat source.

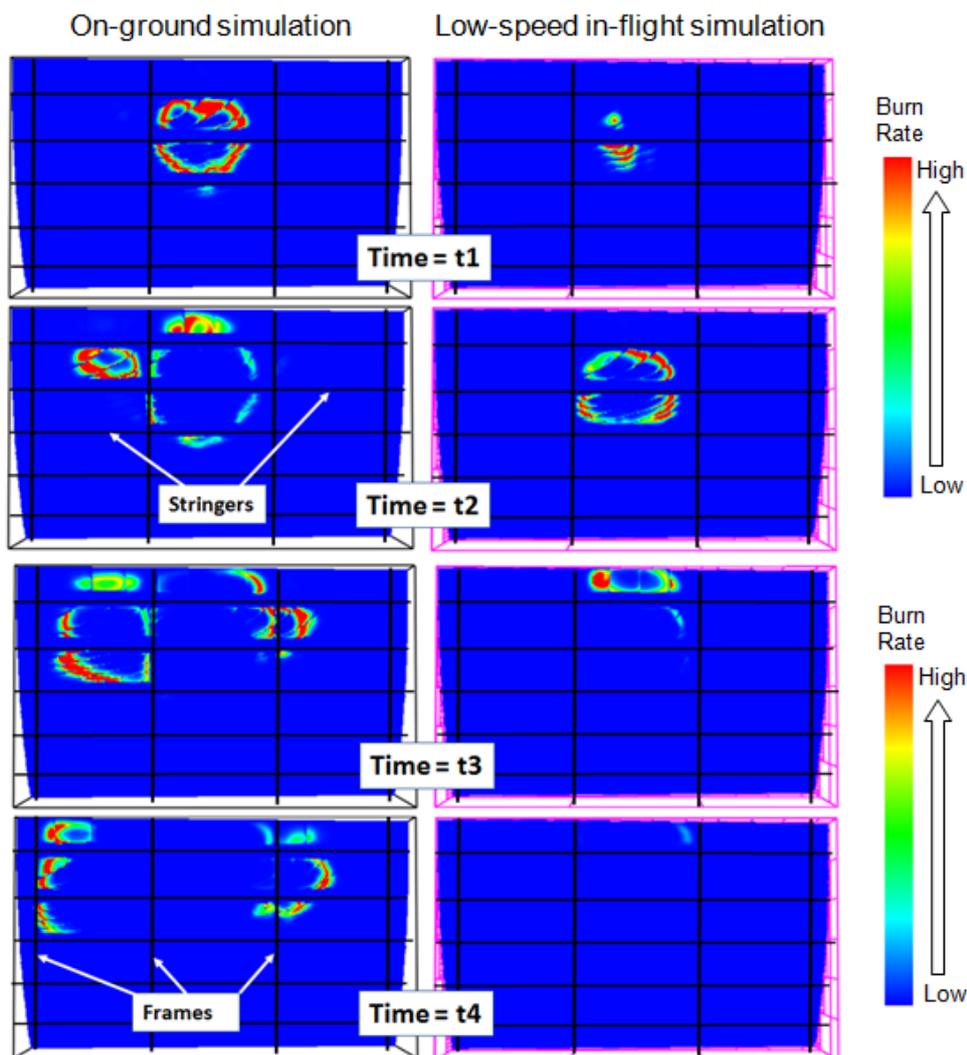
Figure 46

The fire progression in the on-ground and in-flight simulations at four arbitrary times, t1, t2, t3 and t4, are shown in Figure 46. The results show that the effect of external in-flight cooling decreases the flame propagation rate within the structure and limits the damage. It also demonstrates that when the heat transfer rate is high, the fuselage frames become a more effective barrier to fire progression, and the in-flight fire is restricted to a single bay before self-extinguishing. Had the model used a heat transfer rate more representative of cruise conditions, it is likely that this damage would be limited further.

FDS fire model results

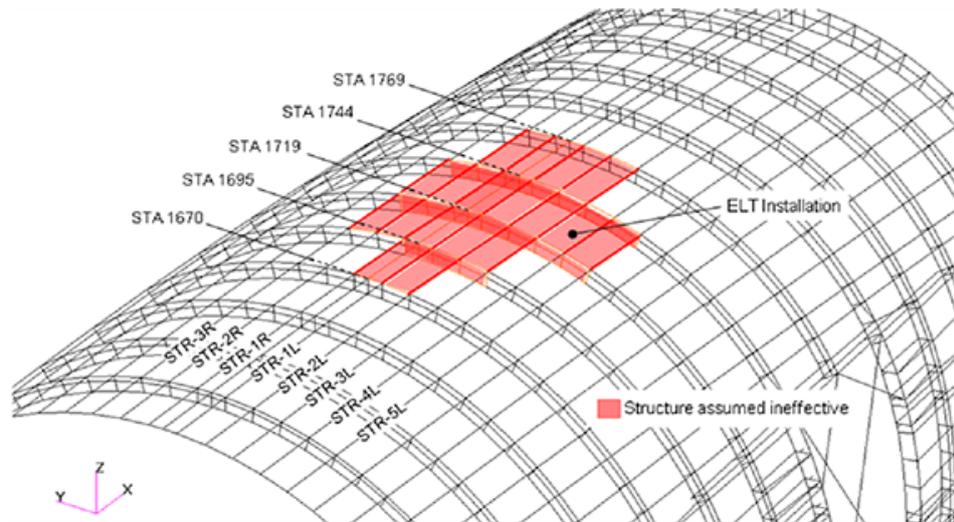
**Figure 47**

The first, a worst-case scenario, assumed that an area of structure equivalent to 18 stringer-frame bays (Figure 47), had no remaining structural strength and the adjoining bays had reduced strength. The results of the finite element modelling indicated that for this scenario cabin pressure would not be maintained but the fuselage would remain capable of carrying flight loads.

In-flight fire - large area of skin damage

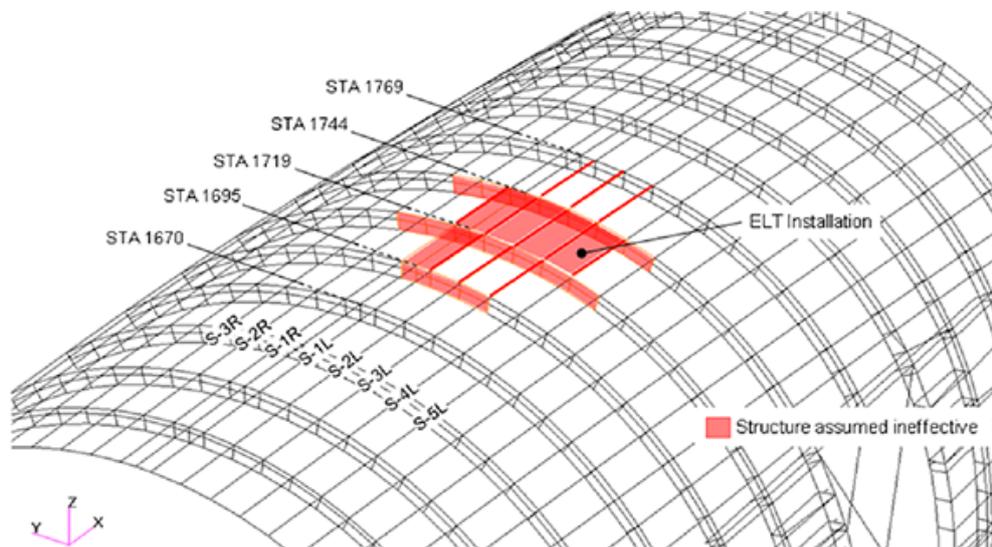
**Figure 48**

The second scenario, assumed that a smaller area of damage, equivalent to 5 stringer-frame bays, was unable to carry structural loads (Figure 48).

In-flight fire - small area of skin damage

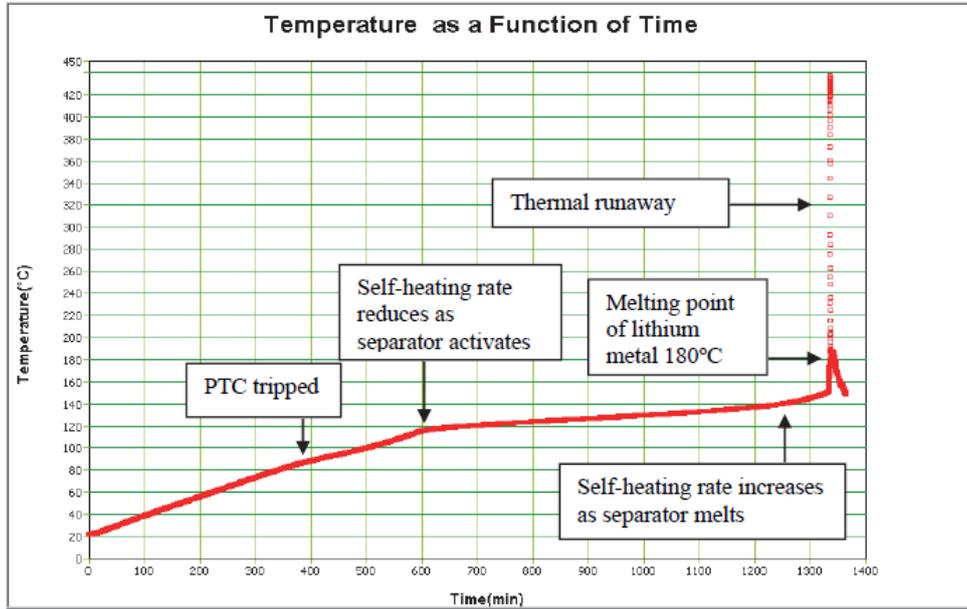
Figure B3

During discharge the battery temperature gradually increased over a period of approximately 8 hrs from an ambient starting temperature of 20°C, until at approximately 98°C, when the battery was 70% discharged, the PTC tripped. The self-heating rate up to this point had been between 0.1 and 0.2°C/min. The test configuration did not allow for measurement of the PTC leakage current or battery pack voltage after the PTC tripped.

At this point the Cell 2 temperature rose sharply, and as the temperature approached the melting point of lithium-metal (180°C) its voltage dropped to zero. This was accompanied by venting and decomposition of the cell under thermal runaway. The failure rapidly propagated to the neighbouring cells in the following order: Cell 1, Cell 3, Cell 4 and Cell 5. The maximum cell temperature measured during the test was 454°C on Cell 2 and the maximum self-heating rate was in excess of 1000°C/min. The results of this test are presented in Appendix B (ii).

Examination revealed that the cell cases were burnt and blackened from the decomposition. However, there was little evidence of carbon powder inside the calorimeter chamber, which indicates that prolonged open flame was not present.

Temperature (°C) versus time (min) for Battery Discharge Test 1
