Report on the investigation of  
a fire on board the RoPax ferry

***Dieppe Seaways***

on the approach to, and subsequently alongside,  
the port of Dover, UK  
on 1 May 2014

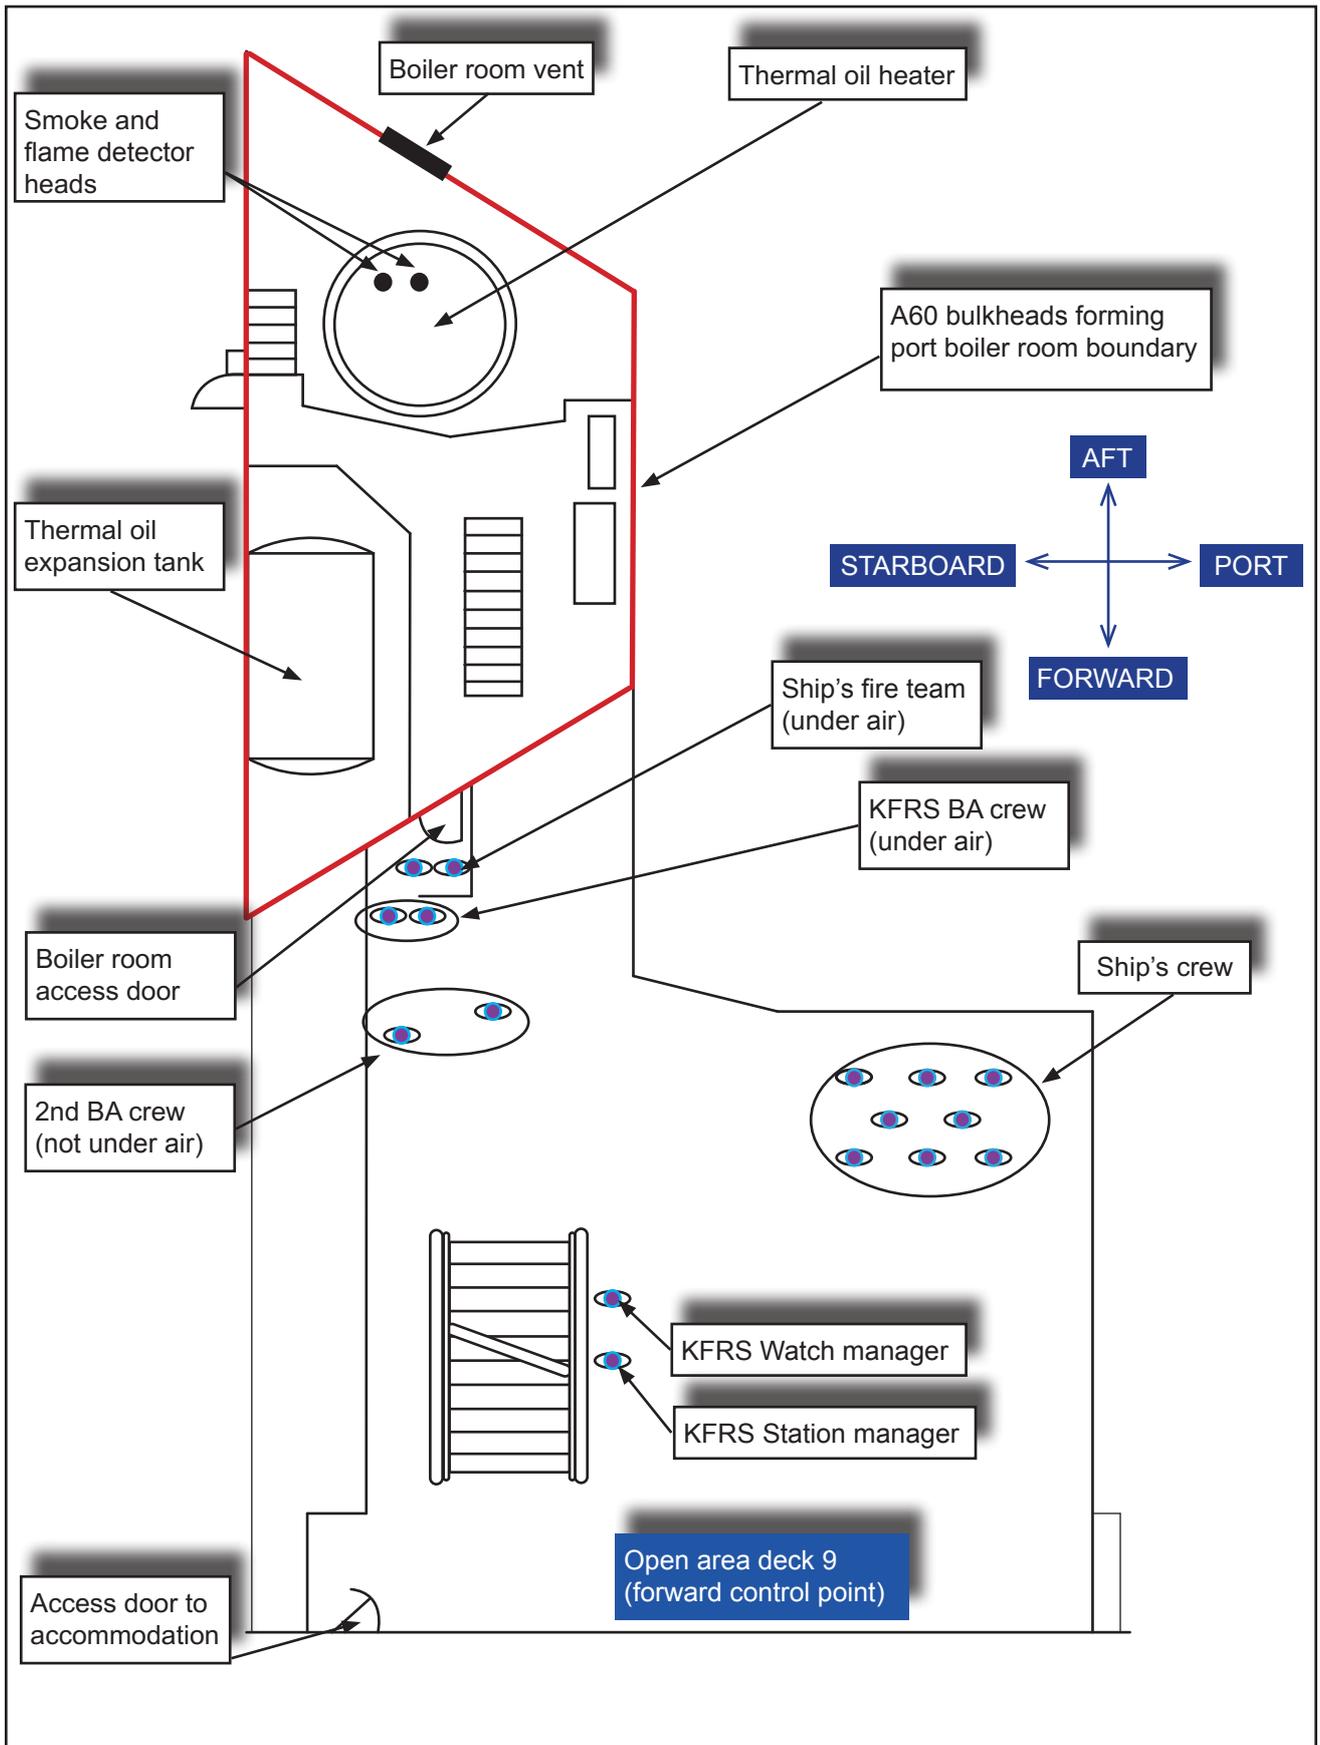
**Figure 2:** Diagram showing location of port boiler room and port thermal oil heater

At 1231, when *Dieppe Seaways* had reached a position approximately 3 nautical miles from Dover, an alarm sounded on the ship's fire detection system. The alarm source was identified as a smoke detector on deck 9 in the port boiler room (**Figure 2**). The master instructed a deck rating to proceed to the port boiler room to investigate the cause of the alarm. On arrival, the rating noted a light smoke haze in the compartment, but that there was no sign of fire and no indication where the smoke was coming from. He reported this to the master, who then instructed the bridge officer of the watch (OOW) to contact the machinery control room (MCR) and to direct the engine room OOW to investigate further.

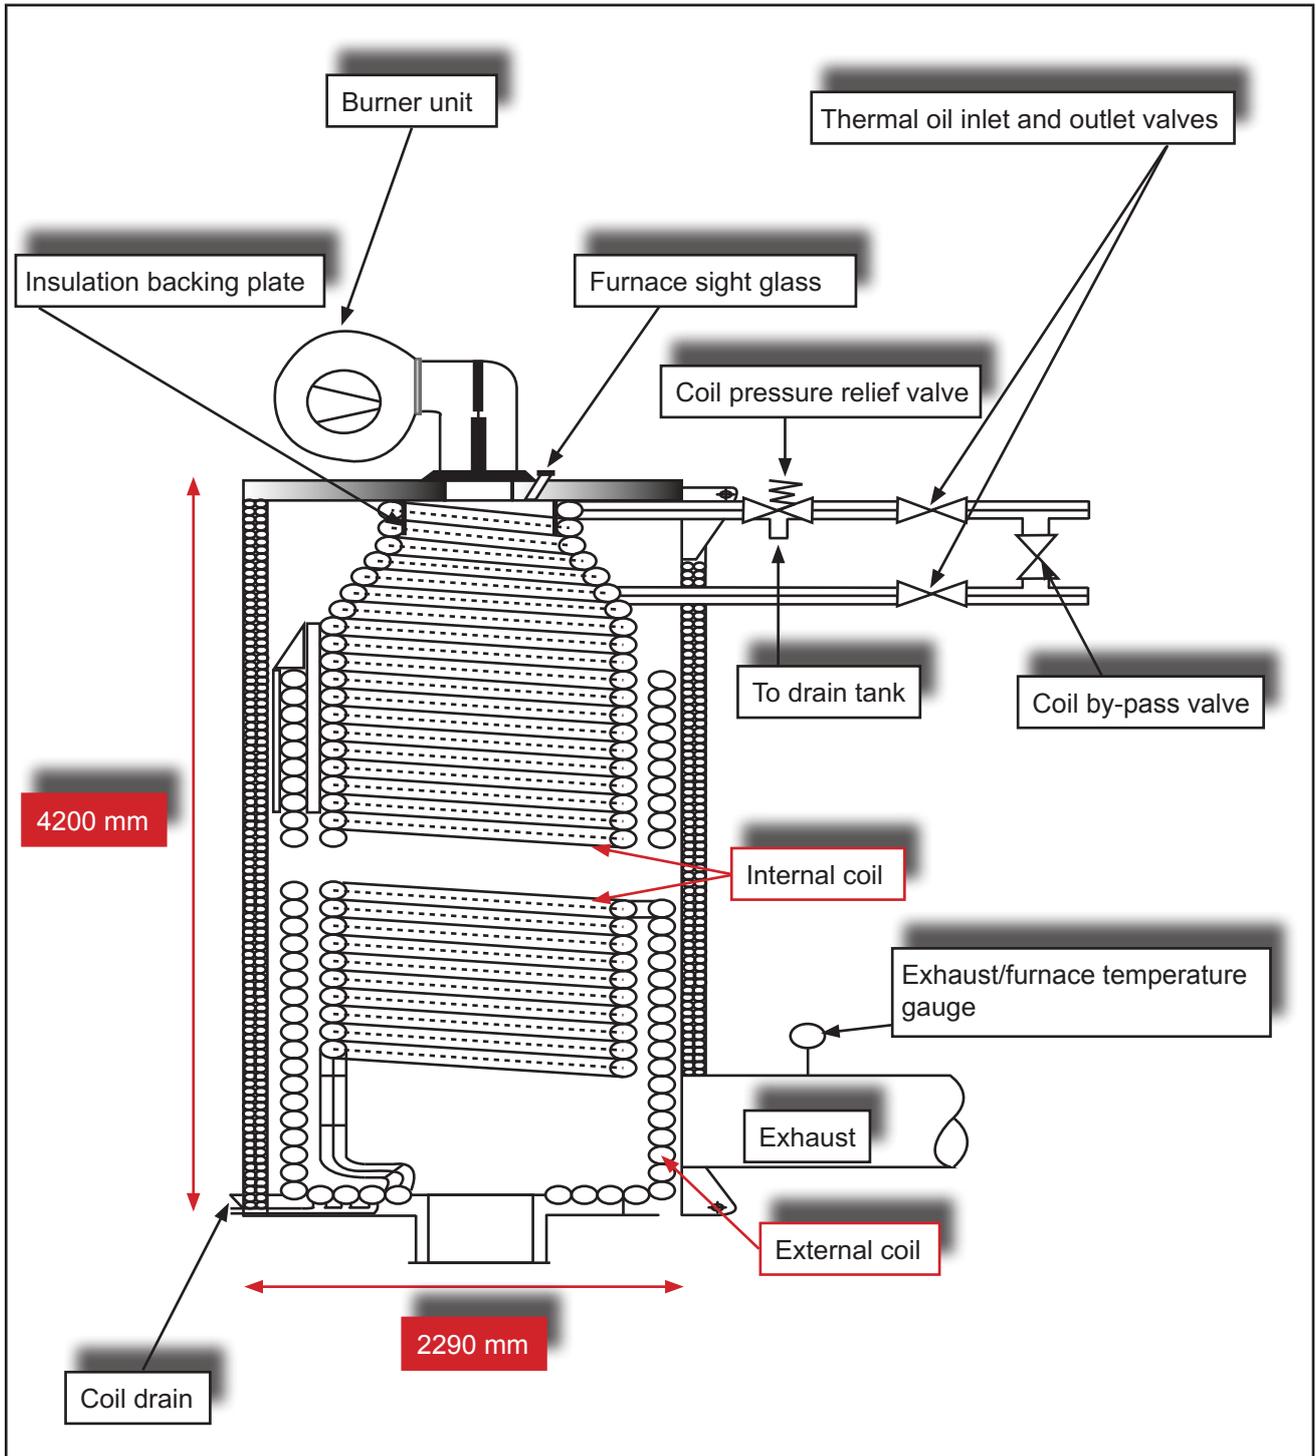
Figure 6: Diagram of the port thermal oil heater

The oil-fired thermal heaters were PWT DW III thermal transfer heaters. These were fitted with a roof mounted burner unit that could be operated using either HFO or MGO (**Figure 6**).

However, the section of coil that failed was particularly difficult to visually inspect due to the refractory insulation located in its vicinity. Furthermore, parts of the external coil (**Figure 6**) were inaccessible for visual examination.

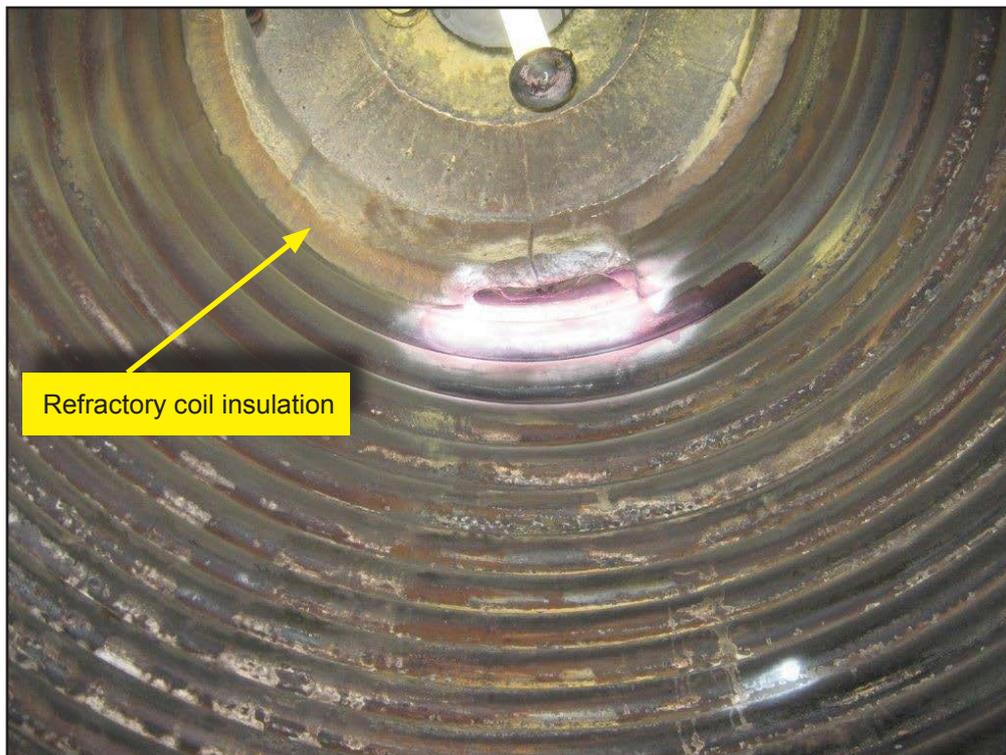
**Figure 7:** Photograph of internal view of a similar thermal oil heater furnace roof showing original refractory

The units were originally supplied with a fire cement type refractory protecting the roof of the furnace and the uppermost section of the thermal oil coil (**Figure 7**). At some point in the vessel's history, the coil refractory had been replaced with a ceramic matting type of insulation with the refractory being retained in way of the furnace roof. This is likely to have been carried out as a result of damage to the original refractory.

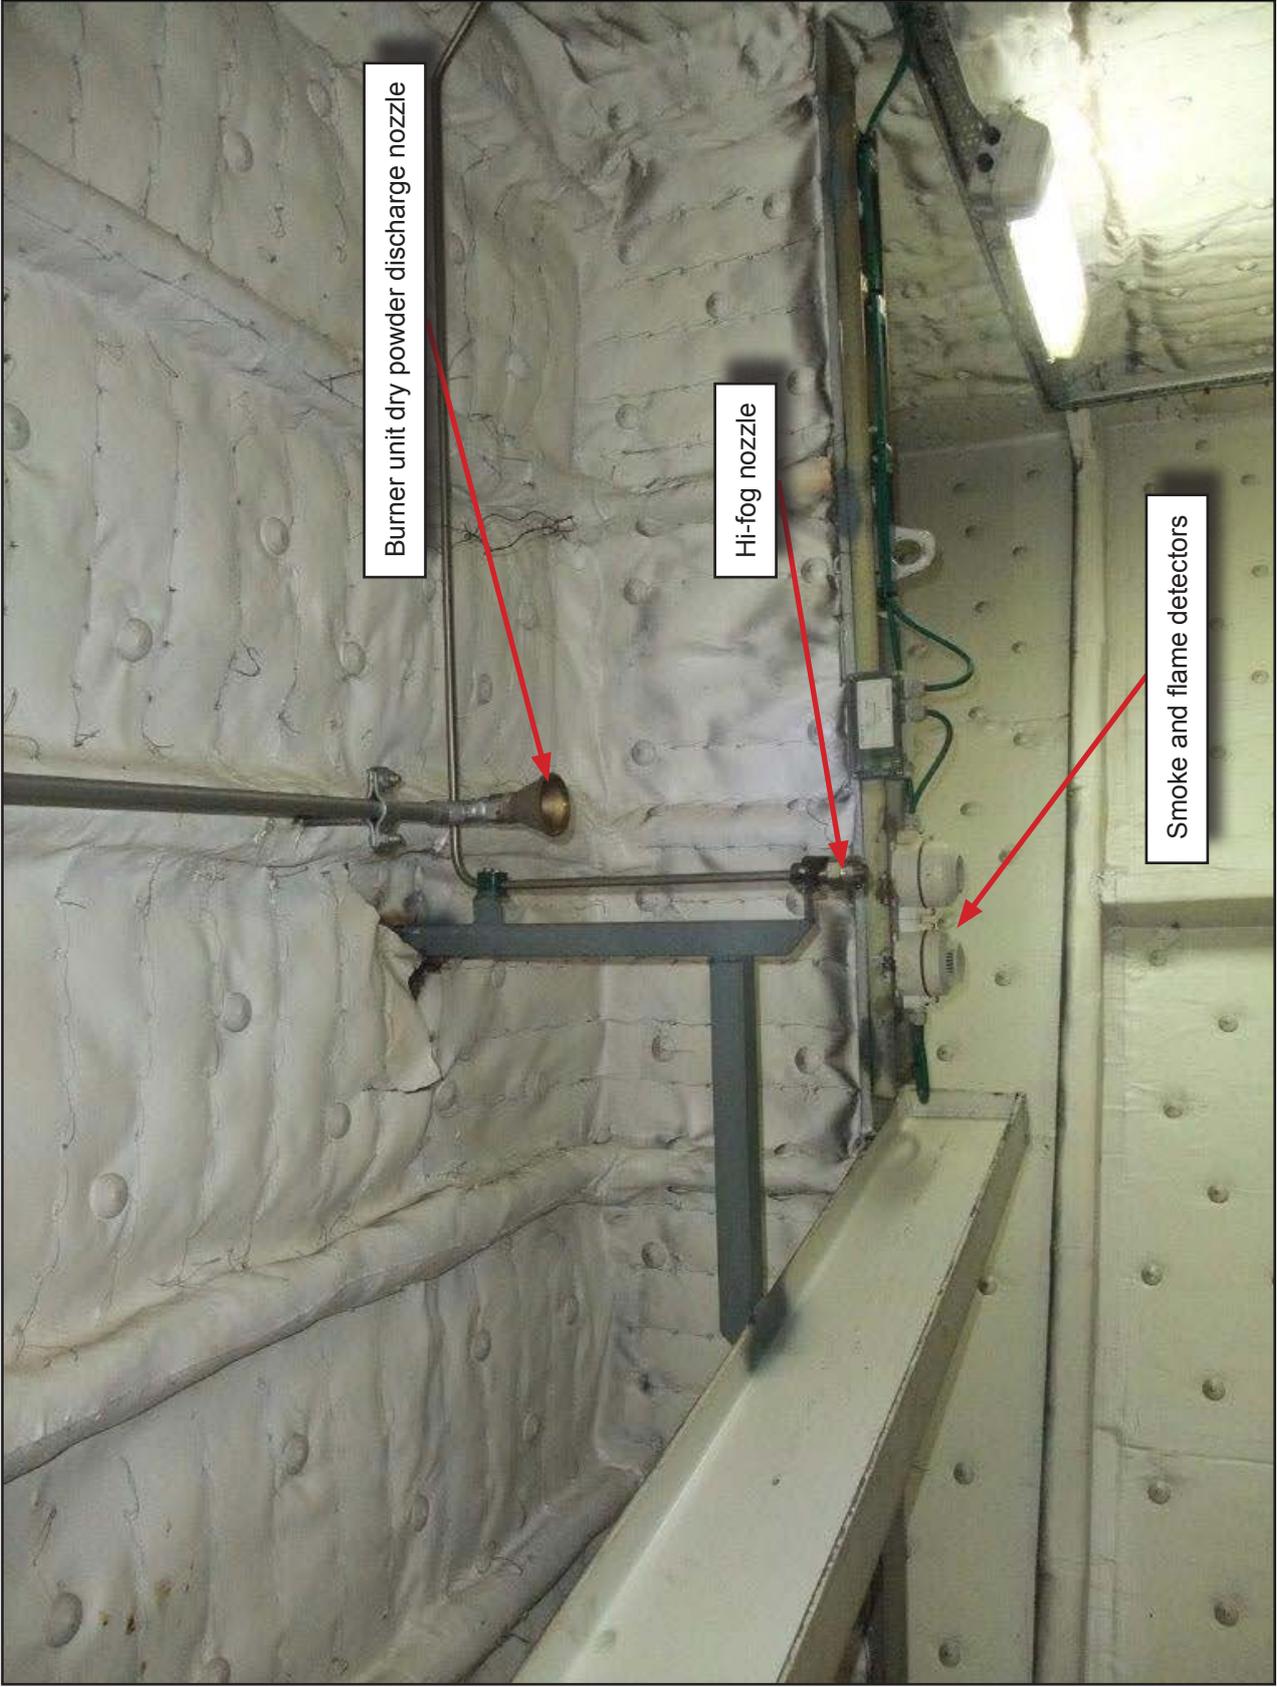
**Figure 8:** Photograph of boiler room fixed fire-extinguishing systems

The port boiler room was fitted with three fixed fire-extinguishing systems (**Figure 8**):

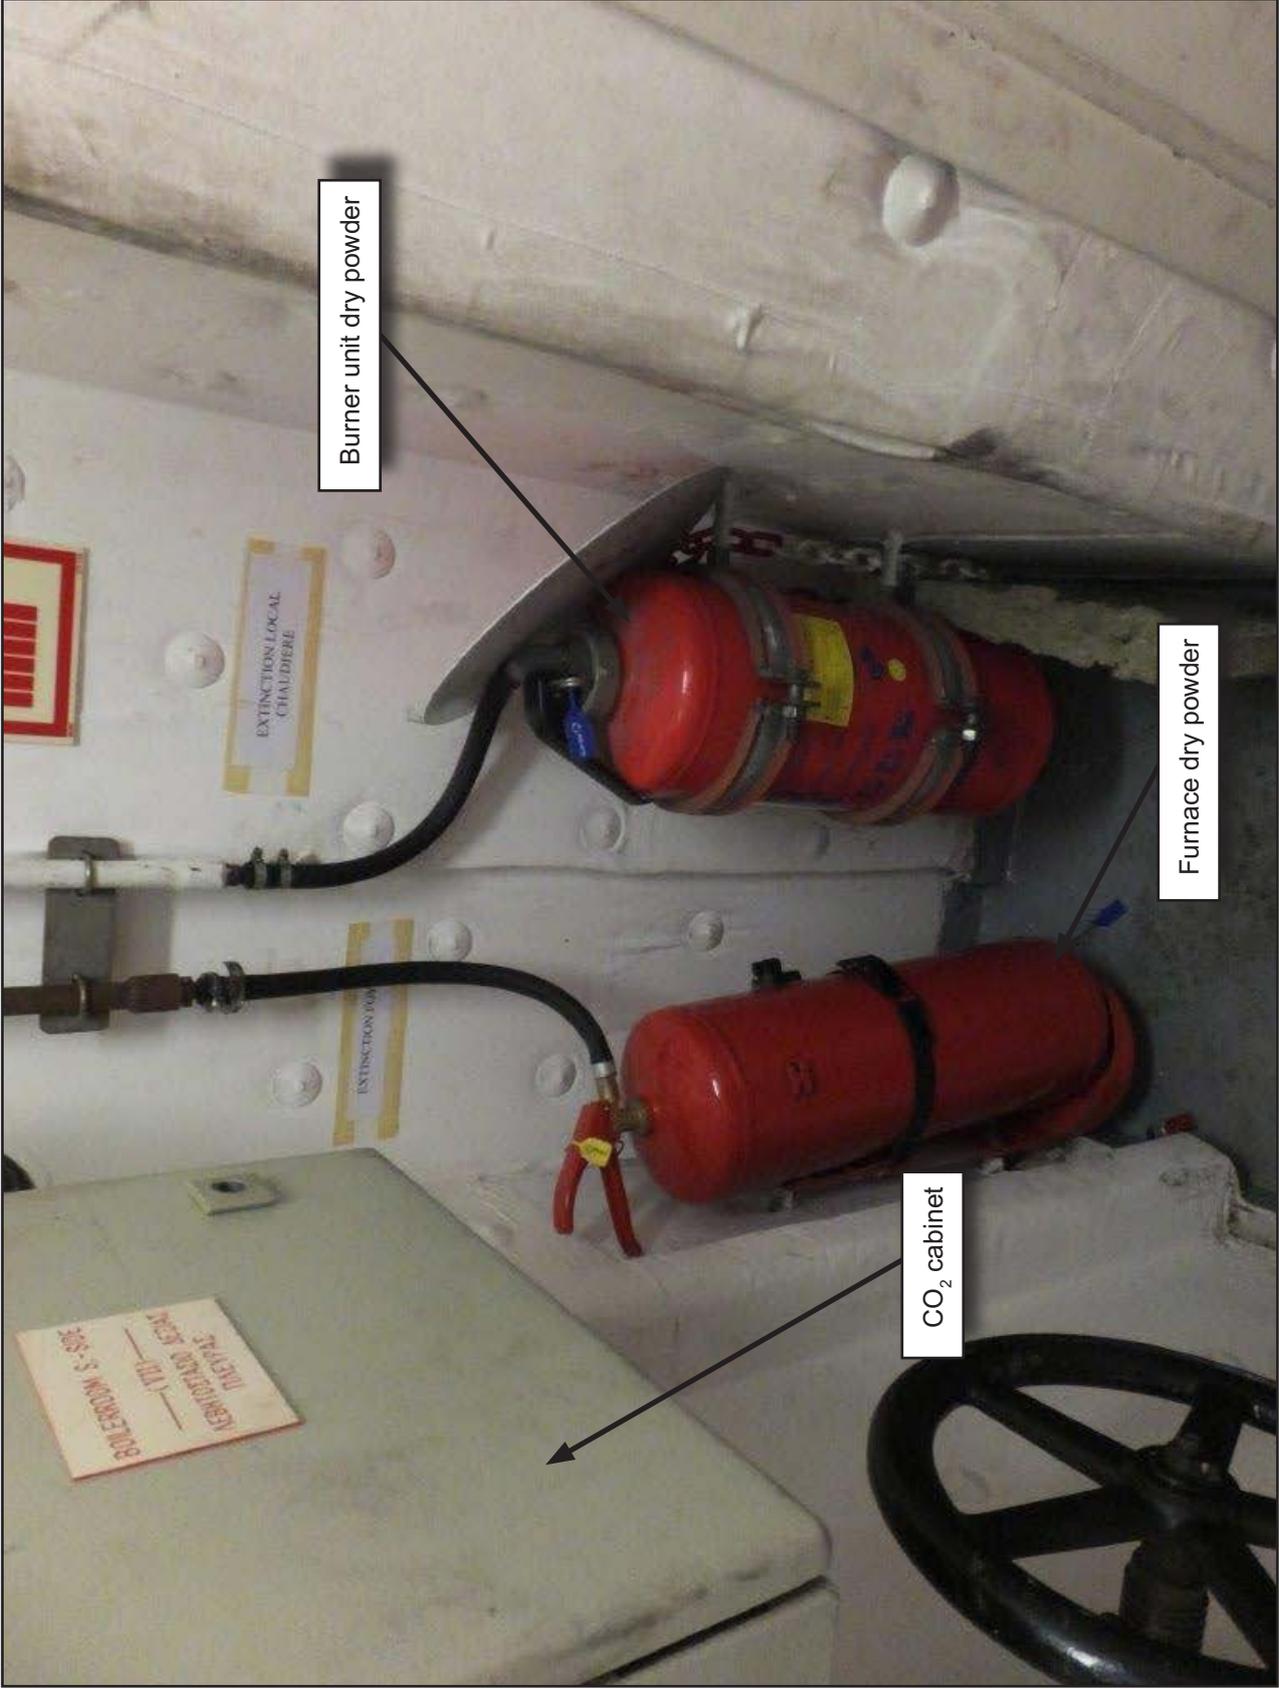
Figure 9: Photograph of fixed fire-extinguishing system control position

Following a previous coil failure and fire, the thermal oil heaters had been fitted with a furnace fixed fire-extinguishing system. This comprised a 15kg dry powder extinguisher (**Figure 9**) coupled by permanent steel pipework to an inlet in the top of the furnace. This system had been installed during the ship's previous ownership.

It was not approved by PWT and did not form part of the ship's mandated fire-extinguishing systems. It was a manually operated system with the extinguisher located at the fire control station on deck 7.
