Fatality following capsizing of Fletcher speedboat

Tor Bay

2 May 2015

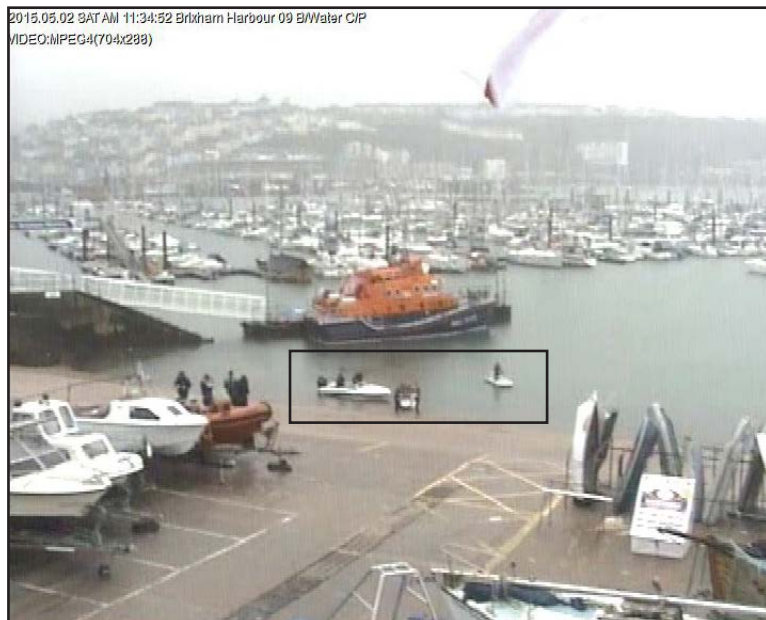
Figure 2: CCTV screenshot of fletcher speedboat and two jet skis at 1134 on 2 May 2015

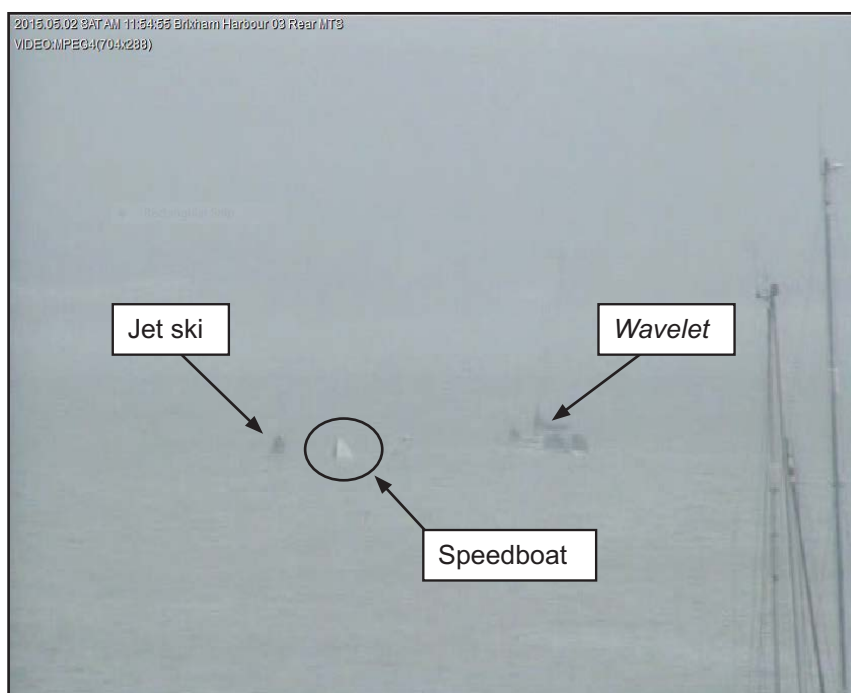
had glanced over his shoulder and seen the inverted speedboat. It quickly became apparent that Emily was missing, trapped under the boat, which sank by the stern until it settled floating in a vertical attitude with approximately 1m of its bow above the water (**Figure 3**). Numerous unsuccessful attempts were made by those in the water, including the jet ski drivers, some of whom removed their buoyancy aids to swim down, to try and release Emily.

Figure 3: CCTV screenshot at 1155 on 2 May 2015

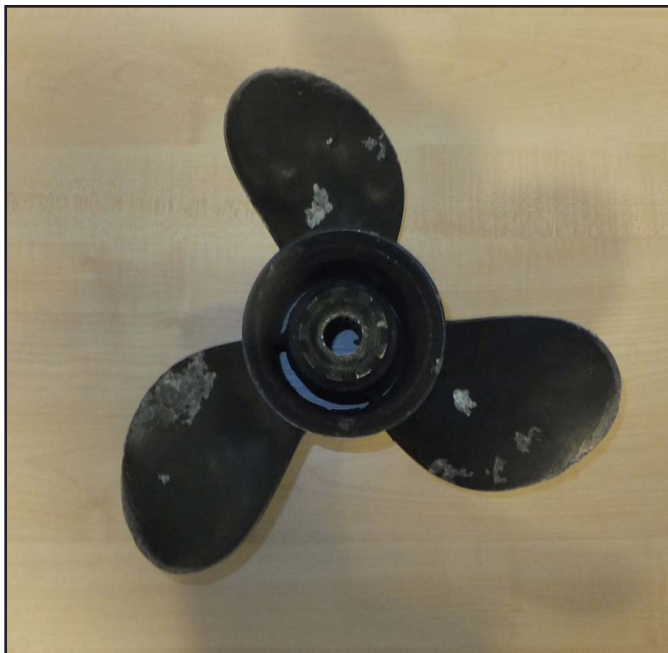
The speedboat was fitted with a two-stroke Mercury 75hp outboard engine. The full throttle rpm range was 4750-5250, with an idling rpm of 650-700. When purchased in August 2014, the engine was fitted with a Mercury three-bladed aluminium alloy propeller (**Figure 6**) of 13-inch diameter and 19-inch pitch⁵. The propeller was right-handed, meaning the propeller rotated clockwise when propelling ahead and viewed from astern.

Figure 6: Three-bladed aluminium alloy propeller
