SERIOUS INCIDENT

Aircraft Type and Registration:	Boeing 747-443, G-VROM	
No & Type of Engines:	4 General Electric CF6-80C2B1F turbofan engines	
Year of Manufacture:	2001 (Serial no: 32339)	
Date & Time (UTC):	29 December 2014 at 1334 hrs	
Location:	Near London Gatwick Airport	
Type of Flight:	Commercial Air Transport (Passenger)	
Persons on Board:	Crew - 18	Passengers - 447
Injuries:	Crew - None	Passengers - None
Nature of Damage:	Damage to right wing landing gear door and strike board	
Commander's Licence:	Airline Transport Pilot's Licence	
Commander's Age:	47 years	
Commander's Flying Experience:	12,279 hours (of which 9,771 were on type) Last 90 days - 162 hours Last 28 days - 95 hours	
Information Source:	AAIB Field Investigation

Synopsis

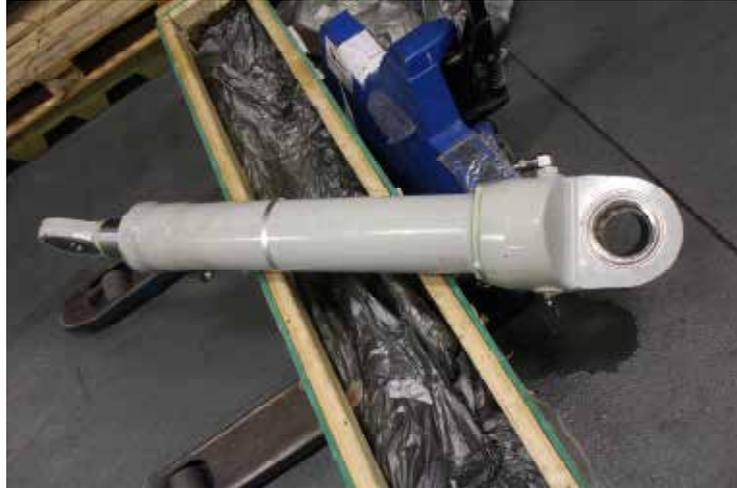
Figure 6

Extension and retraction of a wing landing gear leg is achieved by means of a hydraulically powered actuator piston. The head of the actuator is attached to a hanger within the structure of the wing, with the rod end of the actuator attached to the gear leg trunnion. When the gear leg is in the retracted position, the actuator piston is also retracted and fits within an enclosed location created by 'walking beams', which run either side of the actuator, and the top of the landing gear bay (see Figure 7). The actuator is a large component weighing approximately 85 kg. In order to accommodate movement of the actuator body during the extension/retraction cycle, the actuator is attached to the aircraft hydraulic system by means of two braided flexible hoses. Each hose is connected to a port on the body of the actuator, one located on the top and the other on the bottom at the opposite end of the actuator body. The port at the head end of the actuator is labelled 'UP' and is located on the bottom of the actuator, whilst the port labelled 'DN' is located on the top of the actuator at the opposite end. Apart from a bleed valve on the opposite side of the head of the actuator to the port, there are no other distinguishing labels or features on the actuator to assist with orientation.

Wing landing gear actuator
