AIRCRAFT ACCIDENT REPORT 3/2015

**Report on the accident to
Eurocopter (Deutschland) EC135 T2+, G-SPAO
Glasgow City Centre, Scotland
on 29 November 2013**

Air Accidents Investigation Branch

Published 23 October 2015

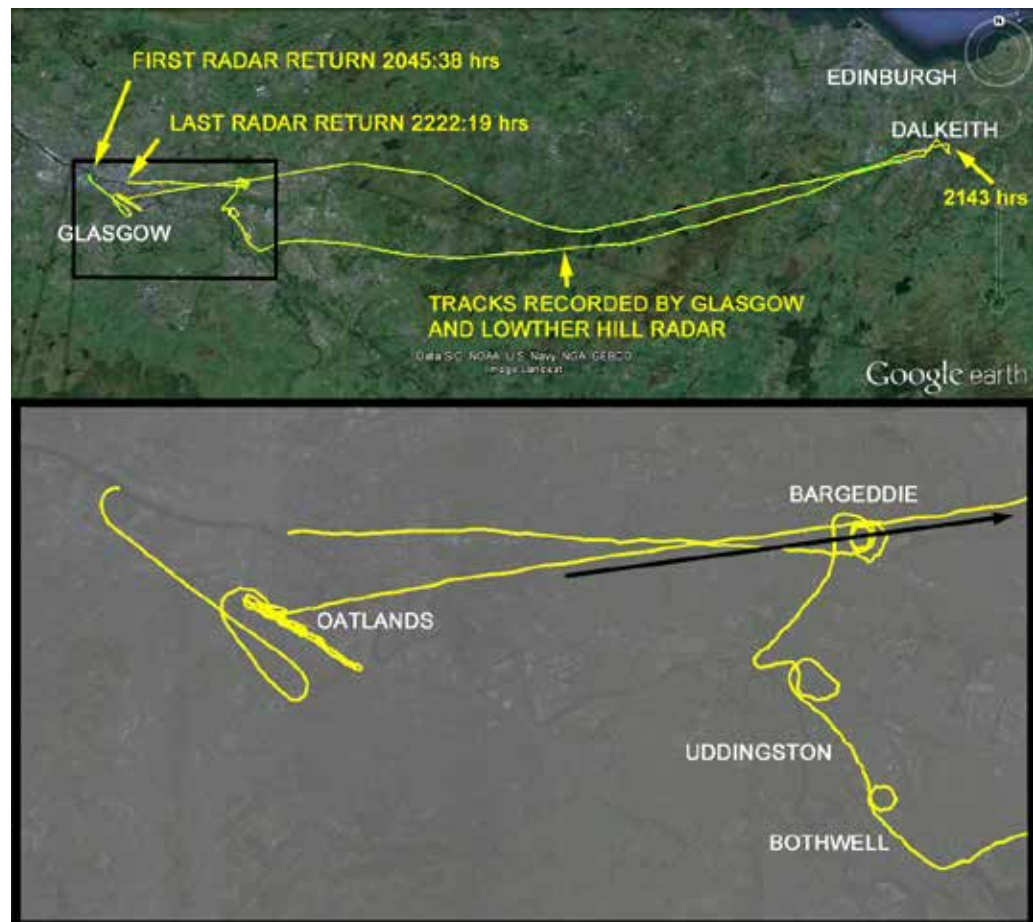
Figure 1

The helicopter tracked towards GCH at an altitude of about 1,000 ft amsl, with a ground speed of approximately 100 kt. Between 2221:35 hrs and 2221:45 hrs, when the helicopter was about 2.7 nm east of GCH, the right engine flamed out, leaving the pilot with one engine inoperative (OEI). Approximately 32 seconds later, about 1.8 nm east of GCH, the left engine flamed out.

Overview of the helicopter's flight path

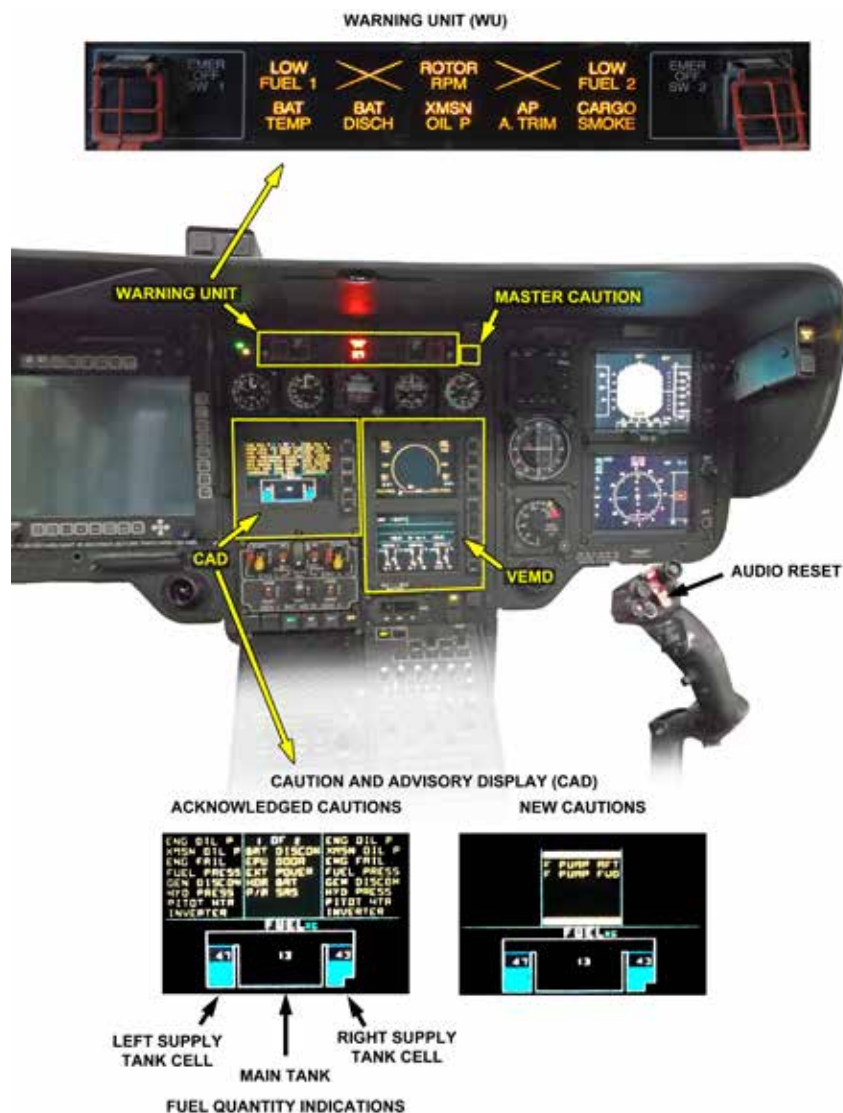
Figure 2

The Warning Unit (WU) is situated centrally on the instrument panel just beneath the cockpit glareshield (see Figure 2). This provides visual and audio indications when warning conditions are triggered. The WU accommodates eight warning captions. They appear red when illuminated and are unlit when inactive. Each caption simultaneously initiates an audible attention-getter 'gong'. The audio for some of the warnings can be silenced using the audio reset button on the top of the cyclic control stick but a visual warning cannot be cleared while the warning condition remains. All warning gongs are audible to the pilot and Observers, through their headsets. All warning captions can be dimmed for night operation.

Warnings, cautions and systems displays

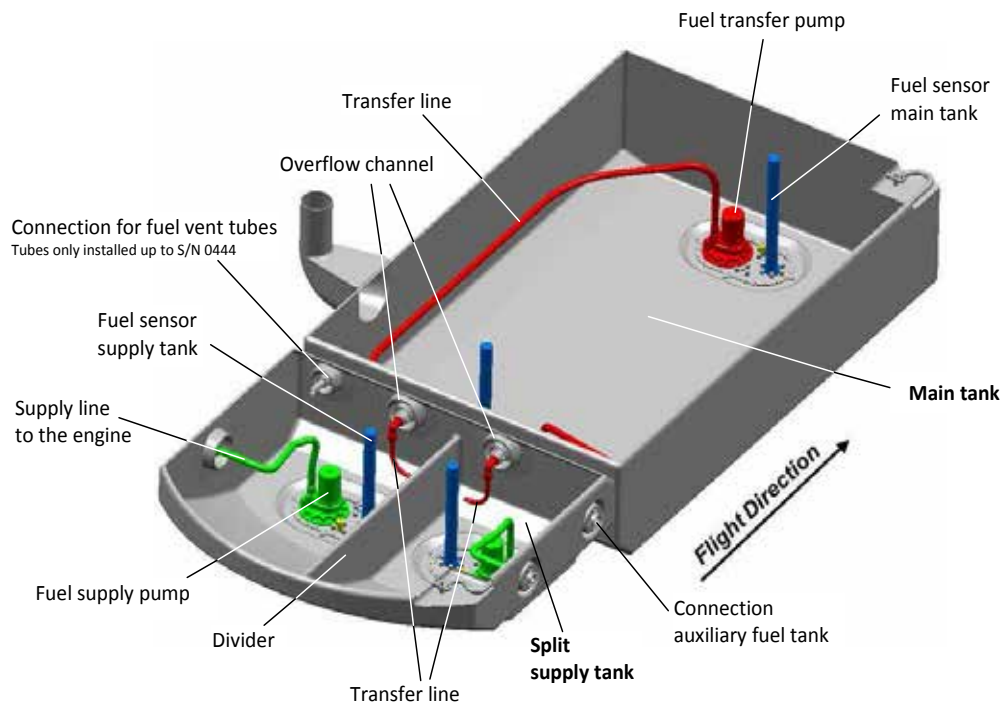
**Figure 3**

Two overflow channels connect the main tank to the supply tank. So, with the system fully replenished, or almost so, fuel can flow freely between the two tanks. The overflow channels are positioned with their lower edges close to the level of the top of the supply tank divider. See Figure 3.

EC135 fuel tank arrangement

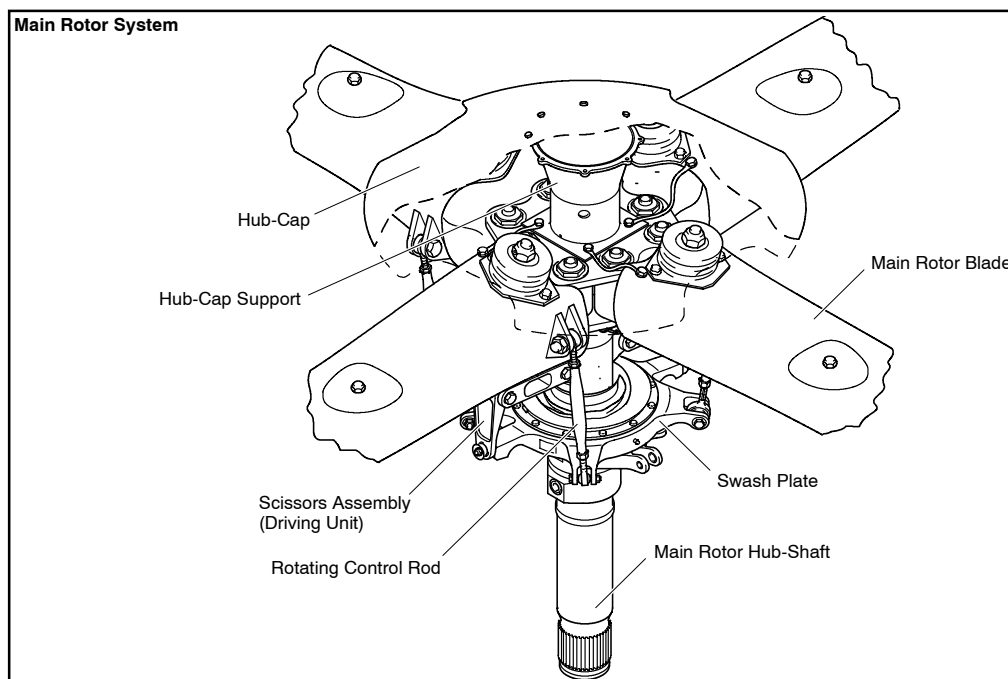
The EC135 main rotor head is of a rigid design and composite construction. There are four main rotor blades, each of which is attached to the steel alloy rotor hub shaft flange plates by two bolts. At the root of each blade there is a 'flexbeam', made of a cruciform section composite material, which absorbs the centrifugal tensile loads. It is designed to twist, to accommodate pitch changes, bend in the vertical plane, to absorb flapping loads, and bend in the horizontal plane, to absorb lead and lag drag loads. The flexbeam is surrounded by the blade cuff.

Figure 5
EC135 main rotor head assembly

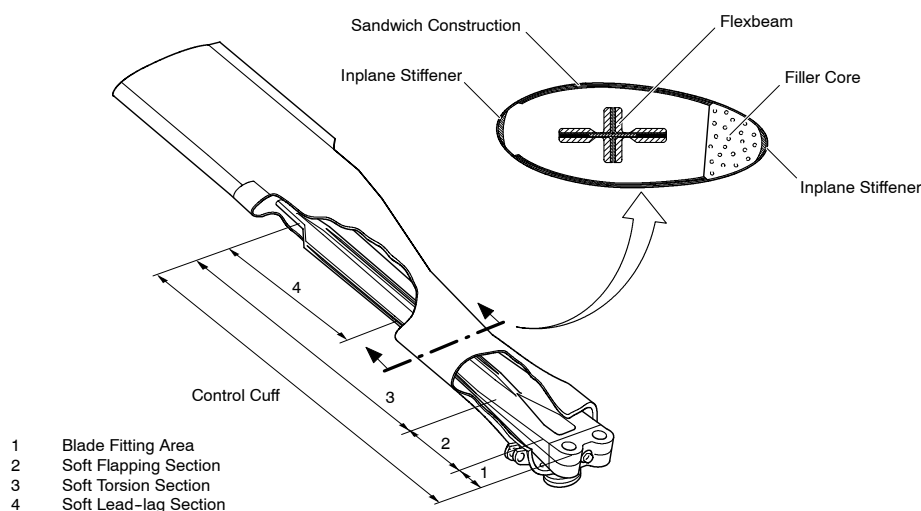
Figure 6

The blade cuff is integrated into the blade skin and surrounds the flexbeam to provide a streamlined transition from the aerofoil section of the blade to the blade root (see Figures 6 and 7). The pitch angle of the main rotor blade is adjusted through a pitch horn, integral to the cuff. The cuff and flexbeam are held in alignment by a link rod, which passes through a spherical bearing in the flexbeam, and is attached to elastomeric¹³ mountings on the upper and lower surfaces of the blade cuff. The elastomeric mountings provide sufficient in-plane lead-lag damping of the main rotor blade to prevent ground and air resonance, within the normal operating N_r (rotational speed of the rotor blades) range.

EC135 main rotor blade

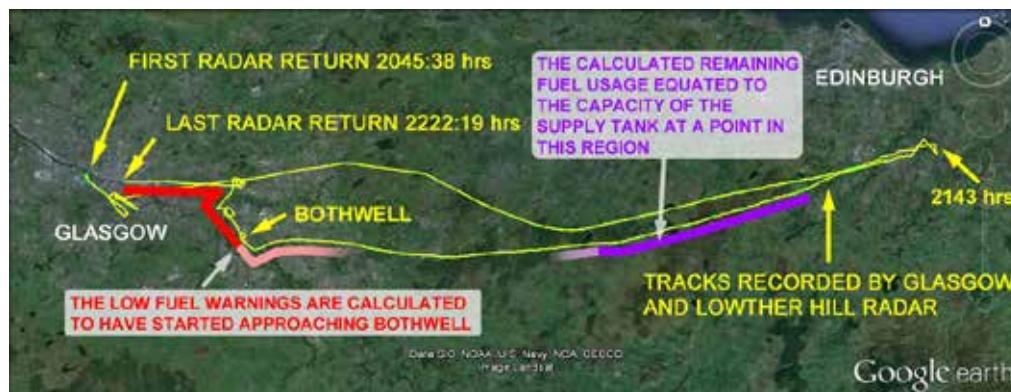
**Figure 8**

Helicopter's track, with calculated fuel contents

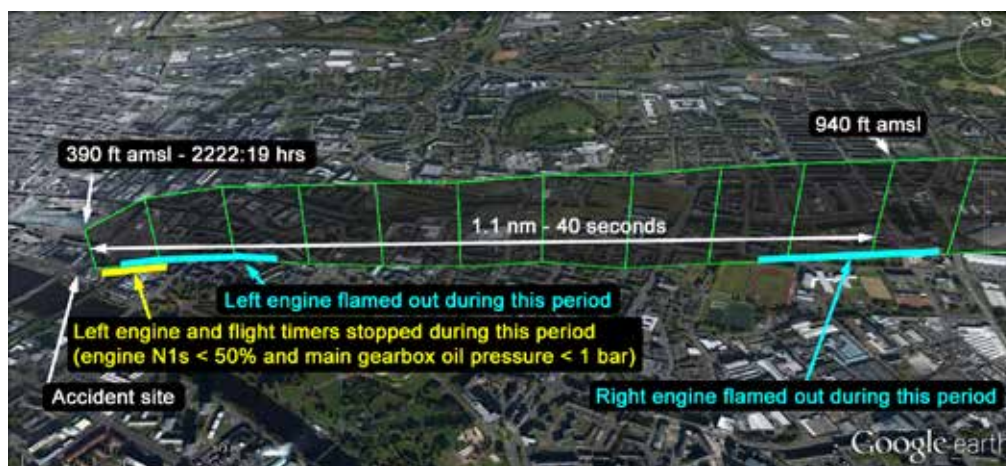
**Figure 10**

The flight path at the end of the flight, derived from radar recordings, is shown in Figure 10.

Flight path at the end of the flight

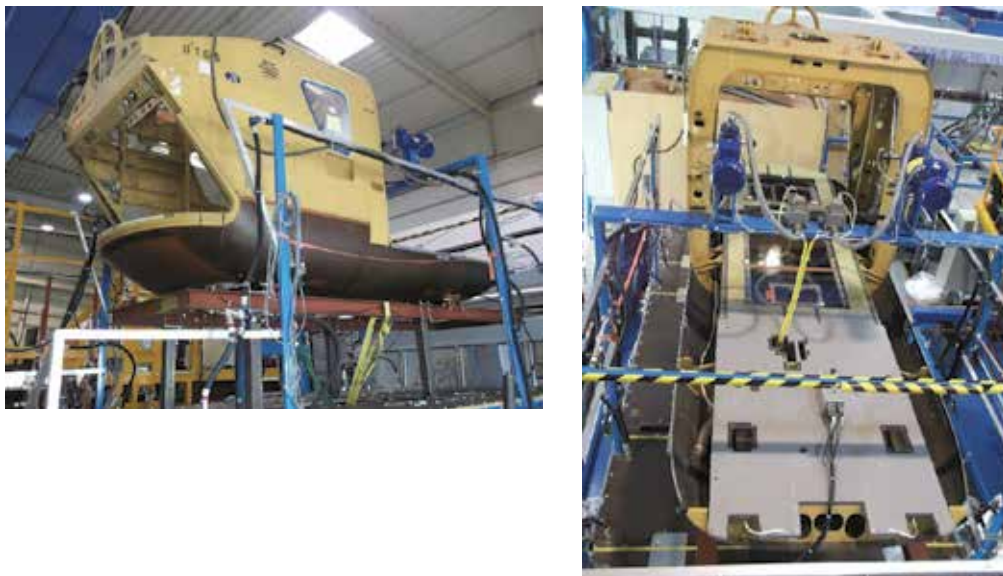
Figure 12

The operator reported that water and compressor washing fluid was entering the fuel tanks of their EC135 fleet under a cold compressor washing routine and this appeared to be happening at random. Furthermore, it seemed to occur a few flying hours after the compressor wash. Using the test rig, it was found that a water and fuel mix, which accumulated in the ventilation system expansion tank, could find its way back into the fuel tanks, due to helicopter pitch and roll movements. However, for this to occur, there needed to be approximately 800 ml of water-contaminated fuel in the expansion tank, enough to cause the water globules at the bottom of the fuel mix to overflow the small lips created in the base of the tank by the ventilation line pipe unions. This explained the in-service experience, that the phenomenon occurred randomly and could not be predicted.

EC135 Articulated Fuel System Test Rig
