Report on the investigation of  
the capsize and foundering of  
the fishing vessel

***Ocean Way FR349***

100 miles north-east of Tynemouth

on 2 November 2014

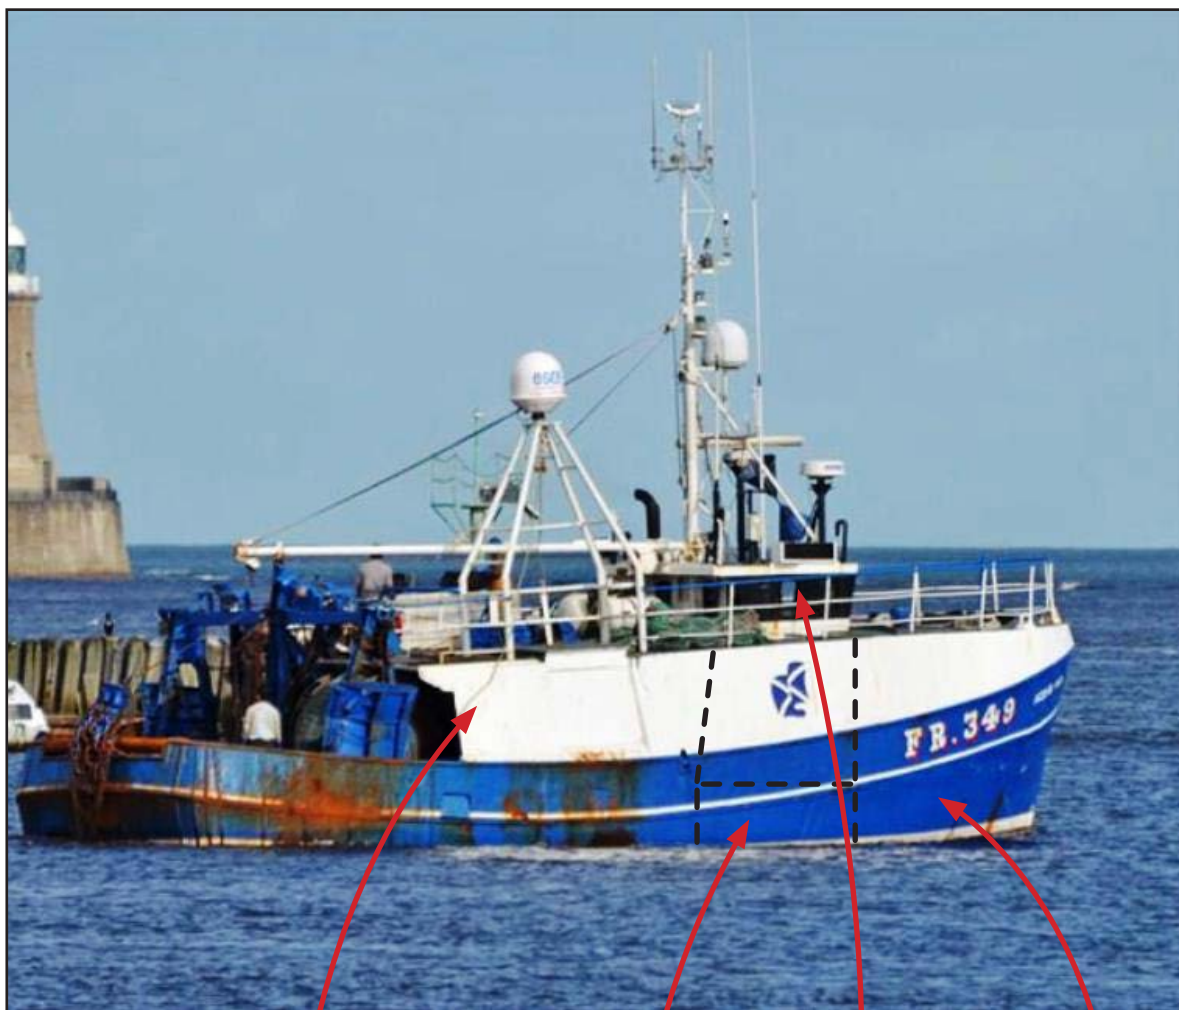
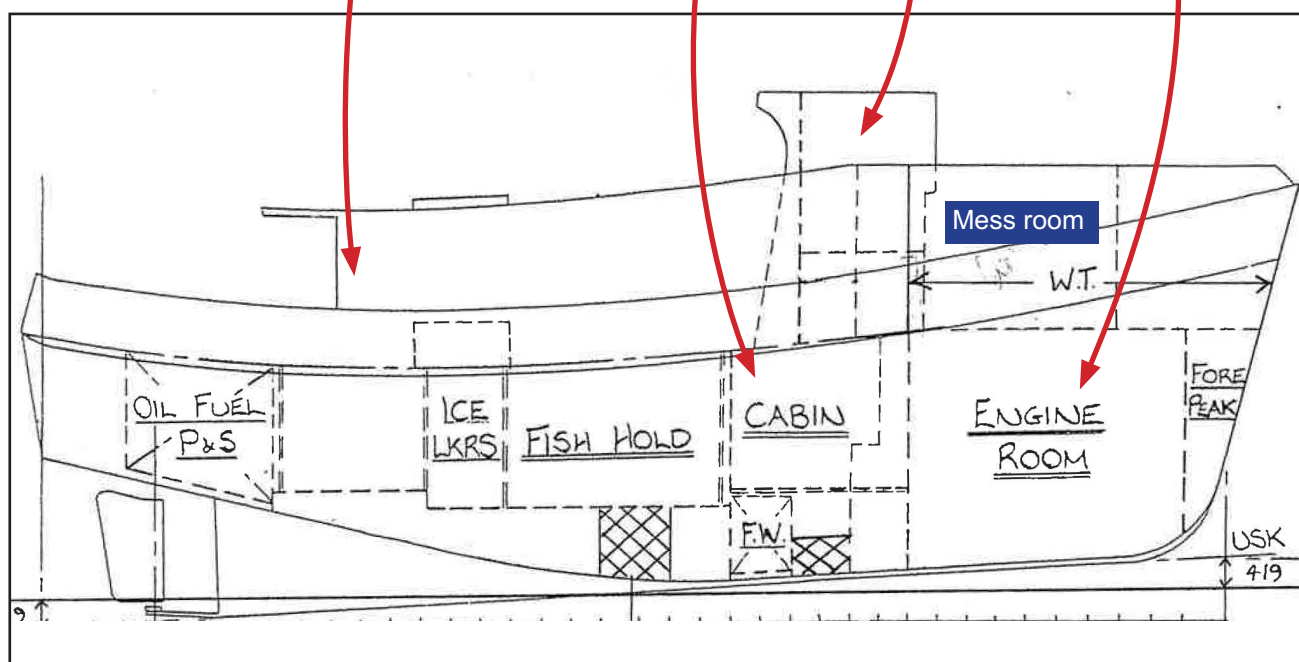
**Figure 1:** *Ocean Way* - general arrangement

The skipper remained in the wheelhouse as the sole watchkeeper until he was relieved by one of the crew at 0200 the following day. He then went below to rest in the communal cabin (**Figure 1**). At 0500 the watchkeeper temporarily left the wheelhouse to check the engine room, where he pumped out the bilges. On his way back to the wheelhouse he noticed that water was being shipped on the main deck under the shelter. He did not consider this to be unusual.

Two crewmen climbed out of the cabin, through the mess room and onto the main deck before climbing onto the top of the shelter via a vertical ladder on the starboard side of the accommodation (**Figure 2**). The vessel was capsizing to port as they reached the top of the ladder and the men helped each other over the rails onto the starboard side of the hull and into the water.

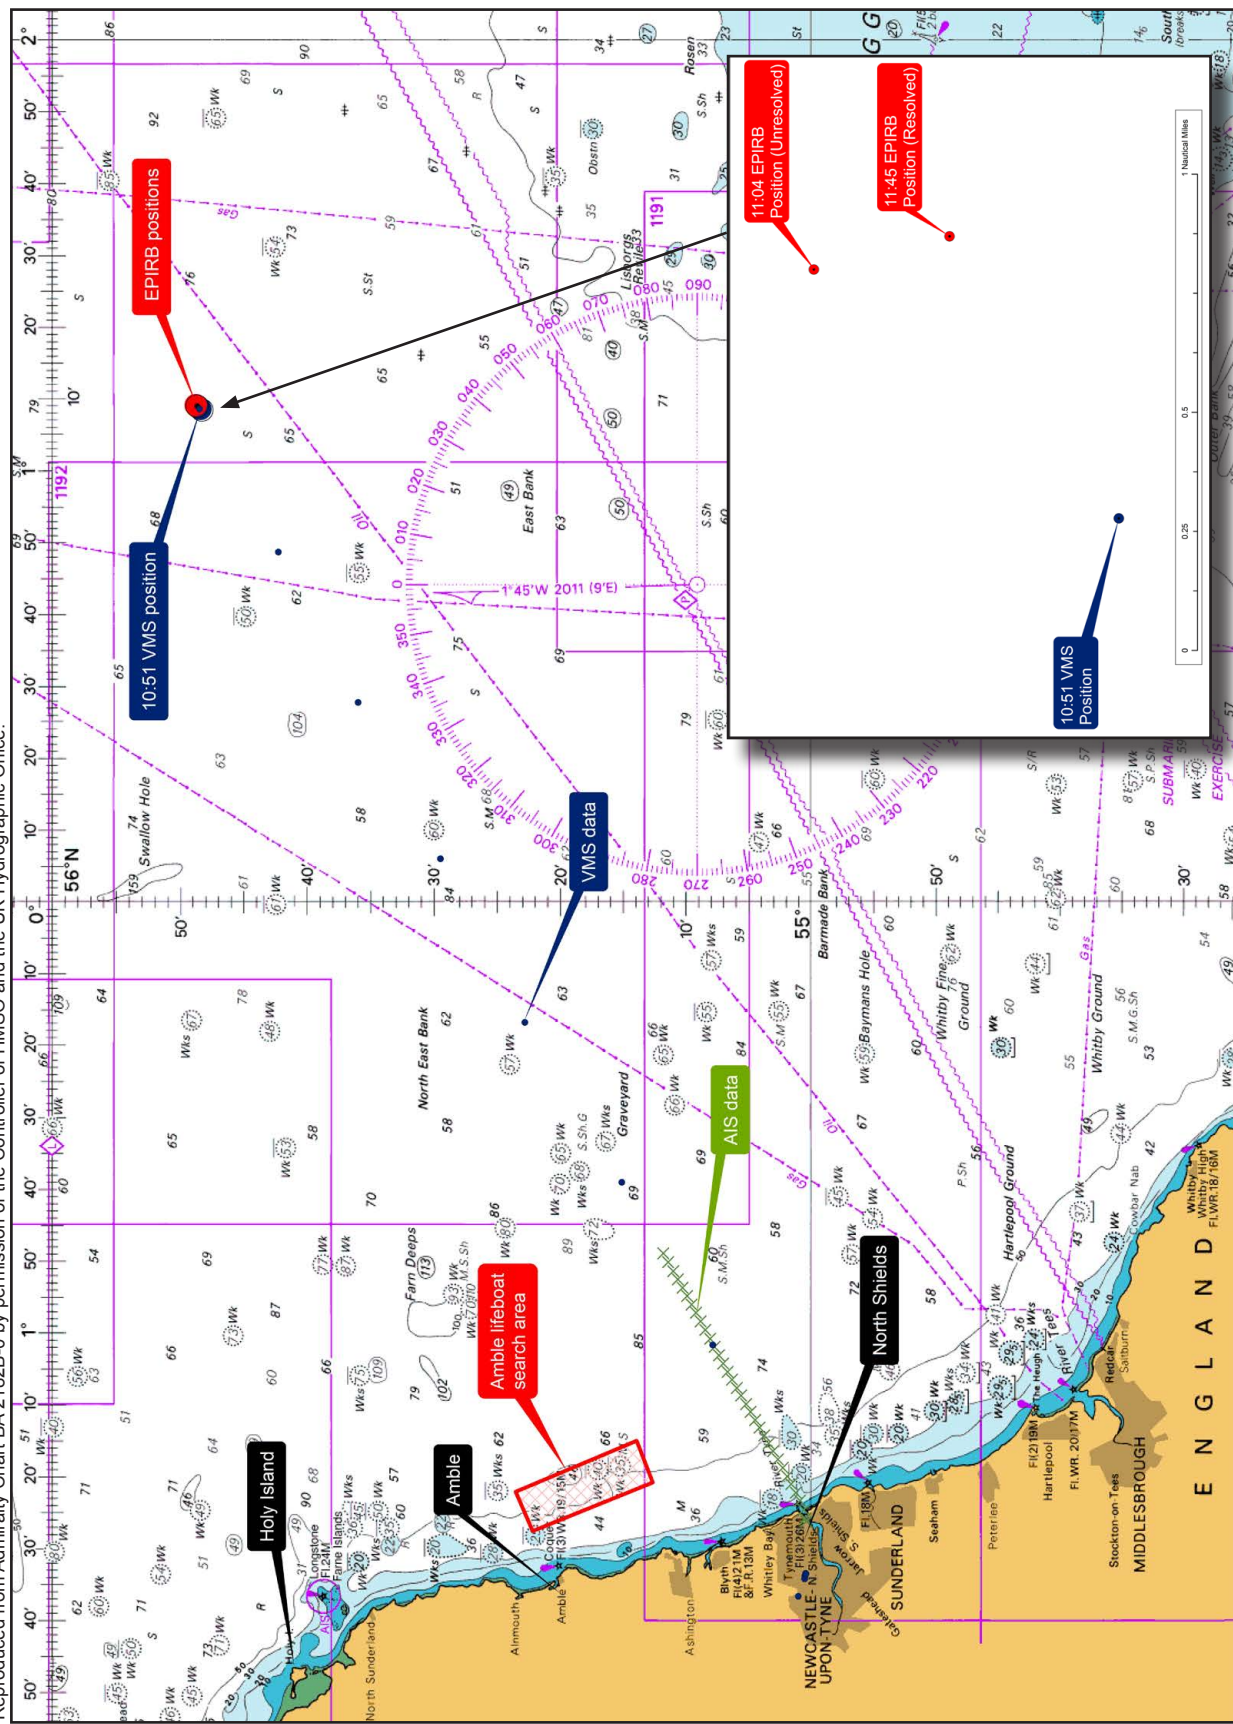
Figure 3: Accident location and related positional information

At 1115 MRCC Falmouth contacted MRCC Humber and advised them that a 'detect only' beacon alert (meaning an alert with no confirmed positional information) had been received from *Ocean Way*. MRCC Humber was also advised that the last available positional data for the vessel, obtained from the IMDatE database, indicated that the vessel was south-south-east of Holy Island (**Figure 3**).

At 1124 MRCC Falmouth telephoned MRCC Humber to advise that one of the possible EPIRB positions was: 55° 48.72' north, 001° 09.12' east. It was pointed out that this was “further out than first thought” and “quite a way out” into the North Sea (**Figure 3**). MRCC Humber acknowledged the information stating “she is about 90 miles off”.

At 1145 a further transmission from *Ocean Way*'s EPIRB was received at UKMCC via a low earth-orbiting satellite, which gave a resolved position for the beacon of 55° 48.56' north, 001° 09.19' east (**Figure 3**).

At 1115 MRCC Falmouth informed MRCC Humber that a 'detect only' alert had been received from *Ocean Way*'s EPIRB and that, based on information from the IMDatE database, the vessel was south-south-east of Holy Island (**Figure 3**). However, this was in fact the final position obtained from the vessel's AIS at 2359 on 1 November, after which its AIS transmissions could no longer be received as *Ocean Way* proceeded further offshore.

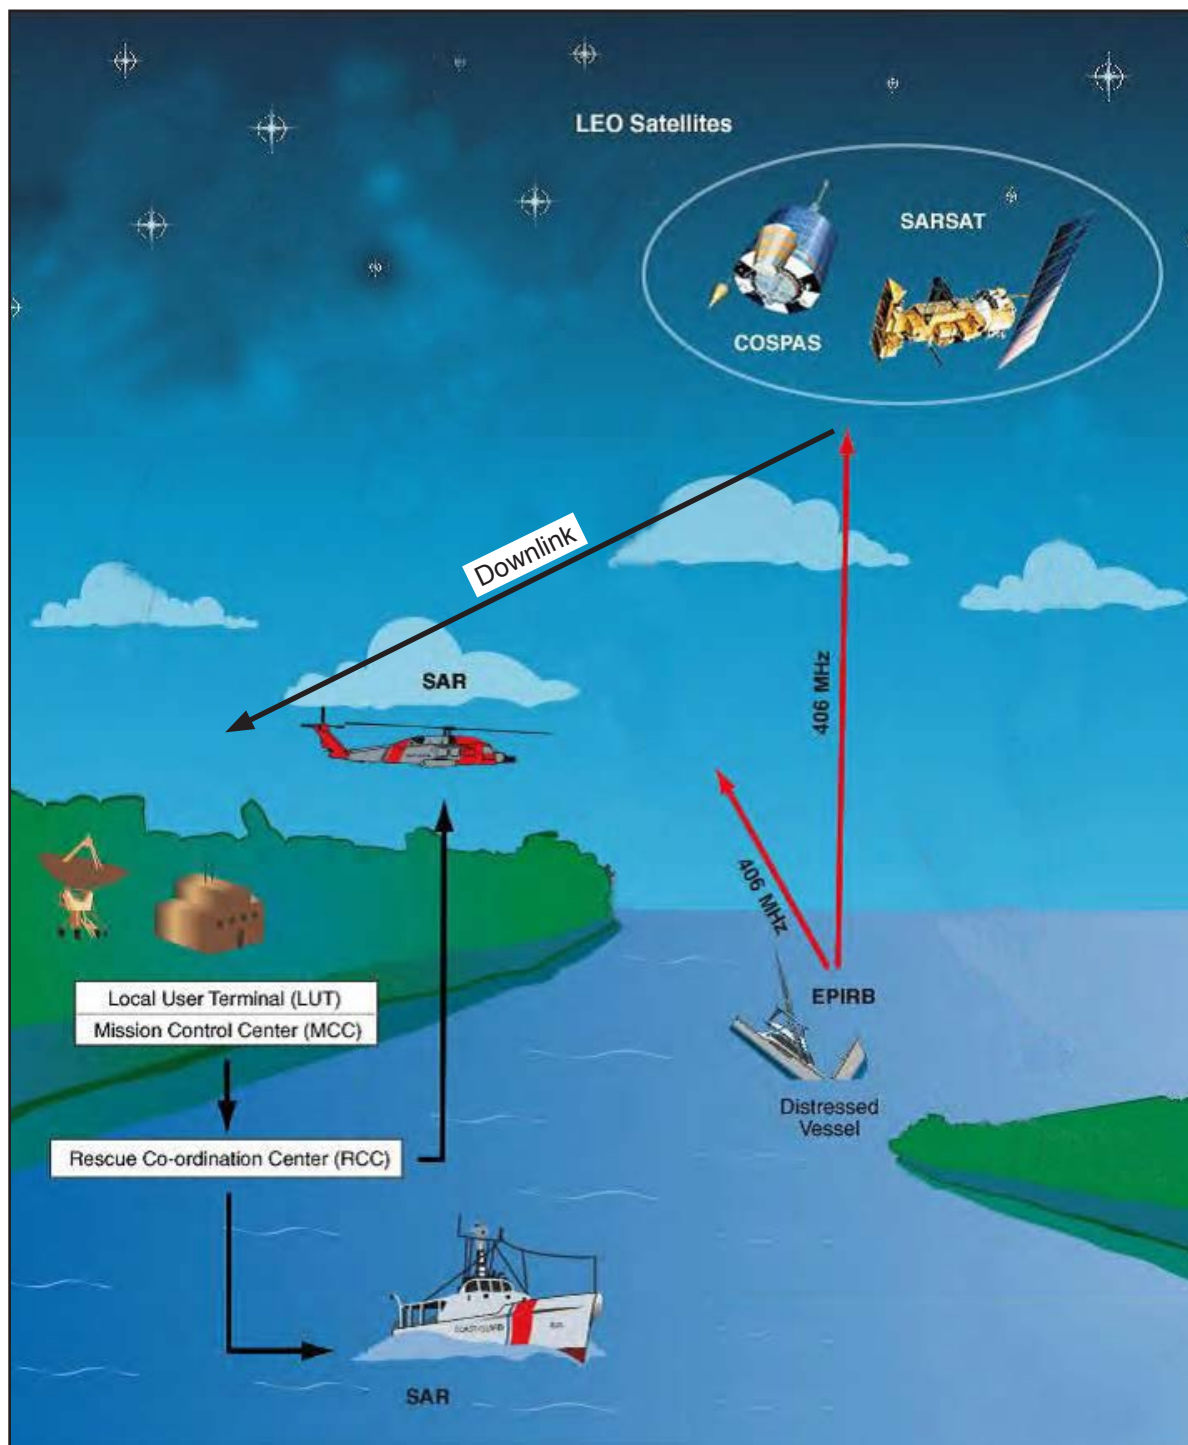
**Figure 8:** Search and Rescue satellite system overview

EPIRB 406MHz transmissions are received by satellites that form part of an international search and rescue system named COSPAS-SARSAT<sup>14</sup> (**Figure 8**).

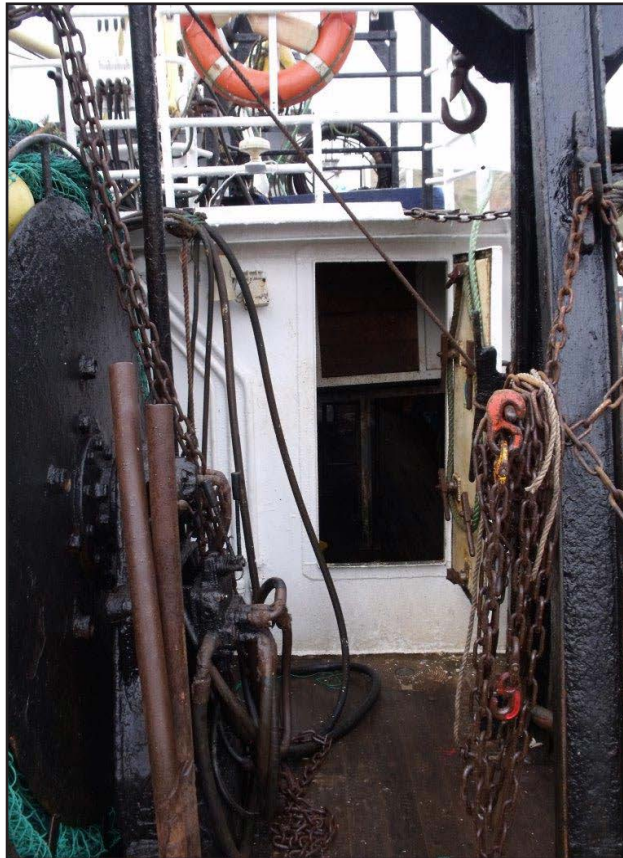
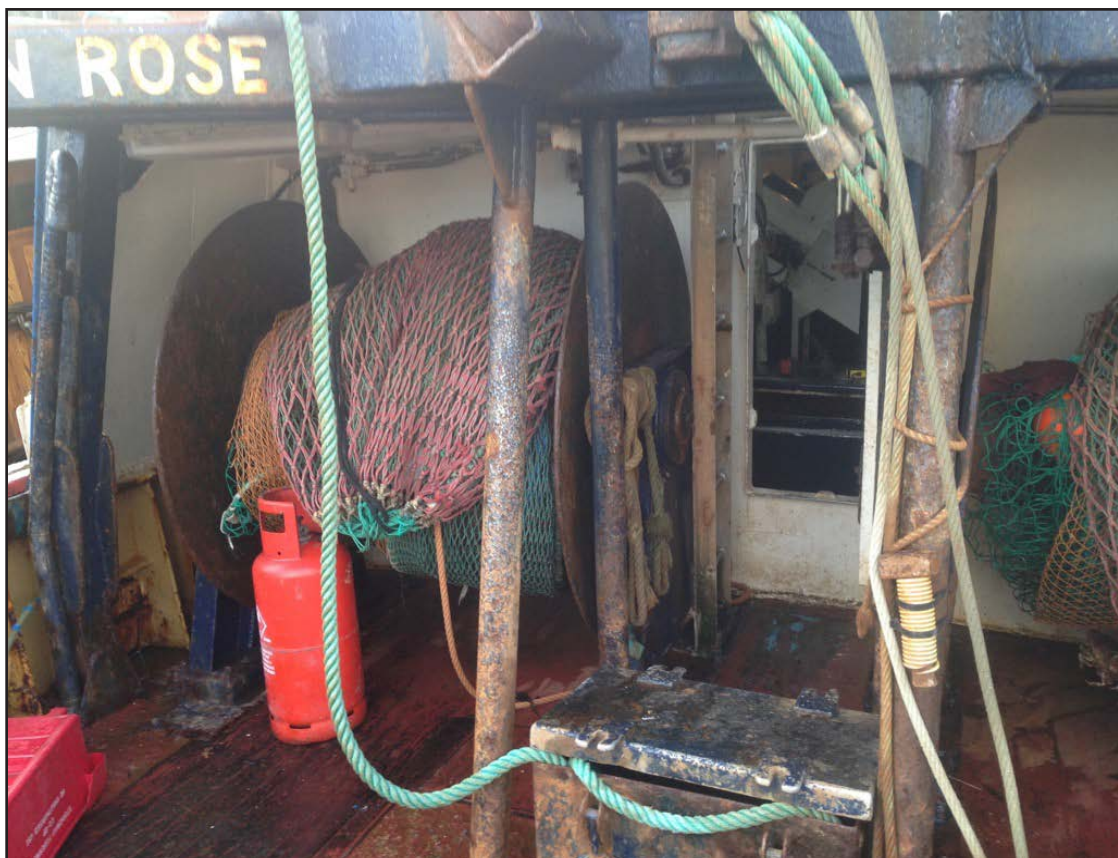
**Figure 11:** Weathertight shelter fitted on sister vessels

The owners of the two surviving sister vessels still fishing in UK waters were contacted after the accident. They confirmed that the shelter decks of their vessels had been previously made weathertight by the installation of a transverse bulkhead with watertight doors at the aft end of the shelter (**Figure 11**).
