Dover Seaways' contact with the South Breakwater,

Dover

9 November 2014

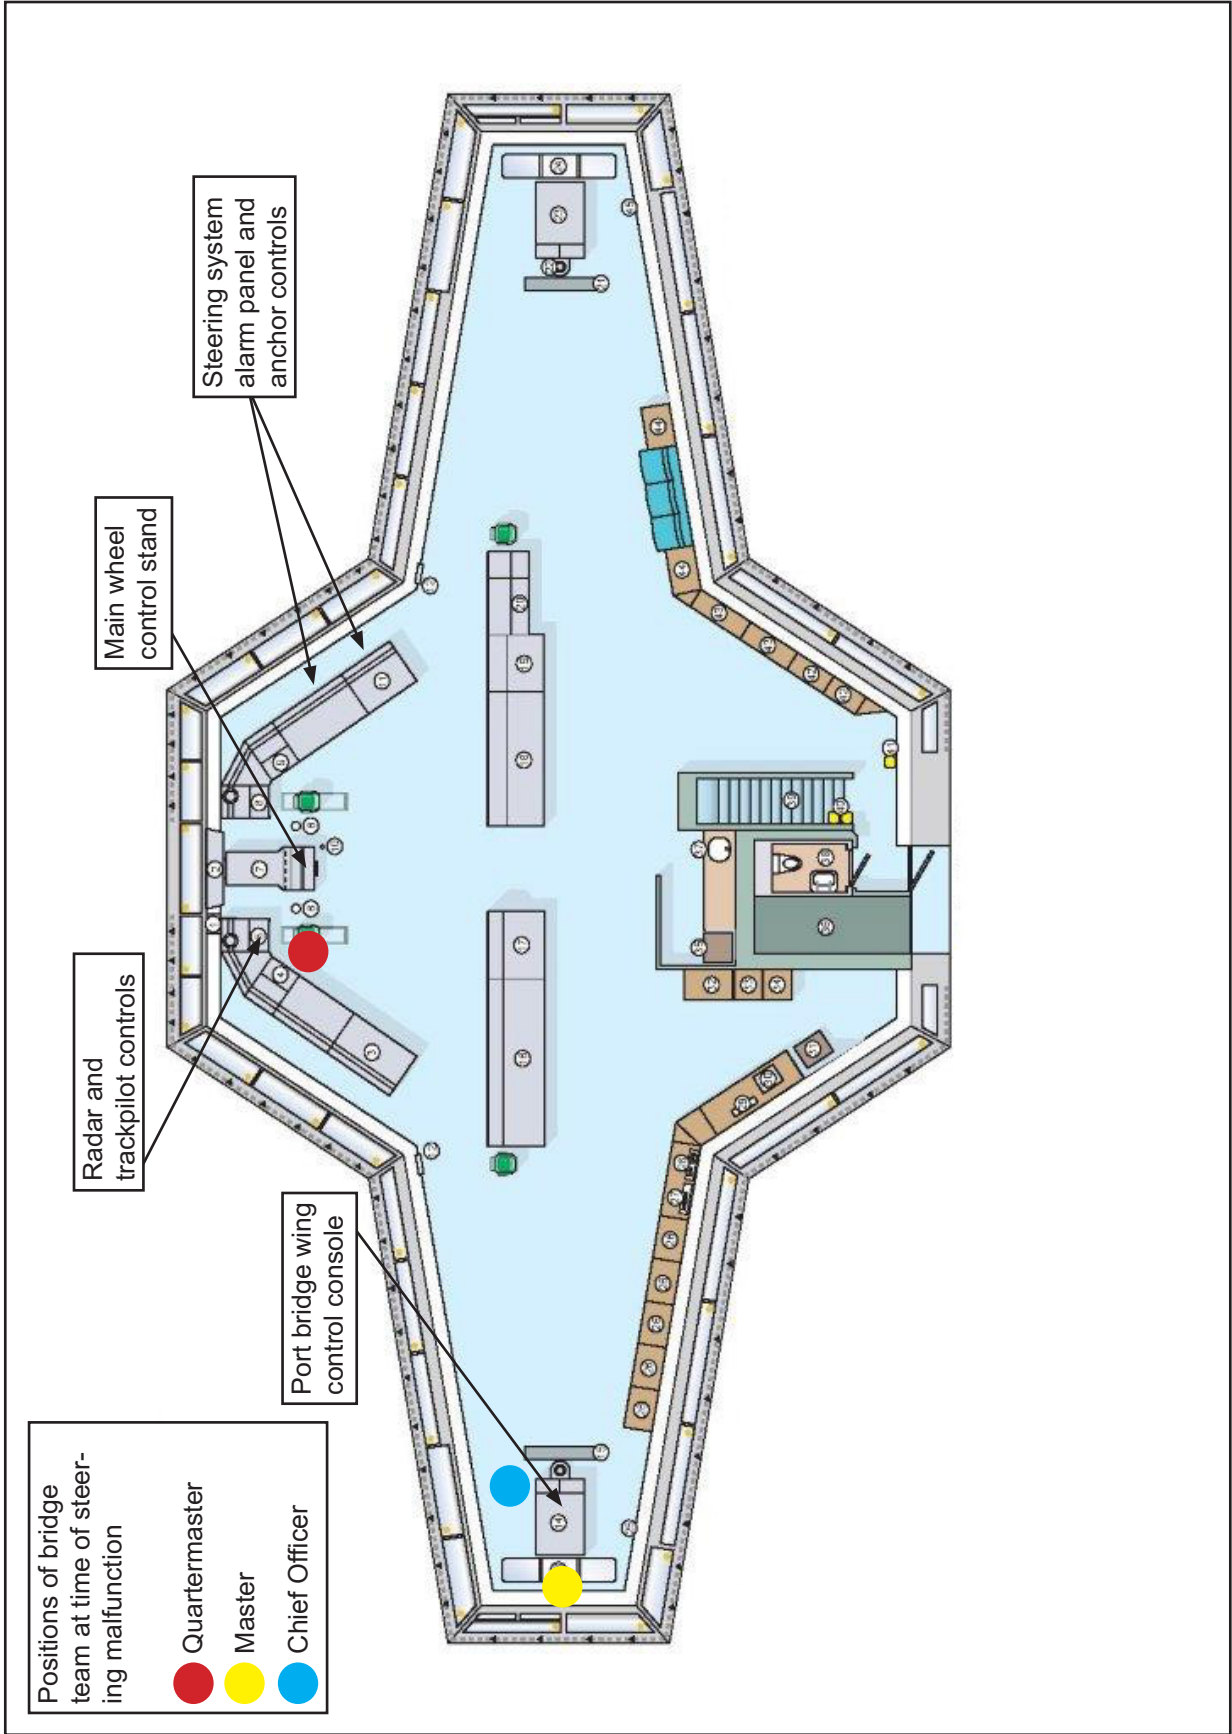
Figure 2: Bridge layout

Dover Seaways sailed at 0756. The master manoeuvred the vessel from the port wing control console (**Figure 2 and 3**) where he controlled the propulsion, steering and thrusters. The chief officer accompanied the master while the quartermaster was by the starboard wing control console checking that the starboard side was clear. The wind was south-westerly at between 7 and 10kts. It was daylight and the visibility was good.

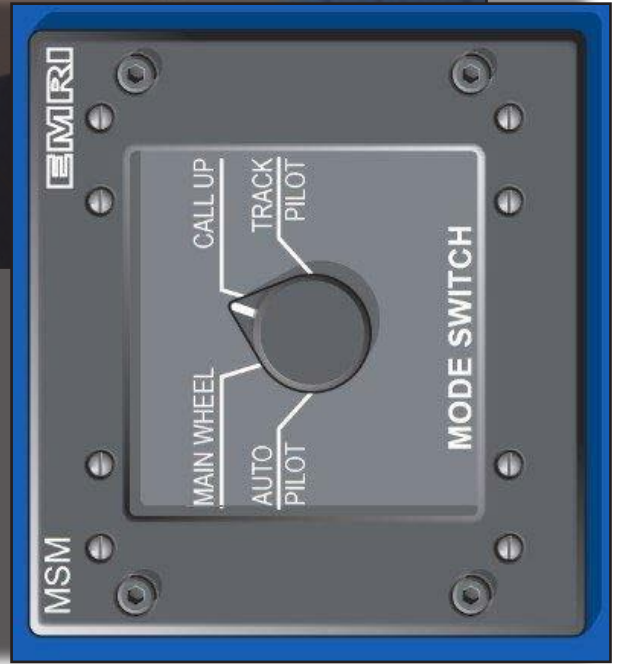
Figure 8: DFDS Decisions Support Checklist 17. Steering failure

When *Dover Seaways* sailed on 9 November 2014, all hydraulic steering pumps were operating. The steering mode selected was 'call-up' and the steering was controlled from the port bridge wing control console. The steering failure decision support checklist (**Figure 8**), the steering system manual, and the steering poster⁸ required by SOLAS were available on the bridge.
