Report on the investigation of
a person overboard from the
fishing vessel

Beryl (BF 440)

with the loss of one life
west of the Shetlands Islands

10 February 2015

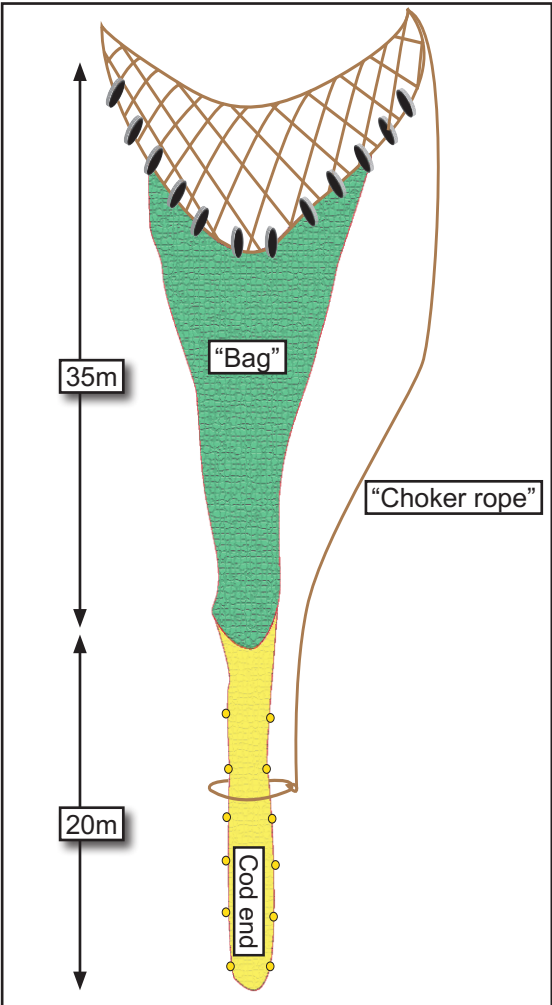
Figure 3: Plan and dimensions of a trawl

The trawl nets were identical, each comprising a 20m 'cod end' and a 35m 'bag' attached to ground gear (**Figure 3**). Hard, moulded plastic floats were secured to the cod end at 2m intervals.

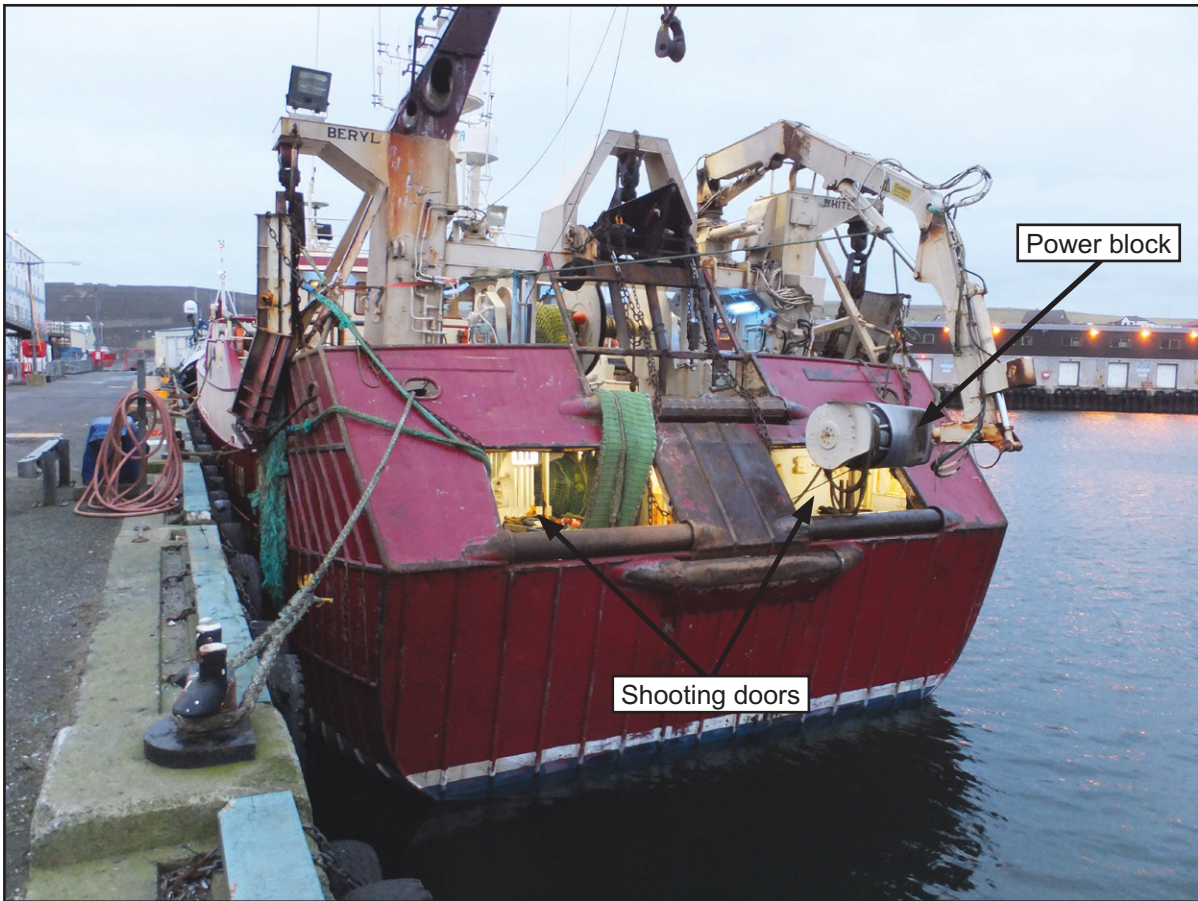
Figure 4: *Beryl's* stern showing the shooting doors and power block

At 0900 on 10 February, *Beryl*'s crew were preparing to shoot the trawl nets on the main deck. The nets had not been used for several weeks and were lashed in tracks¹ (**Figure 2**). Approximately half of the lashings were removed in readiness for shooting. The leading deckhand, Joshua Aryeetey, intended that the remaining lashings would be removed after the cod end and the 'bag' (**Figure 3**) had been deployed through the 'shooting doors' at the stern (**Figure 4**).

To start shooting the nets, the power block pulled the port trawl net's cod end through the port shooting door. As soon as the cod end entered the water and streamed astern, the net remaining in the track started to run out. Shortly afterwards, a float attached to the net snagged on one of the lashings used to secure the nets inside the track (**Figures 2 and 6**). The net stopped running out and the crewman at the net drum controls shouted to the leading deckhand to cut the lashing.

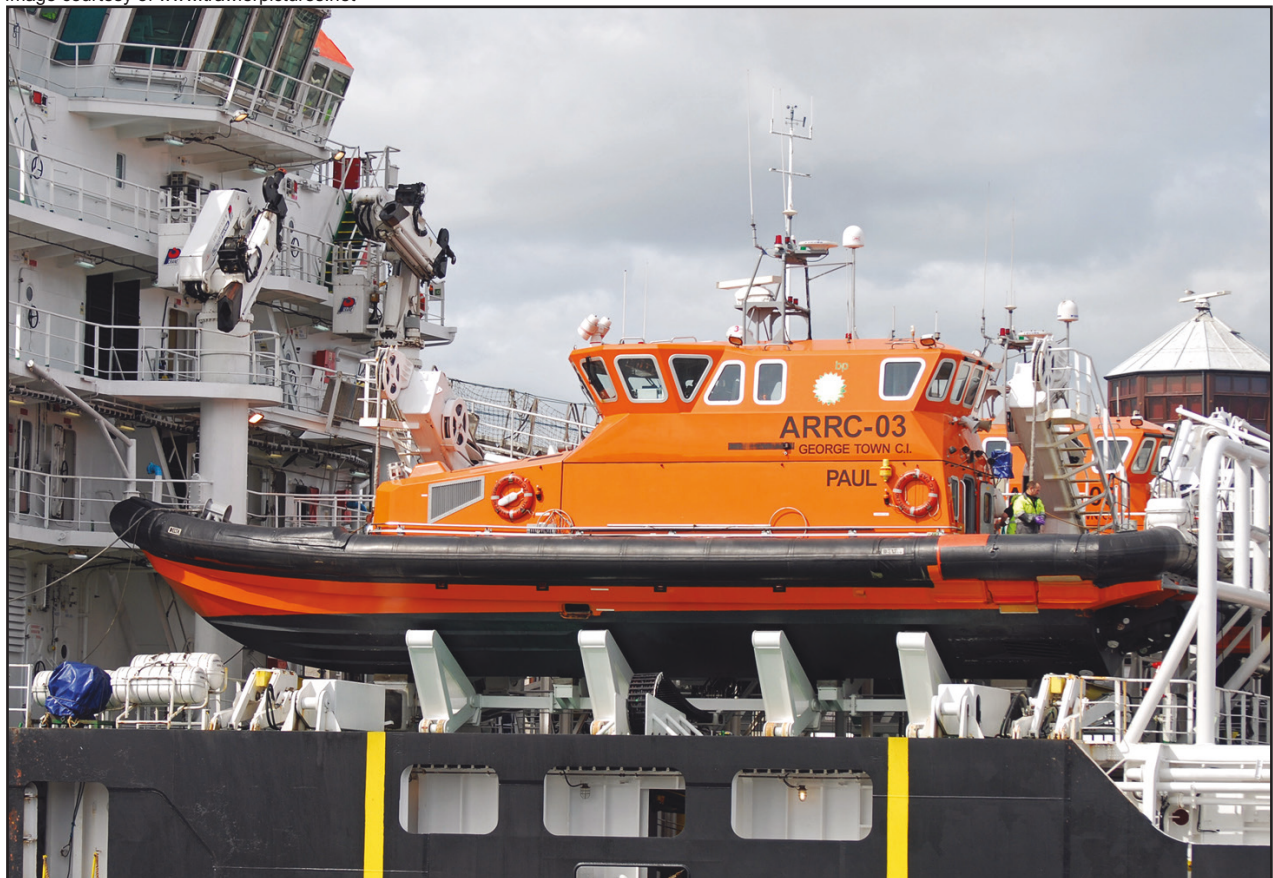
Figure 9: *Caledonian Victory's* autonomous rescue and recovery craft

At 0923, *Beryl's* skipper used very high frequency (VHF) radio channel 16 to request assistance from *Caledonian Victory*, an oil rig support vessel that was 6nm south-east of *Beryl*. *Caledonian Victory's* master immediately arranged for an autonomous rescue and recovery craft (ARRC)³ (**Figure 9**) to be readied for launch and turned the support vessel towards *Beryl* at best speed. At 0926, the master also informed Shetland Coastguard of the situation after he heard *Beryl's* skipper trying to contact the station without success, possibly due to the combination of distance and aerial height.
