Report on the investigation into
carbon monoxide poisoning
on board the motor cruiser

Arniston

on Windermere

1 April 2013

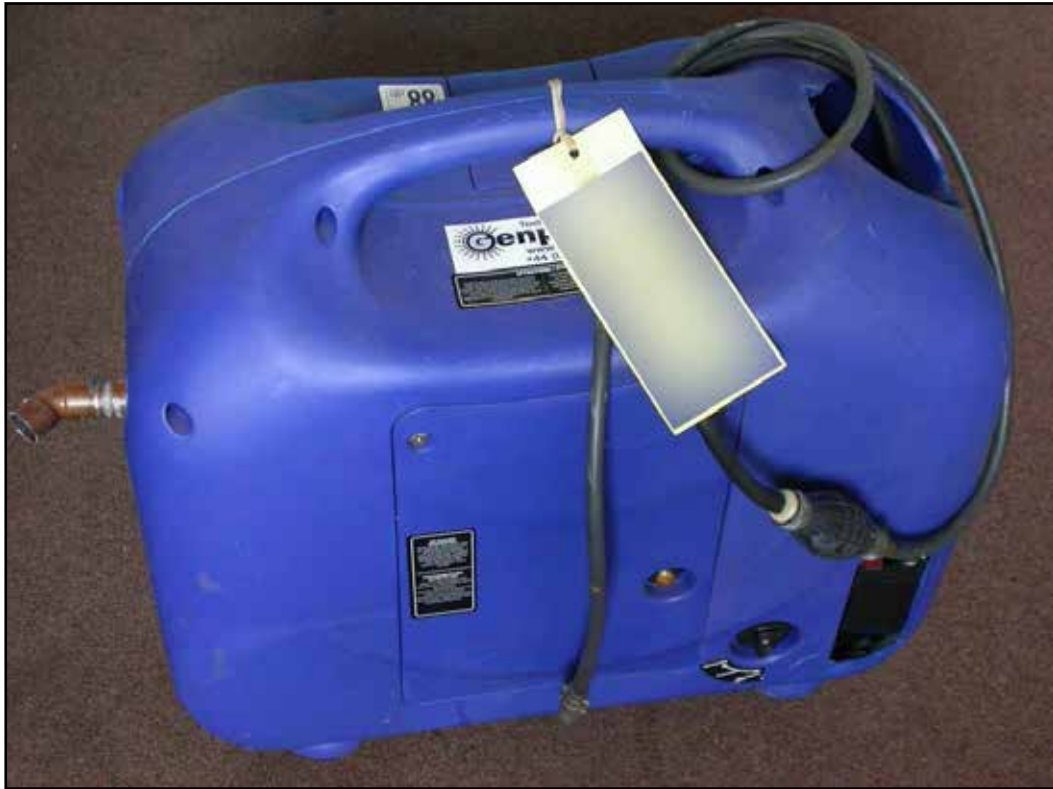
Figure 2: Hyundai generator

After *Arniston* had been secured alongside the public jetty, its owner removed a small "suitcase" type generator (**Figure 2**) from his work van and installed it into *Arniston*'s engine bay (**Figure 3**). The owner had extended and modified the generator's exhaust, which he connected to an outlet in the boat's hull.

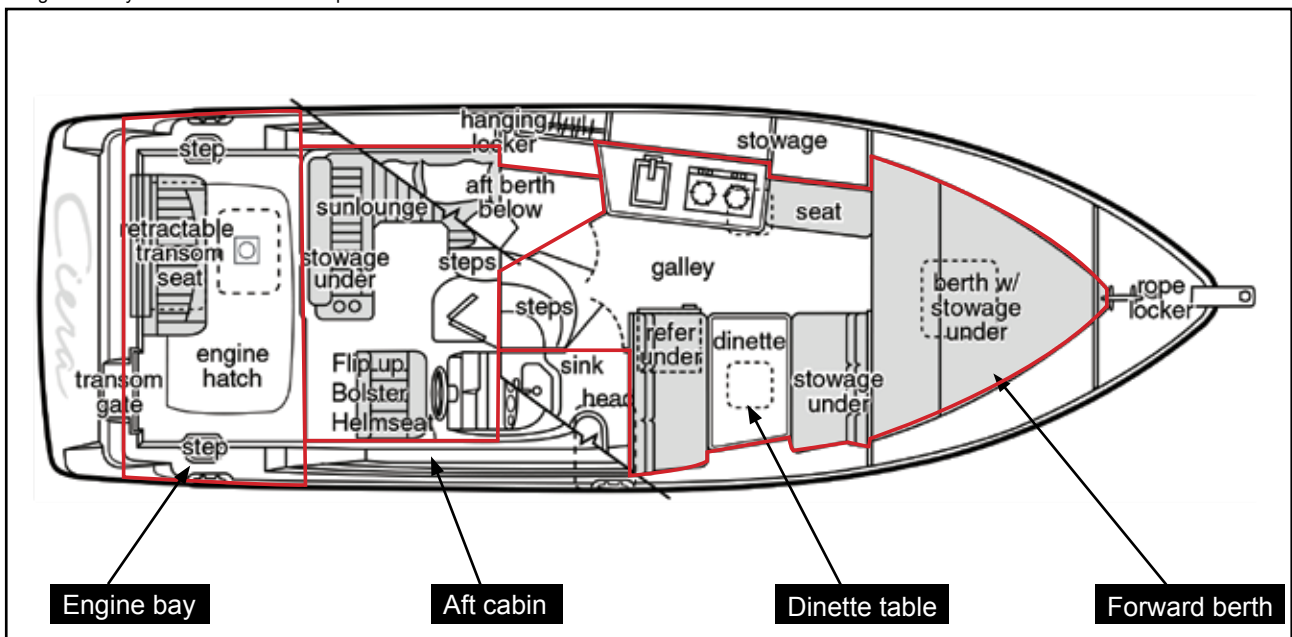
Figure 3: Layout of Arniston

Arniston was divided into four underdeck compartments (**Figure 3**) comprising an engine bay, an aft cabin, heads, and a galley/dinette area that led to a sleeping berth in the forepeak. The engine bay and aft cabin shared a common bulkhead, which was not gas tight (see 1.6.4).

The aft cabin where Kelly and Lauren went to sleep shared a common bulkhead with the engine bay (Figure 3). The bulkhead was not gas-tight. It had large openings (Figure 14) through which electric cables and pipework were routed. These openings allowed the exhaust gases from the generator to flow from the engine bay into the aft cabin (Figure 22). The extensive staining found on the deckhead lining of the aft cabin (Figure 23) indicates that the atmosphere in the engine bay had been venting into the accommodation for a prolonged period.

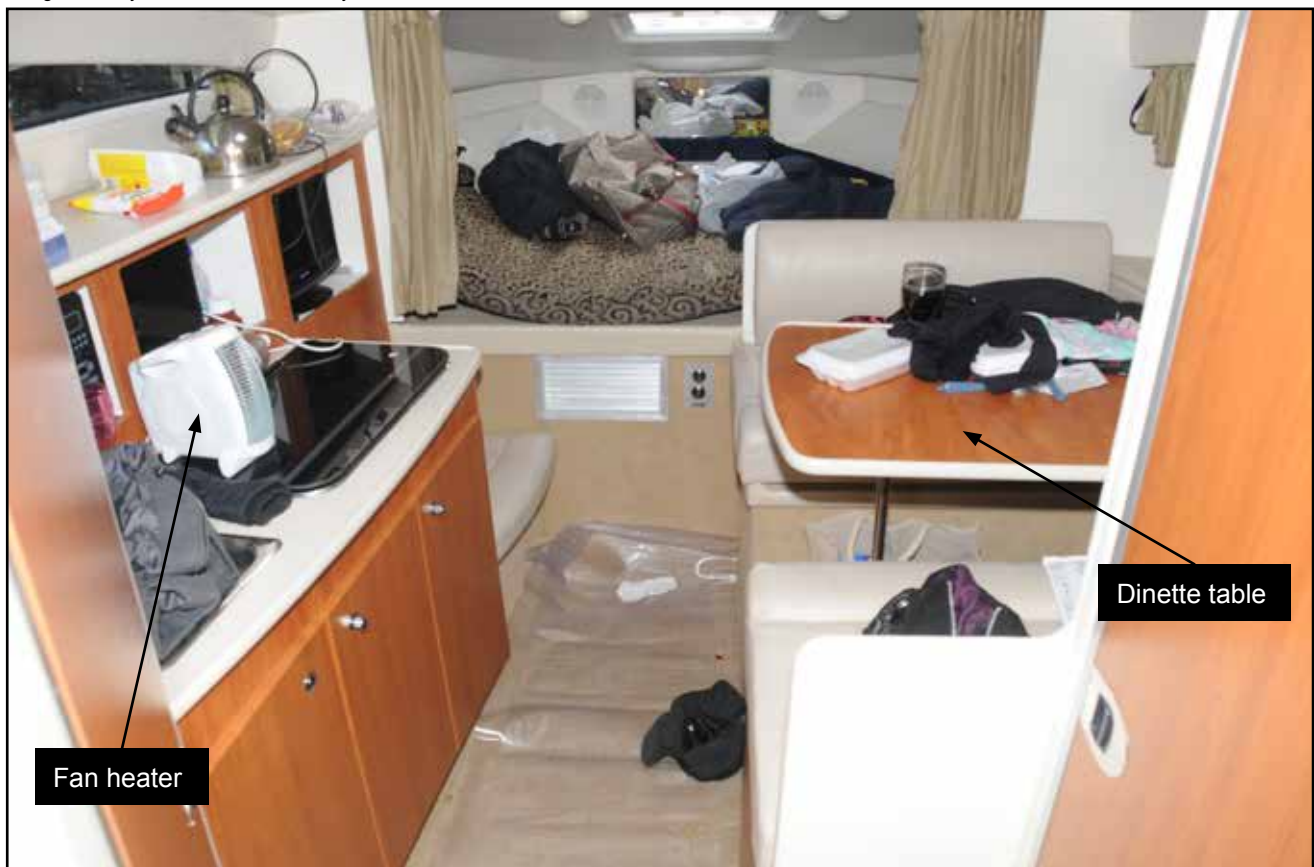
Figure 4: *Arniston* accommodation

The weather was fine with clear skies and light winds, but the temperature was only about 5°C. Kelly and Lauren were cold when the owner returned from the chip shop. To heat the boat's accommodation the portable generator was started remotely using a fob, in order to power a fan heater (**Figure 4**). The fan heater had recently been purchased and could be set to either 1kW or 2kW. On this occasion it was on the 1kW setting.

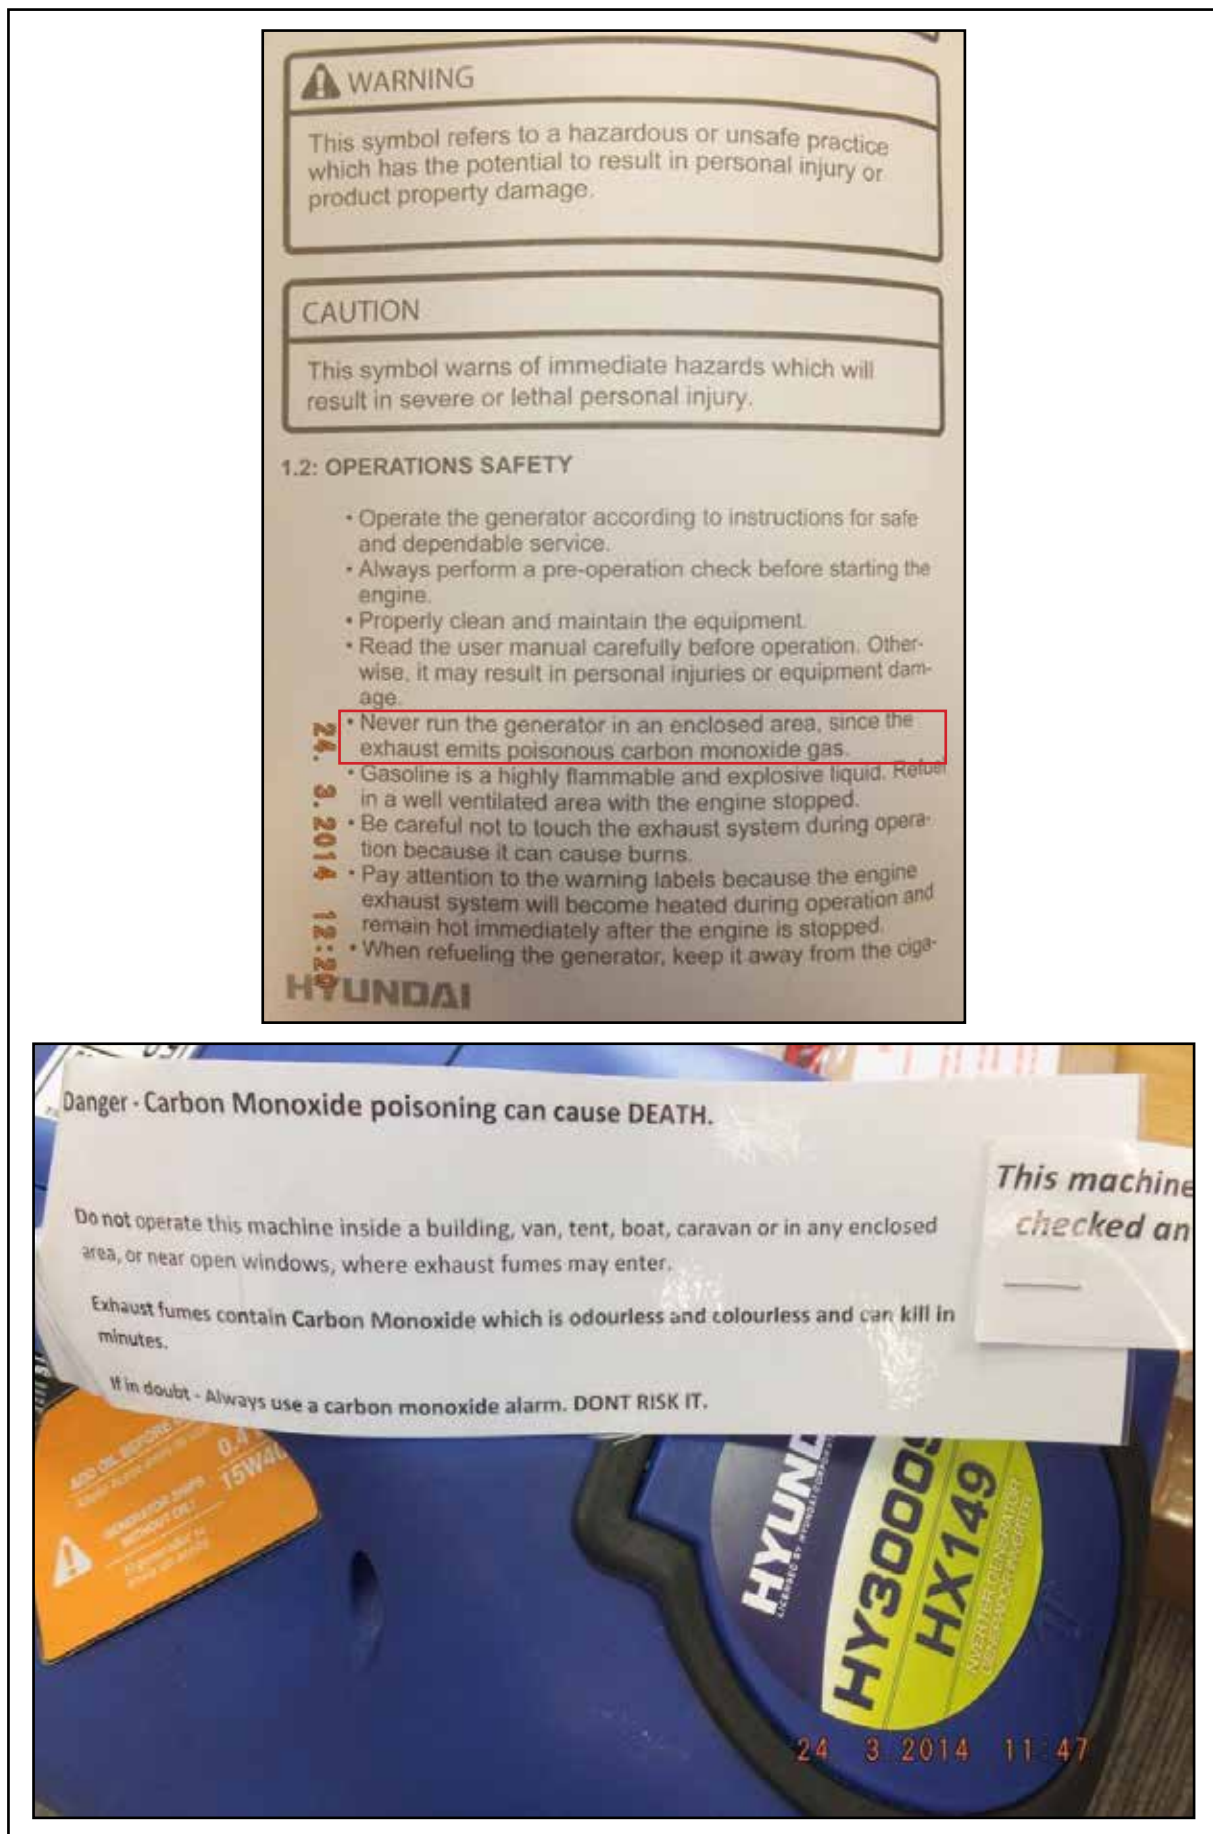
Figure 5: CO warnings

The portable Hyundai generators were usually supplied with warnings that they should not be used in enclosed spaces (**Figure 5**) or be modified (**Figure 6**). The installation of the portable generator into the engine bay on board *Arniston*, and the extension and modification of its exhaust system indicate that these warnings, if supplied in this case, were not heeded by the boat's owner. It is possible that the owner's decision to fit the generator in this manner was influenced by the need to provide a 240V electrical supply on his boat in a cost-effective way. However, although the owner installed the generator in an enclosed space, and subsequently modified its exhaust, it is evident that he foresaw and tried to mitigate some of the potential adverse consequences of his actions. These included: the fitting of fans

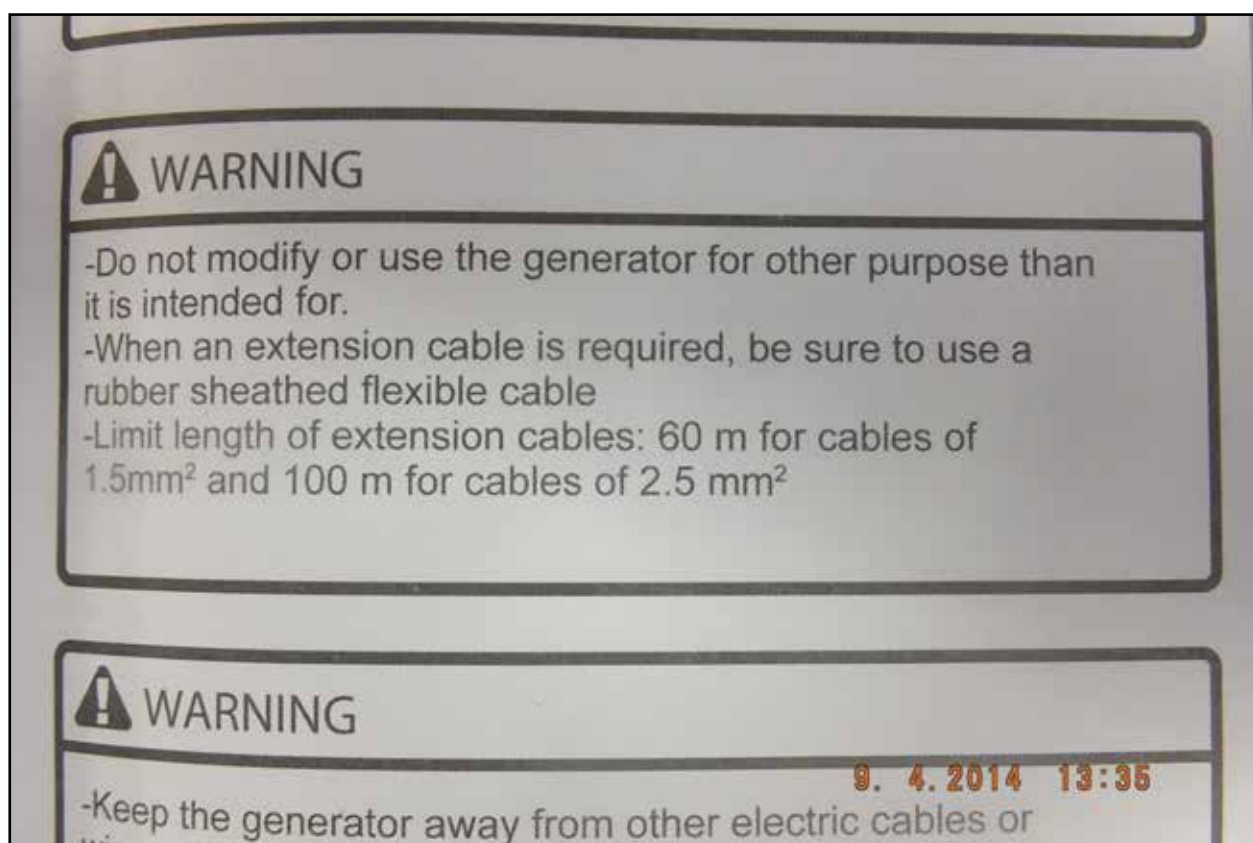
Figure 6: Warning against modification

The user manuals also warned that the generator should not be modified (**Figure 6**).

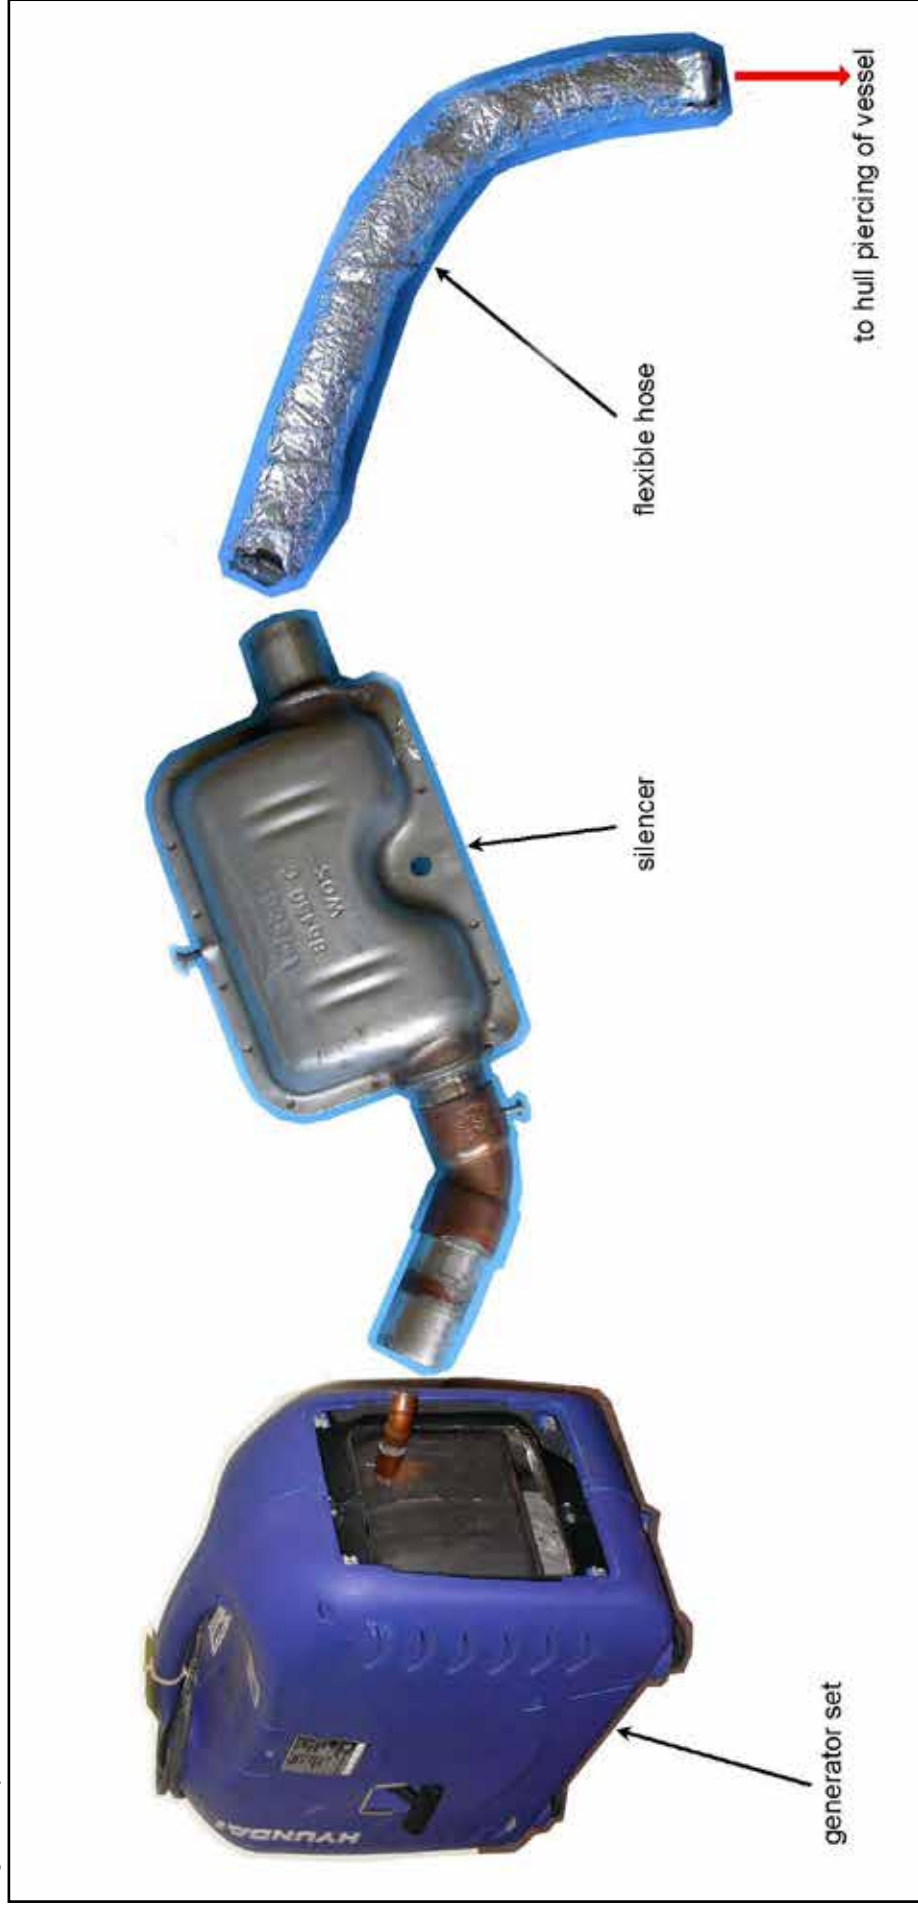
Figure 8: General arrangement of the generator, silencer and pipework

The external exhaust system (**Figure 8**) was constructed as follows:

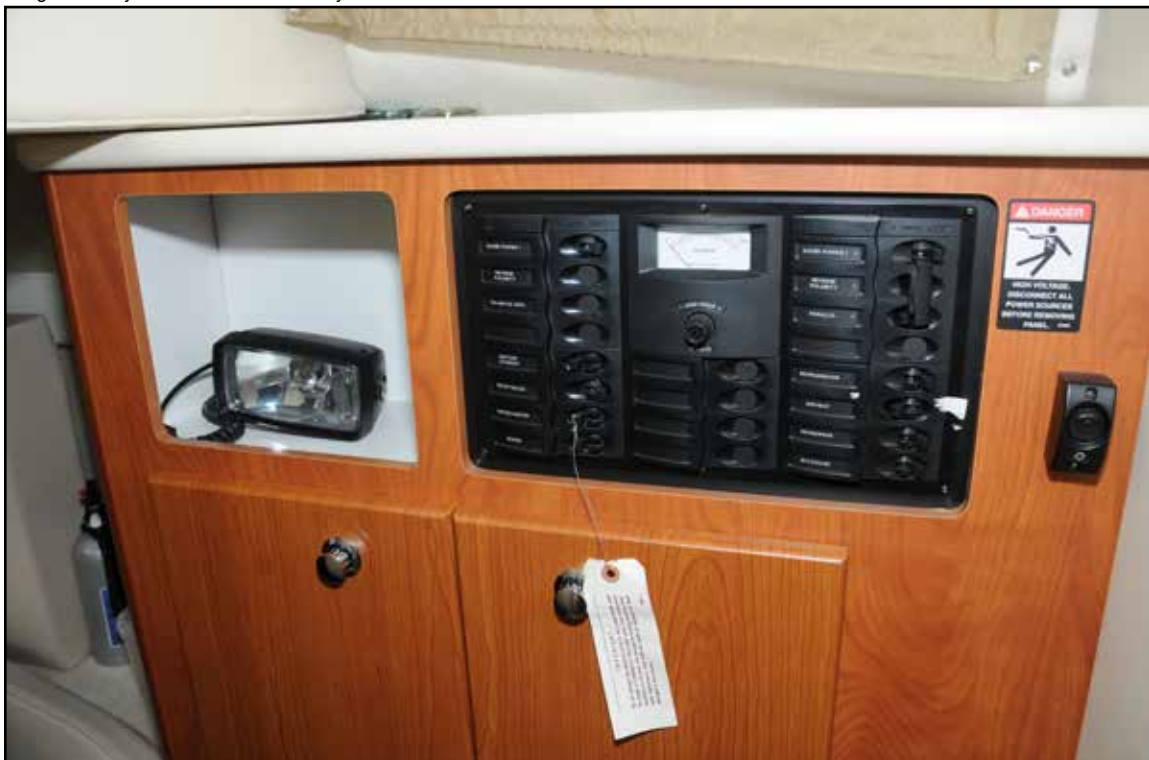
Figure 12: Electrical distribution panel

Arniston was designed and constructed to use a 120V shore power supply, which is used throughout North America. The boat's distribution panel (**Figure 12**) housed the breaker switches for the electrical appliances and lights and was located in the aft cabin. To enable the *Hyundai* generator to supply electrical power, the owner had modified the as-built wiring system by cutting the two cables supplying the distribution panel. In effect this disabled the USA shore power connections. The

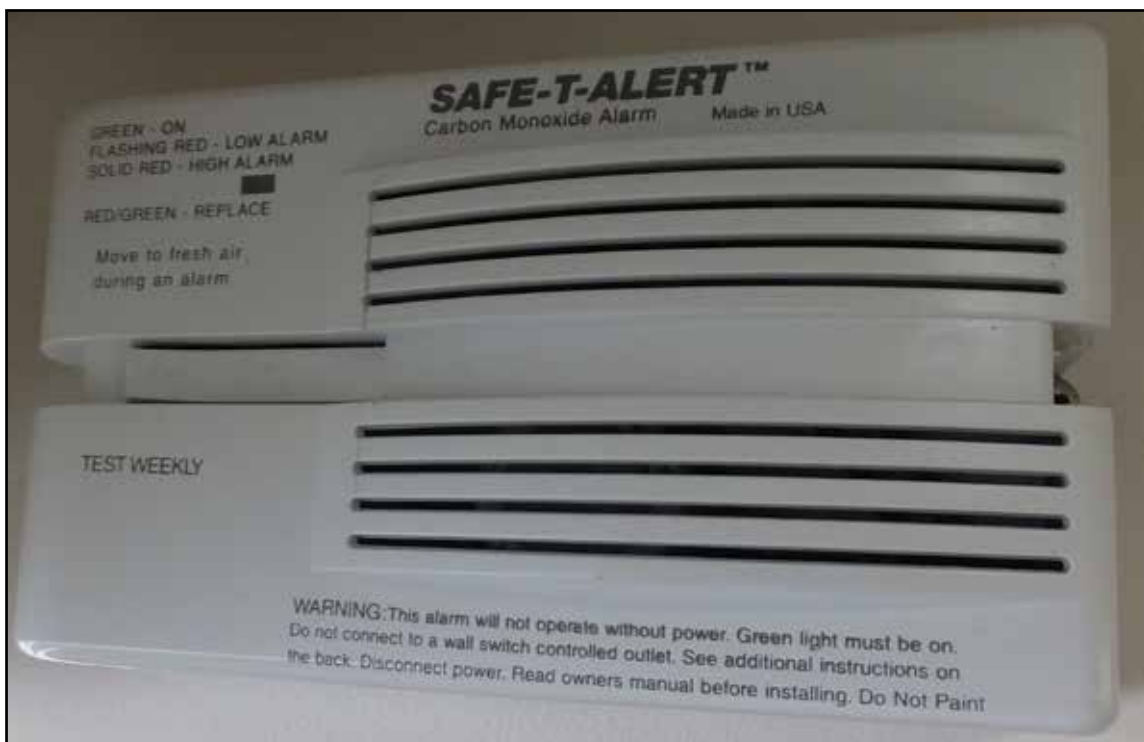
Figure 18: CO alarm

- The breaker switch on the electrical distribution panel, controlling the engine bay fans and the battery charger, was in the 'off' position.
- *Arniston* was fitted with two *SAFE-T-ALERT* CO alarms, model number 60-541 (**Figure 18**). One located on the deck head in the aft cabin and the other fixed on the deck head above the dinette table. Information shown on both alarms indicated that they had been due for renewal in 2005 and had been date-stamped as being manufactured or fitted on October 8 2002 (**Figure 19**).

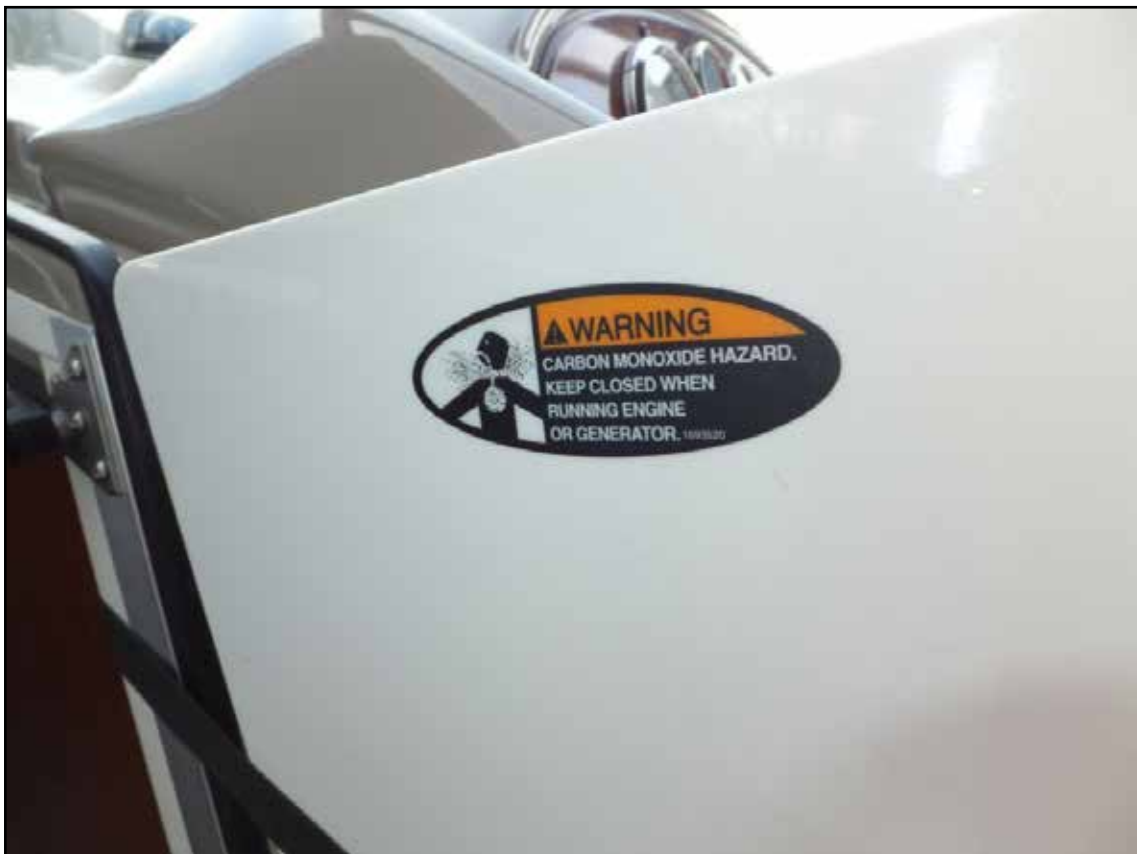
Figure 20: Warning of CO hazard on accommodation door

- Both CO alarms had been disconnected from the power supply (**Figure 19**) and were not fitted with internal batteries.
- *Arniston* was also fitted with several stickers (**Figure 20**) that warned of the hazards of CO. The stickers were required in order for the boat to comply with the NMMA build standard in the USA.

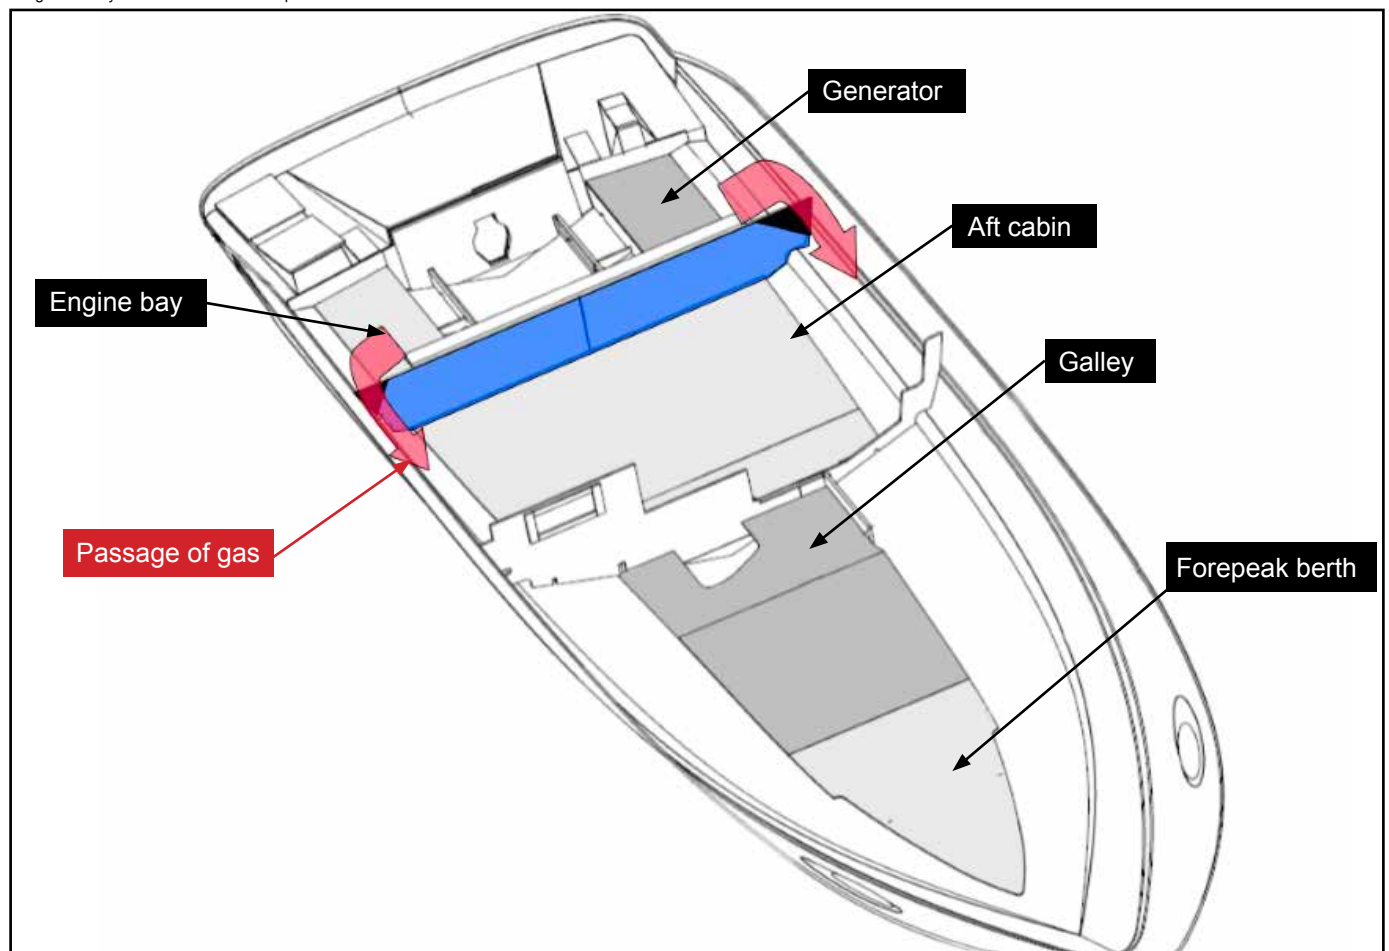
Figure 22: Passage of gas

The accident reconstruction (Annex B) showed that the levels of CO in the aft cabin were considerably higher than those in the galley area, which was consistent with the source and the likely passage of the gas. Therefore, as Kelly and Lauren slept in the aft cabin, they would have inhaled higher concentrations of CO for a longer period of time than *Arniston's* owner, who was asleep at the table in the galley. Nonetheless, the condition and the disorientation of the owner when he awoke indicate that he had also been poisoned by the CO. Even though the owner had mainly been in the open air after waking and had been given oxygen by the attending paramedics and on arrival at the hospital, when tested his CO saturation level was still 16%.
