Report on the investigation of
a fatal man overboard from the Reflex 38 yacht
Lion

14.5 miles south of Selsey Bill, West Sussex

18 June 2011

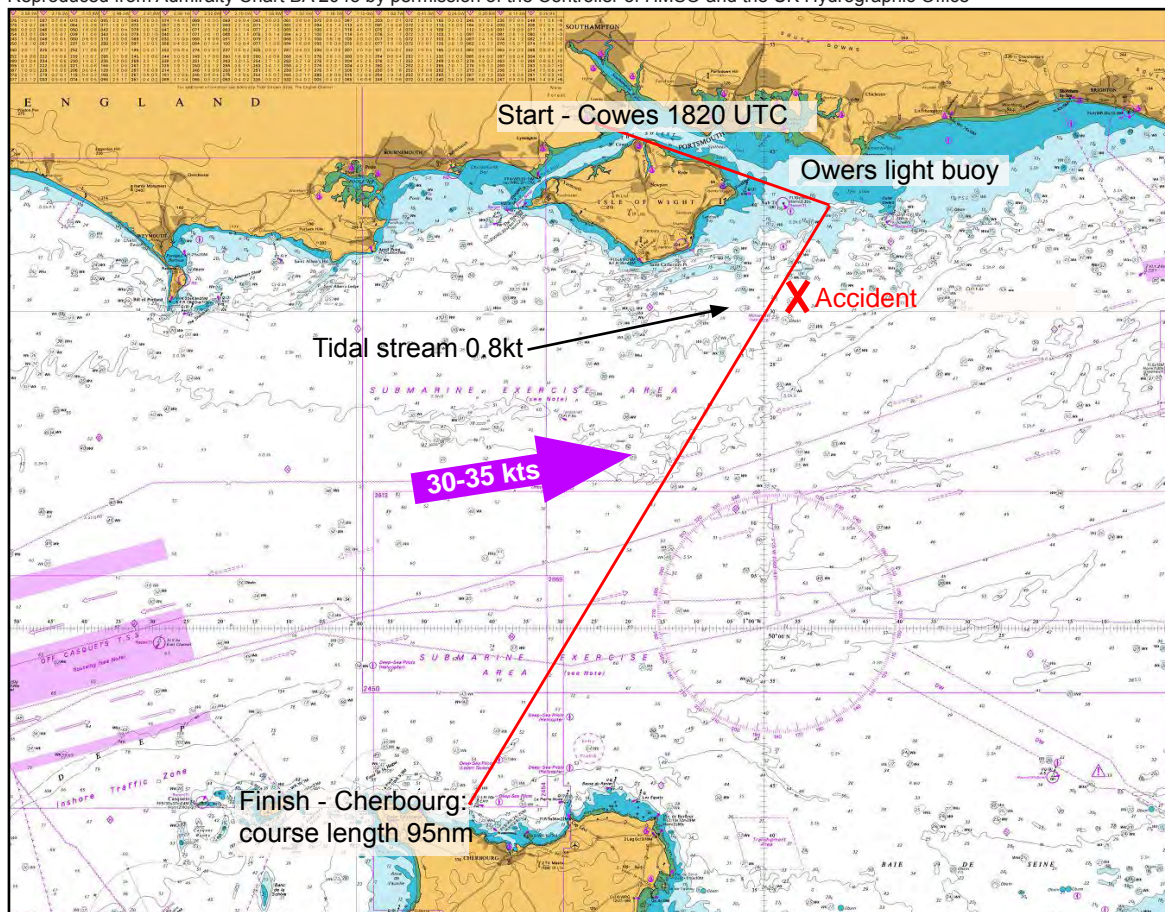
Figure 1: Chartlet showing Morgan Cup Race course and key events

At 1320 on 17 June, RORC's Race Committee sent details of the Morgan Cup Race course to the competitors by e-mail (**Annex C**). The course, at 95 miles long, was relatively short to take account of the difficult conditions expected. A chartlet showing the course is at **Figure 1**.

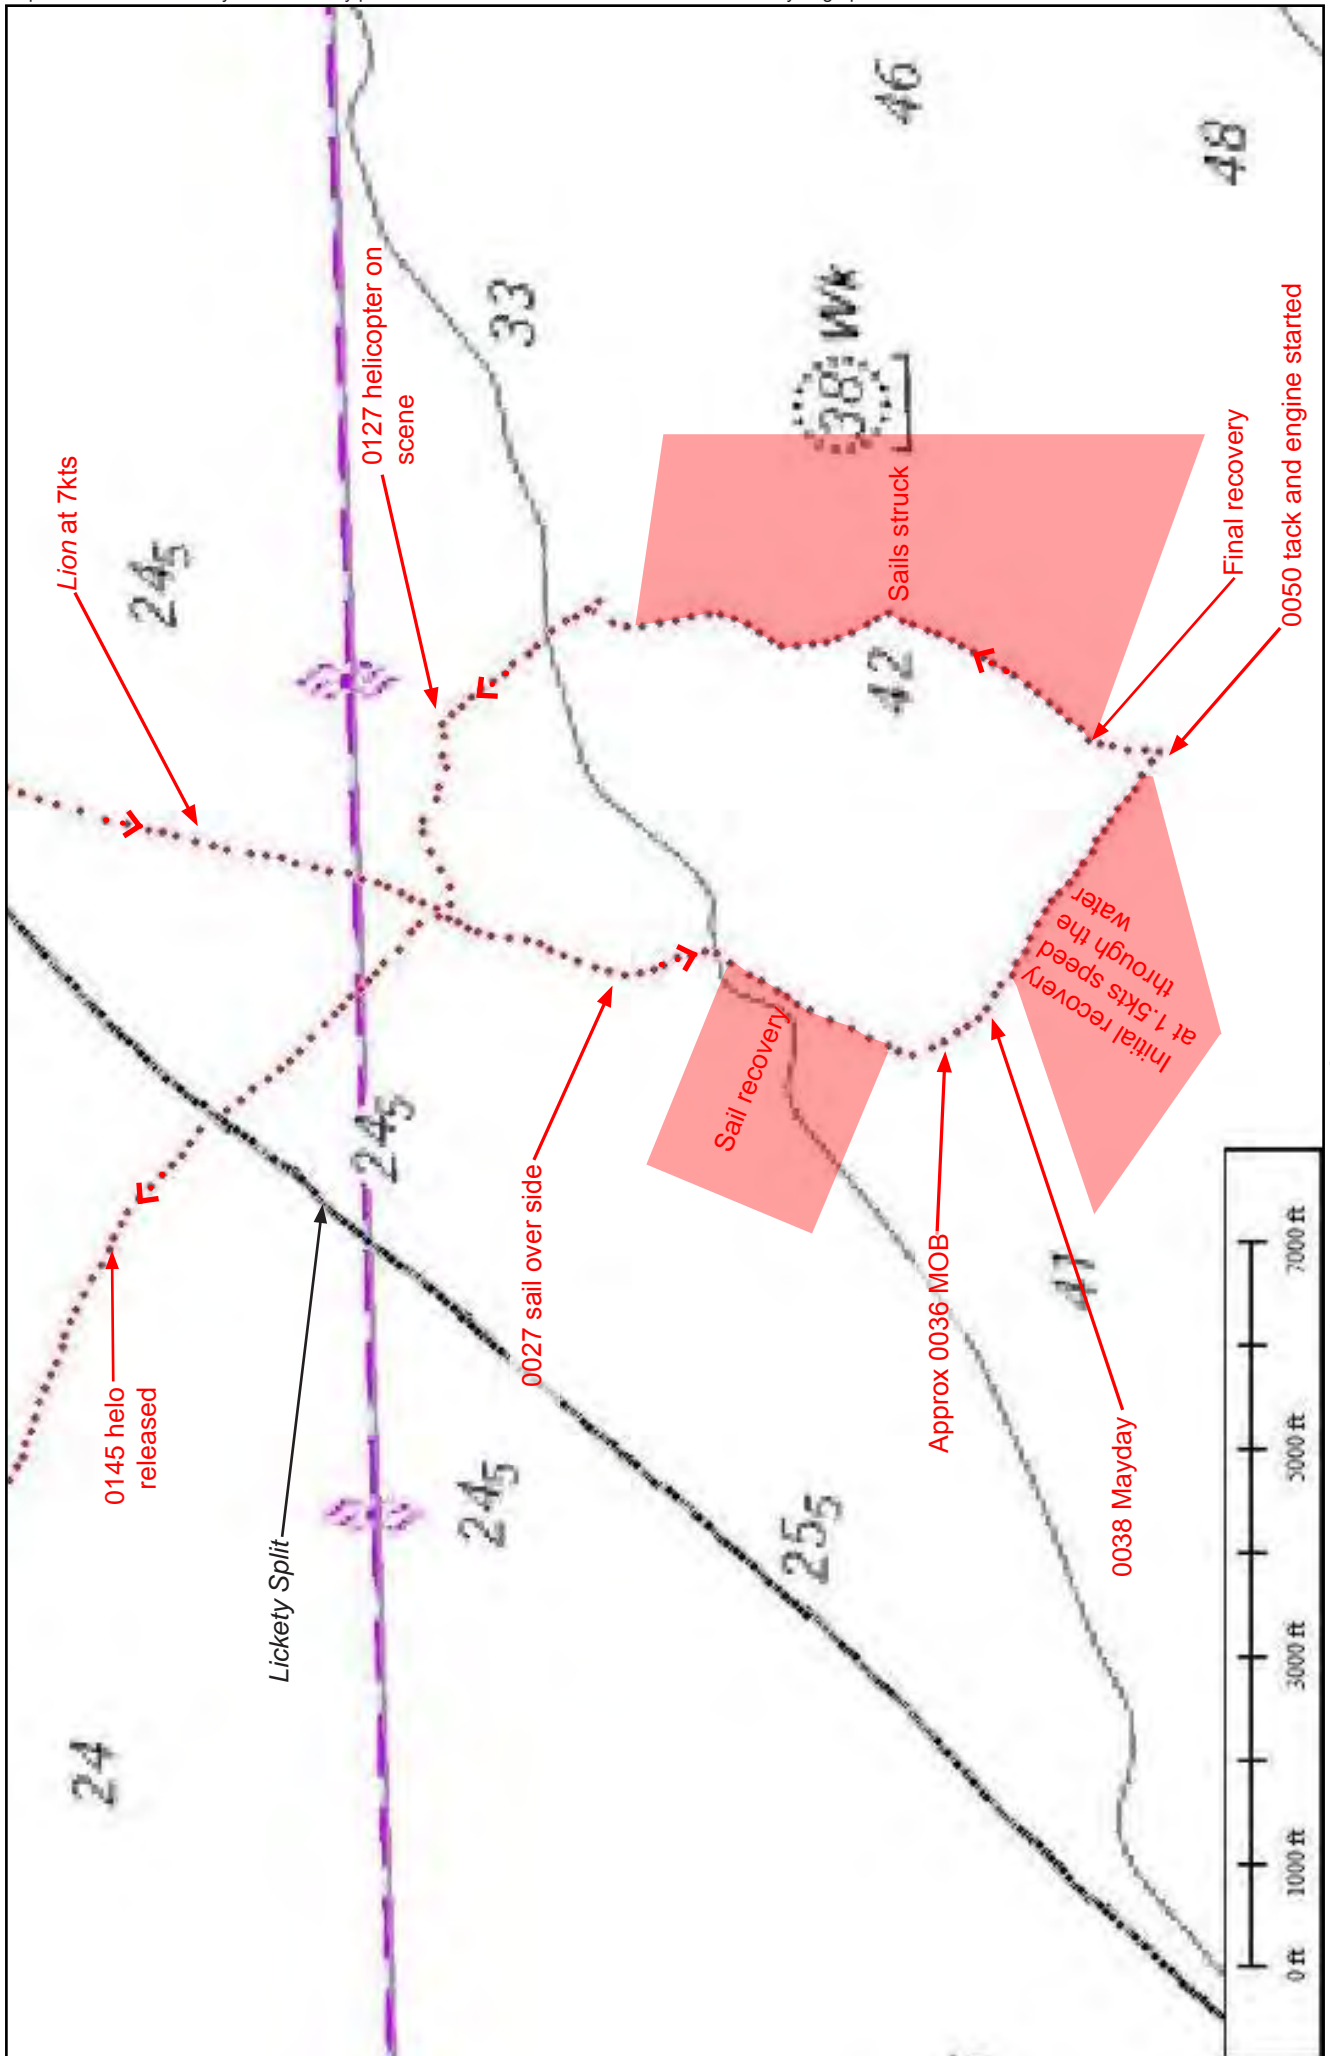
Figure 6: Detailed AIS track showing key events

To assist in the recovery, the helmsman instructed the general duties man to release the mainsheet, which had the effect of immediately slowing *Lion* down from 4.5 knots to 1.5 knots through the water, with a course over ground (COG) of approximately 135° True (T) (**Figure 6**).

A more detailed AIS track for *Lion*, showing the specific stages of the accident and actions taken, is at **Figure 6**.
