Vector 40R powerboat, contact with a navigation buoy

in Southampton Water

13 May 2015

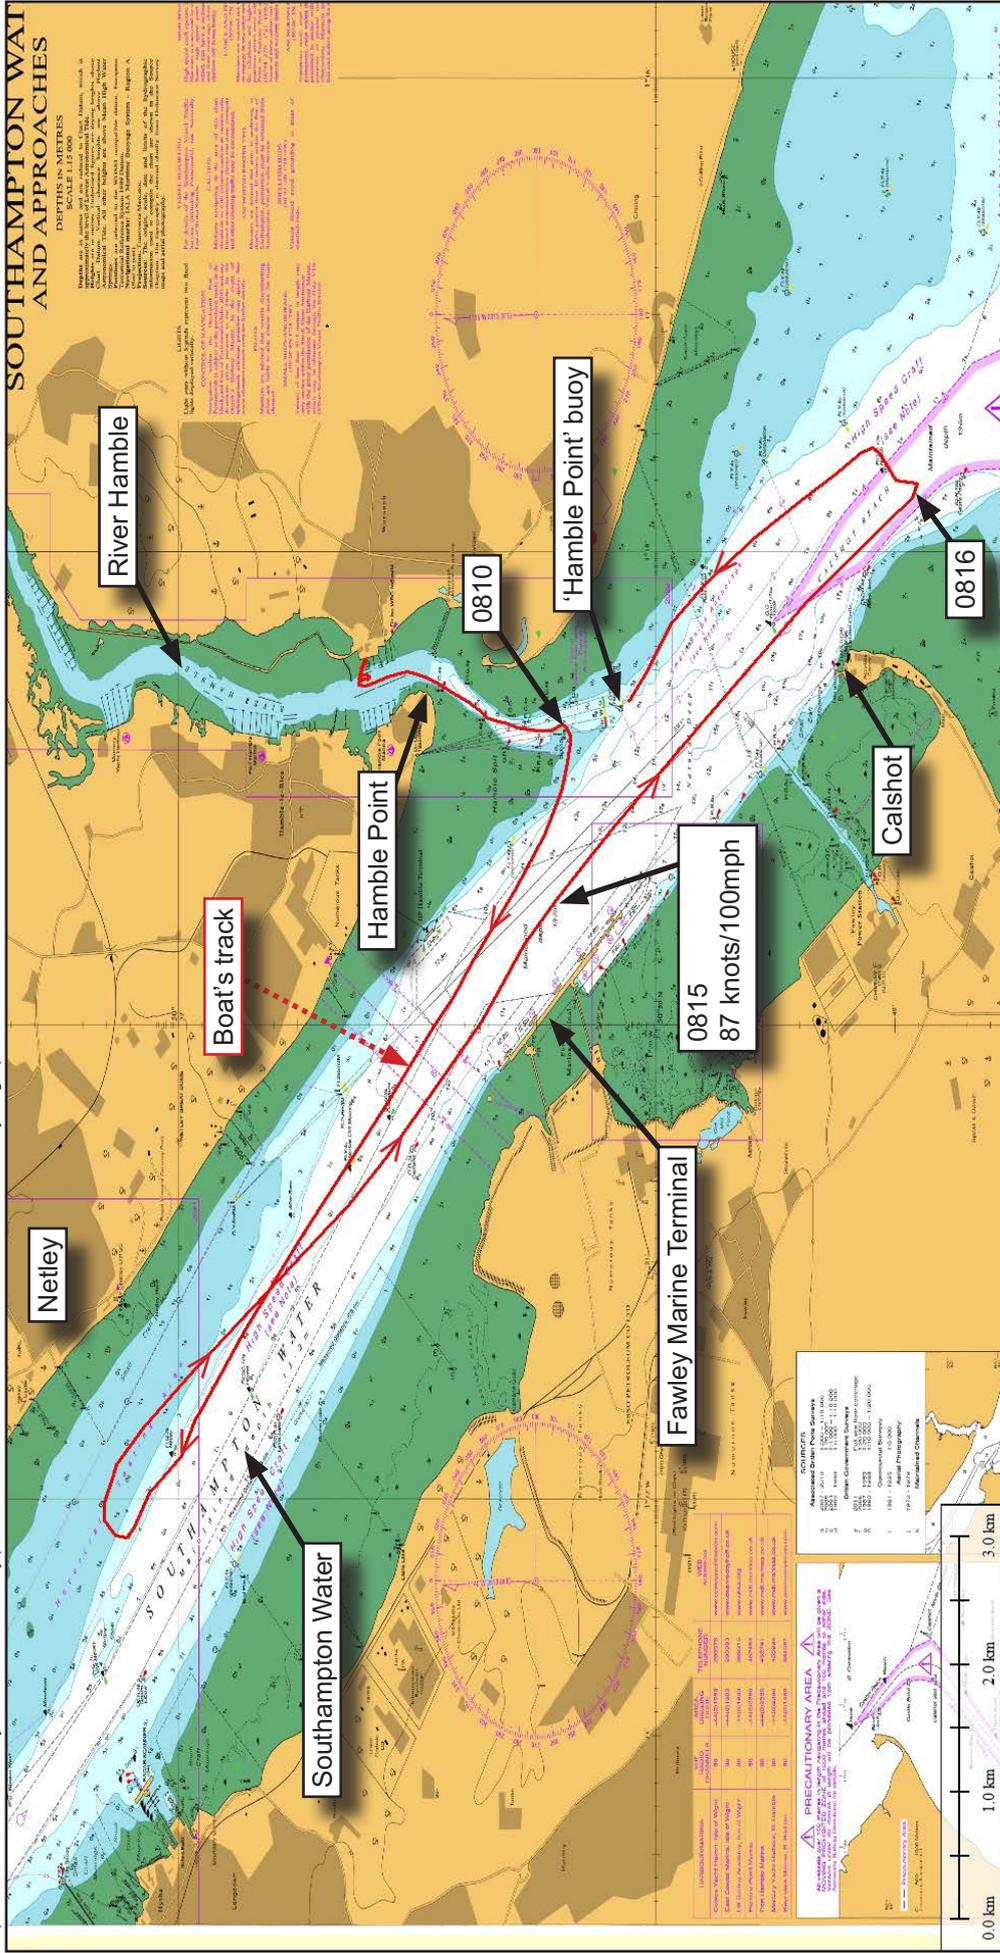
Figure 3: Boat's track during trial

At 0810 the boat passed number 2 Beacon, River Hamble (**Figure 3**), and the driver instructed the others to secure the cockpit hatches. He then turned the boat to starboard onto a north-westerly heading and increased speed to 65kts (75mph) as the boat proceeded up Southampton Water. The wind was light and the sea state was calm.

At 0816 the driver reduced the boat's speed to execute a turn to port around the *Reach* buoy. He then increased speed to approximately 80kts (92mph) on a north-westerly course to head the boat back towards the River Hamble (**Figure 3**).

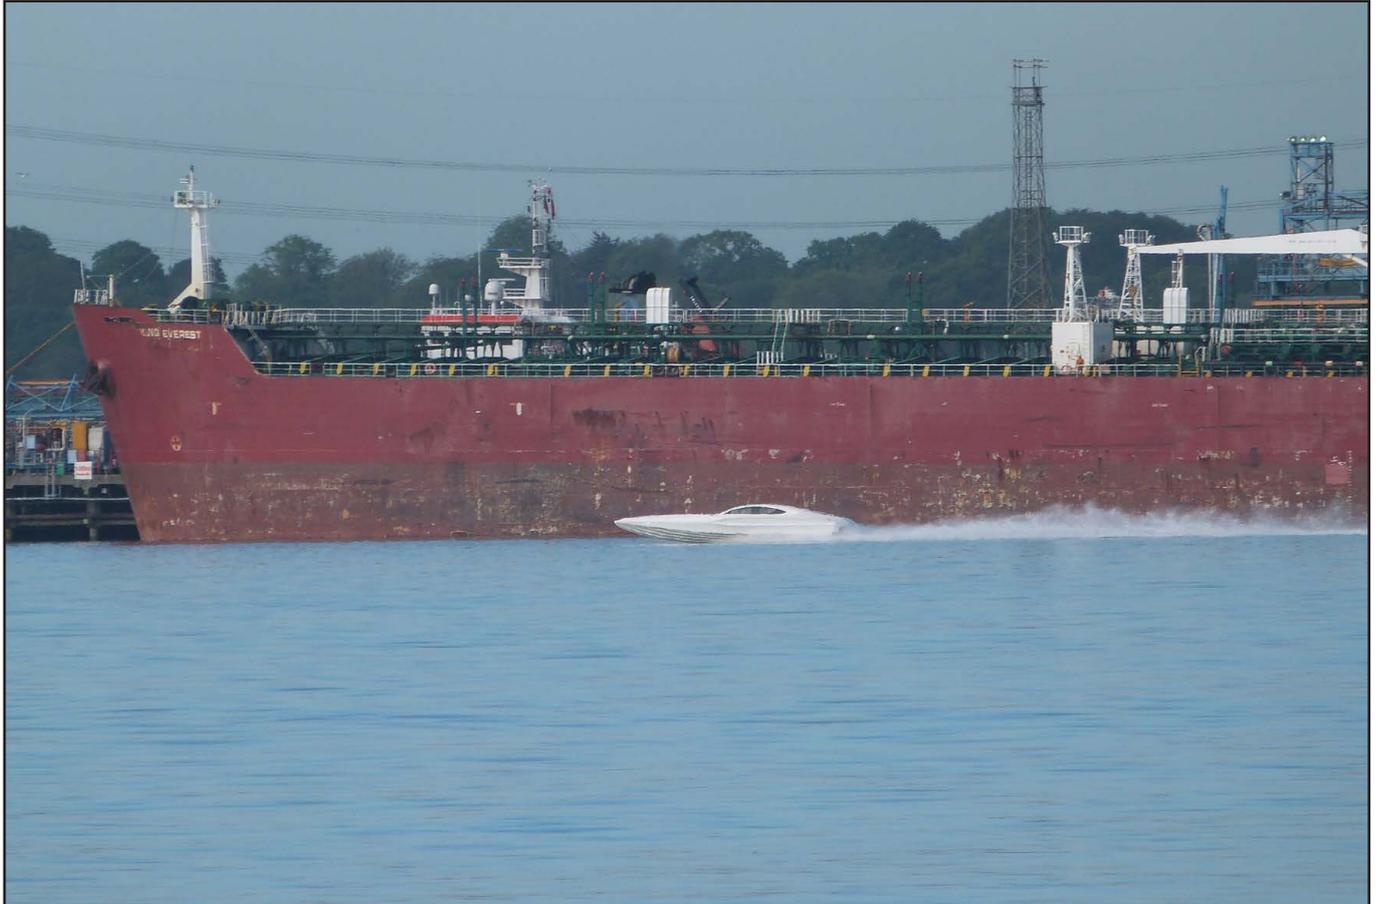
Figure 4: 100mph passing Fawley Marine Terminal

Off Netley, the driver turned the boat to starboard onto a south-easterly heading and increased speed. At 0815 it reached a speed of 87kts (100mph) as it passed the Fawley Marine Terminal (**Figure 4**).
