ACCIDENT

Aircraft Type and Registration:	BAe 146-200, G-RAJJ	
No & Type of Engines:	4 ALF502R-5 turbojet engines	
Year of Manufacture:	1988 (serial number E2108)	
Date & Time (UTC):	23 February 2015 at 1854 hrs	
Location:	Guernsey Airport, Channel Islands	
Type of Flight:	Commercial Air Transport (Passenger)	
Persons on Board:	Crew - 4	Passengers - 47
Injuries:	Crew - None	Passengers - None
Nature of Damage:	Shock absorber damaged beyond economic repair, damage to left main landing gear and No 1 tyre burst	
Commander's Licence:	Airline Transport Pilot's Licence	
Commander's Age:	58	
Commander's Flying Experience:	8,428 Hours (of which 5,300 were on type) Last 90 days - 32 hours Last 28 days - 23 hours	
Information Source:	AAIB Field Investigation

Synopsis

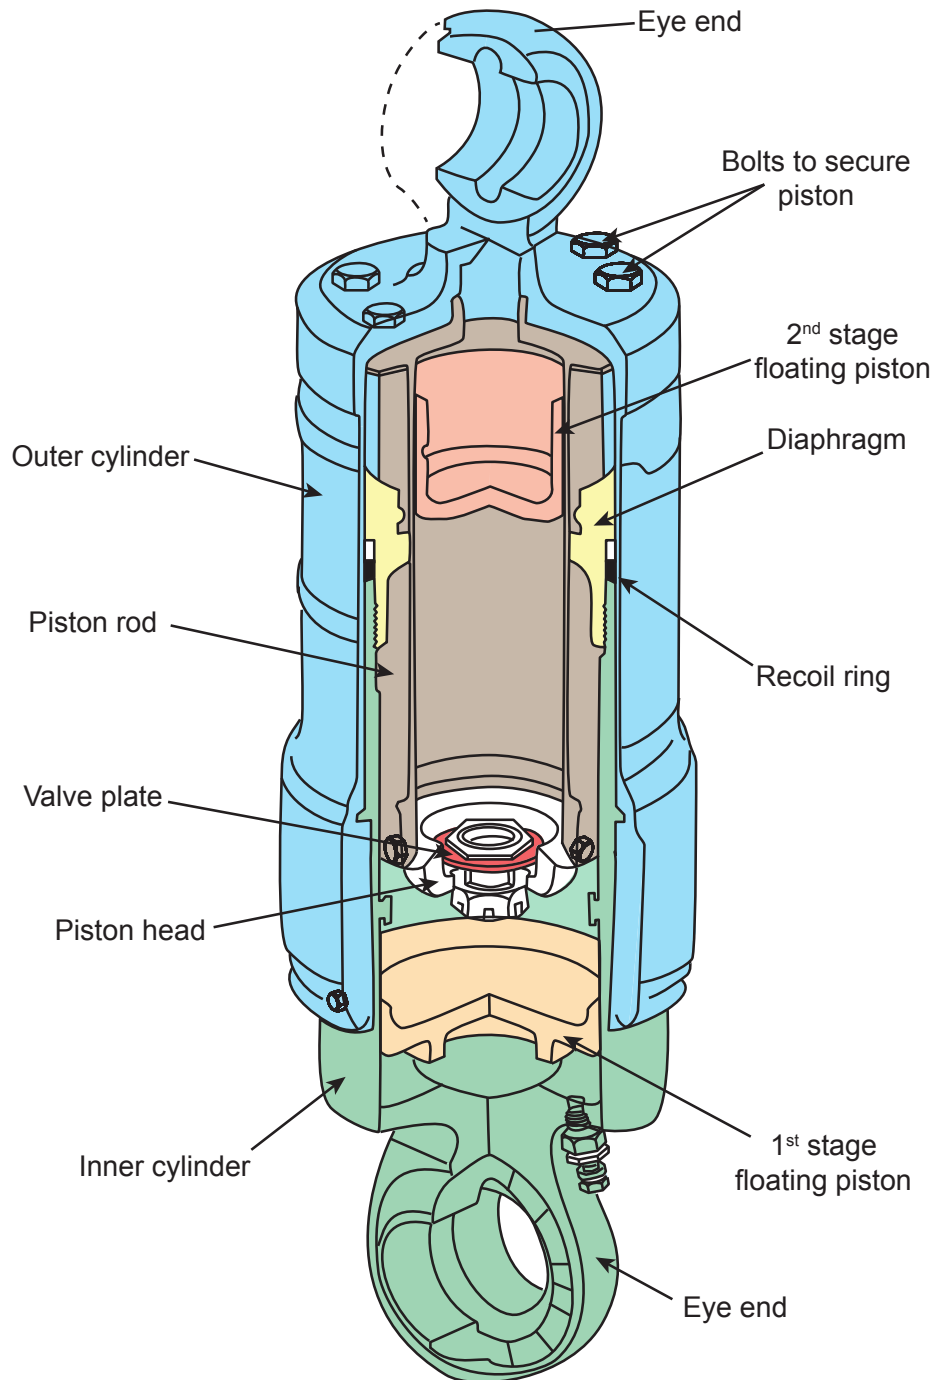
Figure 3

Cutaway of shock absorber assembly

- The threads on the inner cylinder (steel) were found to be intact, whereas the threads on the diaphragm (aluminium alloy) had sheared in a direction consistent with a compressive load forcing the diaphragm and inner cylinder together.

- The locking bolt fracture surfaces only showed evidence of fracture due to shear overload. These bolts had failed in a direction consistent with a tensile load forcing the diaphragm and inner cylinder to separate.
