**ACCIDENT**

<b>Aircraft Type and Registration:</b>	Alpi (Cavaciuti) Pioneer 400, G-CGVO	
<b>No &amp; Type of Engines:</b>	1 Rotax 914F piston engine	
<b>Year of Manufacture:</b>	2011	
<b>Date &amp; Time (UTC):</b>	3 January 2015 at 1528 hrs	
<b>Location:</b>	Near Popham Airfield, Hampshire	
<b>Type of Flight:</b>	Private	
<b>Persons on Board:</b>	Crew - 1	Passengers - 2
<b>Injuries:</b>	Crew - 1 (Fatal)	Passengers - 2 (1 Fatal) (1 Serious)
<b>Nature of Damage:</b>	Destroyed	
<b>Commander's Licence:</b>	Private Pilot's Licence	
<b>Commander's Age:</b>	50 years	
<b>Commander's Flying Experience:</b>	201 hours (of which 5 were on type) Last 90 days - 7 hours Last 28 days - 2 hours	
<b>Information Source:</b>	AAIB Field Investigation

**Synopsis**

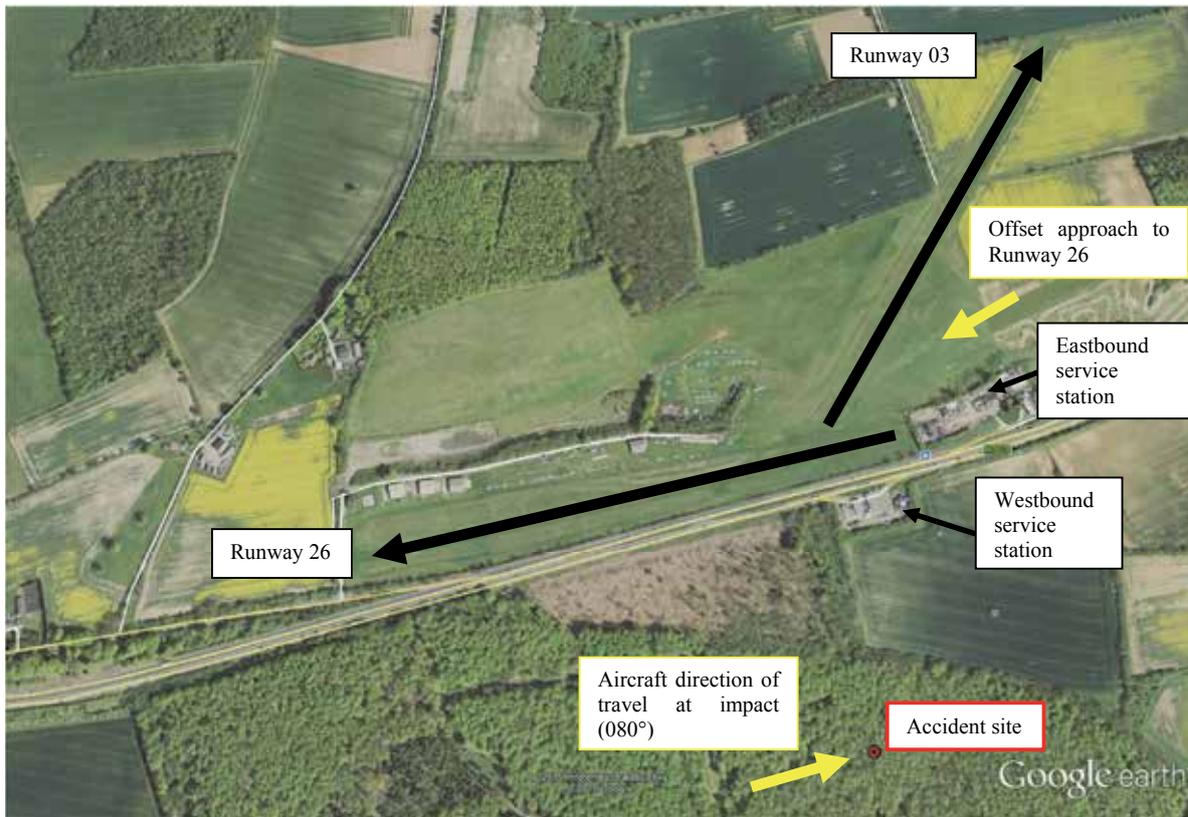
**Figure 1**

At approximately 1525 hrs a motorist who was driving west on the A303 road (Figure 1), briefly observed the aircraft heading towards the airfield at low level. He believed it to be north of the road and presumed it was approaching to land on the westerly runway (Runway 26).

Popham Airfield and accident site

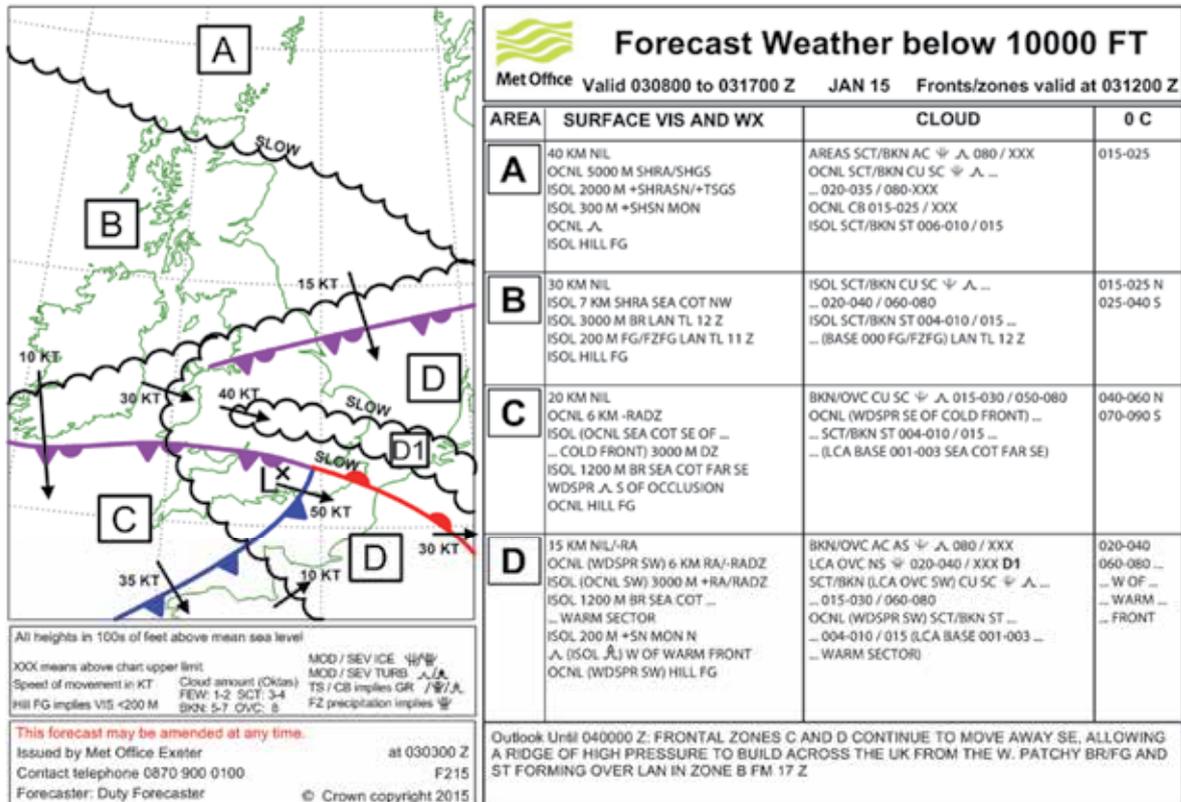
Figure 2

The Met Office aftercast agreed with the forecast chart (F215) for weather below 10,000 ft between 0800 hrs and 1700 hrs. It was issued at 0300 hrs on 3 January 2015 and indicated the expected positions of the fronts at 1200 hrs (Figure 2).

Study of this chart shows that the origin of the flight was within area D and that the aircraft would have had to fly through the occluded front (depicted in magenta). The forecast for the area was for scattered or broken stratus cloud with a base at 400-1,000 ft amsl and tops at 1,500 ft amsl. Above this a broken or overcast layer of cumulus and strato-cumulus extended up from 1,500-3,000 ft amsl with tops at 6,000-8,000 ft amsl. Visibility was forecast to reduce to 6,000 m in rain and drizzle but in isolated places it was forecast to reduce to 3,000 m or to 1,200 m near the coast. The freezing level was forecast to be no lower than 2,000 ft amsl to the north of the occluded front; measurements taken at Gatwick Airport, after the front had passed there, indicated the freezing level was above 4,000 ft amsl.

Forecast weather below 10,000ft (F215)

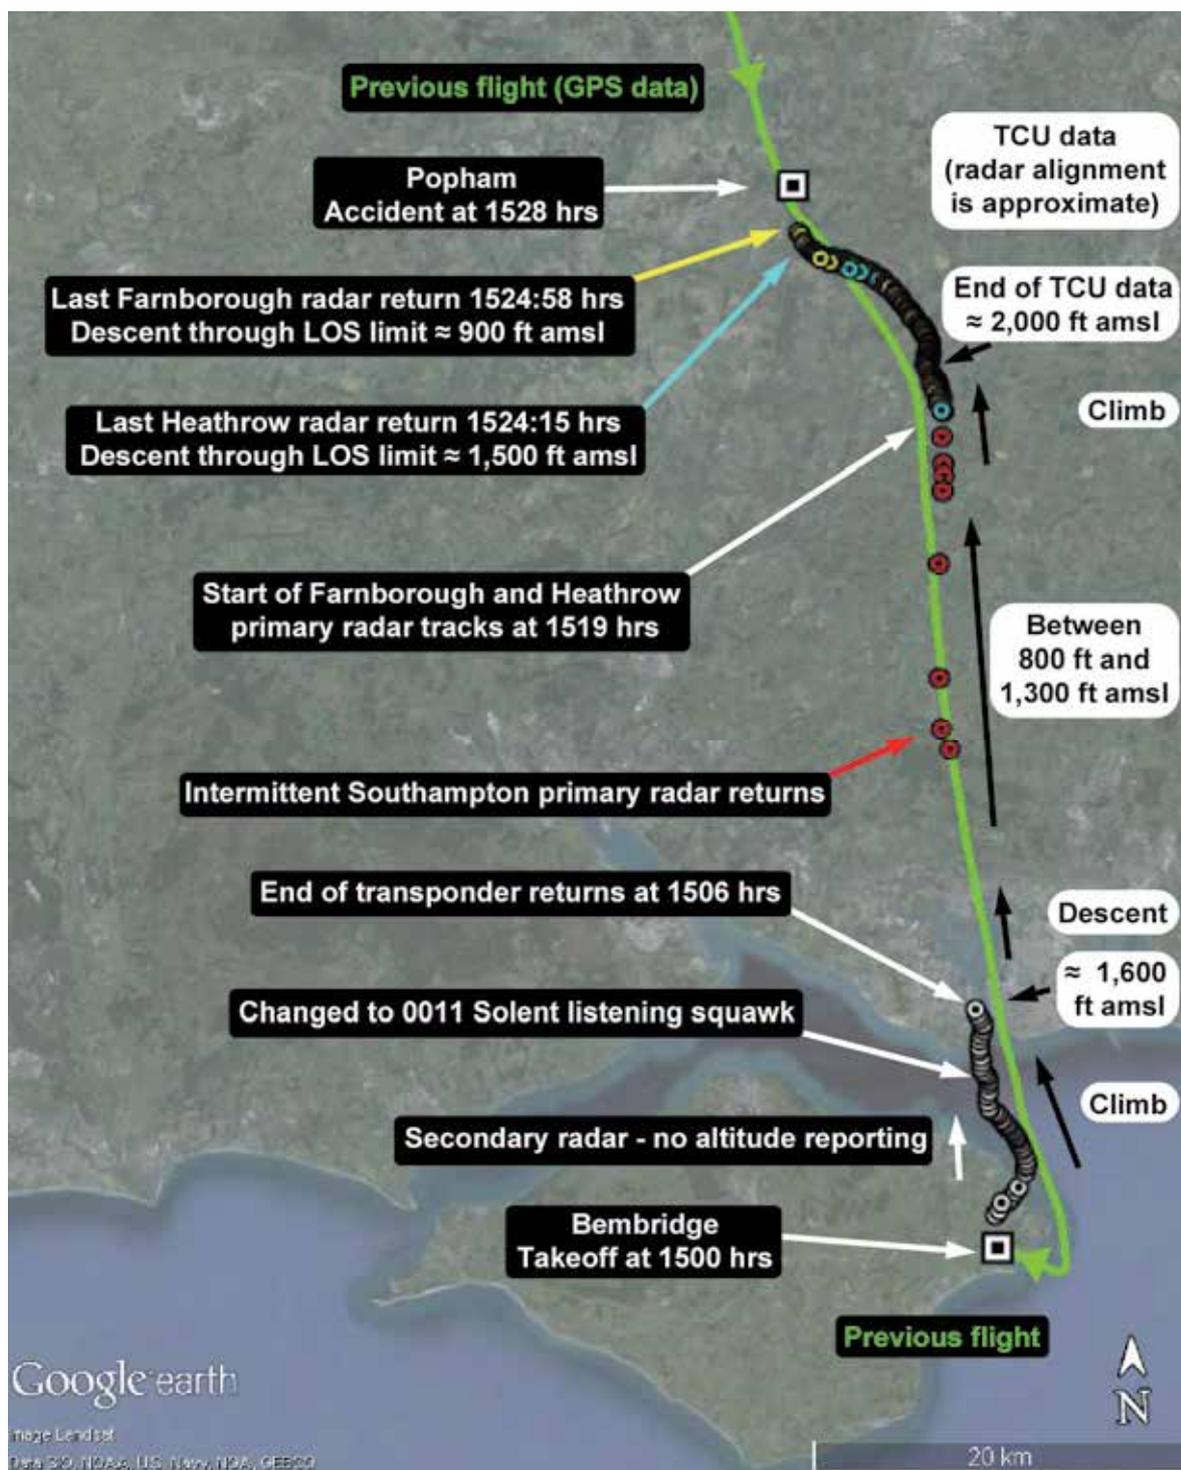
**Figure 5**  
Amalgamated recorded data

The pertinent recorded information is shown in Figure 5. The aircraft took off from Bembridge at 1500 hrs. The aircraft transponder was not reporting altitude but was initially squawking 7000 and then switched to the Solent listening squawk of 0011 whilst over the Solent, approximately 2 nm south of Gosport. The aircraft altitude reached approximately 1,600 ft amsl in the vicinity of Gosport after which the aircraft started to descend and the secondary radar track stopped.
