Rail Accident Investigation Branch

# Rail Accident Report

## **Passenger trapped in train doors and dragged at Clapham South station 12 March 2015**

Report 04/2016  
March 2016

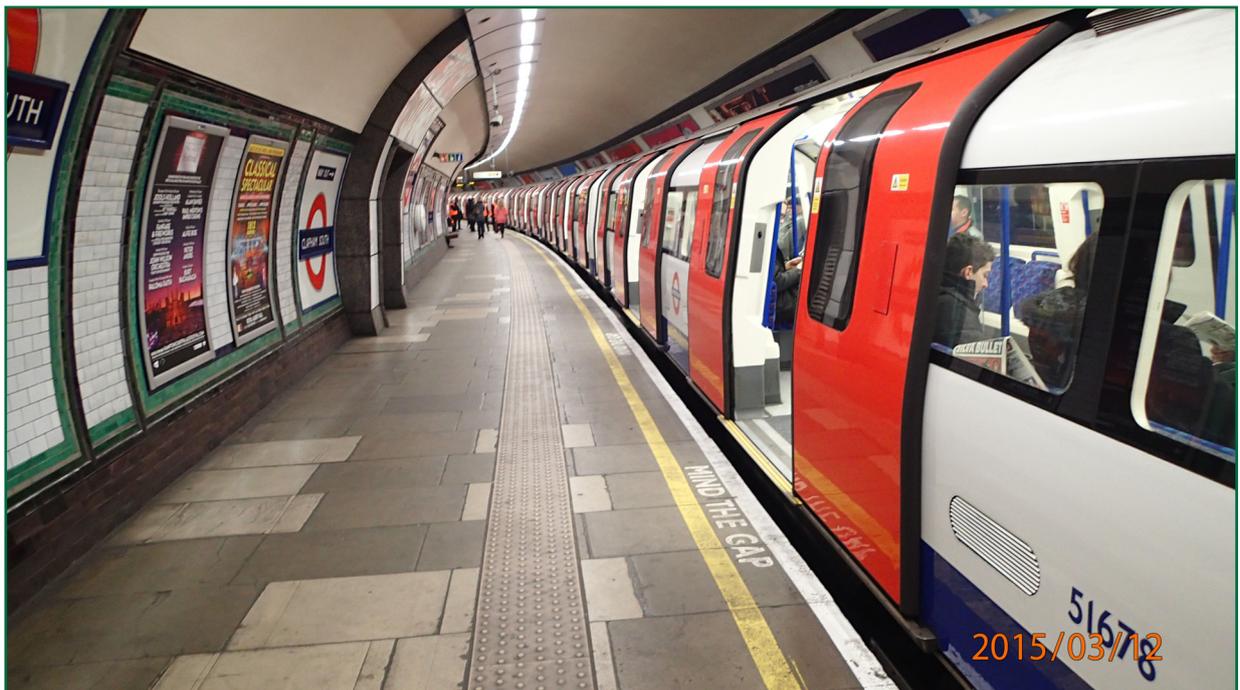
Figure 3: Northbound platform at Clapham South station

- 7 The northbound platform is positioned on the right-hand side of the track, relative to the normal direction of train movement, and is in a single track tunnel. There is a right-hand curve along the entire length of the platform (figure 3).

- 17 A yellow line had been painted along the platform 300 mm from the platform edge, as specified in London Underground standard S1131 (Premises - Station Platforms), to provide passengers with an indication of the distance they should stay back from the platform edge unless boarding or alighting from trains (figure 3). Alternative markings have been applied to the platform since the accident (paragraph 115g).

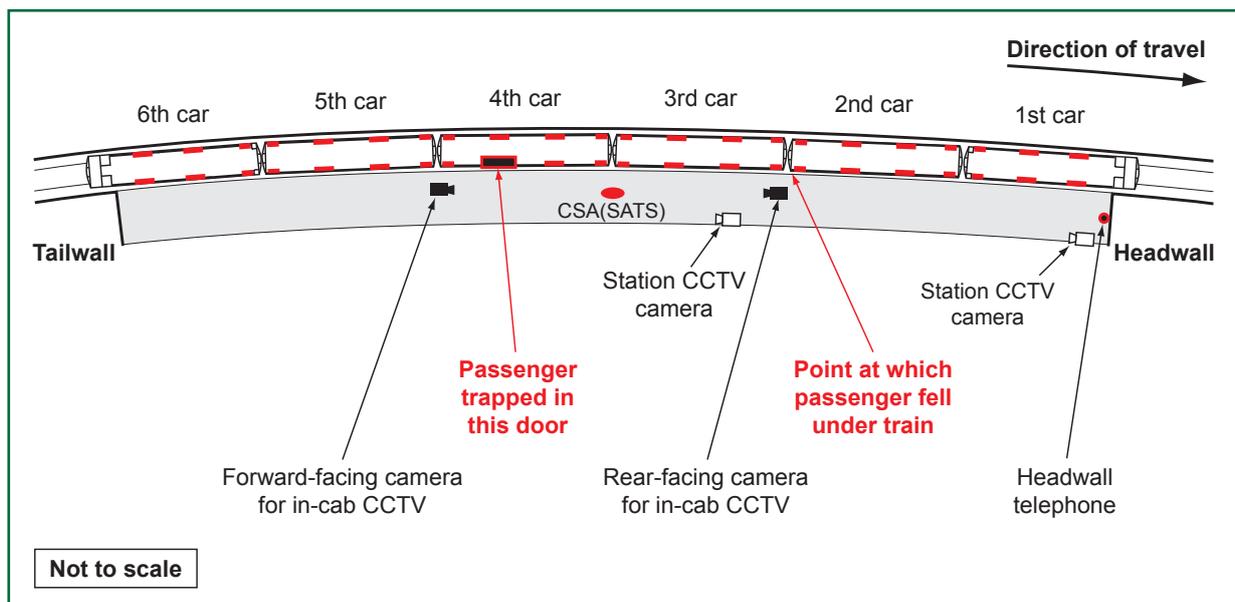
Figure 5: Layout of northbound platform

89 When the train departed, the CSA was standing with his baton raised in the central part of the platform, about midway along the train (figure 5). This was within the area where London Underground expect staff to stand when carrying out SATS duties on the northbound platform at Clapham South. He was approximately 10 metres from the door where the passenger had become trapped but could not see that she was in difficulty because his view of her was obscured by people on the platform who had been unable to board the train.

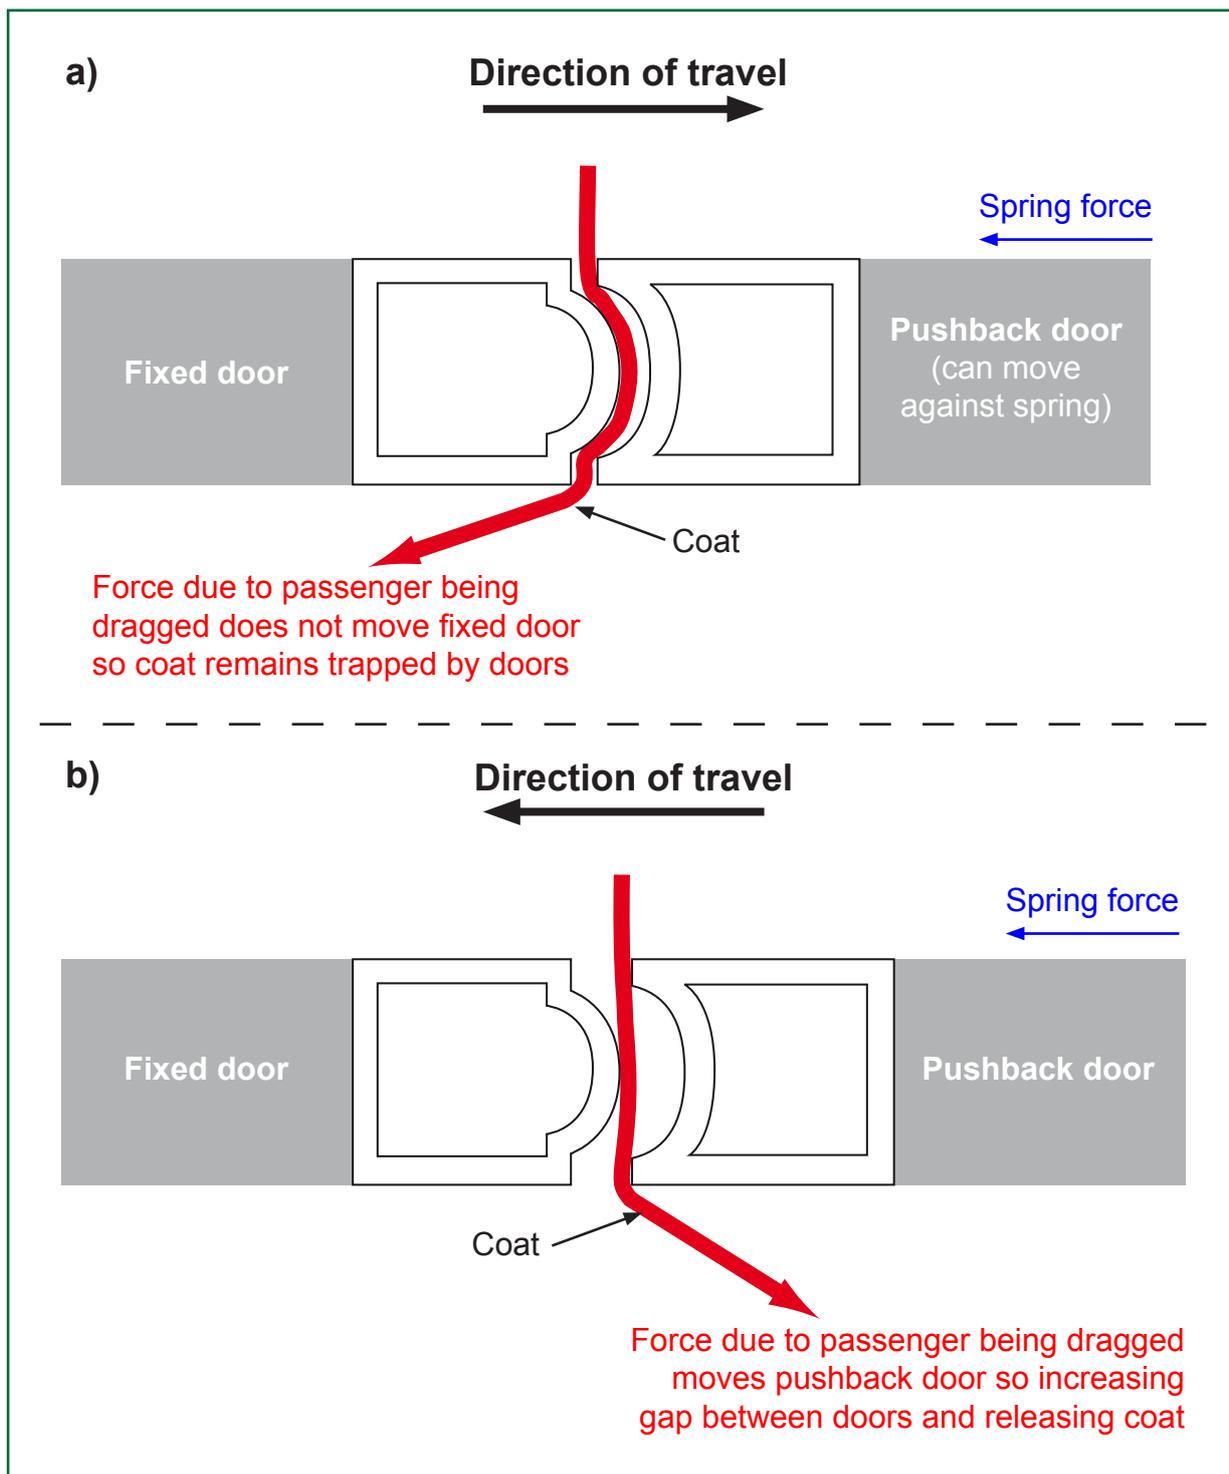
Figure 9: Effect of fixed door trailing

- 46 The configuration at the time of the accident meant that, as the passenger was being dragged, the coat was pulling against the fixed leaf which was unable to move to allow the coat to be released (figure 9a). If the train had been moving in the opposite direction, then the coat would have been pulling against the pushback leaf which would probably have opened slightly and released the coat (figure 9b).

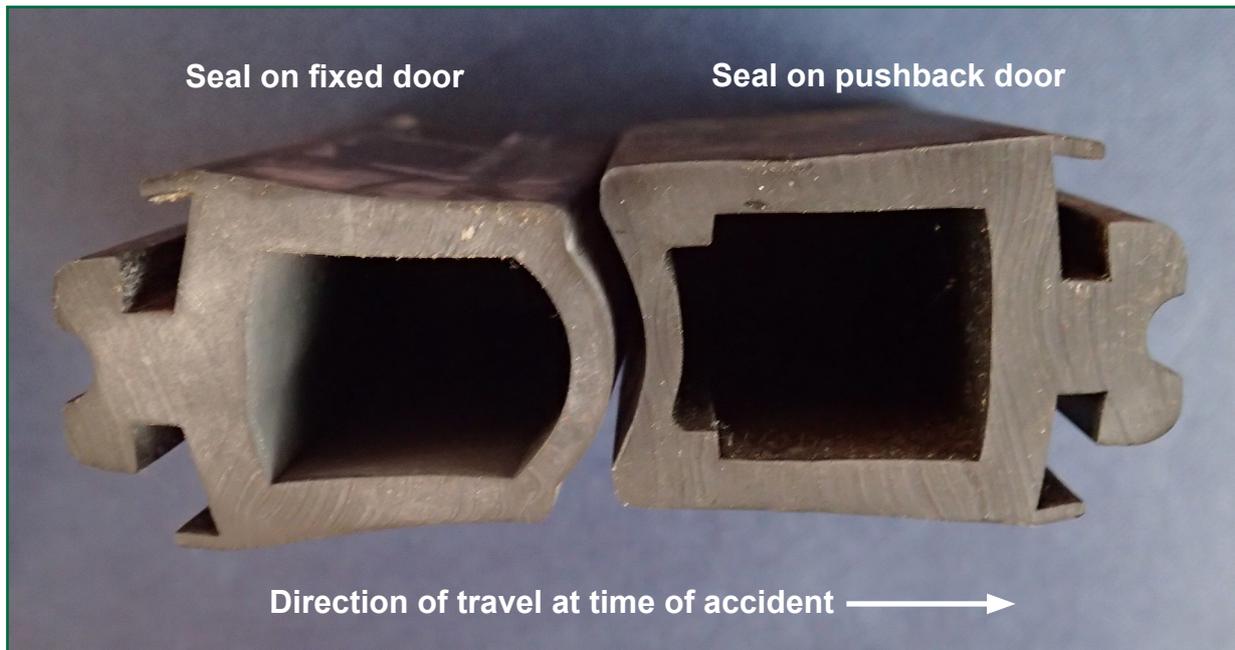
Figure 10: Door seal cross-sections

- 47 This door design is used on the majority of London Underground's trains, although the most recently built trains use different designs.
- 48 The door seals consist of hollow rubber extrusions, with the fixed leaf seal having a convex cross-section and the pushback leaf seal a concave cross-section (figure 10). The seals reduce draughts, water ingress and noise. They are able to compress around small objects when the doors close, but are intended to have sufficient flexibility, when combined with the pushback mechanism, to allow some trapped objects to be withdrawn. Door seal characteristics, particularly shape and flexibility, affect the ease with which trapped objects can be withdrawn from doors. The potential to modify sealing arrangements is discussed at paragraph 101.

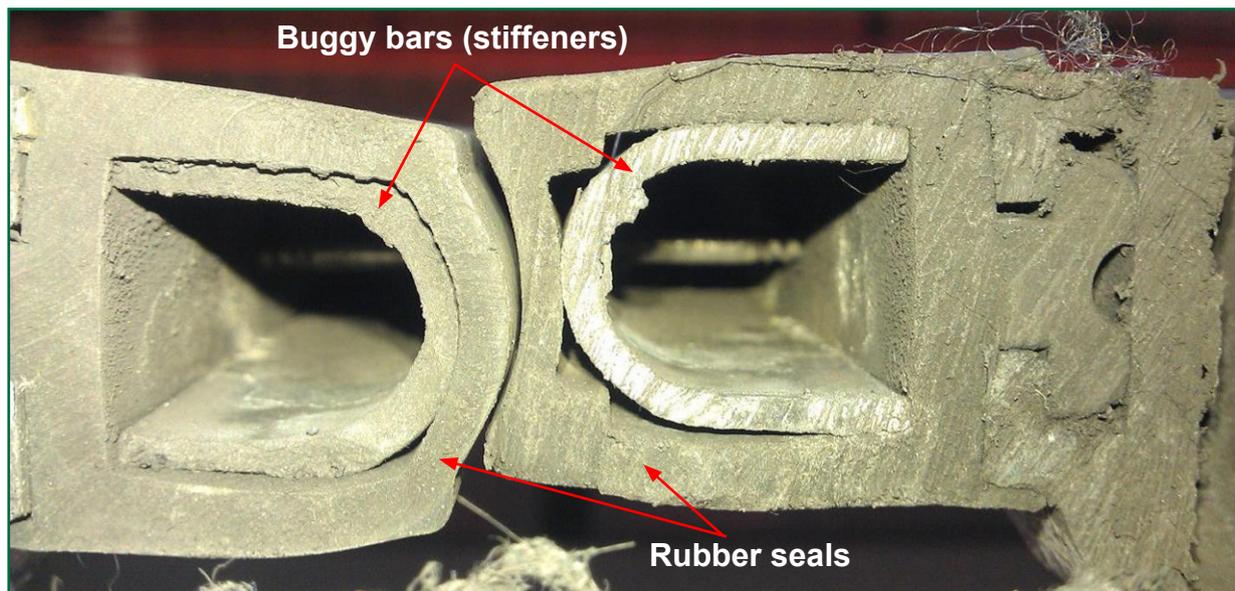
Figure 11: Buggy bars

- 49 A '*buggy bar*' is fitted inside the lower 535 mm of the door seals, with a tapered section on the top 60 mm (figure 15). The buggy bar restricts the ability of the seal to deform around small objects, and is intended to prevent the leaves closing sufficiently for them to be detected as fully closed when small objects, such as tubular parts of a child's push-chair, are still in the doorway close to ground level. The bar is intended to ensure detection of an 11 mm diameter object trapped in the bottom 450 mm of the door as required by London Underground standard 2 - 55, 'Rolling stock bodyside doors and door control system'.
