# **AIRCRAFT ACCIDENT REPORT 1/2016**

**Report on the accident to  
AS332 L2 Super Puma helicopter, G-WNSB  
on approach to Sumburgh Airport  
on 23 August 2013**

**Air Accidents Investigation Branch**

Published 15 March 2016

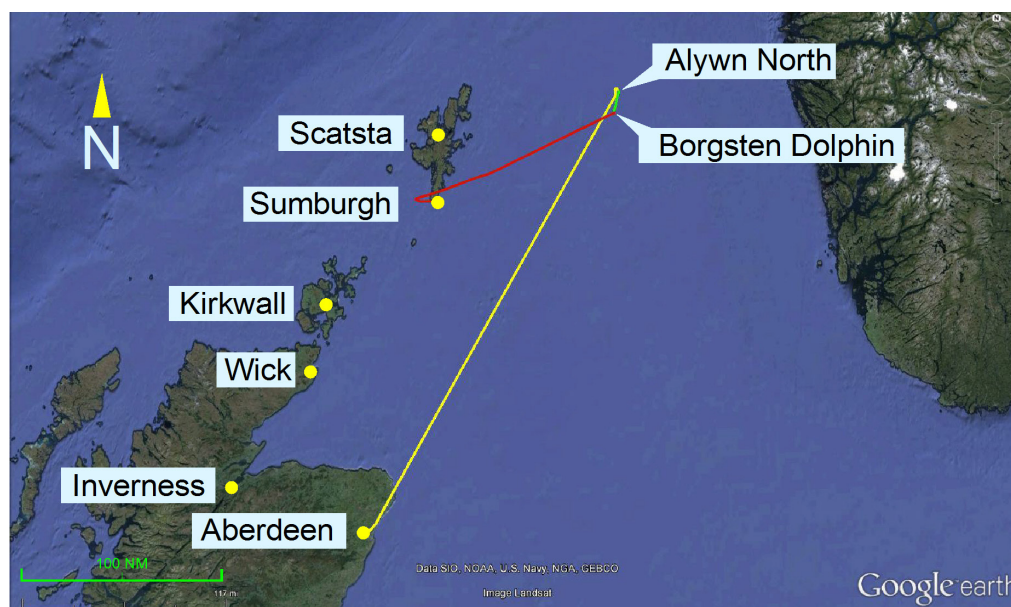
**Figure 1**

G-WNSB flight tracks (accident sector in red)

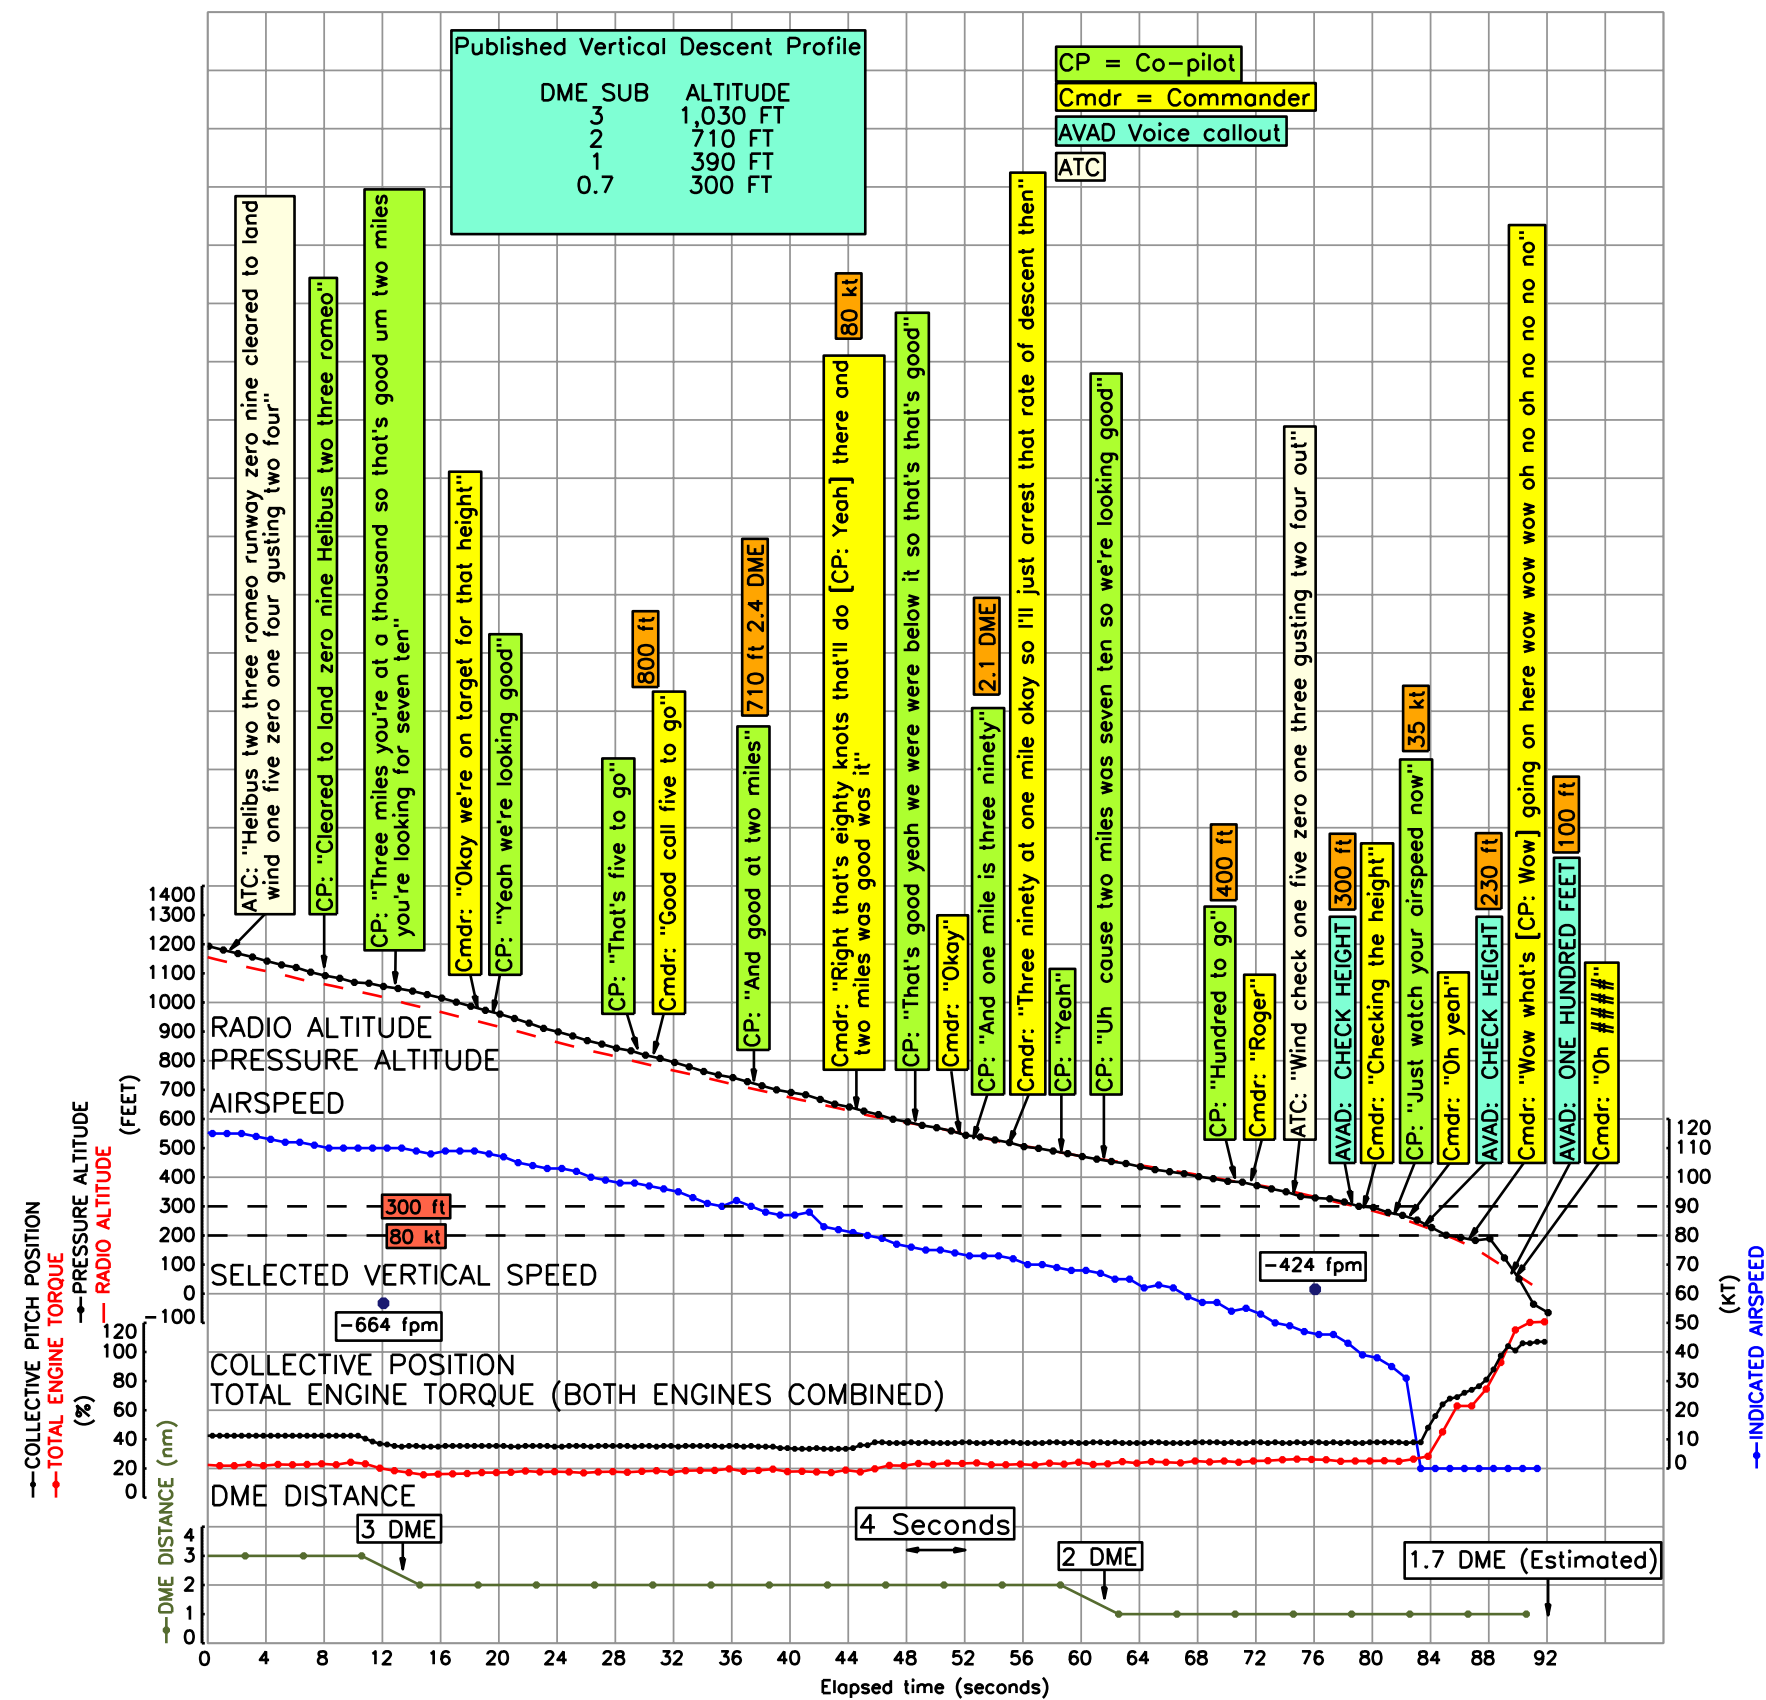
Figure 13  
CVFDR record from 1,200 ft

As the airspeed reduced, the autopilot gradually started to increase the nose-up pitch attitude (Figure 12, Point C), to maintain a calculated vertical speed of about 550 fpm. At 2 nm DME the helicopter was at 460 ft, (250 ft below the published vertical descent profile) and the airspeed was 67 kt. The airspeed started to reduce more rapidly, with the rate of decay increasing to about 1.3 kt/sec.

As the helicopter descended to 340 ft, the selected vertical speed was recorded at 424 fpm. A few seconds later, at 300 ft, the AVAD 'CHECK HEIGHT' callout occurred; the airspeed was now about 40 kt, but there was no increase in collective pitch to prevent the airspeed from decreasing further. Two seconds later, at a height of about 260 ft RA and an airspeed of 35 kt, the co-pilot alerted the commander to the low airspeed. The helicopter's pitch attitude was now 20° nose-up and its rate of descent had increased rapidly to about 1,000 fpm. The commander responded almost immediately, increasing the collective pitch and moving the cyclic forward (Figure 12, Point D). This was coincident with a second 'CHECK HEIGHT' callout. The helicopter continued to descend and at a height of about 230 ft RA the airspeed reduced to less than 30 kt<sup>17</sup>.

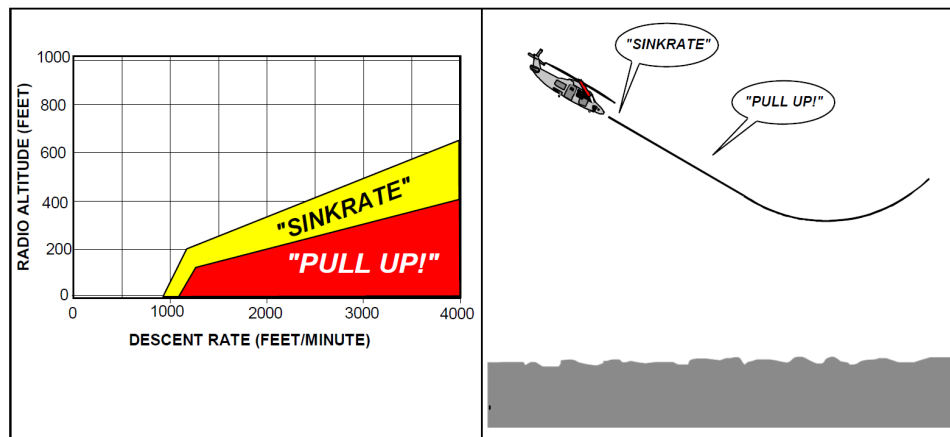
**Figure 17**

The results of the simulation were that: at a height of 179 ft, about 5.7 seconds before G-WNSB struck the surface of the sea, a Mode 1 'SINK RATE SINK RATE' audio alert would have been generated. Figure 17 provides details of the EGPWS Mode 1 envelope used to trigger the alert and Figure 18 is a time series plot of when the alert would have occurred relative to other alerts and impact with the sea.

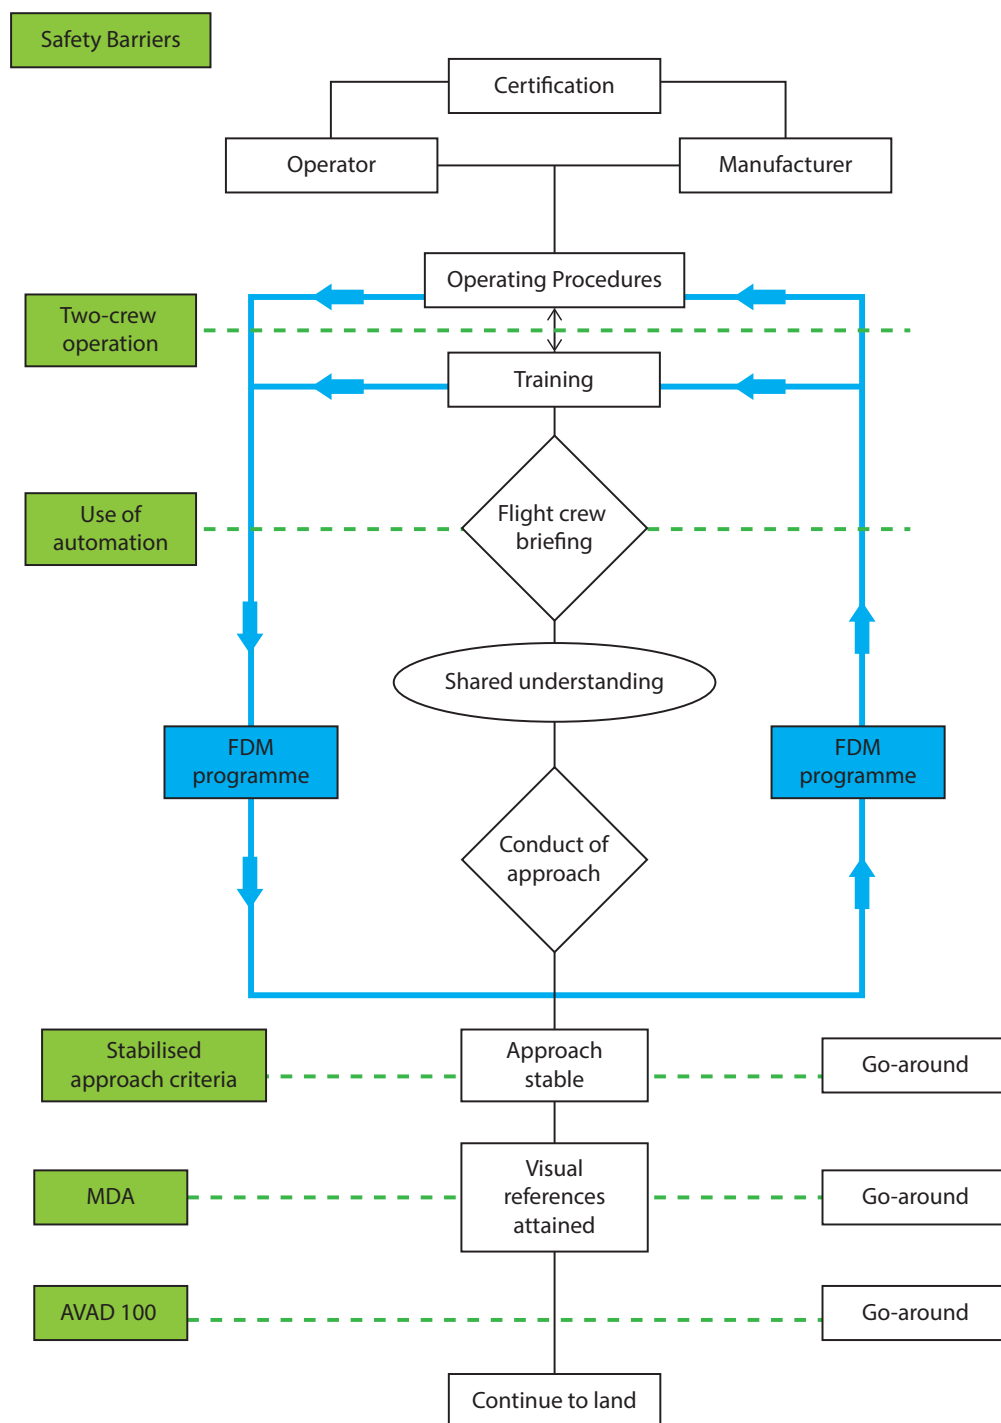
**Figure 23**  
Operational Safety Barriers

Safety barriers were designed within the operation to ensure that instrument approaches were performed safely, whether to a landing or, if visual reference was not acquired, to a go-around. These safety barriers proved to be ineffective. This suggests that safety actions are required to improve their effectiveness, in order to prevent a similar accident in the future. Figure 23 presents a schematic showing the operational safety barriers (highlighted in green); these are considered in turn.

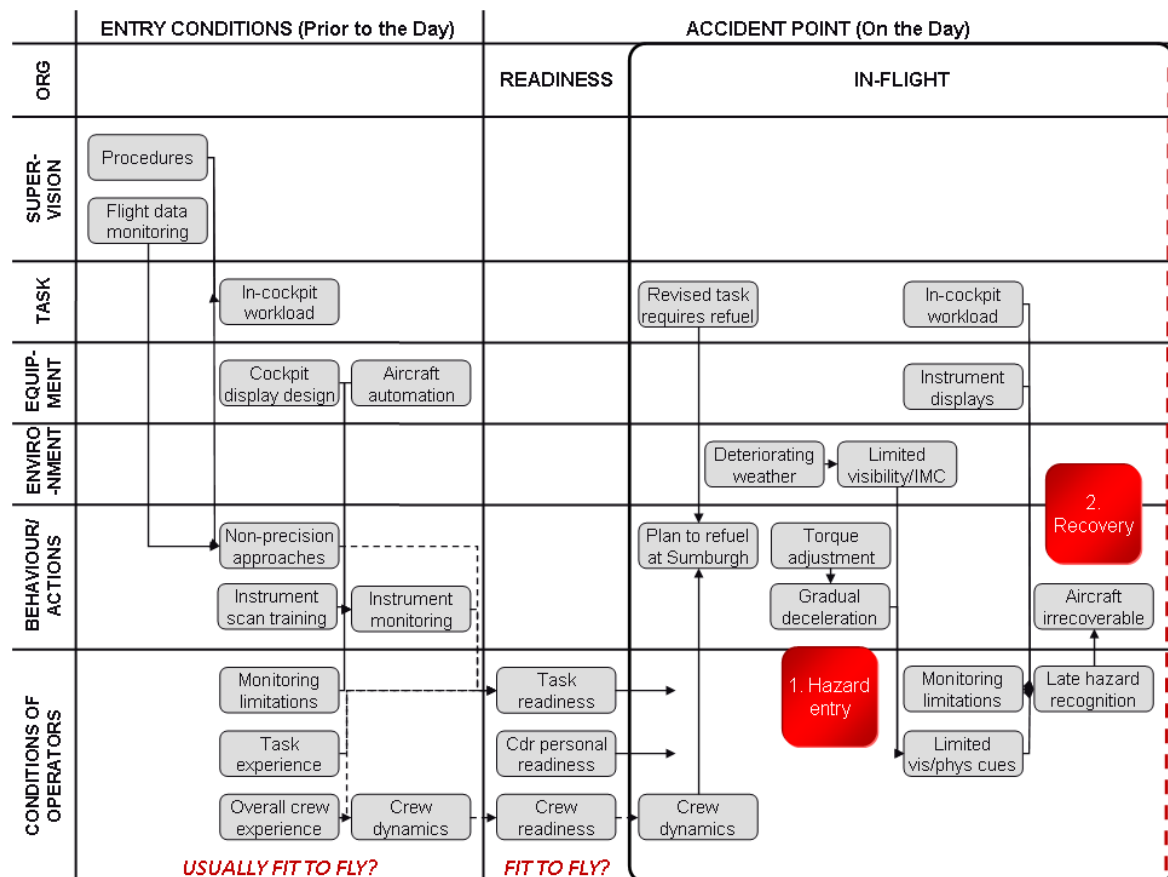
**Figure 2: Accident Route Matrix (ARM) for Super Puma G-WNSB on 23 Aug 2013**

9. The evidence that was collected (as described in the previous section) was plotted against the ARM and the hazard management process. The ARM for the G-WNSB accident is presented in Figure 2: Accident Route Matrix (ARM) for Super Puma G-WNSB on 23 Aug 2013. The remainder of this section presents evidence related to the HF considerations identified in the ARM. The section begins by describing the entry conditions on the left of the ARM – that is those factors present before the day of the accident that influenced readiness and hazard management. The section then describes the factors on the right hand side of the ARM – that is the factors that were specific to the day of the incident and the hazard management process itself.

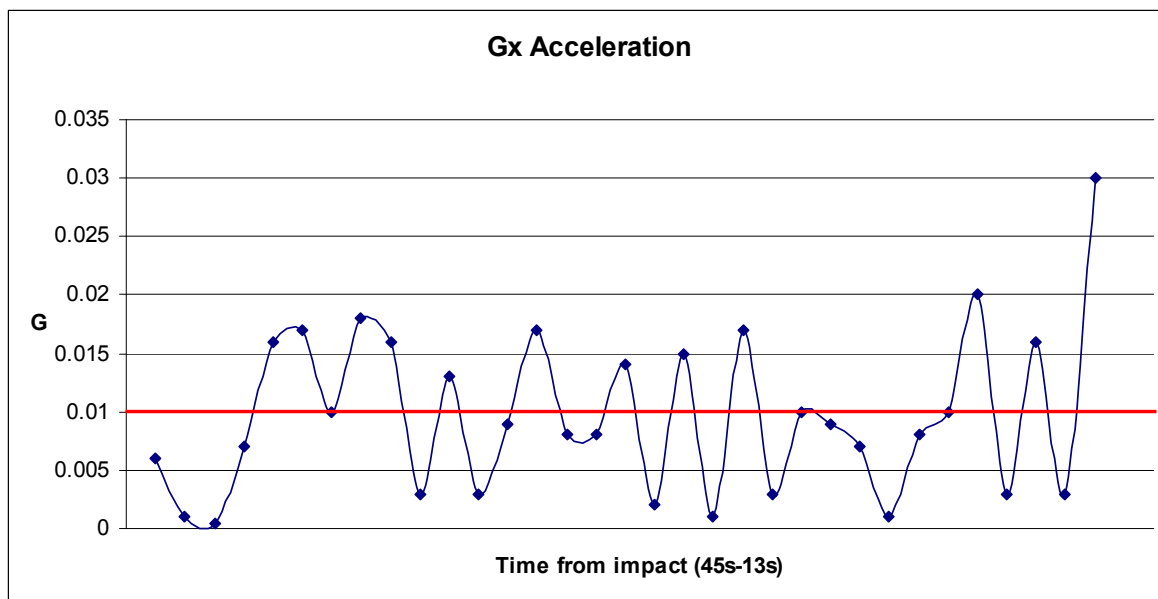
Figure 4: Gx acceleration for G-WNSB

- b. **Physiological.** There were minimal physiological cues for the crew to detect the changes in airspeed and pitch owing to the following factors:
- (1) **Acceleration/deceleration.** The amount of fore/aft (Gx) acceleration that is necessary for a pilot to detect motion equates to approximately 0.01 G of acceleration or deceleration<sup>21</sup>. Figure 4: Gx acceleration for G-WNSB4 shows the change in acceleration for G-WNSB from 45 seconds to 13 seconds prior to impact. It can be seen that the change in acceleration is mostly below the 0.01 G threshold, occasionally entering (slightly) into the detectable range. However, the aircraft was in turbulence and this could have masked the slight changes in acceleration as well as potentially masking other physiological cues to airspeed and orientation.

- c. **Somatogravic illusion.** In the absence of external visual cues, the brain is more prone to misperceptions. When an aircraft decelerates it will give a false-sensation of pitch down and so if accompanied with an actual nose-up attitude may cause the aircraft to feel level<sup>23</sup>. As the aircraft gradually decelerated, the pitch-up attitude of G-WNSB gradually increased. Therefore, the associated counteracting forces may have led the crew to perceive that the aircraft was straight and level with no decrease in airspeed, when in fact it was nose-up and losing airspeed.
