Report on the investigation into
the listing, flooding and grounding of

Hoegh Osaka

Bramble Bank, The Solent, UK

on 3 January 2015

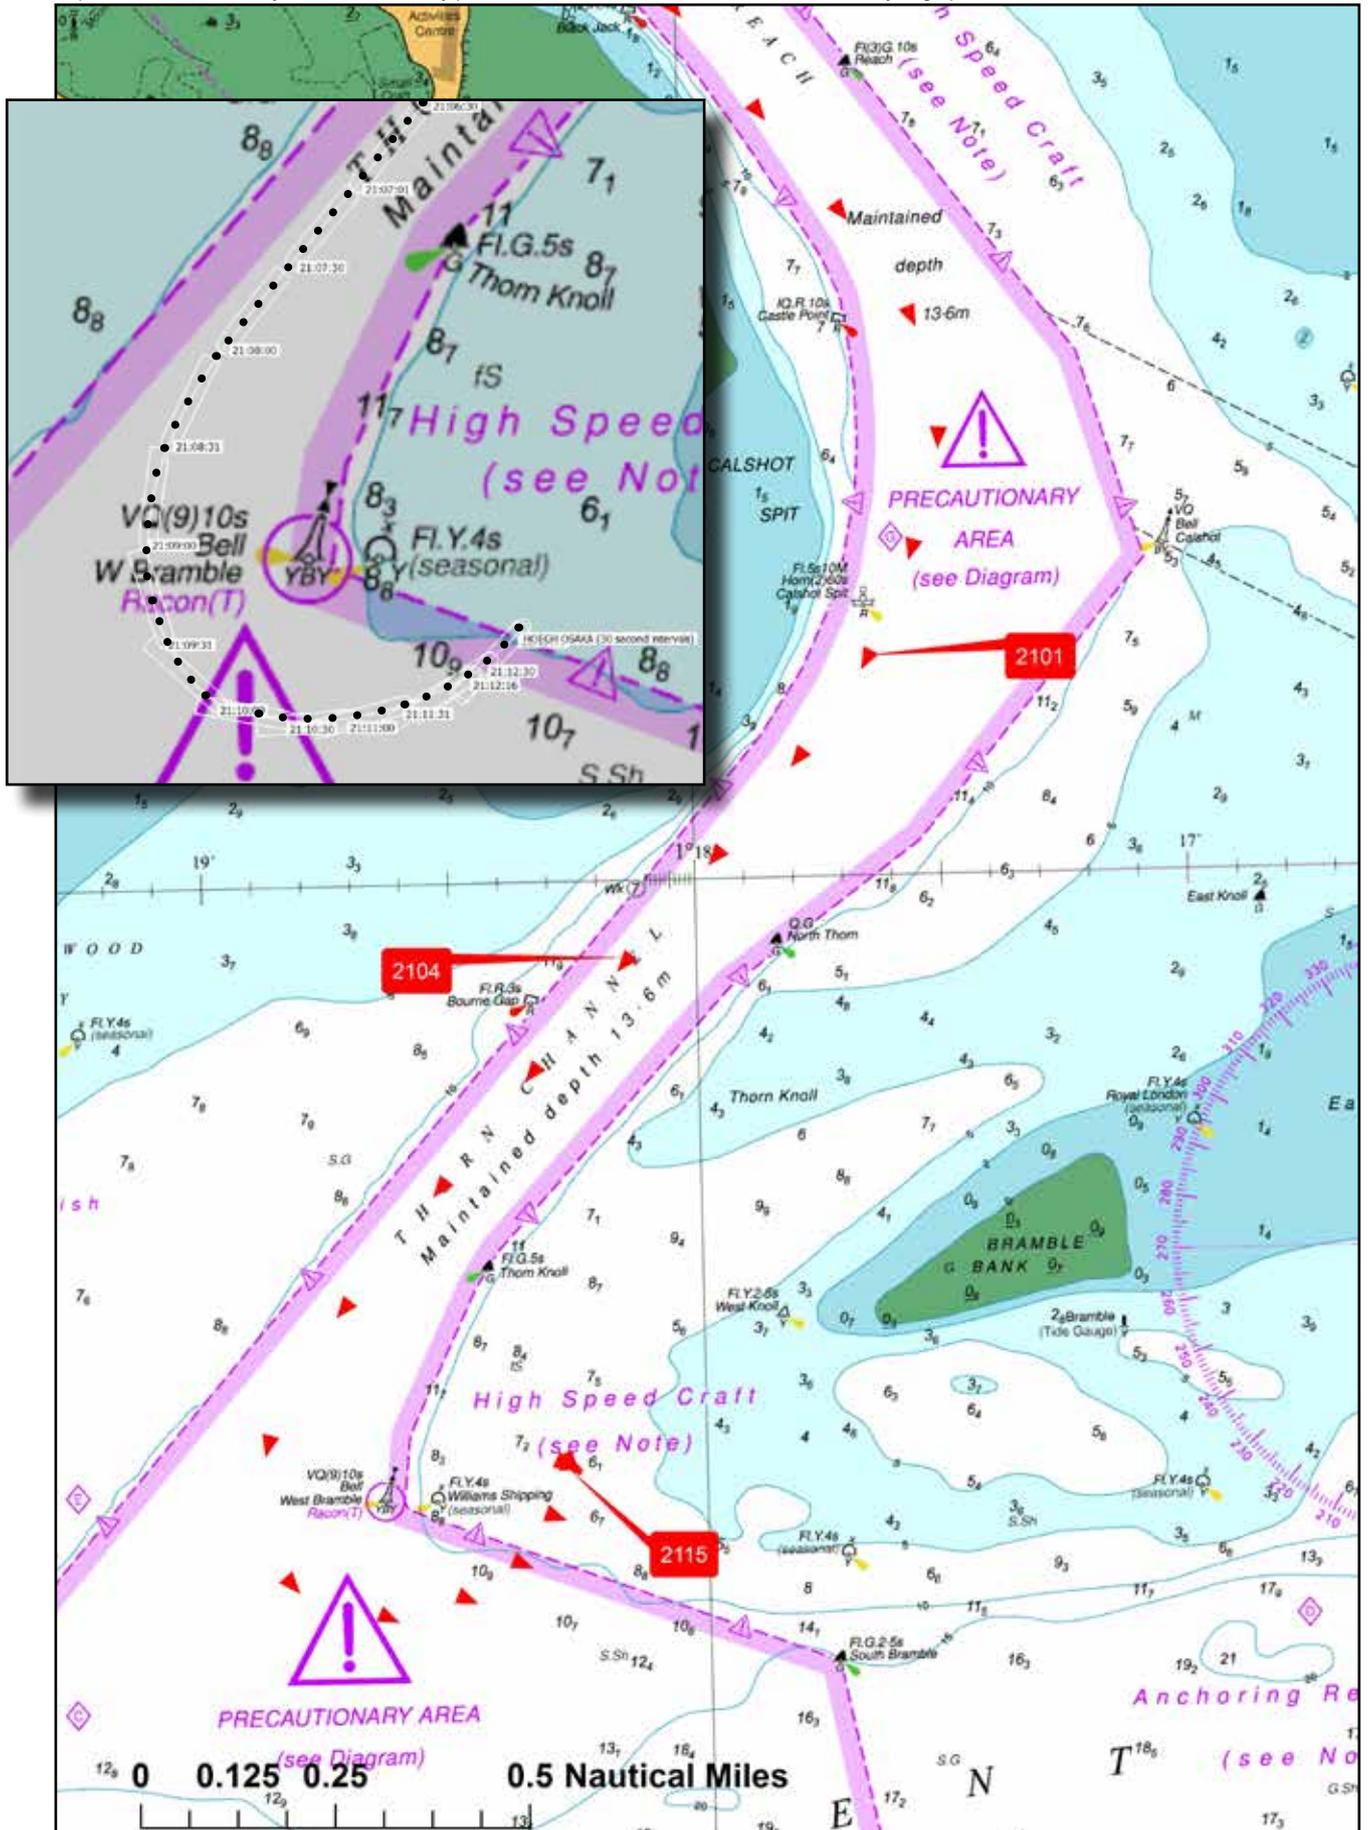
Figure 4: AIS track showing grounding position (with inset showing reconstruction of track)

At 2115, *Hoegh Osaka* grounded on Bramble Bank (**Figure 4**). The pilot observed the inclinometer on the bridge, which was indicating a list of 40° to starboard. This angle was not increasing and it was clear to the pilot that the ship was now aground.

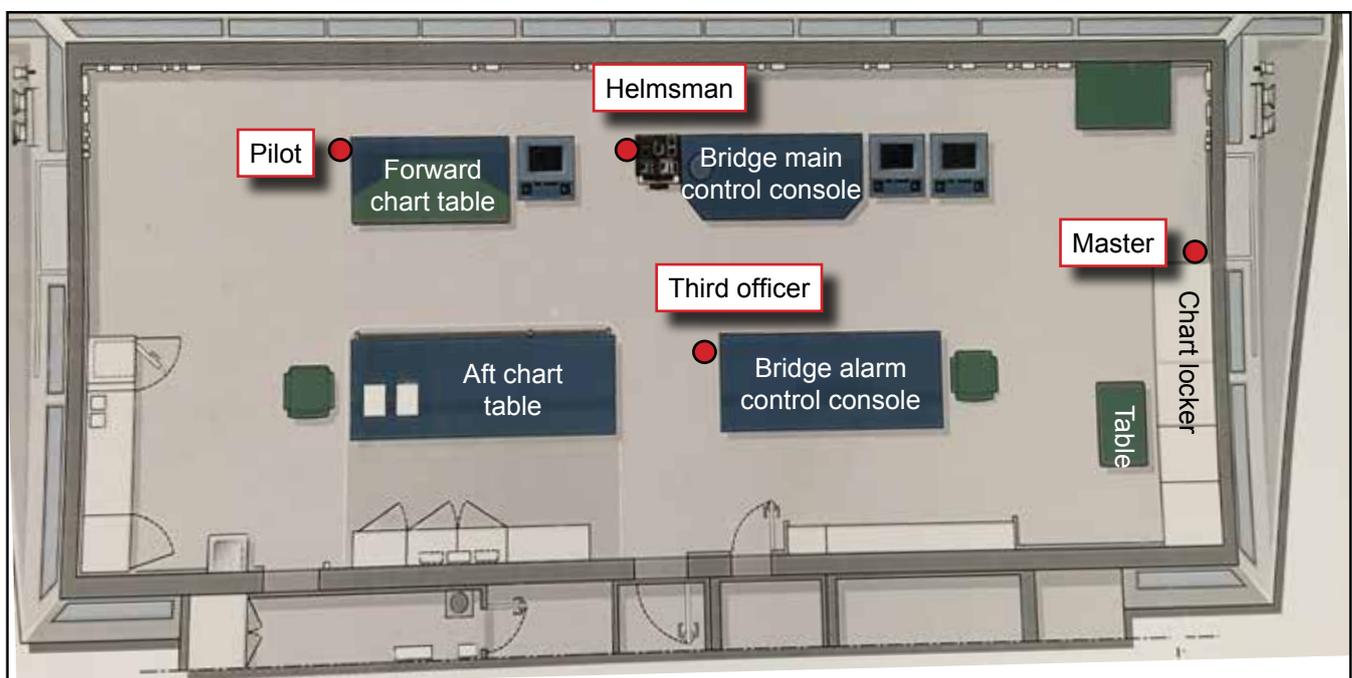
Figure 5: Location of the bridge personnel following list

Following the accident, it was not possible to stand or walk on the bridge. The pilot was initially on the port side, the high side of the bridge. He was able to brace himself against the port side of the forward chart table (**Figure 5**). The master had slid along the bridge deck and found himself on the low side of the bridge, against the starboard bridge wing door. The third officer was able to wedge himself between the bridge consoles, and the helmsman was able to remain between the helm console and the pilot radar. The fire alarms sounded throughout the ship.

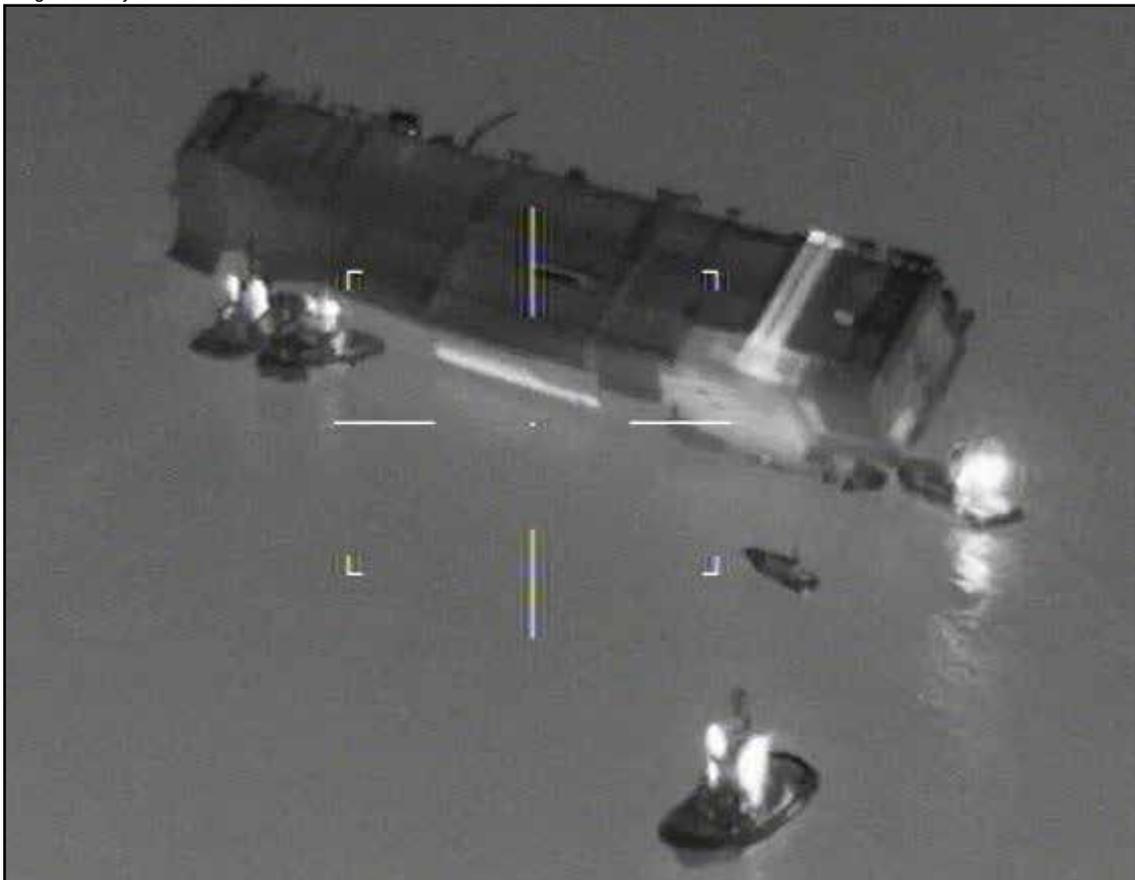
Figure 6: Aerial view of ship with tugs in attendance

By this time, one tug was pushing aft and two were pushing on *Hoegh Osaka*'s port side forward (**Figure 6**), ensuring that the ship remained aground on the bank. The crew of *RFA Lyme Bay*, which was in the vicinity, monitored the stricken ship and reported to VTS that *Hoegh Osaka* appeared to be stationary. The pilot co-ordinated the tug movements and communicated with SP and the harbourmaster throughout.

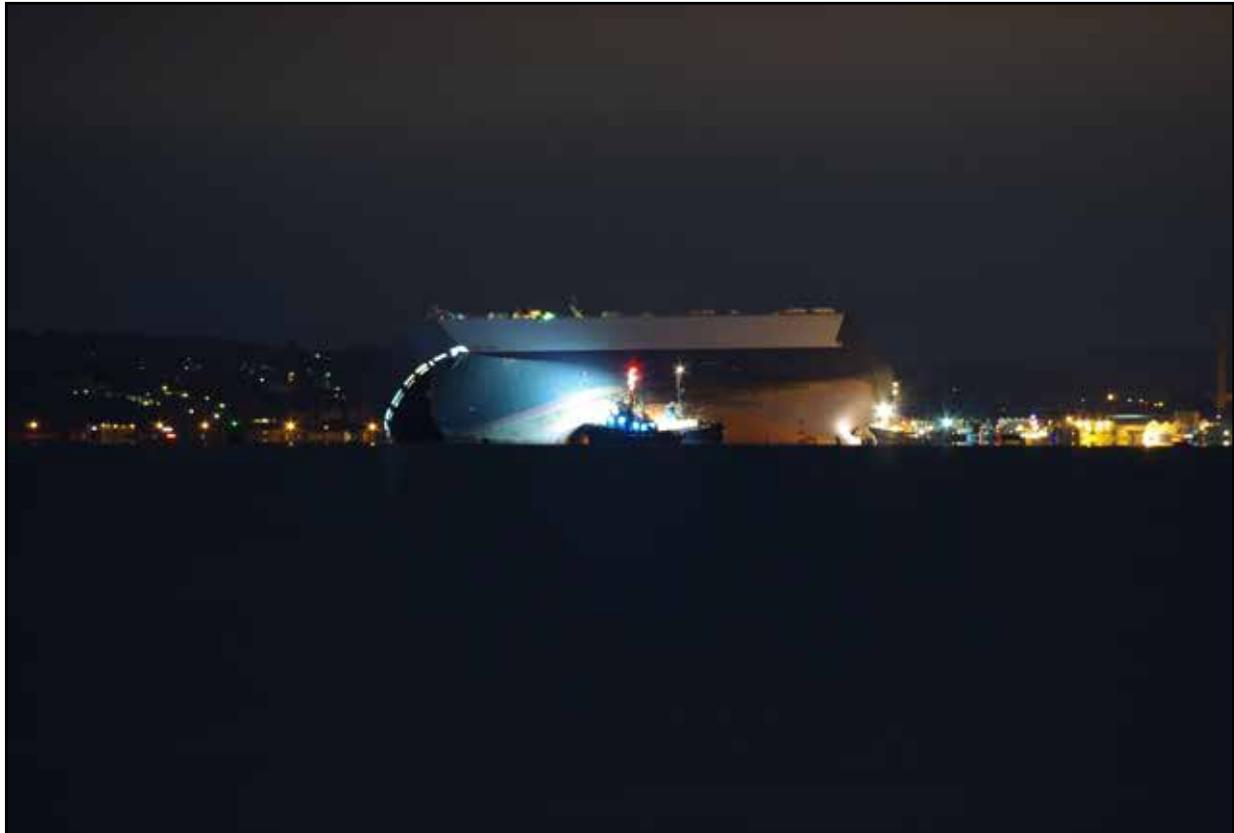
Figure 7: *Hoegh Osaka* aground on Bramble Bank

The tug *Lomax* and SP remained on scene through the remainder of the night (**Figure 7**).

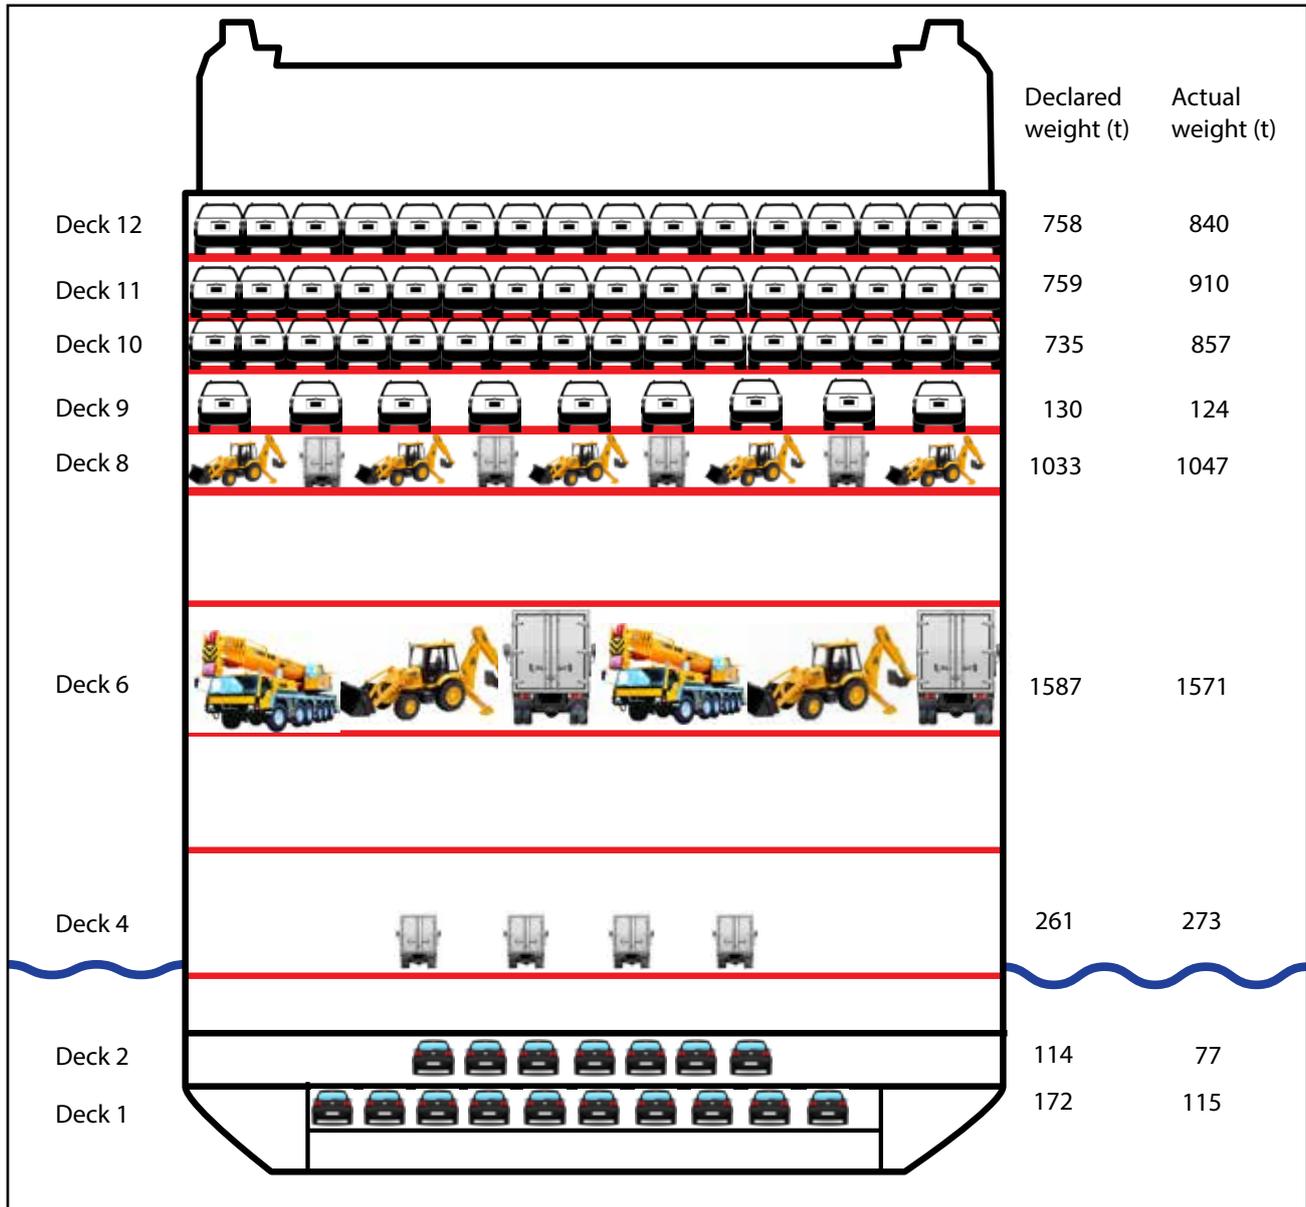
Figure 22: Indicative deck plan - including weights

Table 4 shows the cargo that was on board *Hoegh Osaka* at the time of the accident and its distribution by deck. Following analysis by the MAIB, Table 4 shows the weight that was provided to the ship in the final cargo tally and the actual weight of cargo that was on each individual deck (**Figure 22**).

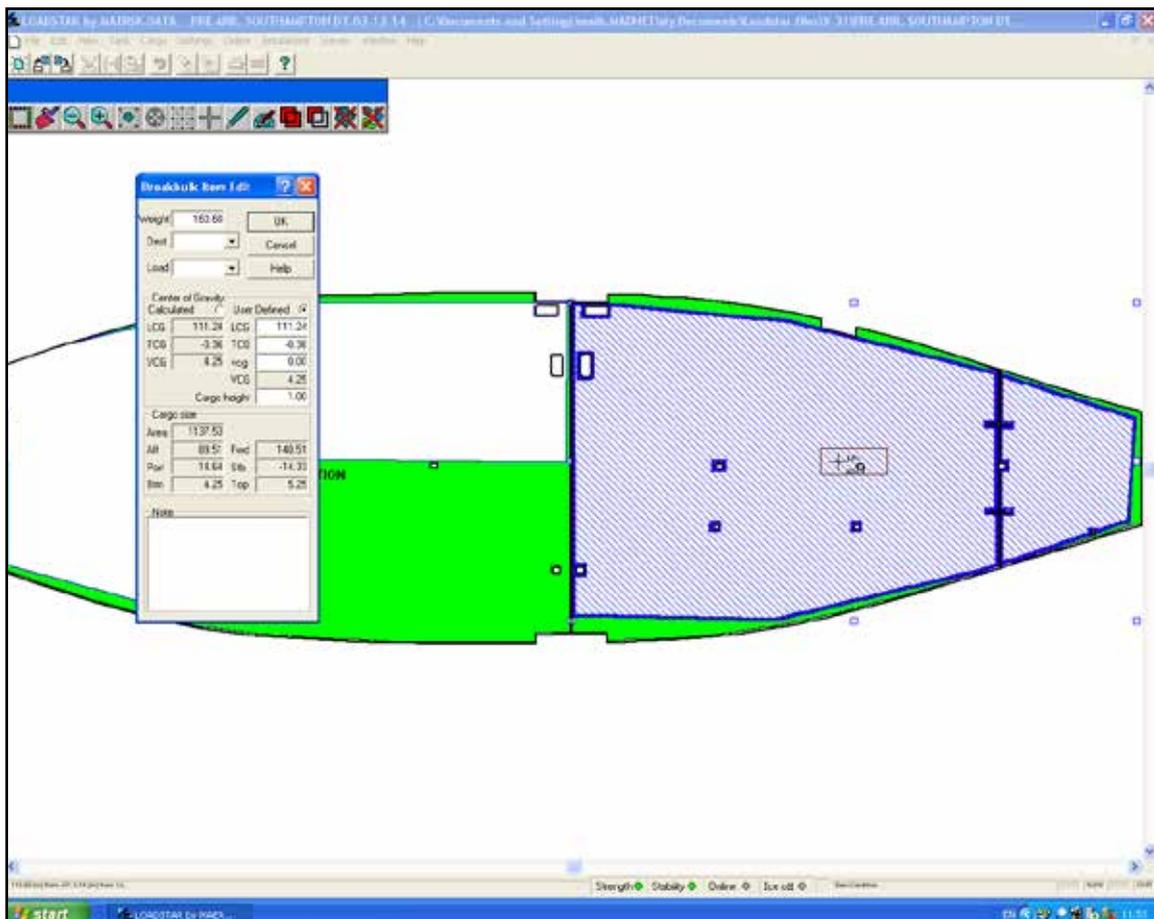
Figure 26: Screenshot from loading computer

The last condition saved on the Loadstar computer related to *Hoegh Osaka*'s arrival in Southampton on 2 January. Examination of a selection of the previous arrival and departure conditions established that the VCG of the cargo was always left to default to deck level.

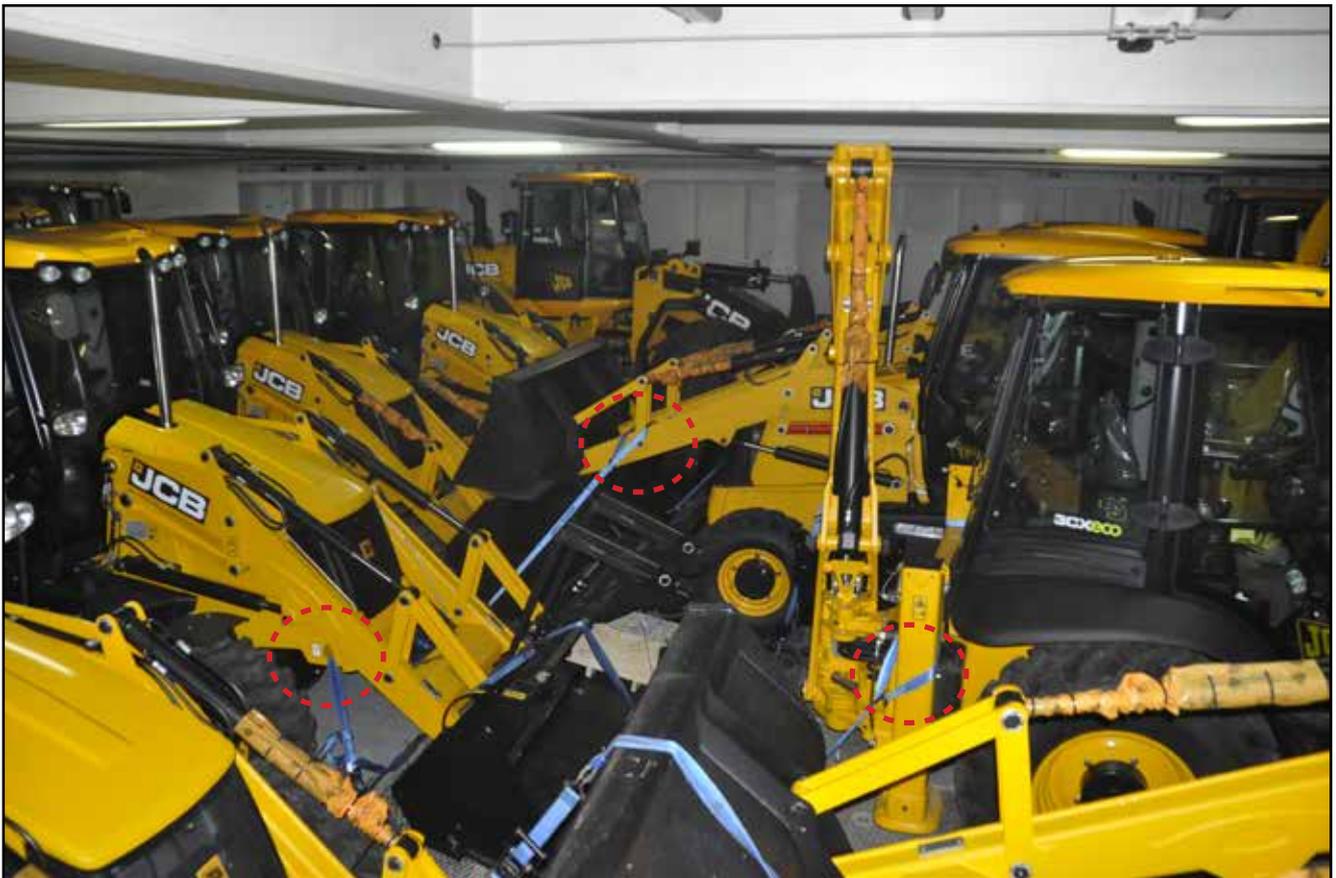
Figure 27: JCB cargo indicating various securing points

All of the cars carried on board *Hoegh Osaka* were fitted with dedicated securing eyes before they were loaded. Although some of the high and heavy cargo had clearly marked securing points, some did not. In those cases, it was left to the stevedores to select appropriate strong points to which to secure lashings (**Figures 27, 28 and 29**).

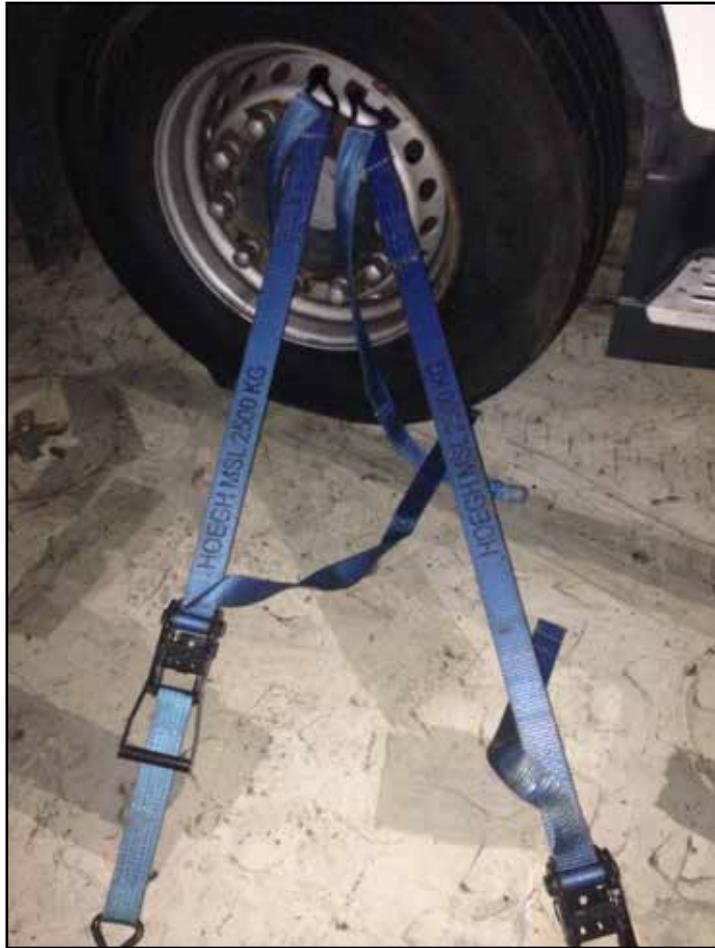
Figure 28: Lorry secured using web lash to wheels

The ten buses loaded on deck 8 were stowed side by side in a block stow and secured by means of lashings connected to their wheels. All of the buses shifted and were damaged as a result of the accident. IMO Resolution A.581(14) does not apply to buses. However, Annex 4 of the CSS Code and IMO Resolution A.533(13) do apply.
