ACCIDENT

Aircraft Type and Registration:	Folland Gnat T Mk 1, G-TIMM	
No & Type of Engines:	1 Rolls-Royce Orpheus 101 turbojet engine	
Year of Manufacture:	1962 (Serial no: FL519)	
Date & Time (UTC):	1 August 2015 at 1302 hrs	
Location:	Approx 1 mile north of Oulton Park, Cheshire	
Type of Flight:	Aerial Work	
Persons on Board:	Crew - 1	Passengers - None
Injuries:	Crew - 1 (Fatal)	Passengers - N/A
Nature of Damage:	Aircraft destroyed	
Commander's Licence:	Private Pilot's Licence	
Commander's Age:	39 years	
Commander's Flying Experience:	706 hours (of which 218 hours were on type) Last 90 days - 6 hours Last 28 days - 2 hours	
Information Source:	AAIB Field Investigation

Synopsis

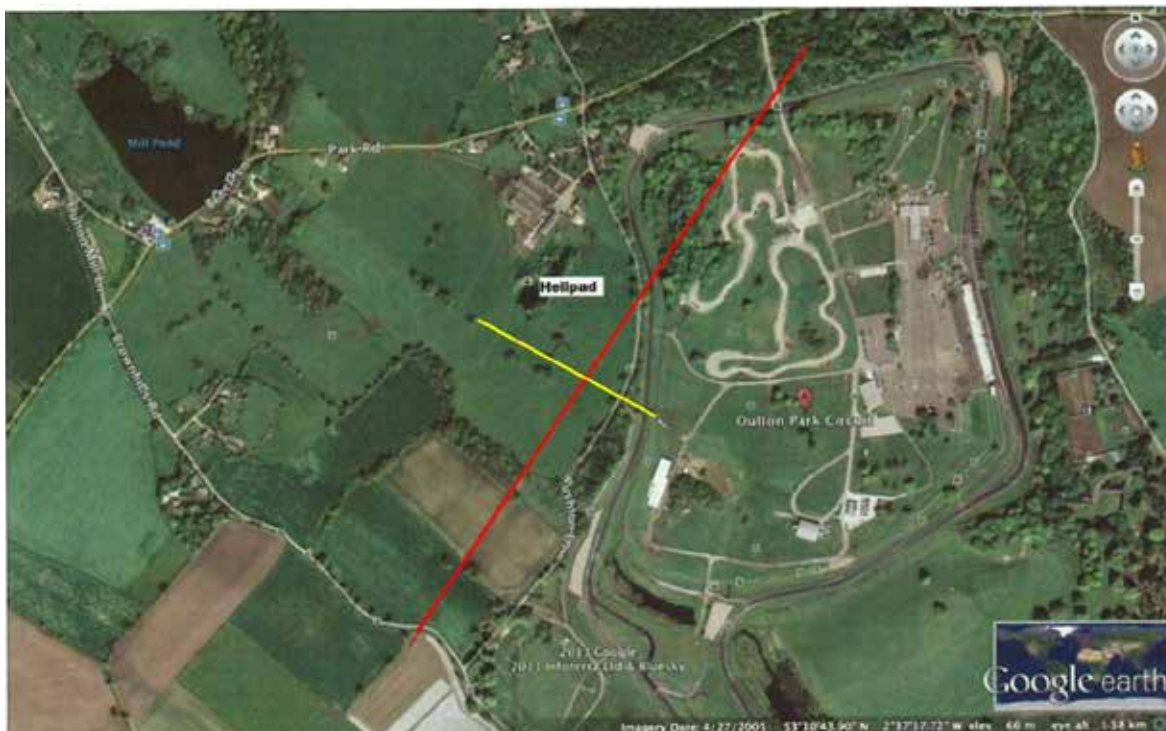
Figure 1

Display line depicted in the Display Pilots' Notes
(Display line in red and display datum line in yellow)

Figures 1 and 3 show that the display line contained within the display pilots' notes passed through an area marked 'event activity'. The CAA Permission changed the display line but the amended line was not the one used by the display pilots because they were unaware of the change. The day visitor car park and camping site were not included in the information provided to the CAA or display pilots because there was an expectation that they would not be accessible while flying was taking place. The images of G-TIMM provided by the witnesses who were standing in the car park suggests otherwise but it was not determined whether the campsite was also in use. Figure 5 shows that the display line in the CAA Permission passed over the car park and the camping site.

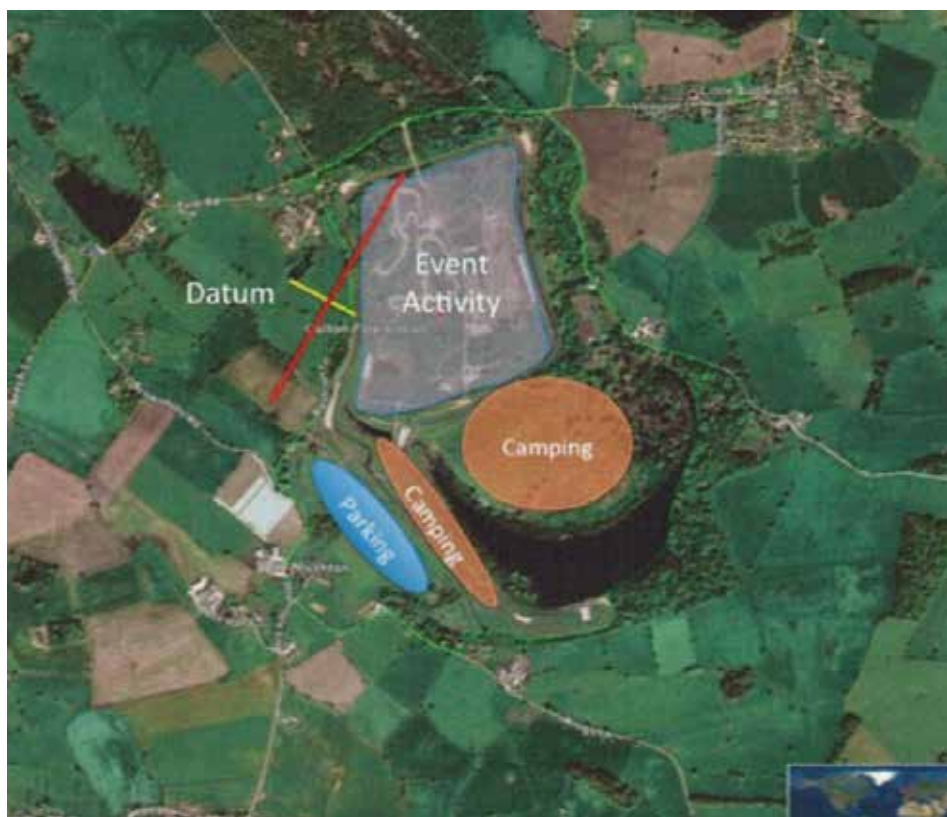
Figure 3

Overall site activity and enclosures

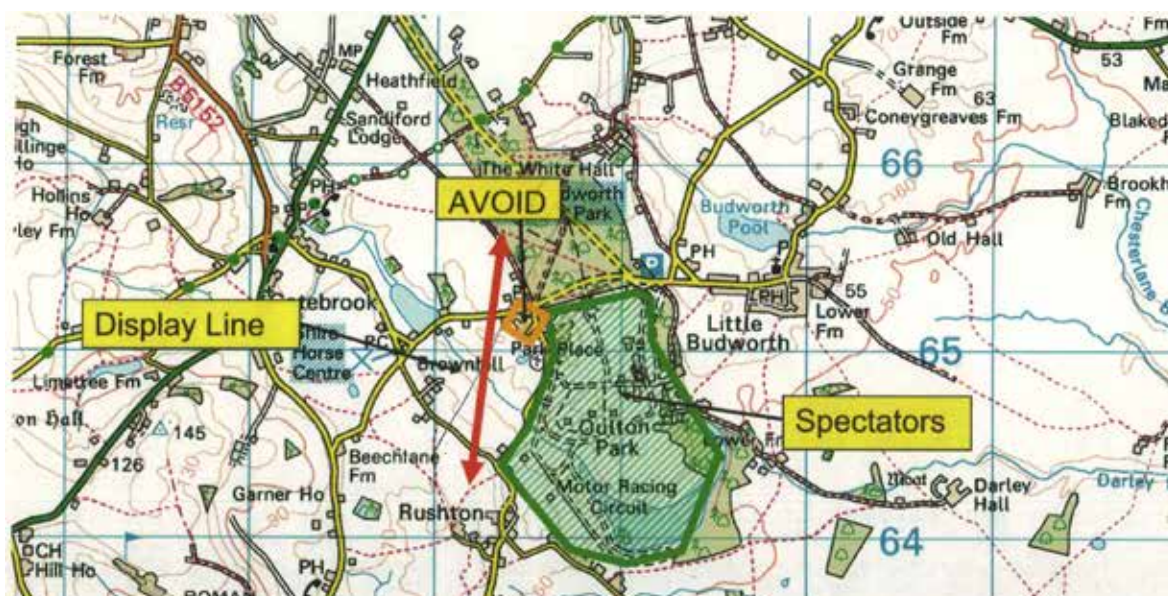
Figure 4

Amended display line from the CAA Permission

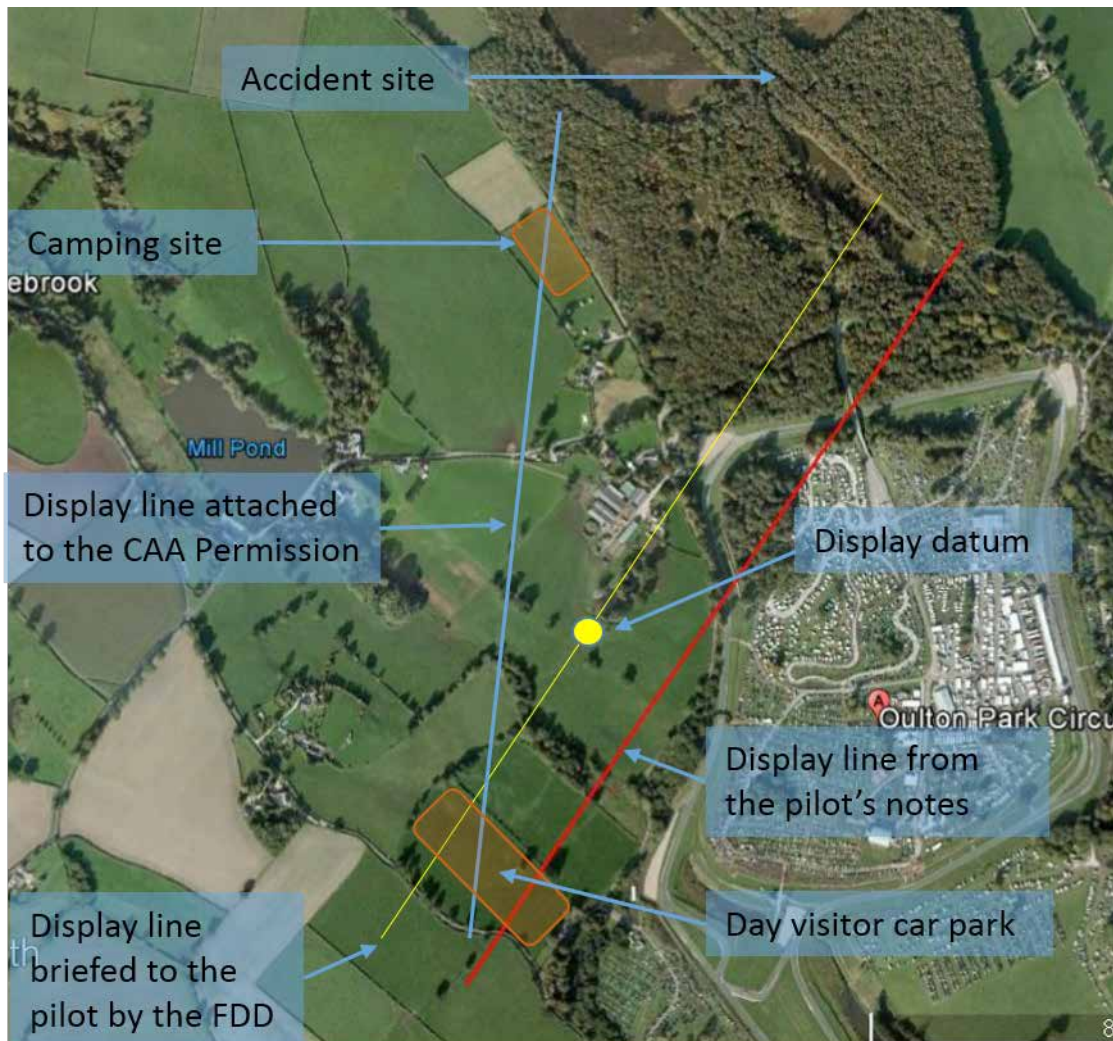
Figure 5

Display line briefed to the pilot of G-TIMM

Data from ATC radar stations at St Anne's, near Blackpool, and Clee Hill, Shropshire, contained information relating to the accident aircraft up until it began its last pass. The final data showed the aircraft 0.5 nm from Oulton Park at an altitude of 600 ft based on 1013 hPa, equivalent to a height of 375 ft above the QFE datum which was near the display datum shown in Figure 5.

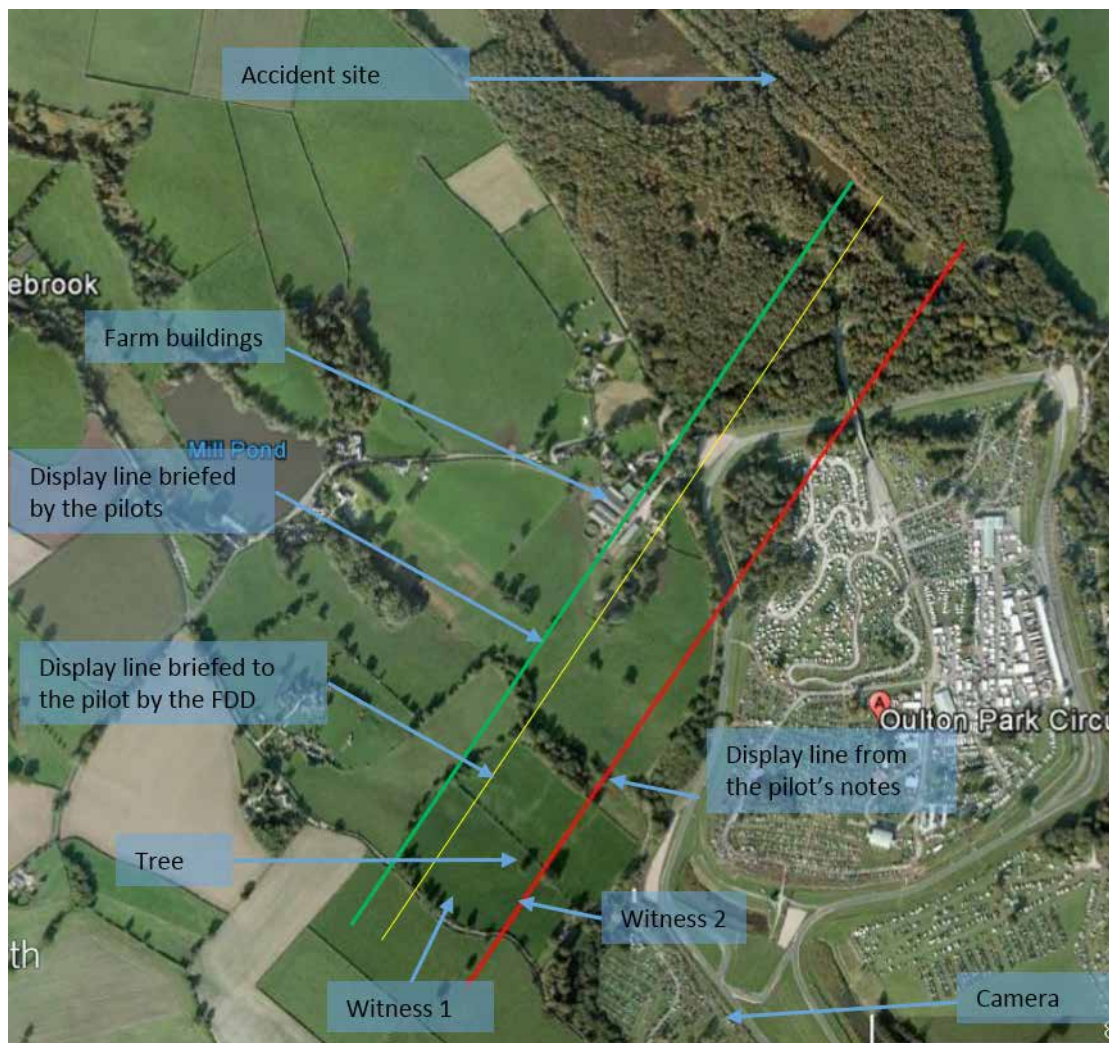
line, made them a good feature to use from the air. Figure 6 also shows the location of a camera which recorded the accident and two witnesses who were standing in the car park referred to earlier. A tree, the relevance of which is discussed in the next section, is also highlighted in Figure 6.

Display line briefed by the pilots

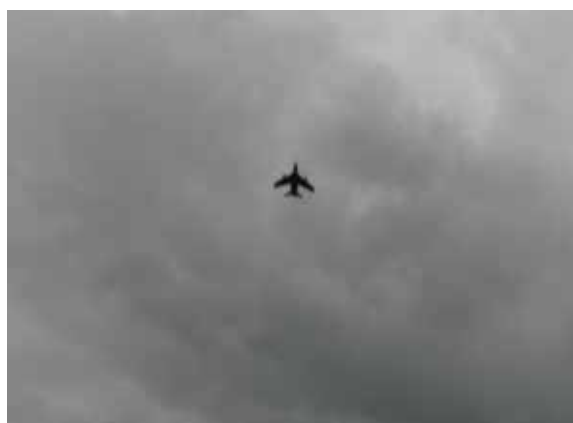
Witnesses 1 and 2 reported their location as shown in Figure 6. Witness 1 took the image shown in Figure 7 and stated that G-TIMM flew “directly overhead” as it began its final pass.

Figure 7 (right)
Image taken by Witness 1

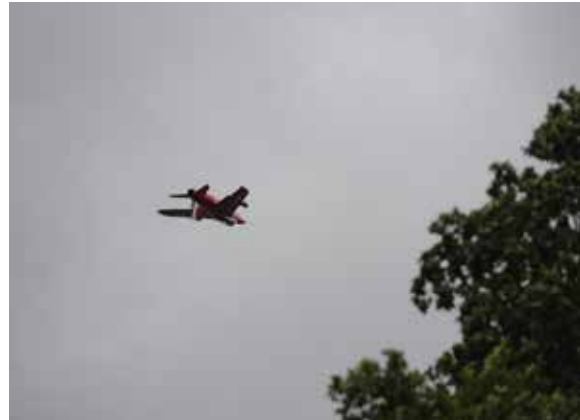
Figure 8 (right)

Witness 2 took the image shown in Figure 8. He stated that “G-TIMM did not fly directly overhead ... but further to the west of my position, and indeed, from the angle of the photos, some way to the west”. The tree in the image is marked in Figure 6.

Image taken by Witness 2

The MOD analysed the still image in Figure 8 and determined that the aircraft was approximately 390 m ± 25 m from the camera used by Witness 2.

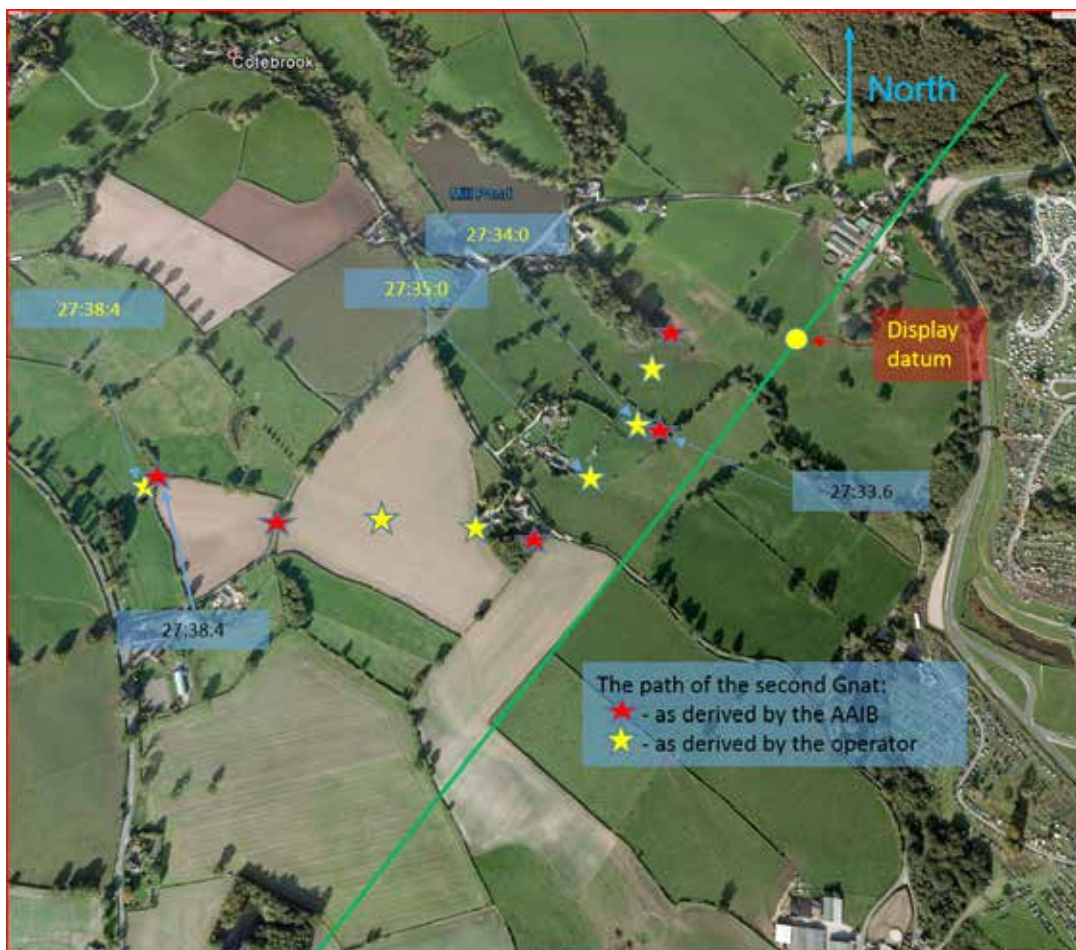
Figure 15

The AAIB and the operator of the Gnat carried out independent analyses of an on-board video recording taken from the second Gnat to establish the aircraft's ground track during the time that G-TIMM was being positioned for its final pass in the area south-west of the display line (Figure 15). The position fixes were established by comparing features on the ground, seen from the on-board video recording, with the same features seen in an overhead view in Google Earth. The associated times were taken from the video and relate to the beginning of the recording. The red and yellow stars represent locations identified by the AAIB and operator respectively.

Ground track of the second Gnat

No quantitative information was available about relative heights of the two aircraft. However, the on-board video in the second Gnat showed that the manoeuvre it flew (described by the points in Figure 15) was flown with vertical extent, and the operator stated that aircraft flying this manoeuvre would typically be between 1,500 and 2,000 ft agl at the apex.

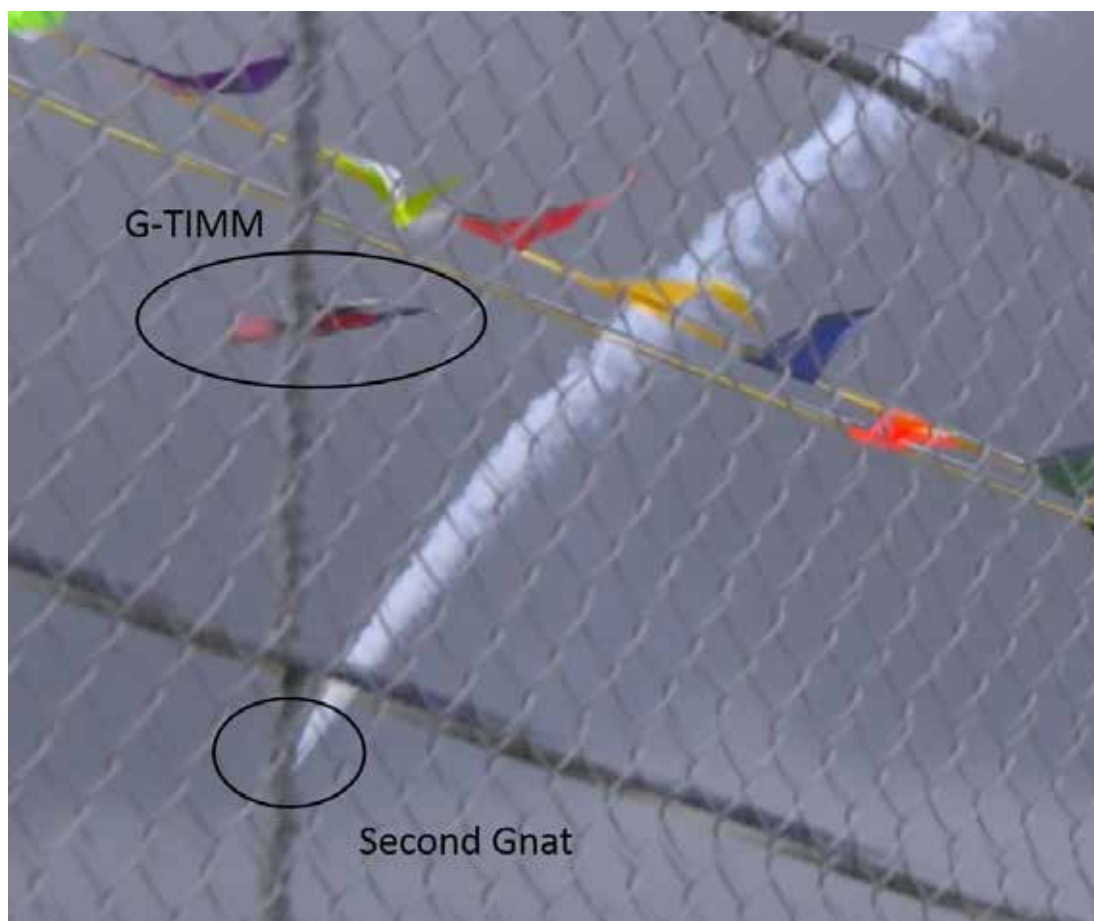
Figure 16 is an image, taken at 27:38.4, of G-TIMM and the second Gnat crossing the line of sight of a ground-based camera (the ground-based camera which provided the video discussed earlier)¹³. At 27:38.4, the operator and AAIB analyses of the second Gnat's

position agree to within approximately 50 m (Figure 17). A line of sight was drawn from the camera's location through the second Gnat's position at 27:38.4¹⁴ and G-TIMM was on this line at this time, although its exact position along the line could not be determined.

Image of both aircraft at 27:38.4 as G-TIMM commenced its final pass
