Rail Accident Report

**Signal passed at danger on approach to
Wootton Bassett Junction, Wiltshire
7 March 2015**

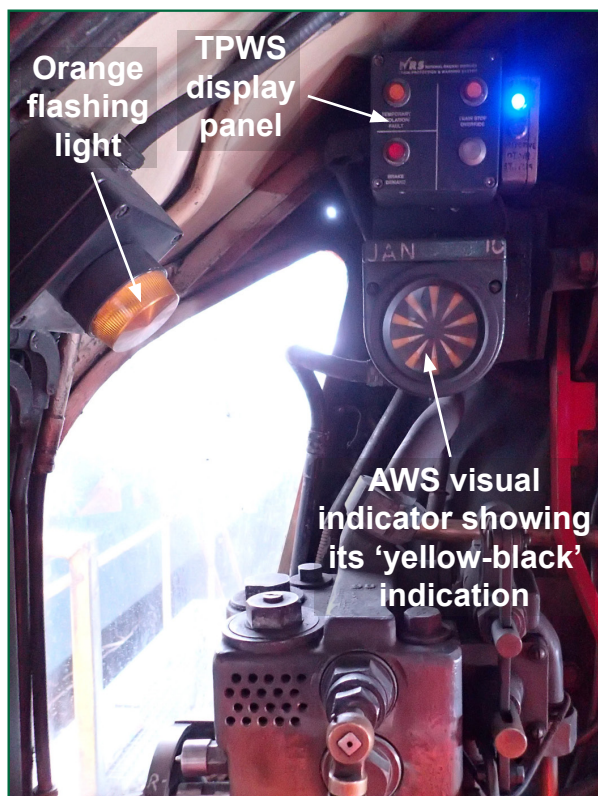
- 15 At the time of the incident, the AWS audible warning indicator on Tangmere was positioned on the inside of the cab roof, just above the *driving position* (which is on the left-hand side of this locomotive) and towards the rear of the driver's side window. The orange flashing light was also positioned on the inside of the cab roof, slightly higher than the audible warning indicator and to the front of the driver's side window (figures 8 and 9). The AWS visual indicator (commonly called the 'sunflower') is mounted in front of the driving position just above the main driving controls, with the TPWS display panel positioned directly above it (figure 9).

Figure 9: The position of the AWS flashing light, AWS visual indicator and TPWS display panel on 7 March 2015. Note: the blue light next to the TPWS display panel relates to the locomotive's OTDR.

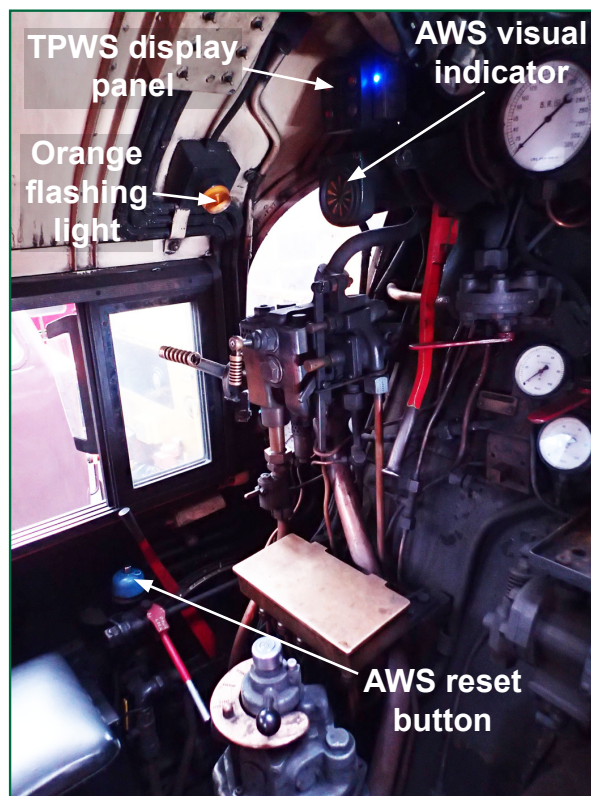
- 16 Drivers acknowledge AWS warnings on Tangmere by pressing and releasing the AWS reset pushbutton, which is located to the left of the driver's seat (figure 10). The *railway group standards* applicable at the time that Tangmere's AWS system was installed required that the driver be given a period of up to 2.7 seconds to acknowledge warnings. Should a driver not acknowledge an AWS warning within this time period, then the combined AWS/TPWS control unit will generate an AWS brake demand. The relevant standards required that AWS brake demands remain active until the driver acknowledged the warning and that any brake demand continue for at least 59 seconds after this had been done. In the event that an AWS brake demand occurs, the *Rule Book*⁴ requires drivers to immediately bring their trains to a stand and then to contact the signaller.

Figure 10: The position of the AWS flashing light, AWS visual indicator, AWS reset pushbutton and TPWS display panel on 7 March 2015
