ACCIDENT REPORT

Report on the investigation into the girding and capsizing
of the mooring launch

Asterix

at Fawley Marine Terminal, Southampton, UK

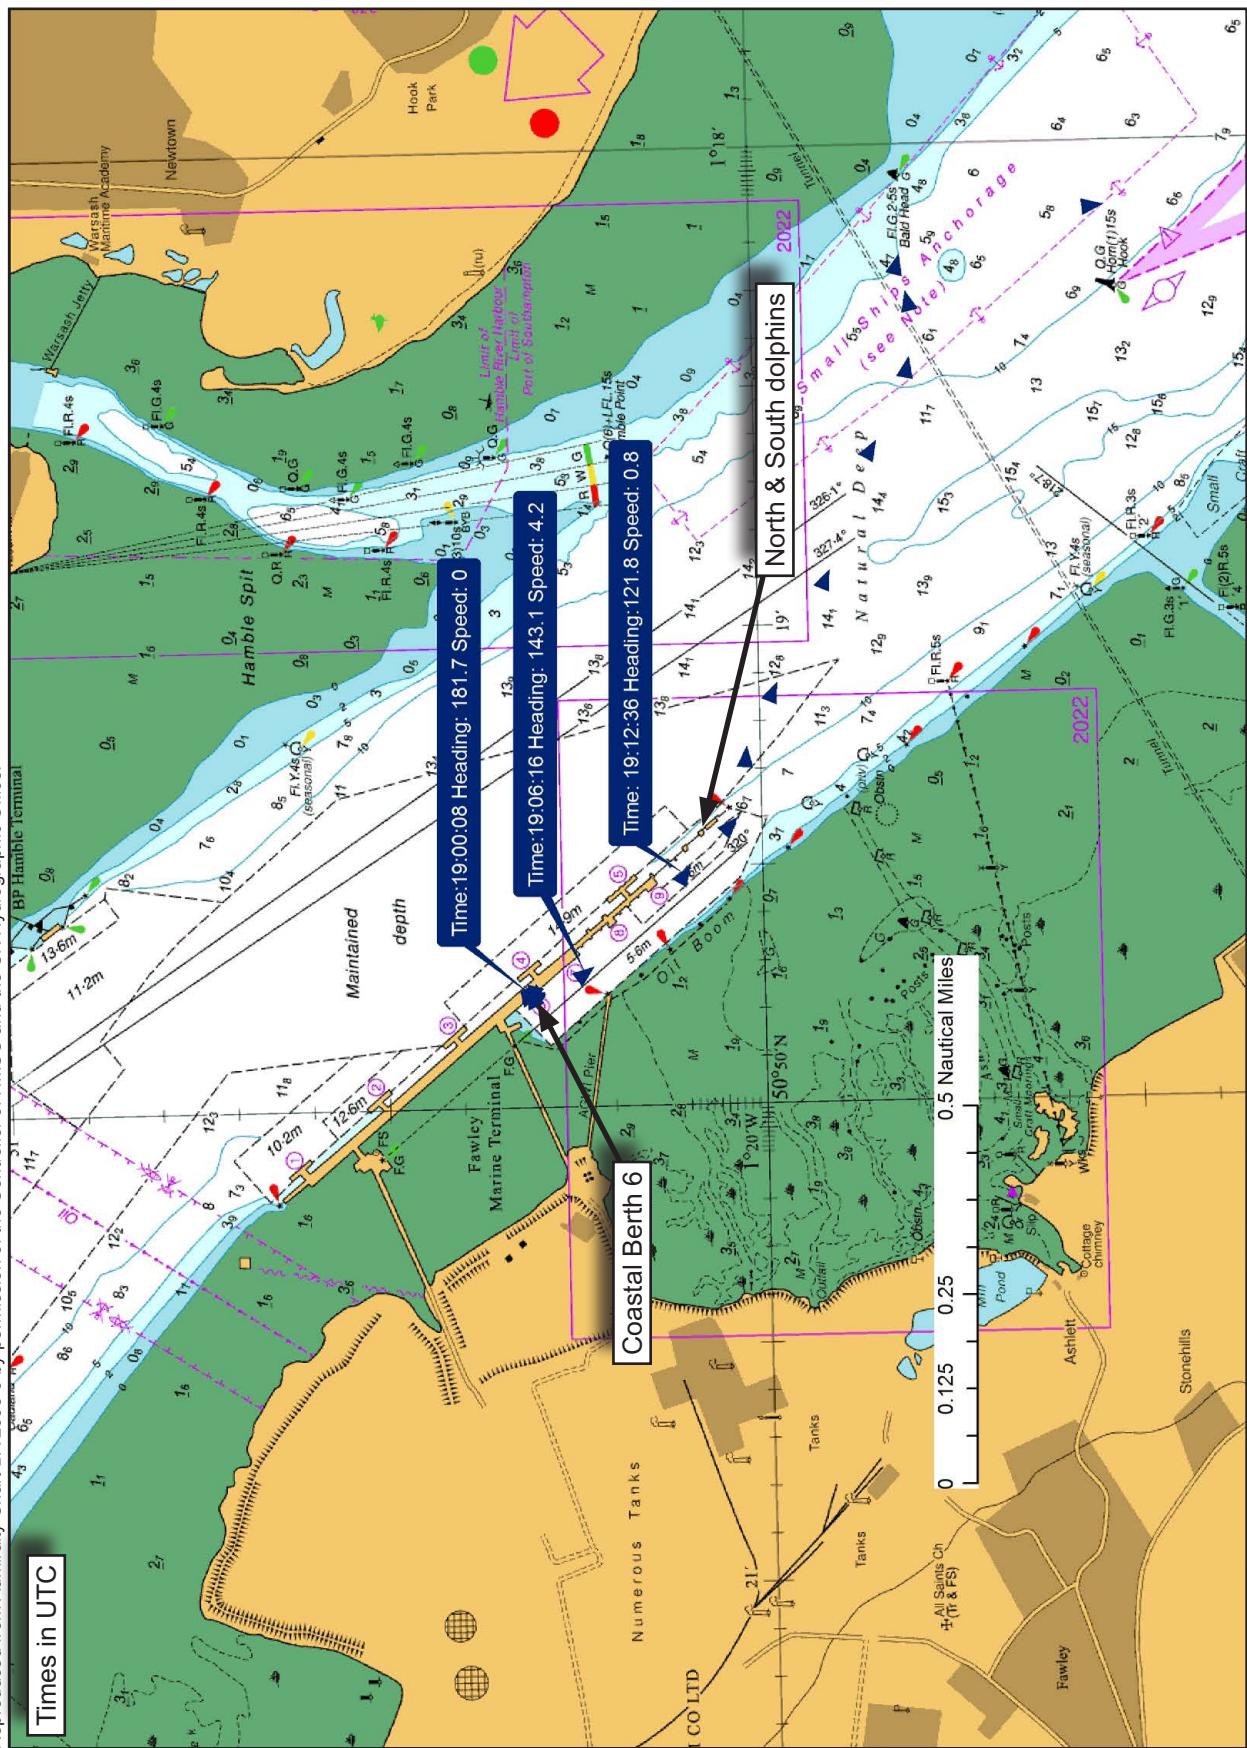
At 2001, the pilot ordered the launch coxswain to make a 'tight line'³. *Donizetti*'s master ordered port full rudder, dead slow ahead on the controllable pitch propeller (CPP) and bow thrust to starboard. At the same time the headlines, stern lines and after spring were released. The forward spring was left attached to allow the vessel to move bodily off the berth. At approximately 2005, *Donizetti* began to move off the berth and the master brought the CPP control to zero. The vessel then began to drift astern as weight came on the forward spring, and the pilot called for clearance distances from the obstruction astern to be reported. The forward spring was then let go, and it is reported that the order 'Asterix all easy' was passed by the pilot and acknowledged by the launch coxswain. The master moved the CPP control ahead and *Donizetti*'s speed increased to between 2 and 4kts ahead (**Figure 3**). *Asterix*'s coxswain attempted to turn the launch to port, applying port rudder with the

Figure 3: Donizetti automatic identification system track (times shown are in UTC)

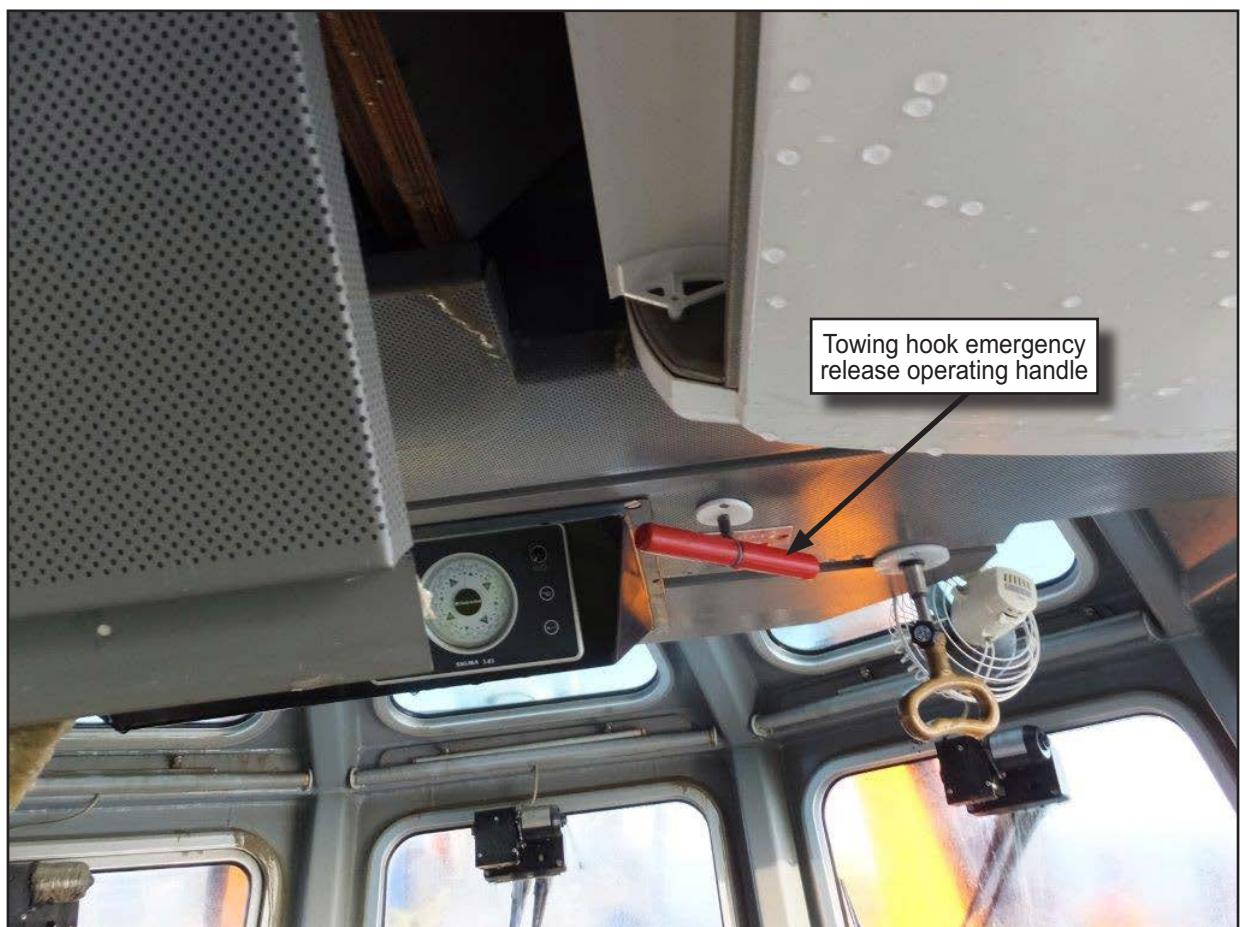
Figure 8: Towing hook emergency release handle

The launch was fitted with a Mampaey quick-release disc type towing hook located on the main deck just aft of the wheelhouse. The hook was designed to rotate through approximately 180° with a tow attached (**Figure 7**). The towing hook had a safe working load of 15t with a test load of 30t. It had an emergency release mechanism, which was activated by pulling on a wire. The wire was connected to an operating handle suspended from the deckhead of the wheelhouse and ran through a raised pulley forward of the towing hook before connecting to the hook release mechanism (**Figures 8, 9 and 10**). This model of towing hook could be fitted with either air or hydraulic actuators to complement the manual emergency release, but these options had not been specified for the build of *Asterix*. When the vessel was salvaged, the towing hook release mechanism was found to have only partially activated, with the towline's eye still located on the closed hook.
