**SERIOUS INCIDENT**

<b>Aircraft Type and Registration:</b>	Bombardier DHC-8-402, G-FLBC	
<b>No &amp; Type of Engines:</b>	2 Pratt & Whitney Canada PW150A turboprop engines	
<b>Year of Manufacture:</b>	2009	
<b>Date &amp; Time (UTC):</b>	16 December 2014 at 1832 hrs	
<b>Location:</b>	En route Glasgow to Belfast	
<b>Type of Flight:</b>	Commercial Air Transport	
<b>Persons on Board:</b>	Crew - 4	Passengers - 76
<b>Injuries:</b>	Crew - None	Passengers - 1 (Minor)
<b>Nature of Damage:</b>	Damage to left engine and engine nacelle	
<b>Commander's Licence:</b>	Airline Transport Pilot's Licence	
<b>Commander's Age:</b>	36 years	
<b>Commander's Flying Experience:</b>	7,847 hours (of which 6,820 were on type) Last 90 days - 185 hours Last 28 days - 59 hours	
<b>Information Source:</b>	AAIB Field Investigation

**Synopsis**

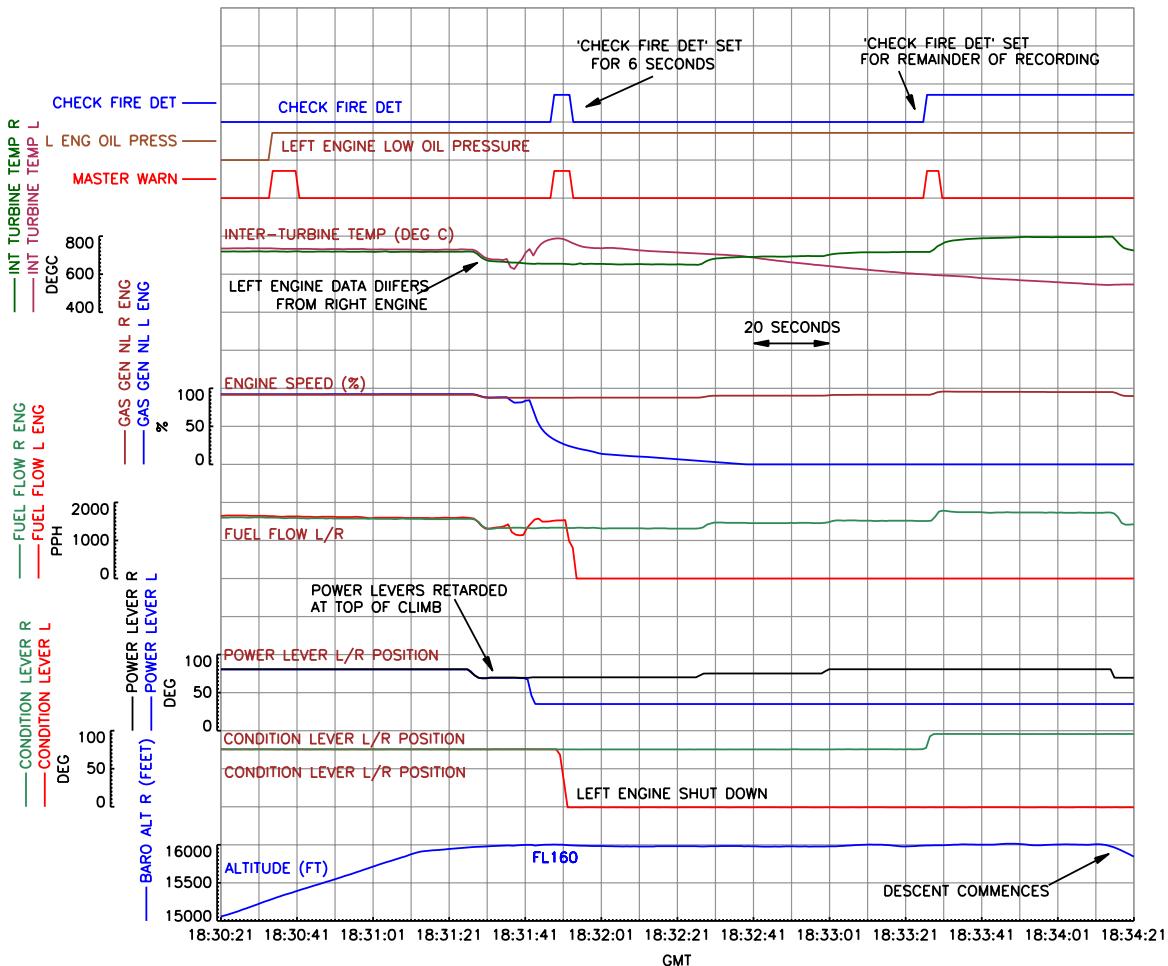
**Figure 8**  
FDR parameters

One second later, at 1830:35 hrs, the FDR recorded a MASTER WARNING and a left engine low oil pressure warning, which is triggered once oil pressure reduces below 44 psi. The EMU also recorded a '*main oil pressure exceedance flag*' which is triggered if the oil pressure is less than 45 psi. The CVR recorded the flight crew acknowledging this warning with the aircraft climbing towards its cruising altitude of FL160. Just after both engine power levers were retarded at the top of the climb, engine data started to differ between the left and right engines (see Figure 8). At 1831:36 hrs, the EMU recorded an '*engine flameout*' on the left engine. Thirteen seconds later, the FDR recorded a change of state in the CHECK FIRE DET light on the CWP, along with a MASTER WARNING. This was activated for five seconds, then cleared. The CVR recorded the flight crew acknowledging the warning, which occurred just after the left engine power lever had been retarded as part of the engine shutdown procedure.
