Report of Thorough Examination of Loader Crane

**LABORATORY INVESTIGATION REPORT**

***Report on the Failure  
of the  
Holding Down Fasteners on a Crane***

Report completed for  
Marine Accident Investigation Branch

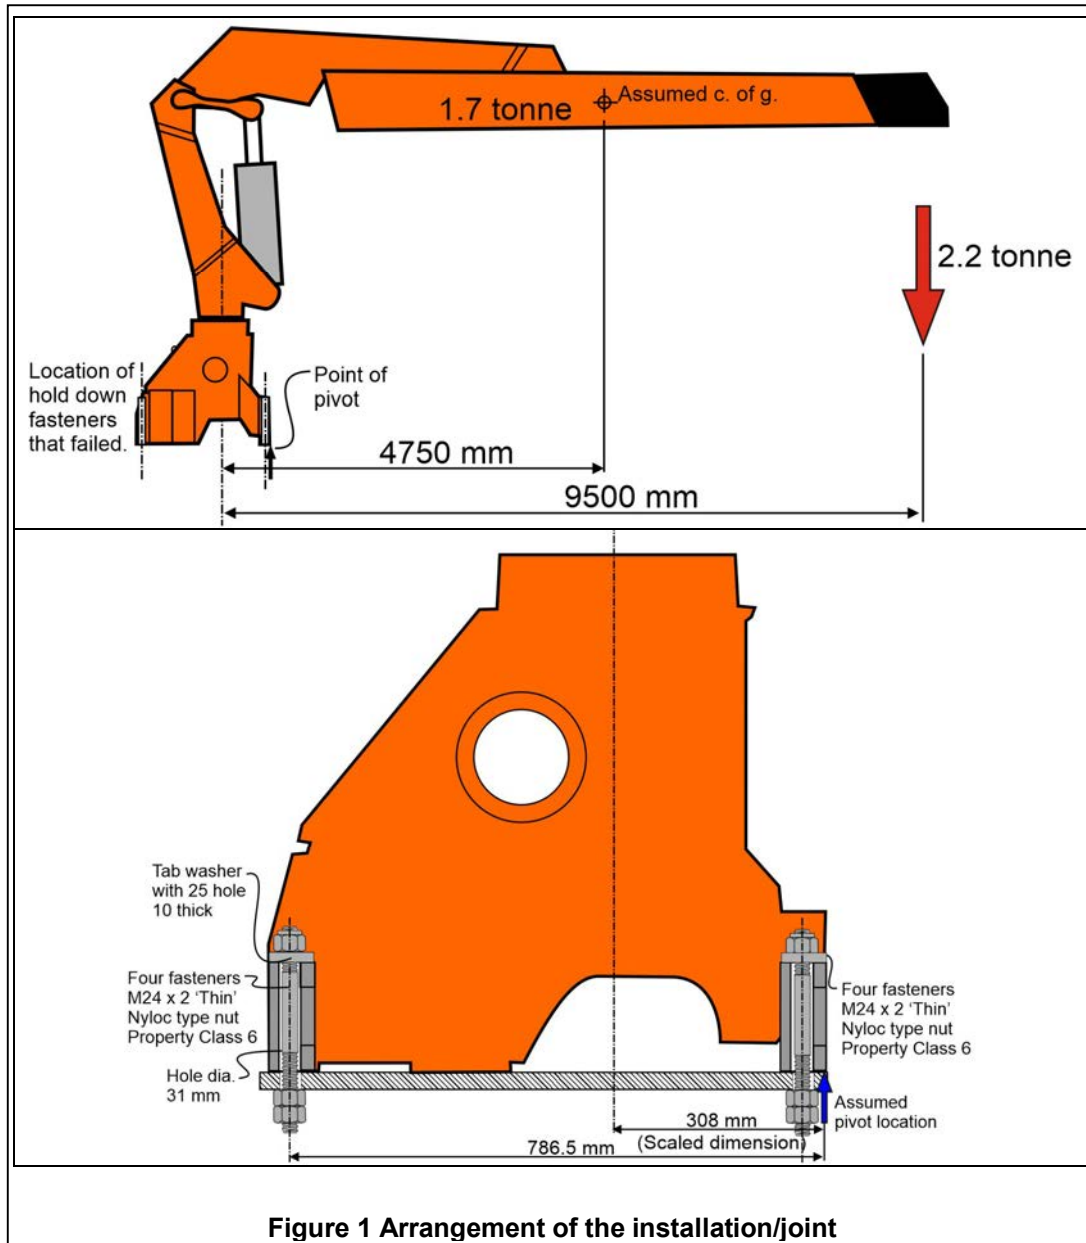
My understanding is that a number of fasteners failed that were holding down a 170.2 VCS crane to its foundation. The holding down fasteners consisted of two rows of M24 property class 10.9 studs, each row having 4 sets of fasteners. The studs had M24 x 2 (fine pitch series) threads. The arrangement of the assembly and the joint is shown in figure 1. On each stud two nuts were located under the foundation with a single thin non-metallic prevailing torque type ('Nyloc') nut used to tighten the stud. My understanding is that the nut was to the standard DIN 985<sup>1</sup>. The key dimensions of the nut, taken from the DIN standard are shown in figure 2.

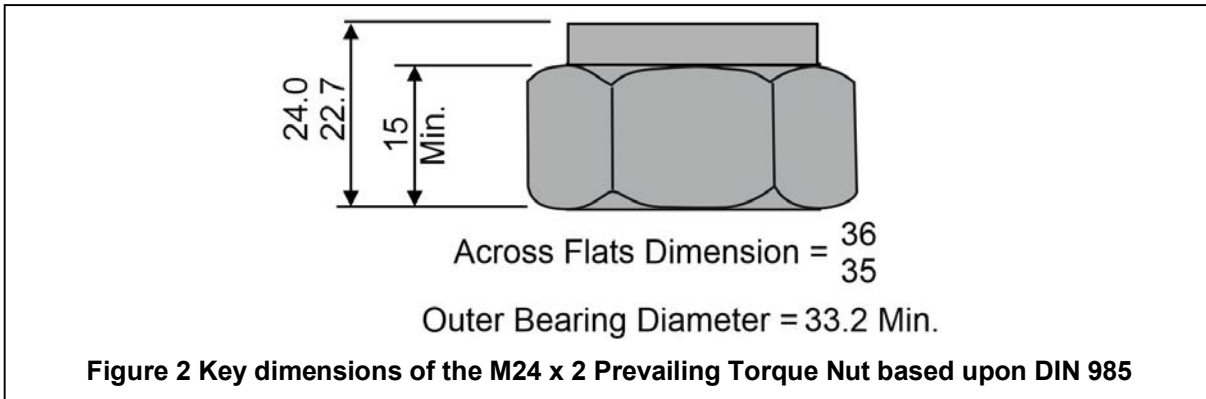
My understanding is that when the crane was lifting a weight of 2.2 tonnes, the nuts on one side failed by thread stripping allowing the crane to topple.

As can be seen in figure 3, one or more of the washers had been severely distorted, before or as a result of the accident.

It is uncertain whether the collapse of the washer occurred during tightening or was damaged during the collapse of the crane. If the deformation of the washer occurred when the nuts were initially tightened, which is a distinct possibility, it would point towards the preload in the fastener being high. My understanding is that the washer is made from mild steel. The limiting surface pressure for mild steel depends upon the specific steel used. For a low strength mild steel (tensile strength 340 N/mm<sup>2</sup>), the limiting surface pressure<sup>11</sup> is 490 N/mm<sup>2</sup>. This would point towards the preload value approaching or exceeding the thread stripping load.

The large gap under the washer would also result in bending stresses being incurred by the washer in addition to the direct bearing stresses. If the washer distorted during tightening an uneven loading would occur in the threads, resulting in the thread stripping load being lowered. Such loading is not represented in a standard proof load test or in the calculations presented in this report. The author has previously observed such a reduction on an offset pull test on a fine threaded fastener.
