Report on the investigation of the grounding
of the cruise ship
Hamburg
in the Sound of Mull, Scotland

11 May 2015

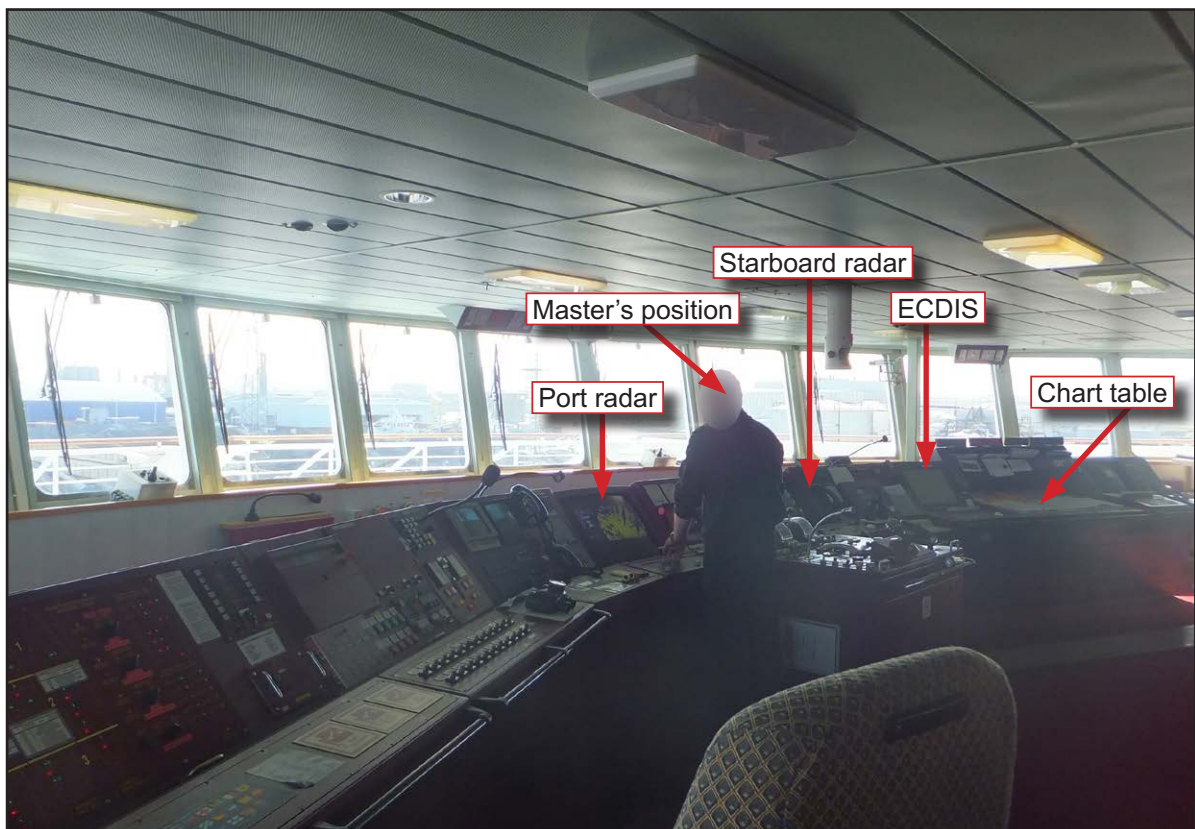
Figure 2: Photograph of *Hamburg*'s bridge

The following day, 11 May, the master arrived on the bridge at 0700 and took up his usual position by the port radar (**Figure 2**). The safety officer, who was the officer of the watch (OOW), was stationed at the starboard radar where he could also see the ECDIS. He was assisted by the cadet and the duty able seaman (AB), who was the lookout. With its stabiliser fins deployed, *Hamburg* had maintained a steady passage in the south-westerly swell and the master was fully rested after a good night's sleep.

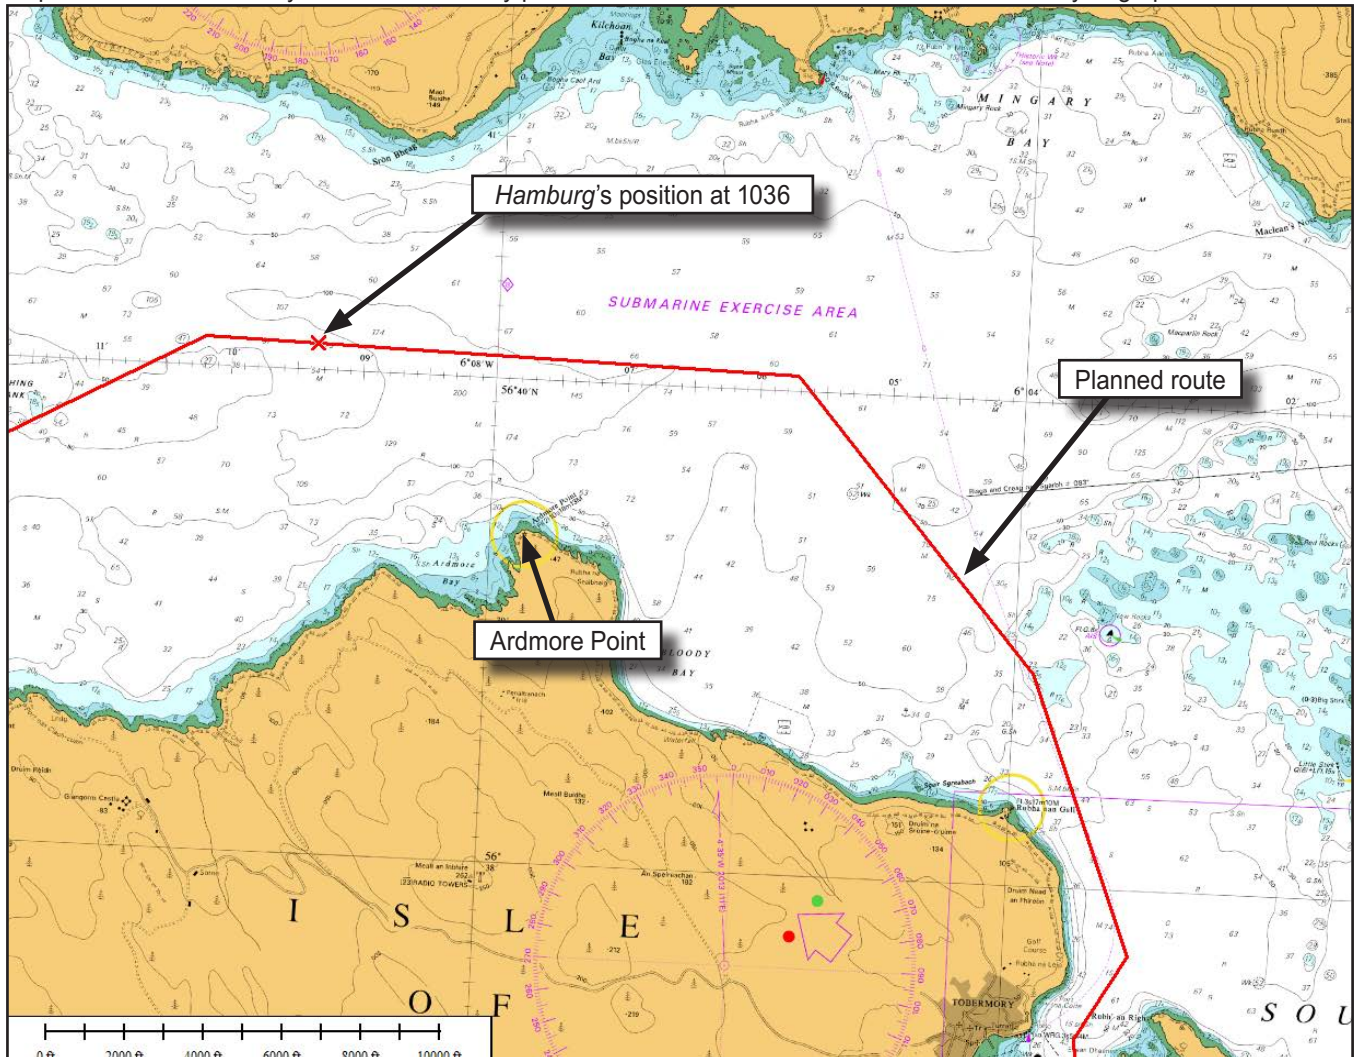
Figure 3: Extract of chart BA 2392 showing *Hamburg's* position at 1036

At 1036 *Hamburg* approached Ardmore Point (**Figure 3**). The master decided that *Hamburg* would continue towards Tobermory and then drift in the northern part of the Sound of Mull. He advised the OOW of his intentions but did not amend the passage plan.

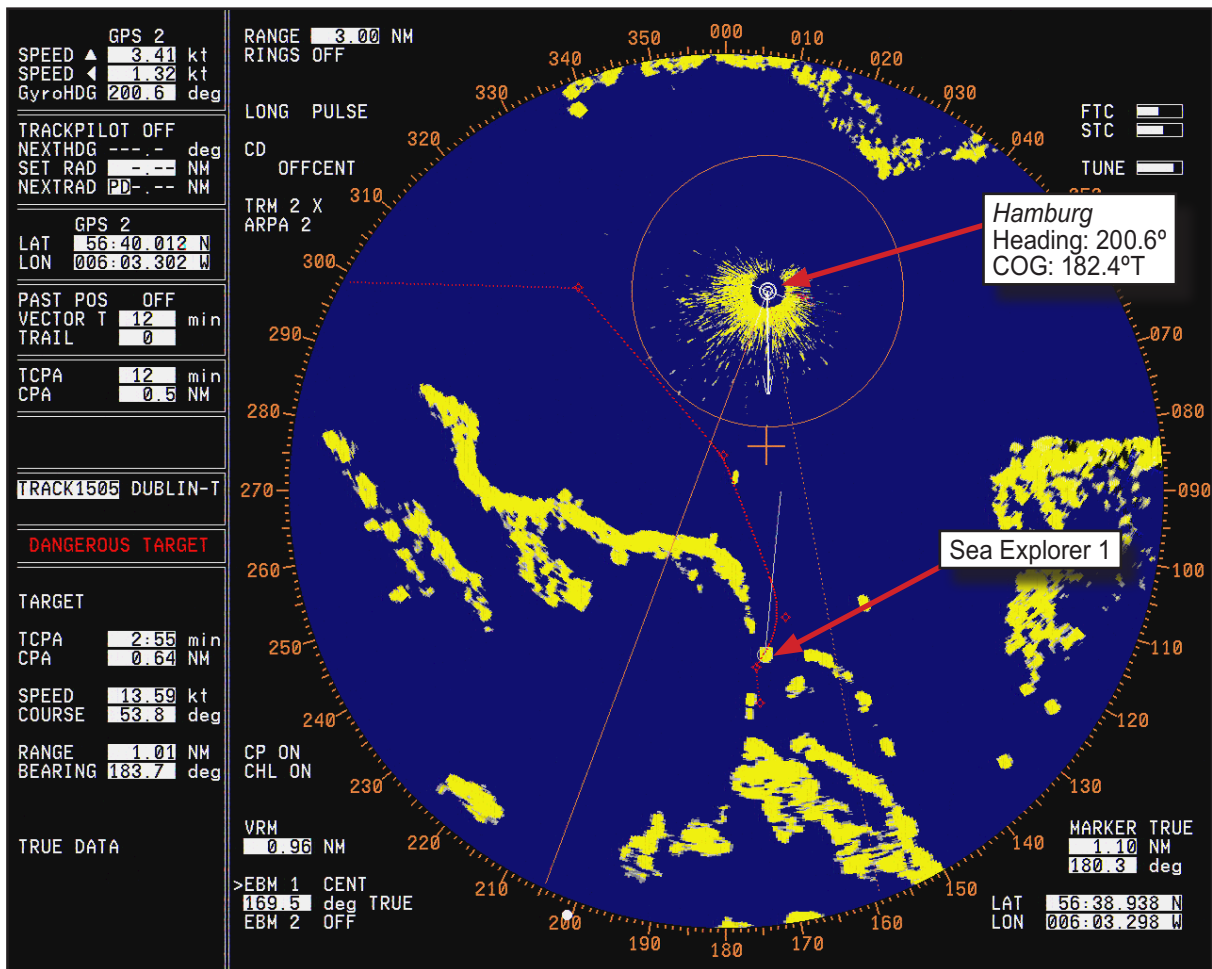
Figure 4: Radar display showing the positions of *Hamburg* and *Sea Explorer 1* at 1318

By 1318 *Sea Explorer I* had cleared Tobermory Bay and was on a northerly heading through the Sound of Mull. *Hamburg* was on a heading of 200.6° with a COG of 182.4° and a SOG of 3.41kts (**Figure 4**). *Hamburg's* master then ordered the AB to steer 195°. By 1320 the master had set the engine control to 'half ahead' and *Hamburg* was steady on 195° with a COG of 181° and a SOG of 3.72kts.

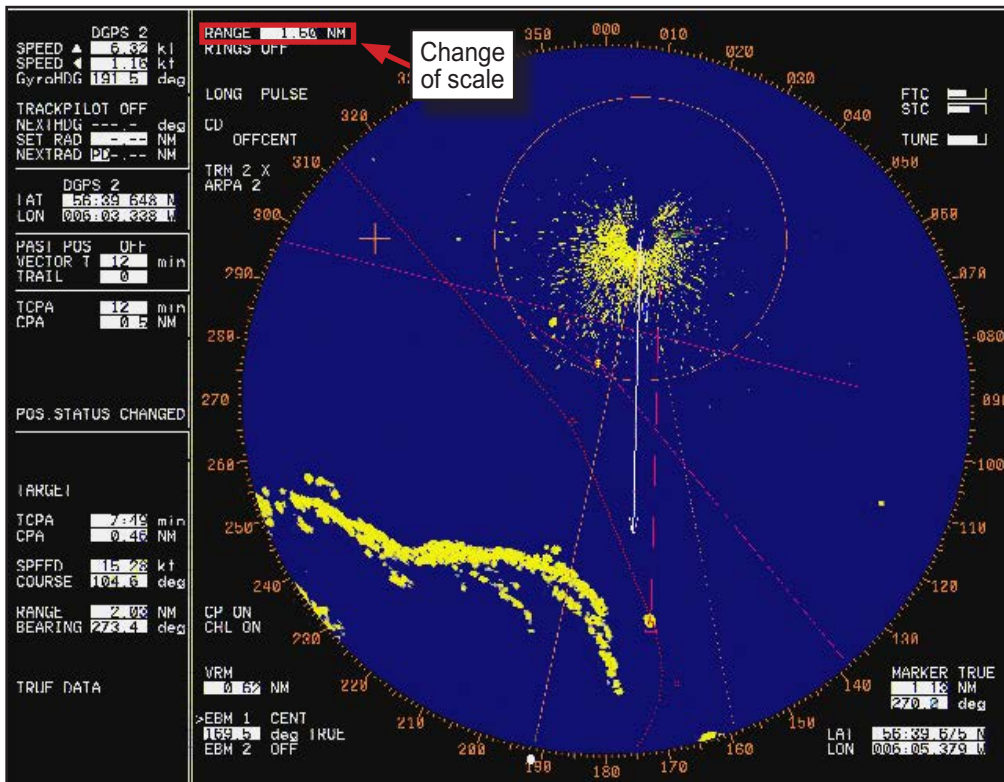
Figure 6: Radar display showing Hamburg's position at 1322:55

At 1321 both the OOW and the cadet plotted *Hamburg*'s position on the chart (**Figure 5**). The cadet saw that his plotted position was some distance away from the OOW's position but closer to the New Rocks shoal. Without consulting the OOW, the cadet assumed his own position was incorrect and removed it from the chart using an eraser. At 1322:55 the OOW reduced the starboard radar display to the 1.5nm setting (**Figure 6**).

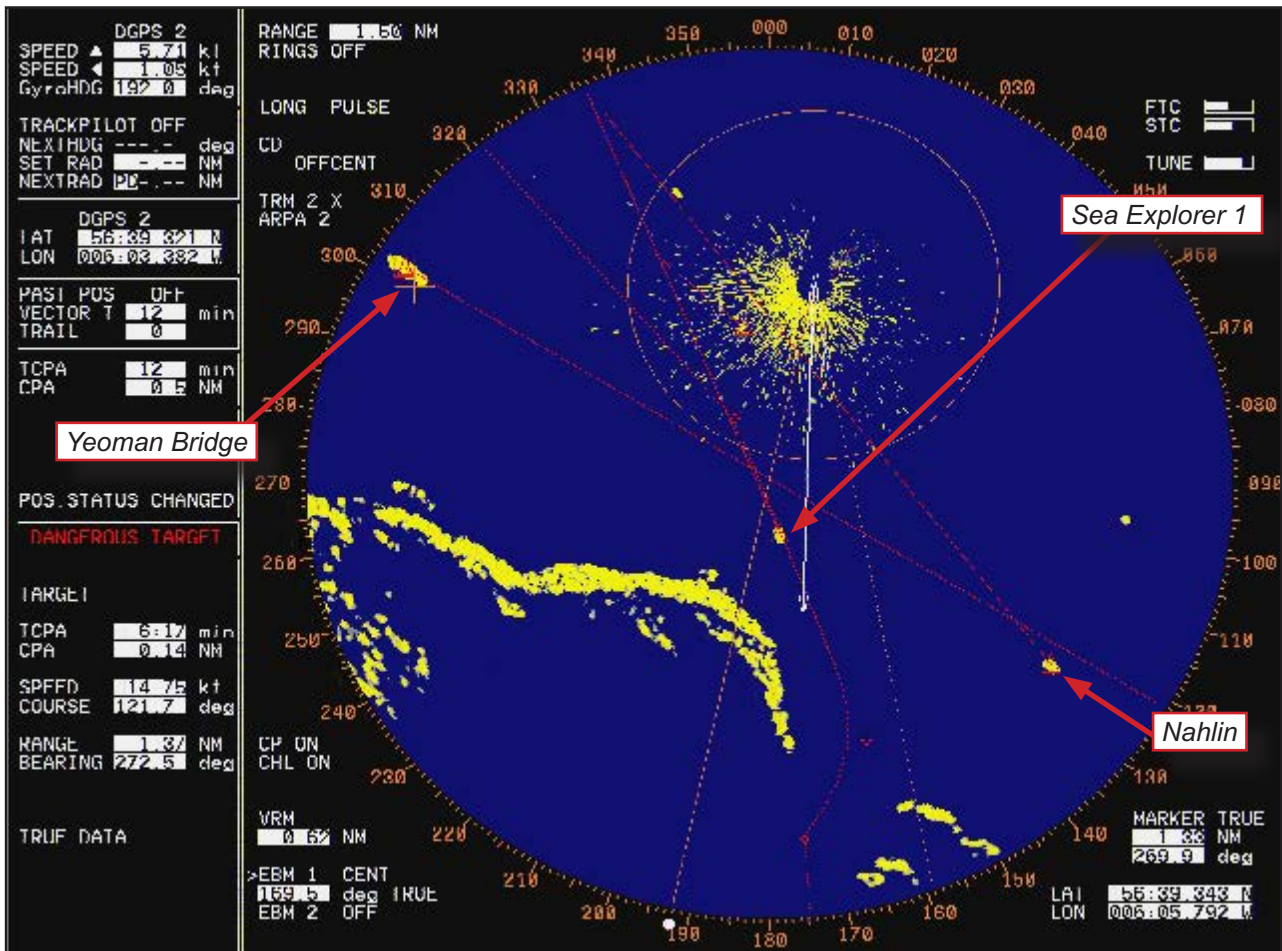
Figure 7: Radar display showing positions of Hamburg, Sea Explorer 1, Nahlin and Yeoman Bridge

Shortly afterwards, at 1324, motor yacht *Nahlin* was on a north-westerly course and approaching the New Rocks buoy from the south-east. At the same time the bulk carrier *Yeoman Bridge* was approaching the New Rocks buoy from the north-west (**Figure 7**). Simultaneously, officers on board both *Nahlin* and *Yeoman Bridge* called *Hamburg* on VHF radio channel 16 and *Hamburg's* OOW replied. A transcript of the resulting VHF conversation is at **Table 1** below.

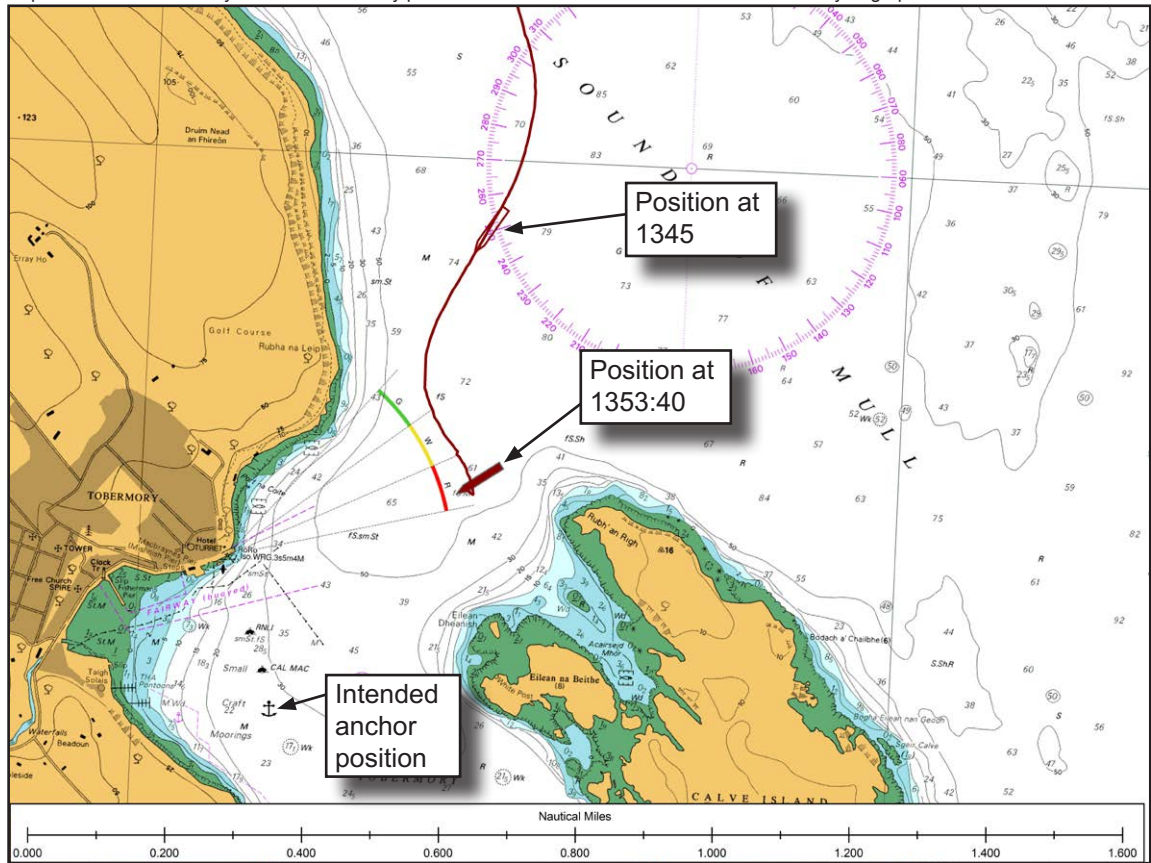
Figure 9: Extract of chart BA 2392 showing *Hamburg's* position and track between 1345 and 1353:40

At 1345:37 *Hamburg* was at the entrance to Tobermory Bay (**Figure 9**) heading 209.5° with a SOG of 4.5kts. The wind continued from a south-westerly direction but its strength had decreased slightly in the sheltered bay. The master saw that there were many small boats on moorings in the bay and, unwilling to continue into the congested area, he decided to anchor in the bay entrance rather than in the planned position at the THA designated anchorage to the south-west. The master continued to reduce *Hamburg's* speed in preparation for anchoring.

By 1351:29 *Hamburg's* master had ordered the starboard anchor to be let go to 5 shackles⁶ on deck⁷. The cruise ship was on a heading of 223.9° and the charted depth of water was 61m. As the anchor was deployed, *Hamburg* was slowly moved astern using its engine and assisted by the wind. The cruise ship travelled in an easterly direction across the bay entrance and, at 1353:40, the OOW advised the master that there was a shallow patch of water on the vessel's port side (**Figure 9**).
