Fatal man overboard accident from the fishing trawler *Enterprise* (PD147)

North of Dogger Bank, North Sea
9 July 2015

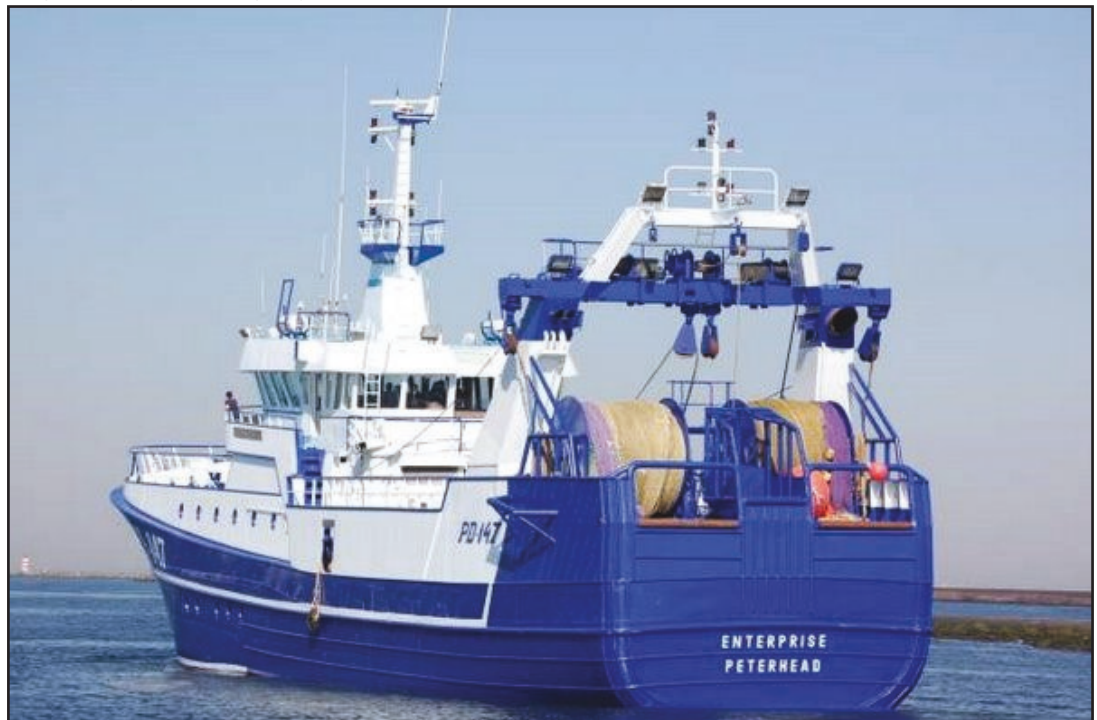
Figure 1: Fishing vessel *Enterprise*

At around 0415 on 9 July 2015, Jan de Boer, the skipper of the fishing trawler *Enterprise* (Figure 1), fell overboard through one of the vessel's ports for shooting fishing nets when he lost his footing in rough weather. He was not wearing a lifejacket or other buoyancy aid. The vessel was 16nm north of the Dogger Bank in the North Sea.
