# Rail Accident Report

**Passenger trapped and dragged by a train at  
Hayes & Harlington station  
25 July 2015**

Report 12/2016  
June 2016

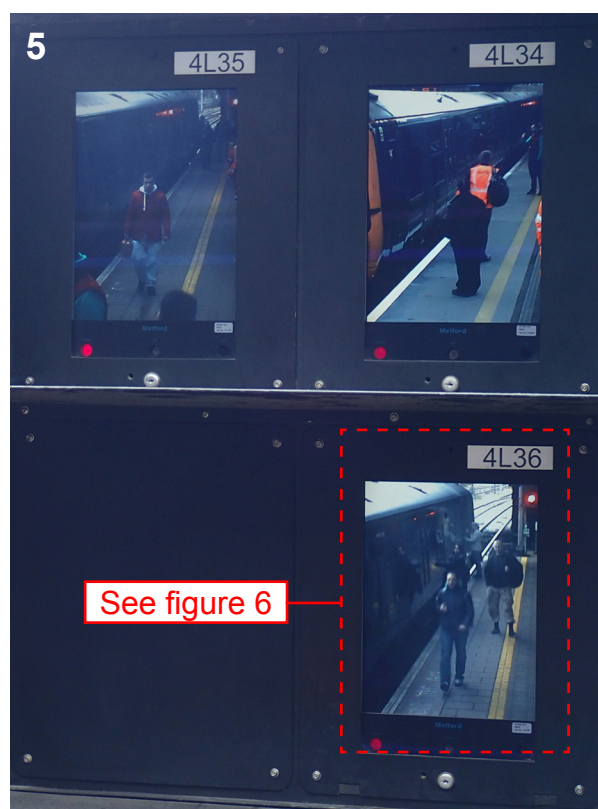
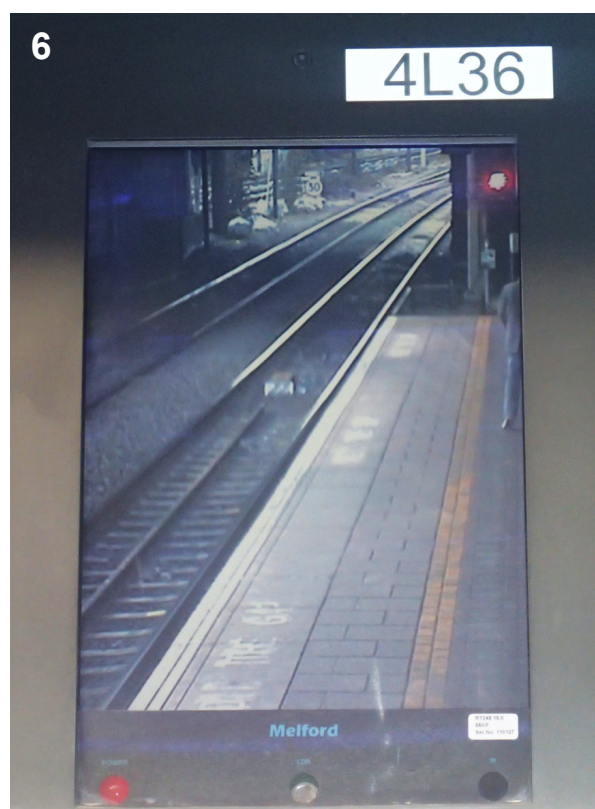
- 7 For all trains calling at Hayes & Harlington station, drivers are responsible for door operation and train dispatch (this method of working is commonly known as 'Driver Only Operation' (DOO)).
- 8 Closed Circuit Television (CCTV) monitors on platform 4 (figures 5, 6 and 7) are provided to assist drivers to dispatch the train. The three screens are located within a shrouded cover and provide train drivers with a colour view of the side of the train and all the passenger doorways.

Figures 5 and 6: CCTV at the three-car stopping position on platform 4

- that the CCTV monitor(s) are displaying the correct images; and
  - the quality and contrast of the displayed picture(s).
- 64 The most recent Network Rail assessment was completed five days before the accident on 20 July 2015. No defects were identified, the DOO monitors were cleaned, and the CCTV camera angles were checked.

- 65 Analysis of the platform CCTV shows the train had stopped at the correct position (3 car marker point). No defects were reported by any driver on the day of the accident, and therefore the RAIB consider the quality of the images was unlikely to have been a factor in this accident.

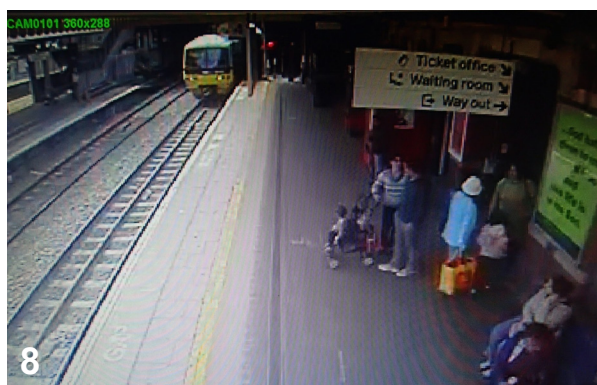
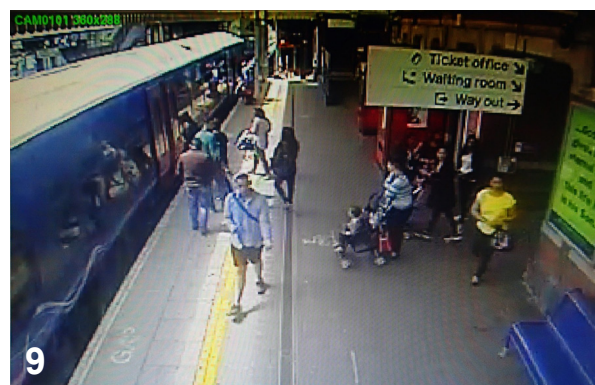
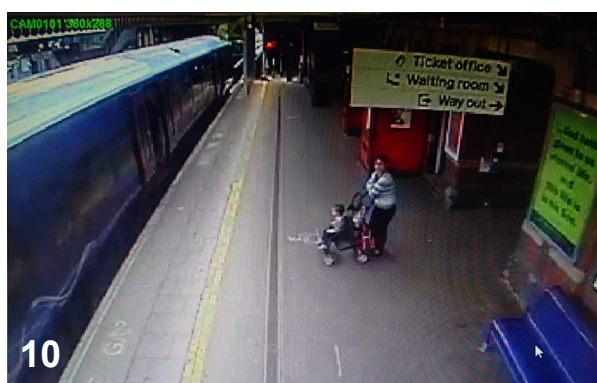
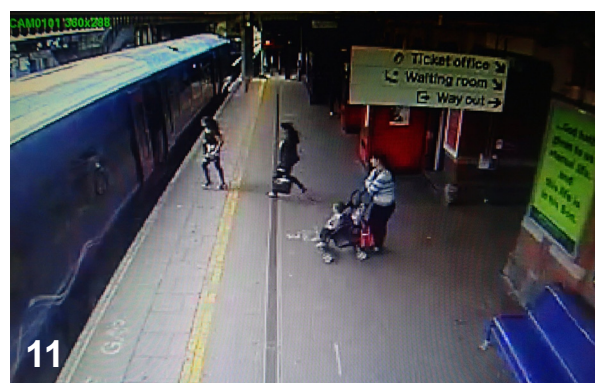
- 15 Train 2P48 departed from Oxford on time at 11:37 hrs, and remained on time throughout its journey to London Paddington. On arrival at Hayes & Harlington station<sup>1</sup> (figure 8), the driver released the doors at 13:08:36<sup>2</sup>. A few passengers alighted and by 13:08:57 all passengers on the platform intending to travel had boarded (figures 9 and 10). A small number of passengers remained on the platform, waiting for a later train. At 13:09:26, a male and two female passengers arrived on the platform and boarded the train (figure 11).

Figures 8 to 11: CCTV images showing train 2P48 arriving at Hayes & Harlington and subsequent activity on the platform (courtesy of GWR)

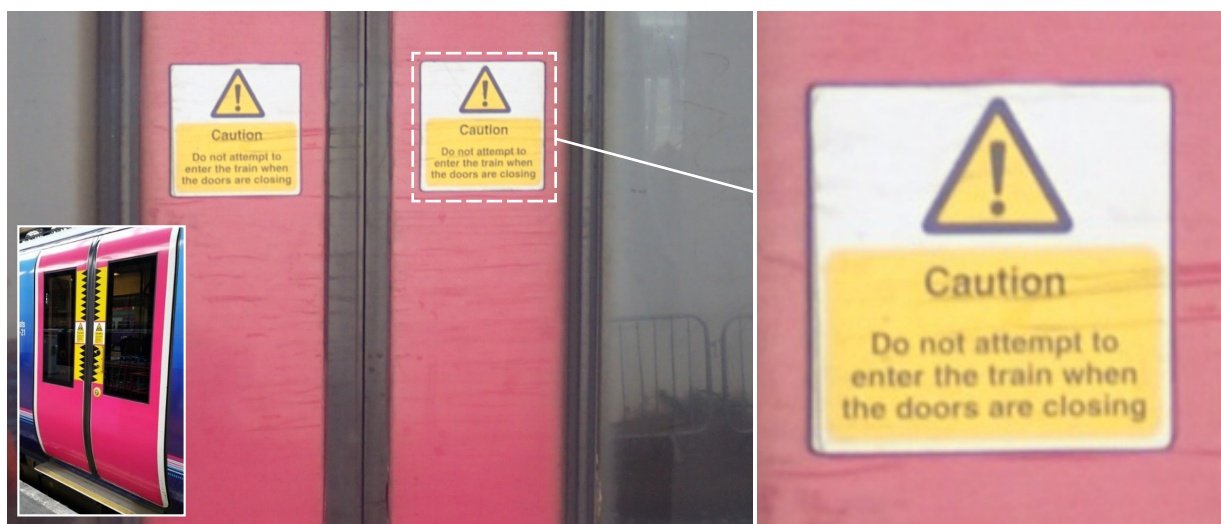
- 36 The passenger placed her hand into the gap between the door leaves as they were closing.**
- 37 CCTV and witness evidence shows that the passenger attempted to board the train as the doors were closing. The passenger believed that if she placed her hand into the gap between the door leaves, it would cause them to re-open. She said that as she ran towards the train she did not see the cautionary sticker (figure 24) placed on the outside of the door requesting passengers not to attempt to board the train as the doors are closing. Although she was aware that obstructing the doors was potentially unsafe, she thought that the train would not be able to move if her hand was caught in a door, and that in any case the driver would see her and would re-open the doors. As a result, when her hand first became trapped and the train was still stationary, she made no attempt to pull it out of the doors<sup>4</sup>.

<sup>4</sup> RSSB project (T426) Minimisation of accidents at the platform-train interface (2006) identified that passengers perceived train doors were similar to lift doors in that they would reopen if they encountered an object. The behaviour of the public suggested that the risk is poorly understood. The research recommended that a campaign message should cover both information on the door mechanism and alert passengers to not attempt to obstruct the doors once they are closing. The research resulted in changes being made to the signage on train doors and this research has now been extended to understand passenger behaviour and optimising door closure arrangements to improve boarding and alighting (T1102).

Figure 24: Cautionary sticker on the outside of the class 165 trains requesting passengers to not attempt to board the train when the doors are closing. Inset image showing 'sharks teeth' graphic design on the livery of a TransPennine Express train to warn passengers of the dangers of obstructing a door.

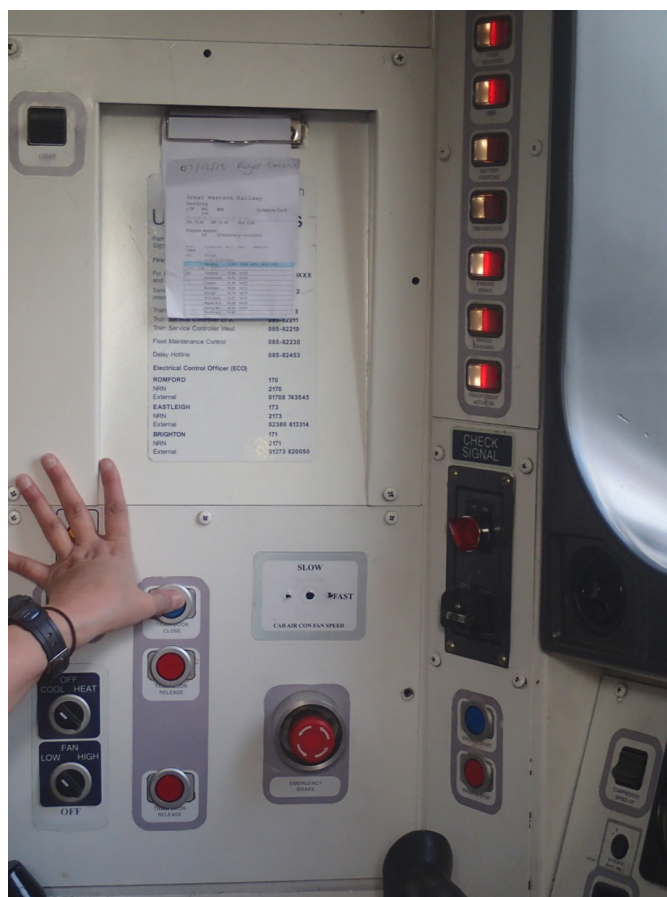
- 47 **The driver was able to start the train with the passenger's hand trapped in the door.**
- 48 Class 165 trains are fitted with a door safety system or interlock, which is designed to detect the presence of an obstruction of defined dimensions. If an obstruction of size equal to or greater than the defined dimension is inserted between the door leaves, the system should detect its presence. Should an obstruction be detected, the interlock circuit should not complete, the interlock light in the driver's cab should remain unlit and the driver will thus be unable to start the train.

- 49 For the purposes of testing whether the door interlock is working properly, a test object is used. FGW specifies a test object 25 mm thick for testing the door interlock (this is derived from the British Rail Standard GO/OTS 300 and therefore more onerous than the requirement in the current equivalent Standard GM/RT2473, which specifies a test object 30 mm in width). The test involved inserting the object into the closing leaves of a train door and confirming that interlock prevents the driver from taking power (figures 25, 26(a) and 26(b)).

Figure 25: Train driver pressing the button to initiate the door closure

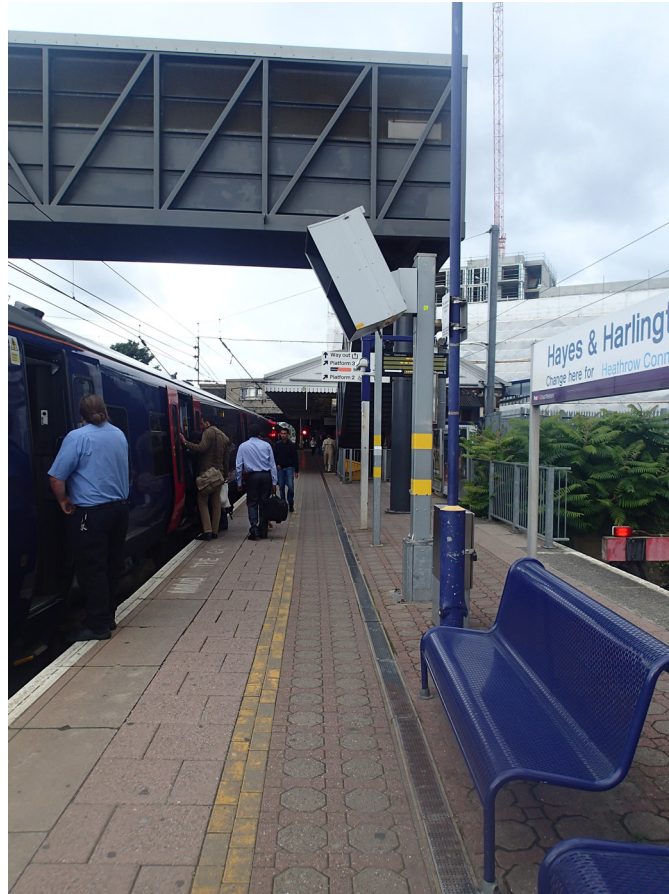
- 56 FGW's Professional Driving Policy (module ARB 48) supplements the requirements of the rule book. The policy outlines the key responsibilities of a train driver and incorporates much of the guidance from RSSB RIS-3703 'Rail Industry Standard for Passenger Train Dispatch and Platform Safety Measures' (Issue Two, March 2013) on the hazards a train driver should look for before and after closing the train doors (paragraph 127b). The policy also states that a train driver must ensure that during station arrival and departure, all procedures are undertaken correctly as accidents where people come into contact with a train can result in them sustaining life-changing or fatal injury (figure 27).

Figure 27: Image showing a train driver checking the platform during the dispatch process. Various methods of DOO dispatch were observed by RAIB (door open / door closed with window open and closed).
