## Foundering of fishing vessel *Majestic* (LK678) 5 nautical miles off Yell, Shetland 21 January 2016

### SUMMARY

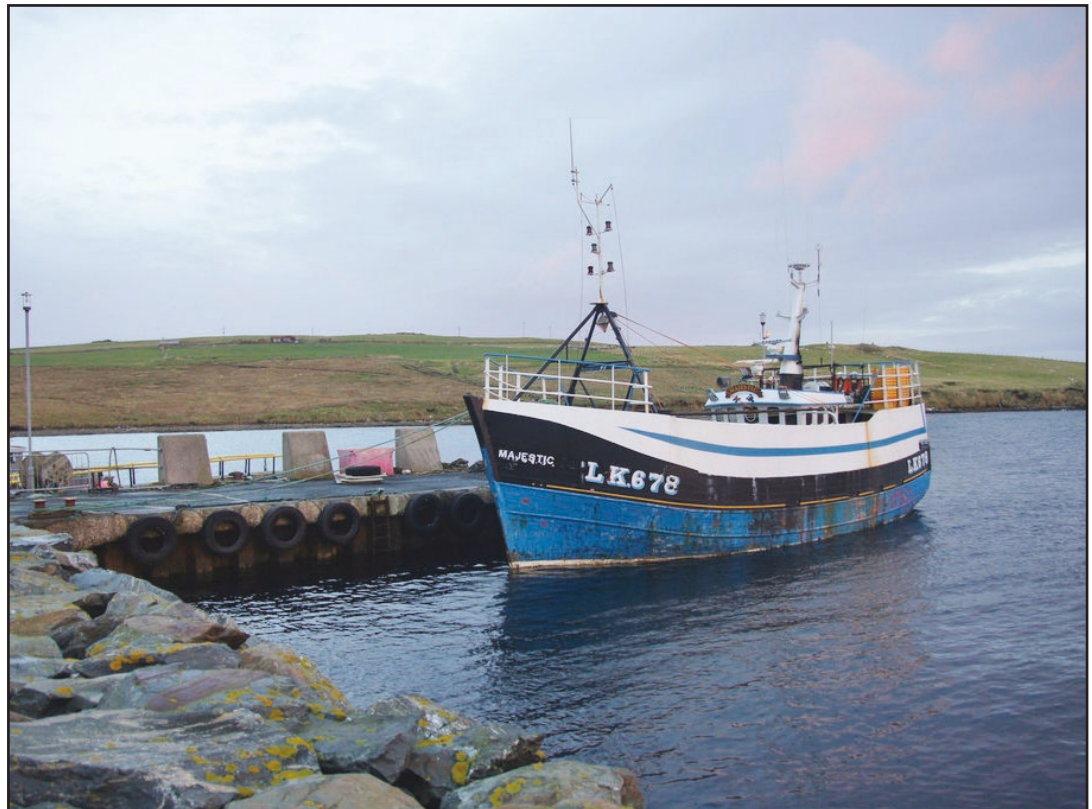
At 1443<sup>1</sup> on 21 January 2016 the 16m wooden potter *Majestic* (LK678) sank close to a gas pipeline off the Point of Fethaland, Shetland. The vessel's sinking resulted from a flood in the engine room that had started sometime between 0900 and 1000. The skipper and crewman abandoned into a liferaft shortly after they became aware of the ingress of water and were rescued by a nearby fishing vessel. No efforts were made to stem the flood and the vessel foundered approximately 4 hours after it was abandoned. There were no injuries and no pollution. The pipeline's owner, British Petroleum, later arranged for sandbags to be placed on the seabed between it and the wreck to prevent damage to the pipeline.

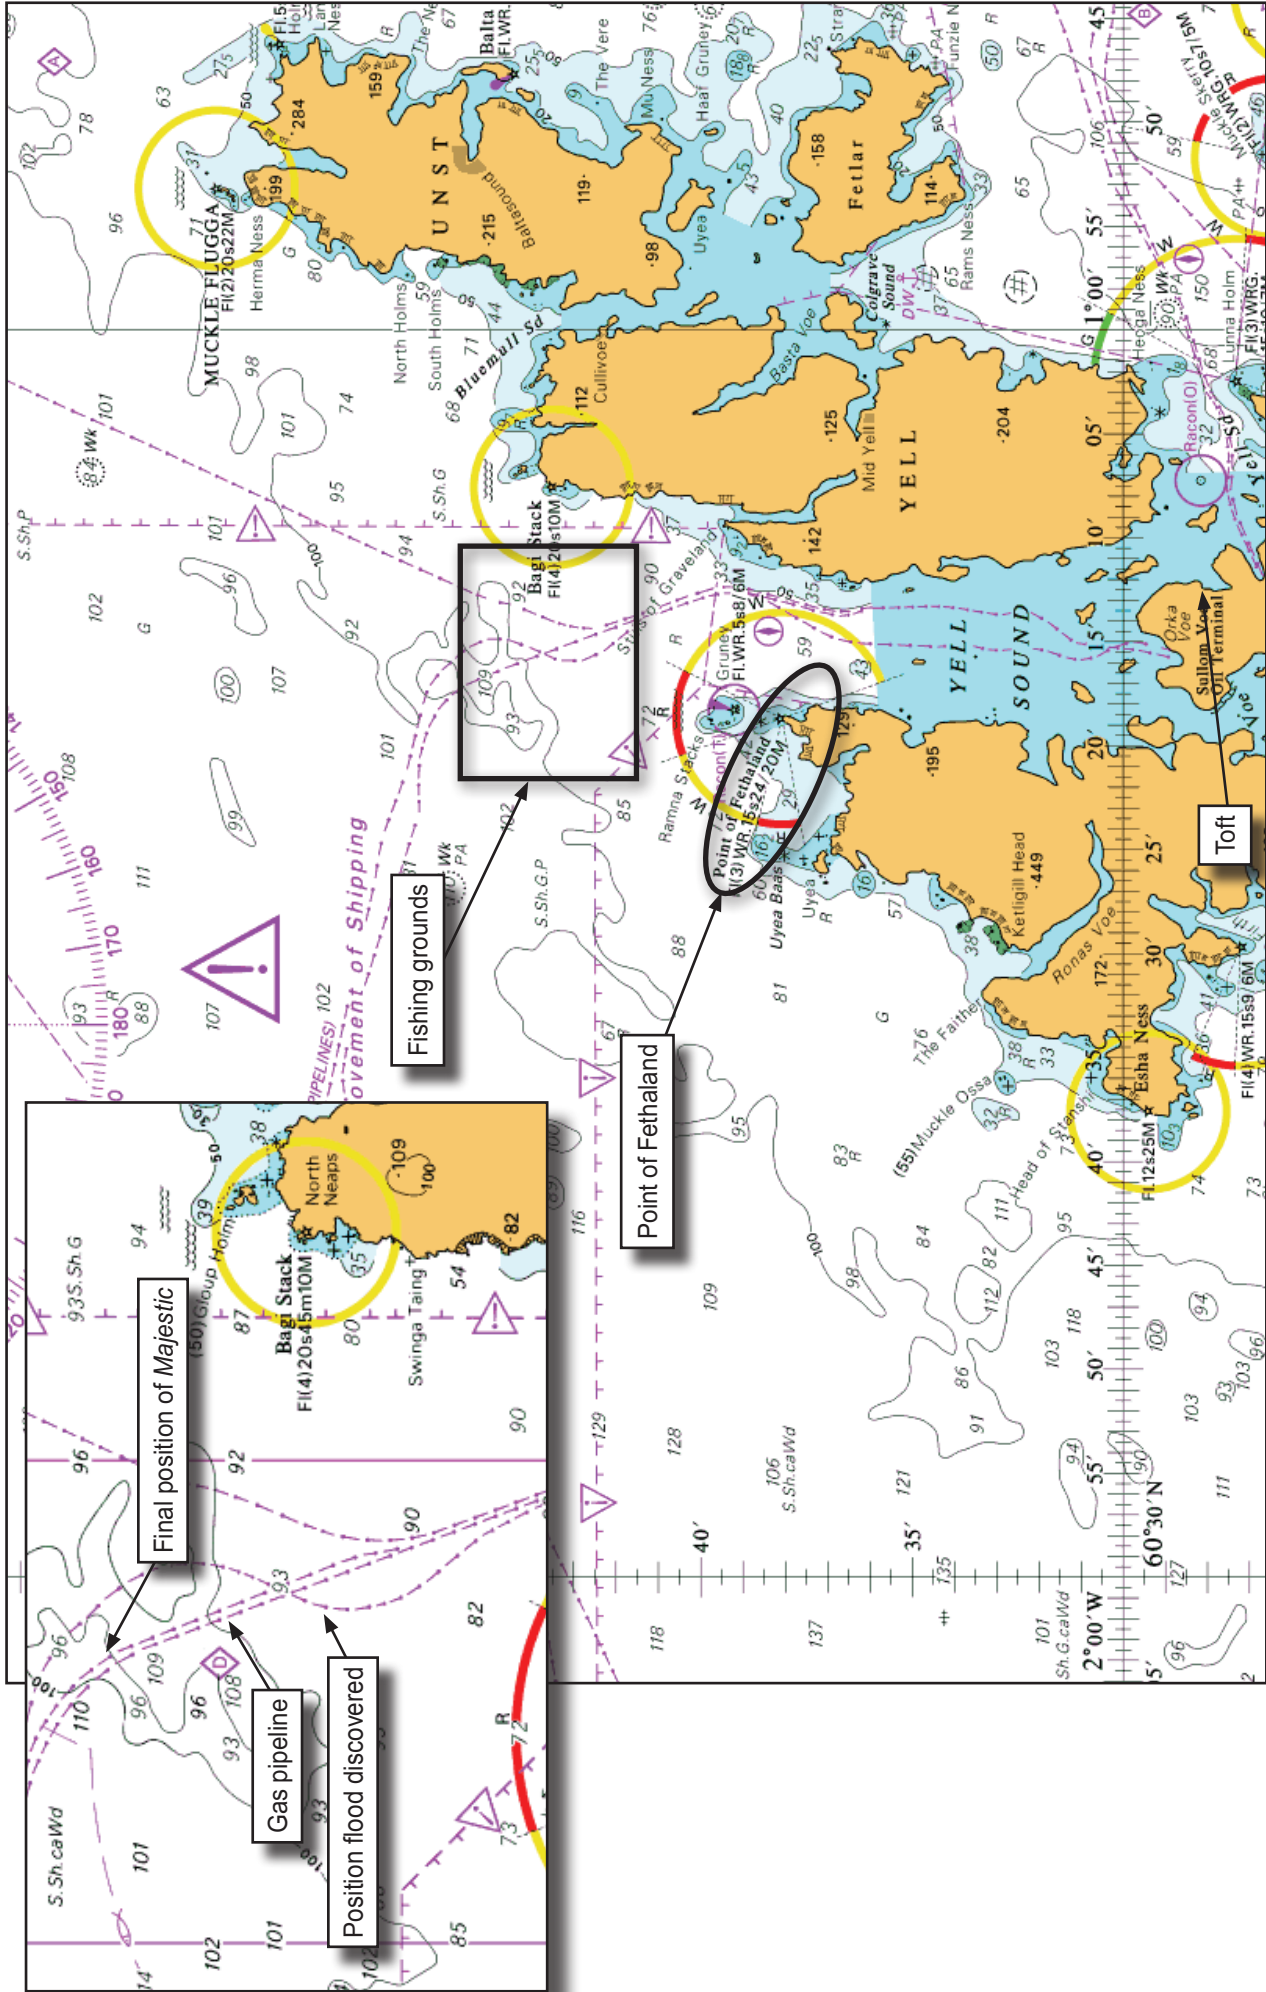
Figure 1: Yell sound fishing grounds (inset: Orka gas pipeline and position of sinking)

At 0530 on 21 January 2016, the 16m wooden potter *Majestic* (LK678) sailed from Toft, Shetland, and headed for fishing grounds approximately 5nm to the north-east of Point of Fethaland (**Figure 1**). On board were the vessel's skipper and a crewman; both men were wearing oilskin trousers and jackets. The weather was fine and clear and the visibility was good. There was a moderate south-easterly breeze and the sea was slight with a 1m swell.
