# Rail Accident Report

## Overspeed at Fletton Junction, Peterborough 11 September 2015

Report 14/2016  
August 2016

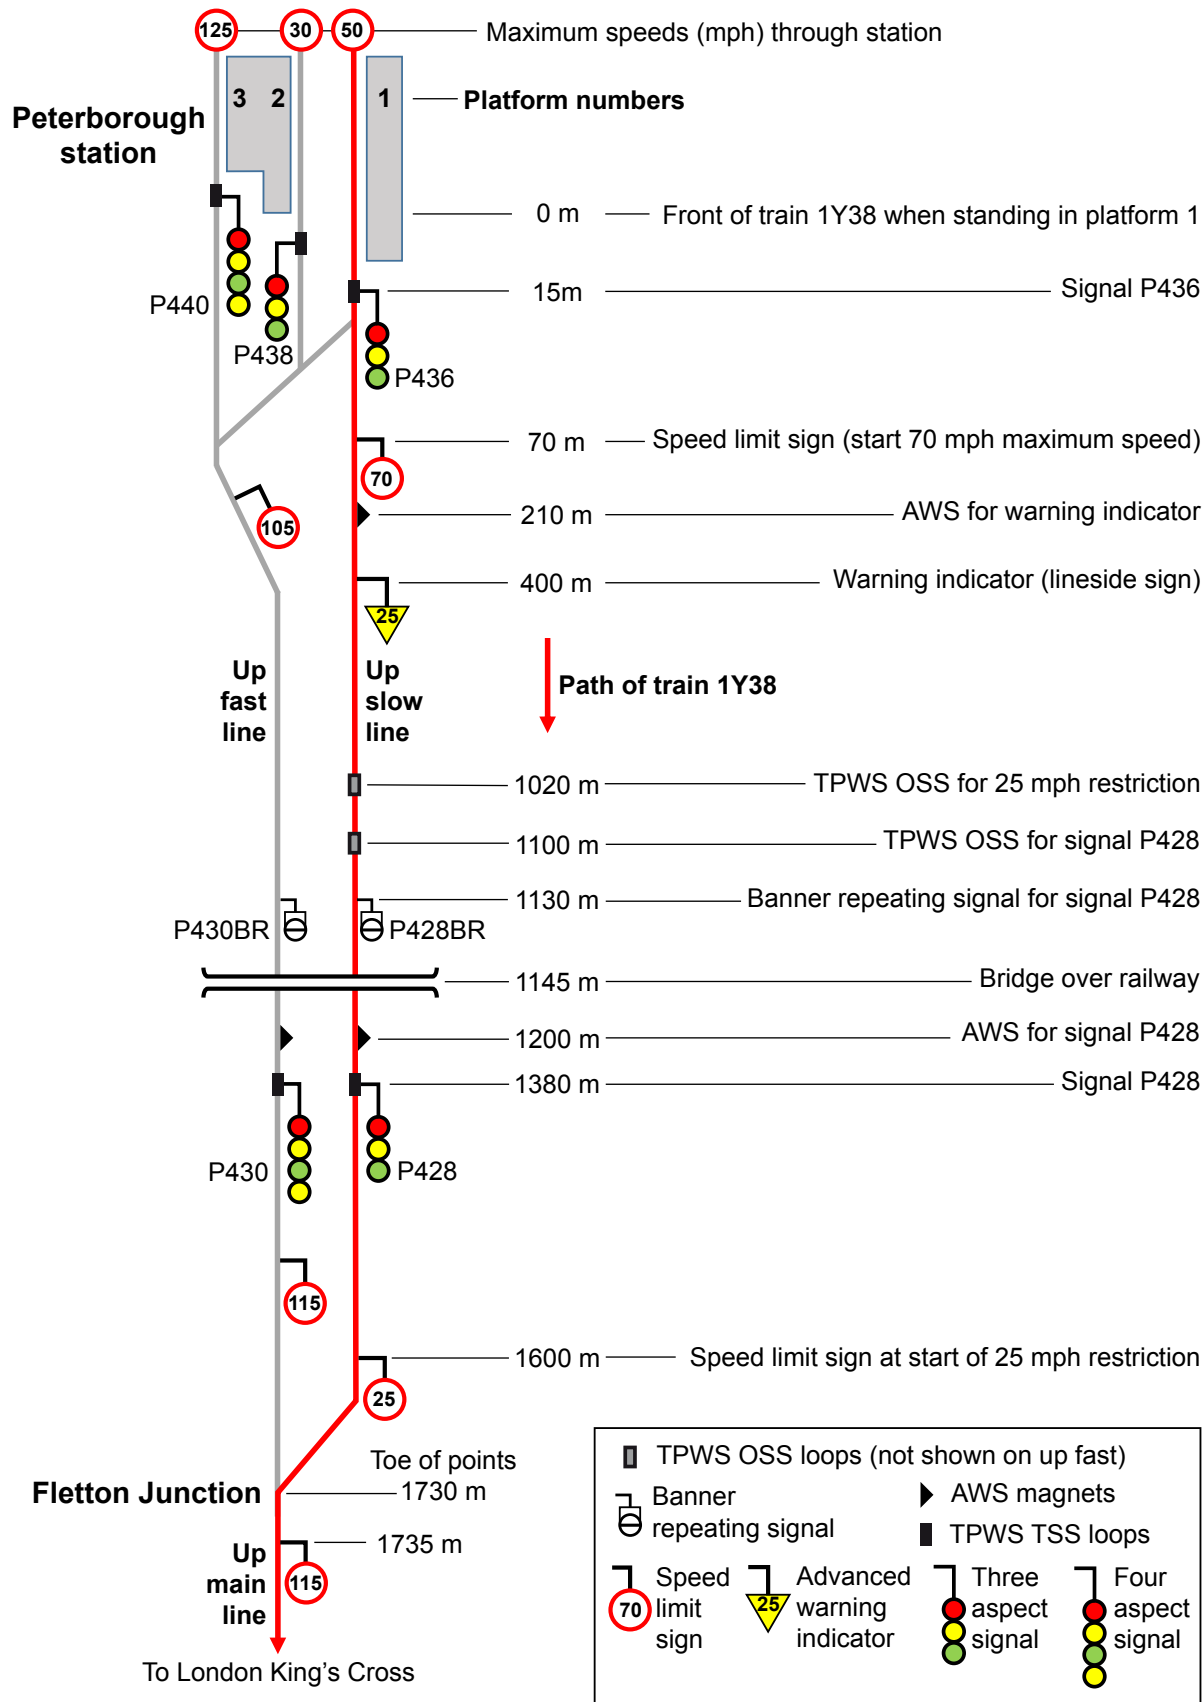
Figure 2: Infrastructure between Peterborough station and Fletton Junction (simplified)

- 6 Fletton Junction is on the East Coast main line around 1.25 miles (2 km) south of Peterborough station and 75 miles and 2 chains<sup>1</sup> from King's Cross station. At this junction, the *up* slow and *up* fast lines merge to become the *up* main line (figure 2).
- 7 These lines carry trains travelling south from Peterborough. The *up* slow line passes through platform 1 at Peterborough station and the *up* fast passes through platform 3. Southbound trains departing from platform 1 can be routed onto the *up* fast line at a *crossover* immediately south of the station, or continue along the *up* slow line to Fletton Junction.

- 62 Operating arrangements at Peterborough mean that trains departing from platform 1 using the up slow line are likely to encounter a green aspect when they approach signal P428. As a result, the associated AWS magnets, located about 400 metres from the start of the speed restriction, will cause the AWS visual indicator to change to a clear (all black) indication. This means that drivers no longer see the black and yellow indication as a reminder that they have passed the advance warning for the 25 mph (40 km/h) speed restriction. If signal P428 is not displaying a green aspect, the AWS visual indicator will continue to show the black and yellow indication, but there is a risk that drivers will now associate this with the signal and forget about the warning indicator while concentrating on their approach to the signal (although they should receive a reminder when they see the permissible speed indicator at the start of the restriction; figure 2).

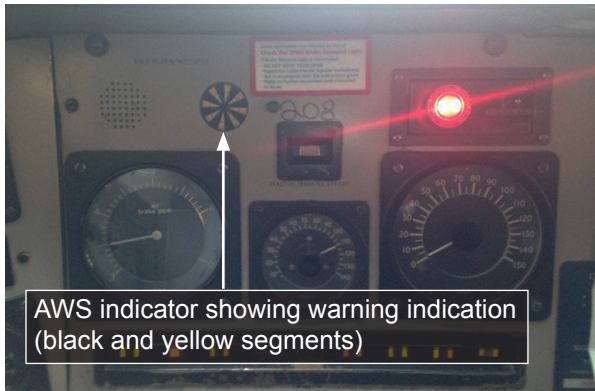
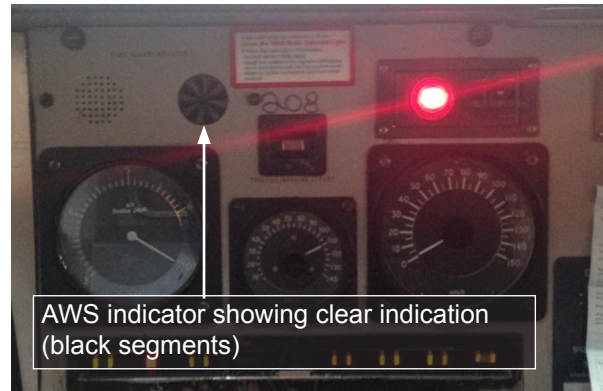
Figure 3: AWS visual indicator

- 14 Train 1Y38 was being driven from the driving van trailer (number 82223) at the front of the train. Equipment fitted to this vehicle included:
- a. An *automatic warning system* (AWS) receiver which responds to magnets fixed to the track between the rails. A single permanent magnet is provided at locations where the AWS is always required to provide a warning. At other locations, an electro-magnet is added and energised when a clear indication is required. If a warning is given, a horn sounds in the driving cab, and if the driver does not acknowledge this warning within about 2 seconds<sup>6</sup>, the train's brakes will automatically apply to stop the train. If a clear indication is given, an electronic bell sounds in the driver's cab and the driver is not required to take any action. An *AWS visual indicator* in the driving cab, sometimes known as a 'sunflower', displays alternate black and yellow segments as a visual reminder to the driver if a warning was acknowledged at the last AWS location. In other circumstances it shows an all-black indication and this is the normal indication after passing an AWS location associated with a signal displaying a green aspect (figure 3).
