Road Traffic Injury on Rural Roads in Tanzania: A study to determine the causes and circumstances of motorcycle crashes on low-volume rural roads/

FINAL REPORT, v1.1

Tom Bishop and Deepani Jinadasa, Amend

AFCAP/TAN/115

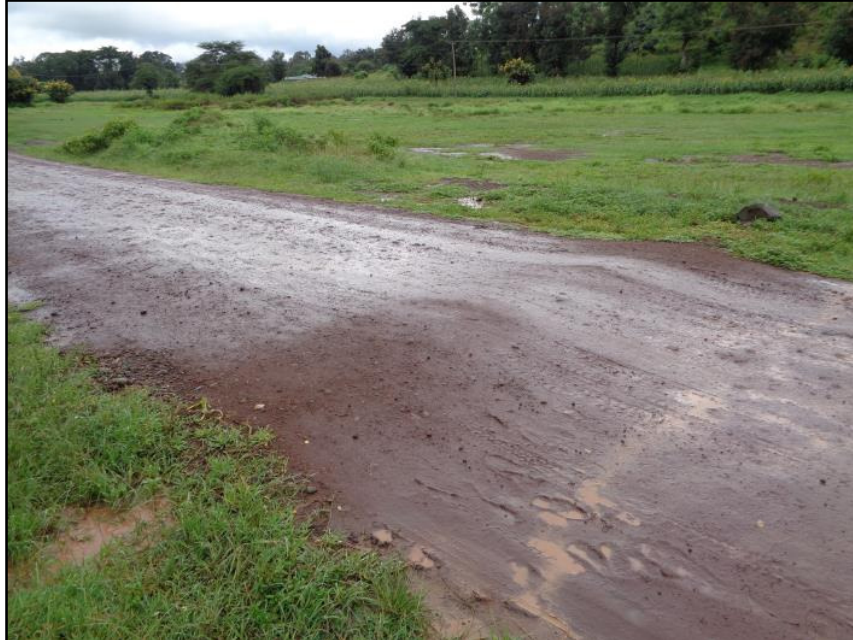
Photo 19: An Earth Speed Hump Constructed By the Siha District Engineer (L-K)

Some earth and concrete humps had been newly installed by the District Engineer on the Lawate to Kibong’oto road.

The speed humps along both roads are effective at slowing motorcyclists down, although those along the Bago to Talawanda road are not signed and so have the potential to cause loss of control for motorcyclists who do not see them.

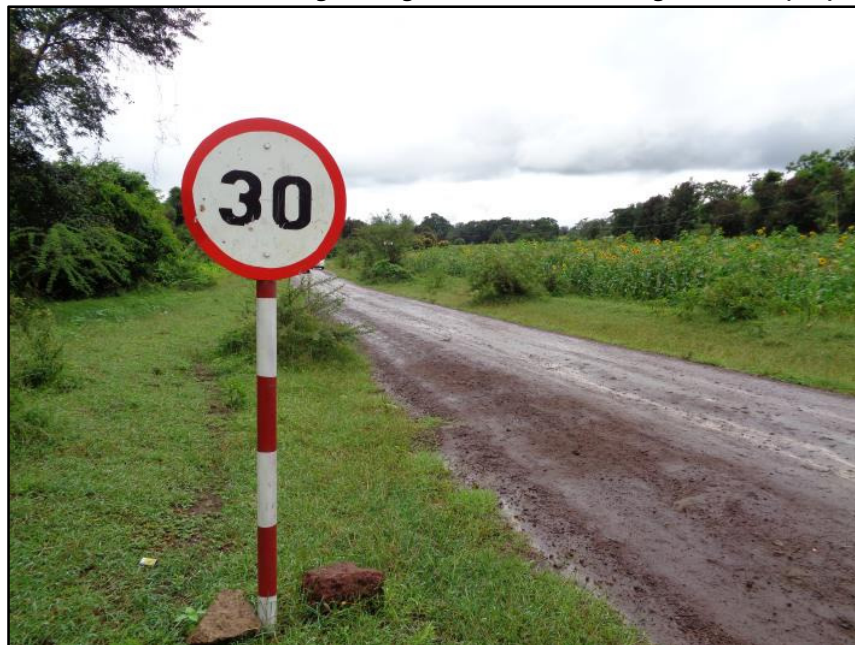
Photo 21: A New Road Sign along the Lawate to Kibong'oto Road (L-K)

Several new road signs were erected along the Lawate to Kibong'oto road in between the dry season and rainy season data collection periods.

The Motorcycle Safety Expert observed that most of the drivers who knew the road less well observed these signs and modified their behaviour accordingly, which usually meant reducing their speed in anticipation of an obstacle. However, he also observed that drivers who knew the road well did not adhere to the signs.
