Back Analysis of Previous Constructed Low Volume Rural Roads in Mozambique

AFCAP/MOZ/001/G Final Report CPR1612

June 2013

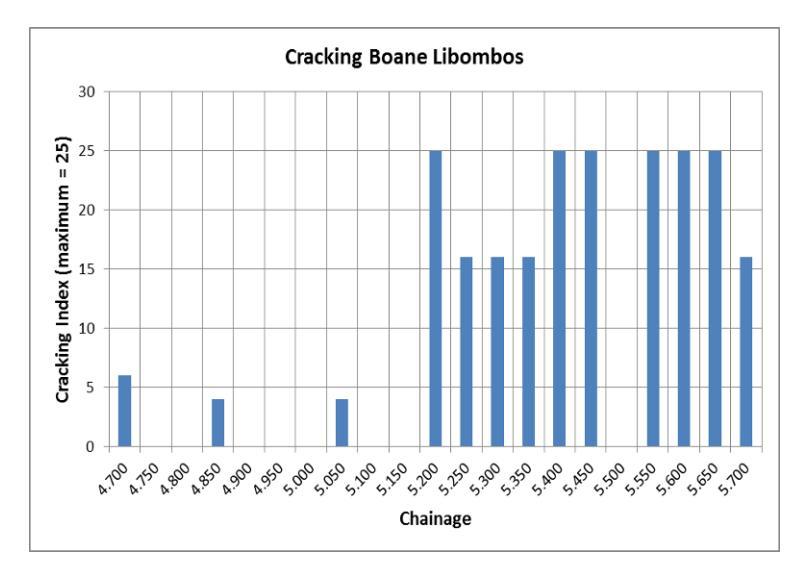
Figure 5-2 Cracking Sections 1 and 2 of the Boane Libombos road

Section	Chainage		Priof description	Figure	
Section	From	То	Bher description	No	
1	4+700	5+100	Very little cracking Rutting rarely exceeded 10mm. There is no patching and the crown height is generally good (379mm on gentle slope). Considering the traffic over 13 years this probably indicates that the road base and overall structure are satisfactory. The DCP and test pit data shown in Table 5-2 confirm this.	5.2 and 5.3	
2	5+300	5+700	Very extensive cracking and a few potholes. The rutting is not serious but Figs 5.2 and 5.3 indicate that rutting is probably beginning to follow on from the cracking. The cracking was attributed primarily to aging of the surface.	5.2 and 5.3	
3	8+000	8+400	Some cracking and no significant rutting; cracking clearly preceding rutting indicating adequate base strengths for the traffic. Some minor deformation was noticed in the wheel track on the right hand side possibly caused by poor subsurface drainage.	5.4 and 5.5

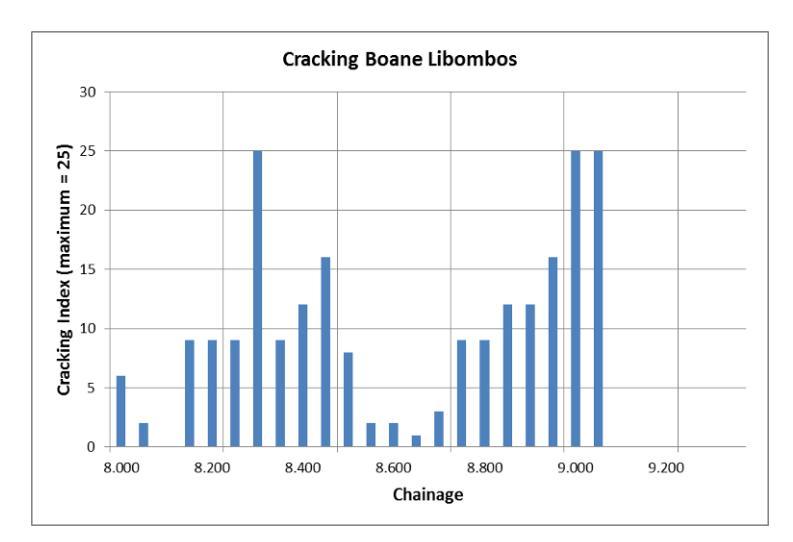
Figure 5-4 Cracking Section 3, 4 and 5 of the Boane Libombos road

4	8+400	8+700	Extensive cracking, no ruts and minor deformation. Cracking preceding rutting indicating adequate base strengths for the traffic.	5.4 and 5.5	
5	8+700	9+000	Extensive cracking, no ruts and minor deformation. Cracking clearly preceding rutting indicating adequate base strengths for the traffic.	5.4 and 5.5	
6	9+050	9+350	This section is in good condition and it is very smooth. No cracking or potholes were noticed. It appeared as though there had been some recent rehabilitation works carried out on it.	5.4 and 5.5

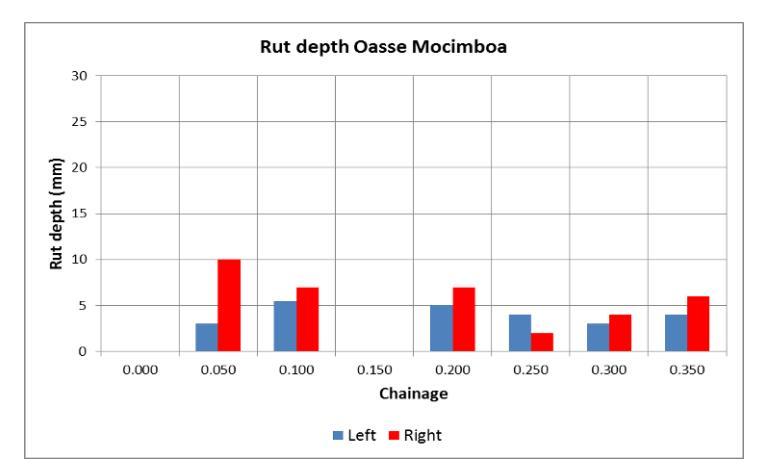
Figure 5-9 Rut depth on Section 1 of the Oassie Mucimboa road

Three sections were selected in good, fair and poor condition. Figure 5-8 and Figure 5-9 show that Section 1 had some cracking and that rutting did not exceed 10mm. This probably indicates that the road base and overall structure are satisfactory for the traffic but the DCP and test pit data shown in Table 5-7 indicate a relatively weak roadbase and no obvious difference between the three sections. In fact there is an exact correspondence between the in-situ roadbase CBR by DCP and the DN 150 value, as would be expected (DN 150 < 40 indicates insitu CBRs < 80%).

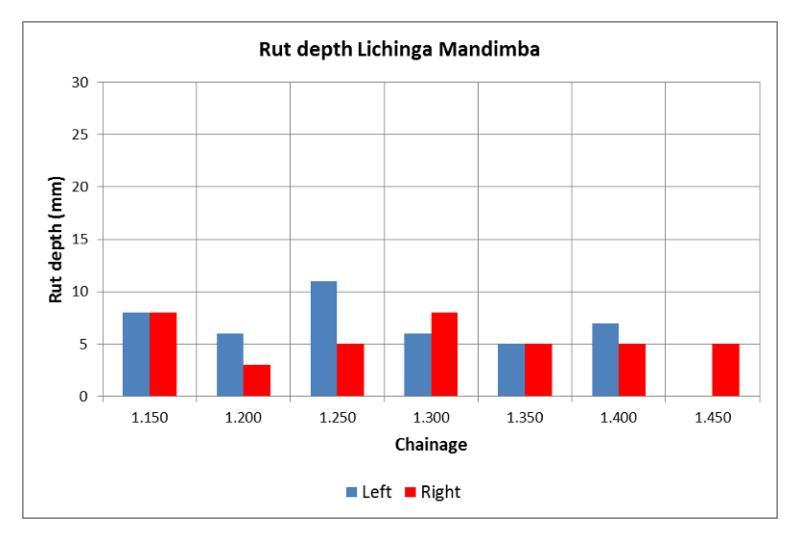
Figure 5-14 Rut depth on Section 1 of the Lichinga Mandimba road

There exist deposits of laterite, which are good for road construction in this area in contrast to other areas in most of Mozambique where good road building materials are scarce. The section from 1+150 to 1+450 has performed well with no serious defects (Figure 5-14 and Figure 5-15).

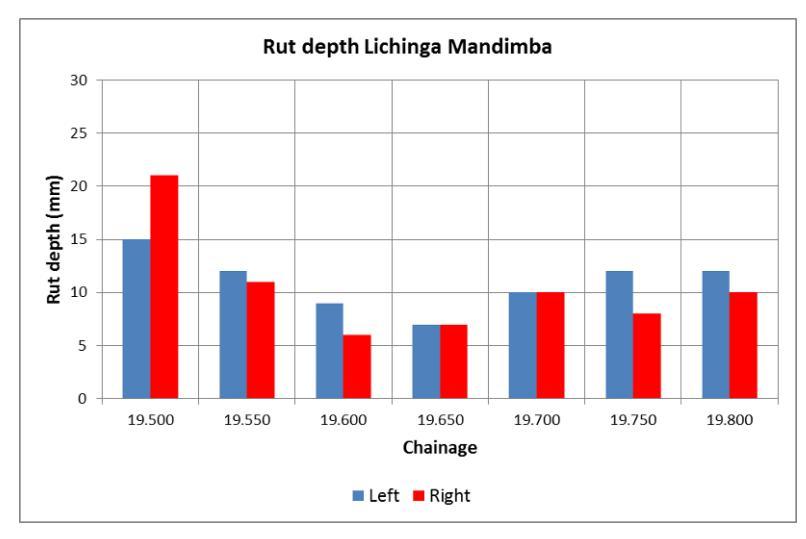
Figure 5-16 Rut depth on Section 2 of the Lichinga Mandimba road

The second section from 19+550 to 19+850 had failed with excessive potholing and patching (Figure 5-17) and a deep rut at the beginning, otherwise deformation was slight and in the outer wheel tracks.

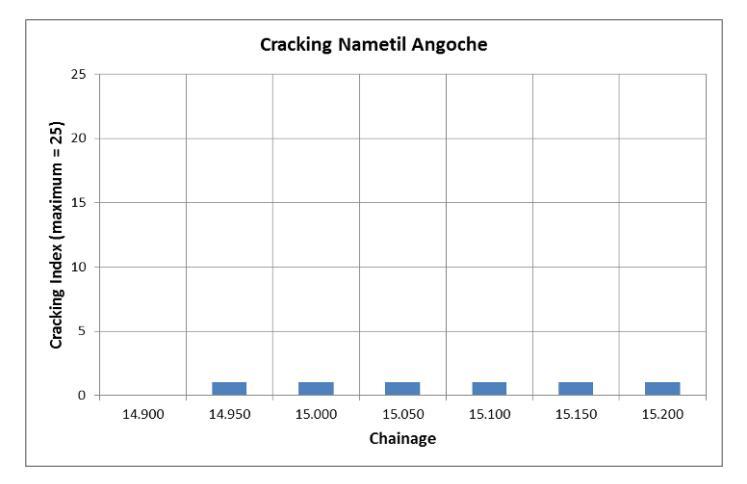
Figure 5-21 Cracking on Section 2 of the Nametil Angoche road

The cracking and rut depth on Section 2 are shown in Figure 5-21 and Figure 5-22. There was only very minor cracking and the rut depths did not indicate any structural failures.

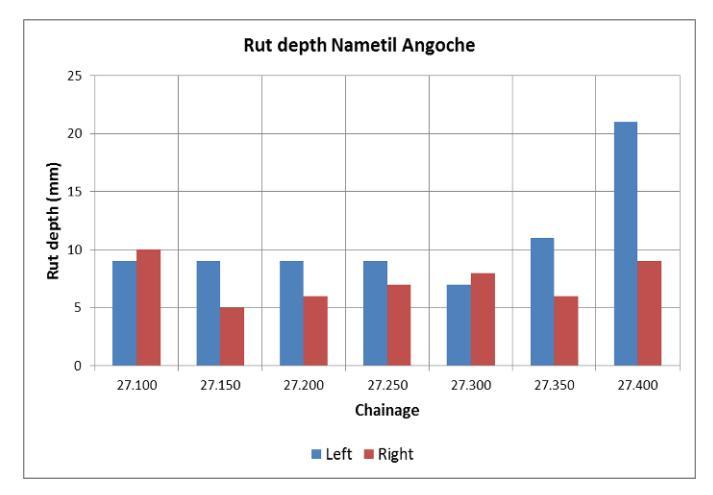
Figure 5-23 Rut depth on Section 3 of the Nametil Angoche road

On Section 4 there were two chainages showing deep ruts as shown in Figure 5-23. On excavation of the test pit at chainage 27+400, it was found out that the surfacing had delaminated from the base. The surfacing $(1m^2)$ could be lifted from the base intact. The base was very weak (see the DN 150 values) and appeared uncompacted and loose. The in-situ CBR from DCP tests was 39% which is very low. It is surprising how the surfacing over this base did not fail over the years.

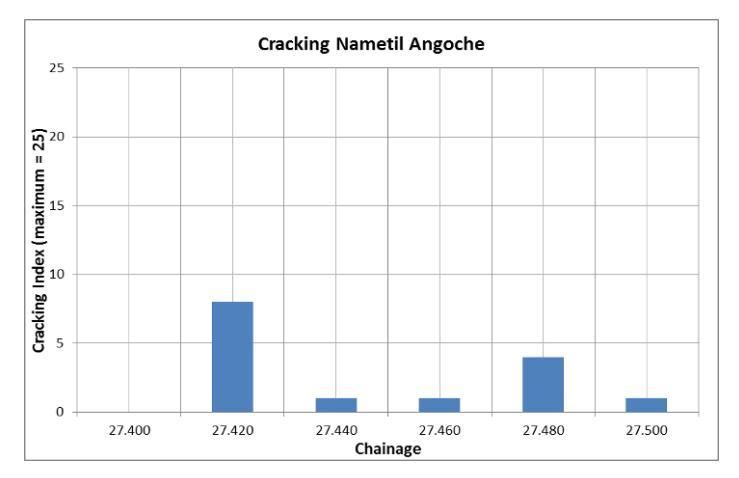
Figure 5-24 Cracking on Section 4 of the Nametil Angoche road

Continu	Chainage		Brief description	Figuro no	
Section	From	То	Briel description	Figure no.	
1	14+550	14+750	This experimental section without surfacing has completely deteriorated and there is more of the exposed gravel base than the primed surface.	None	
2	14+900	15+200	The section was in good condition. There was no cracking but the rut depths were slightly higher than desired. The base, which was said to be cement stabilised, exhibited low strength (CBR < 80%). This is unusual.	Fig 5.21 and Fig 5.22	
3	27+100	27+400	The section with natural base and Otta seal with sand seal capping was in good condition with no cracking and acceptable levels of rutting.	Fig 5.23	
4	27+400	27+500	The surfacing was a single Otta seal and has deteriorated, though not badly. There was some cracking but the rutting indicates complete structural failure at one point and near failure at another.	Fig 5.24 and Fig 5.25

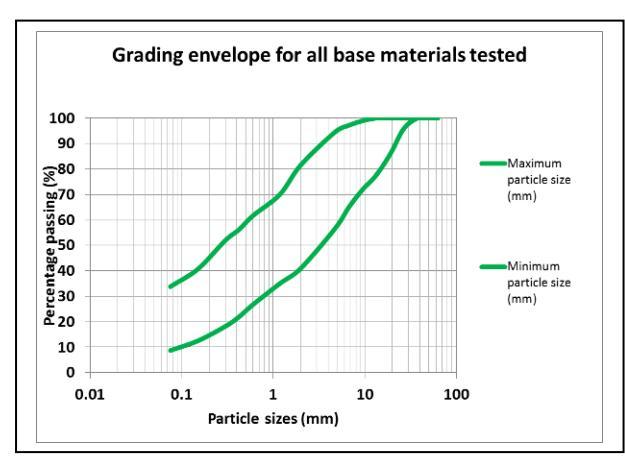
Figure 6-12 Grading envelope for all bases tested

Figure 6-12 shows the grading envelope of all base materials that were tested. This will be useful in developing grading specifications for base materials for low volume roads. Other grading parameters are given in Table 6-4.

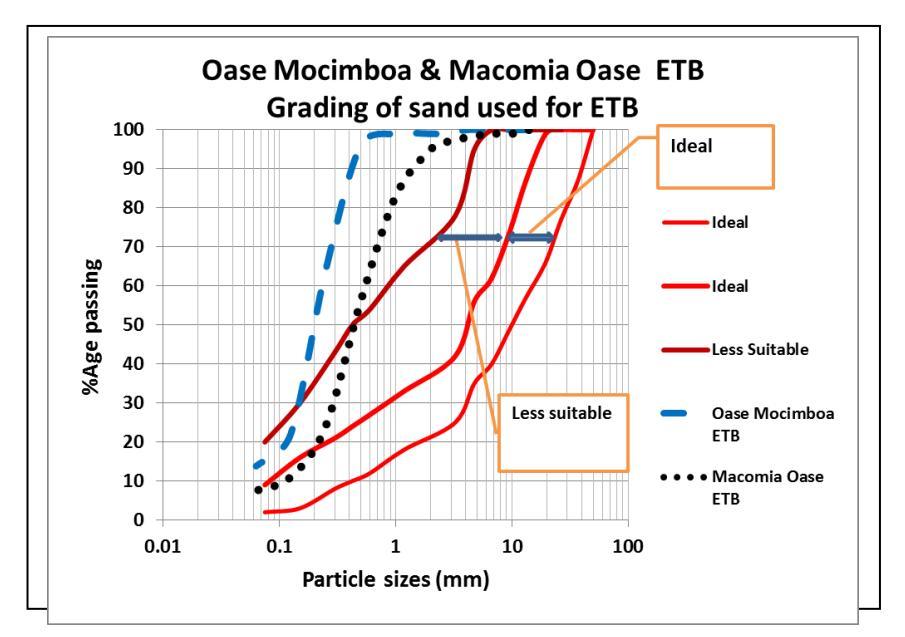
Figure 6-17 Grading of sand used for ETB on Oasse Mocimboa da Praia Road

Figure 6-17 shows the particle size distribution of the sand used for the ETB. It shows that the sand was unsuitable in terms of the particle size distribution compared with recommended specifications for ETB for low volume roads i.e. less than 1 million standard axles (< 1M). The sand is single-sized and needs high bitumen content if the mix is to achieve the desired characteristics.

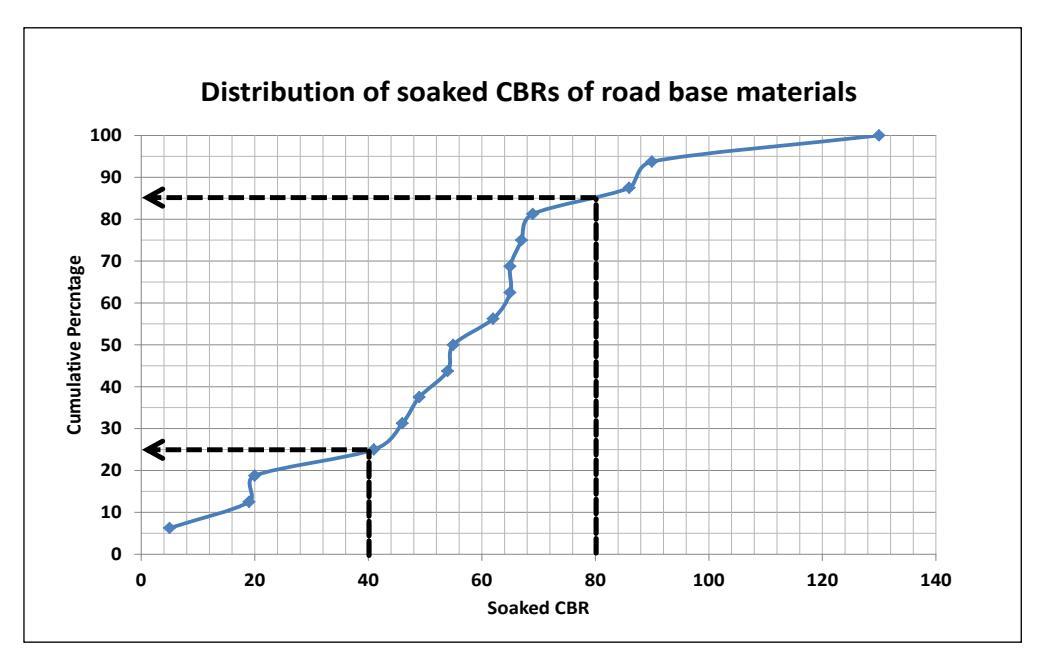
Figure 7-1 Limits of percentiles determined from known soaked CBR limits for LVRs

- 2. Recommendations for strength in terms of soaked and in-situ CBRs are given in Figure 7-1 and Figure 7-2 and Table 7-2. The normal standard specification for roadbase material is a minimum soaked CBR of 80%. The Figure shows that 85% of the roadbases were below this value but have performed well, thus the specification appears to be very conservative. Relatively recent research elsewhere in southern Africa (TRL. Environmentally Optimised Design) has also shown that lower CBR values are acceptable. The minimum recommended soaked CBR for the roadbases of low volume roads is about 40% (and even lower for very low volume roads). This corresponds to the lower 25th percentile for the roads in this project indicating that a CBR of 40% might still be conservative. However, in view of the relatively small sample of roads in this project it is recommended that 40% is used.

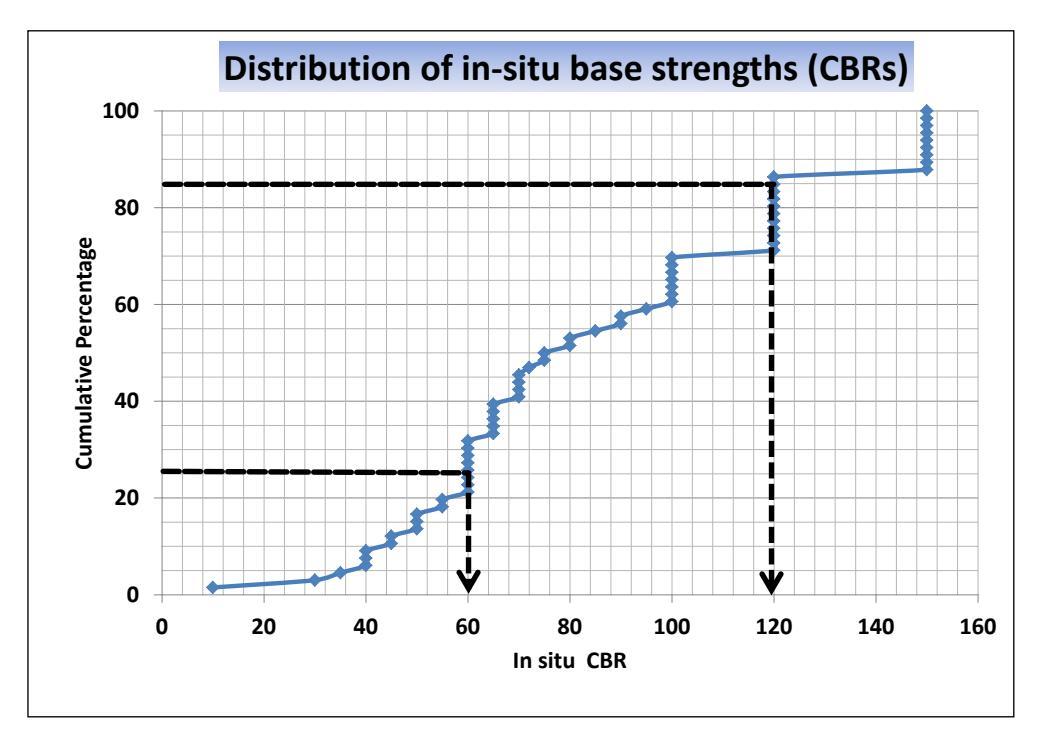
Figure 7-2 Determination of average in-situ CBR limits for bases on LVRs

- 3. However, recent research has shown that it is the in situ CBRs at the worst likely moisture content that are more important and that the moisture content is very rarely above OMC. Figure 7-2 shows that the lower quartile was about 60%. The 25% of the roads with lower values all performed well so 60% may be considered conservative but the in situ values were not all obtained during the wettest period of the year so, until more data are available, 60% is a reasonable recommendation.

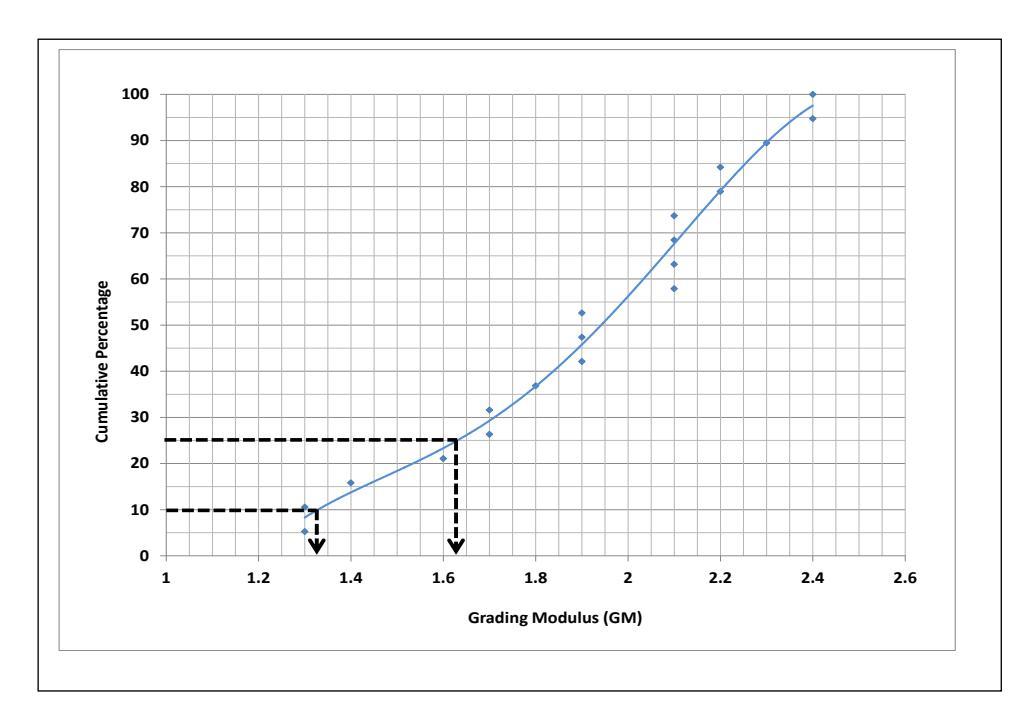
Figure 7-3 Determination of limits for GM for LVRs

- 4. Figure 7-3 shows the distribution of Grading Modulus for the roadbase materials. A recommended value of > 2.05 is sometimes quoted but values much lower than this have performed well. Recent research elsewhere is showing that provided the CBR criteria are met, the Grading Modulus is not as important as previously thought. From this research the recommended minimum grading modulus (GM) is 1.6. This may be conservative for very low volume roads but until more data are available, this is a prudent choice. When GM is between 1.3 and 1.6 the PP must be less than 200. This range of GM is for very fine gravel or fine to coarse sandy material.

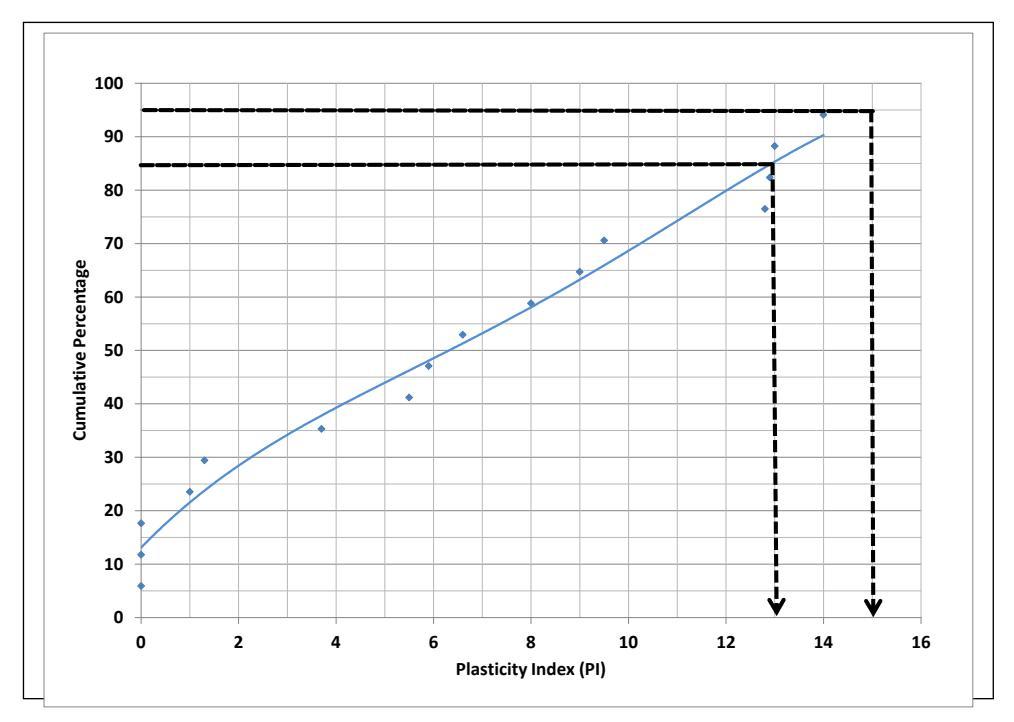
Figure 7-4 Determination of limits for PI for LVRs

- 5. Plasticity (Figure 7-4) is considered to be an important parameter in the performance of gravels. Based on the analysis, none of the test sections failed significantly. The upper limit of the plasticity in terms of the plasticity index (PI) and the plasticity product (PP) determines the quality of the base material. The 85th percentile PI was 13 and the 95 percentile PI was 15. Since no failures were obtained, 15% is acceptable and can be considered as the maximum limit.

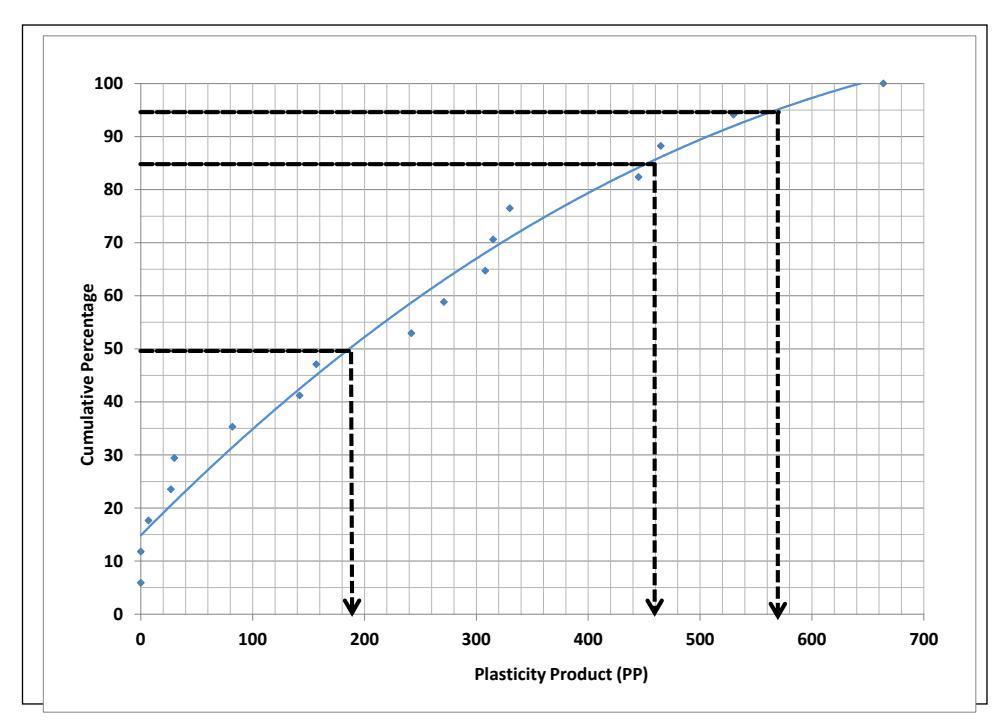
Figure 7-5 Determination of PP limits for LVRs

Plasticity Product (Figure 7-5) is more representative of the plasticity of a material because it takes into account the amount of material that is plastic. The 85th percentile value for PP was 460 and the 95th percentile was 570. Recent research elsewhere is showing that provided the CBR criteria are met, the plasticity is not as important as previously thought. However, until more data are available it is prudent to recommend that the PP should not exceed 460.

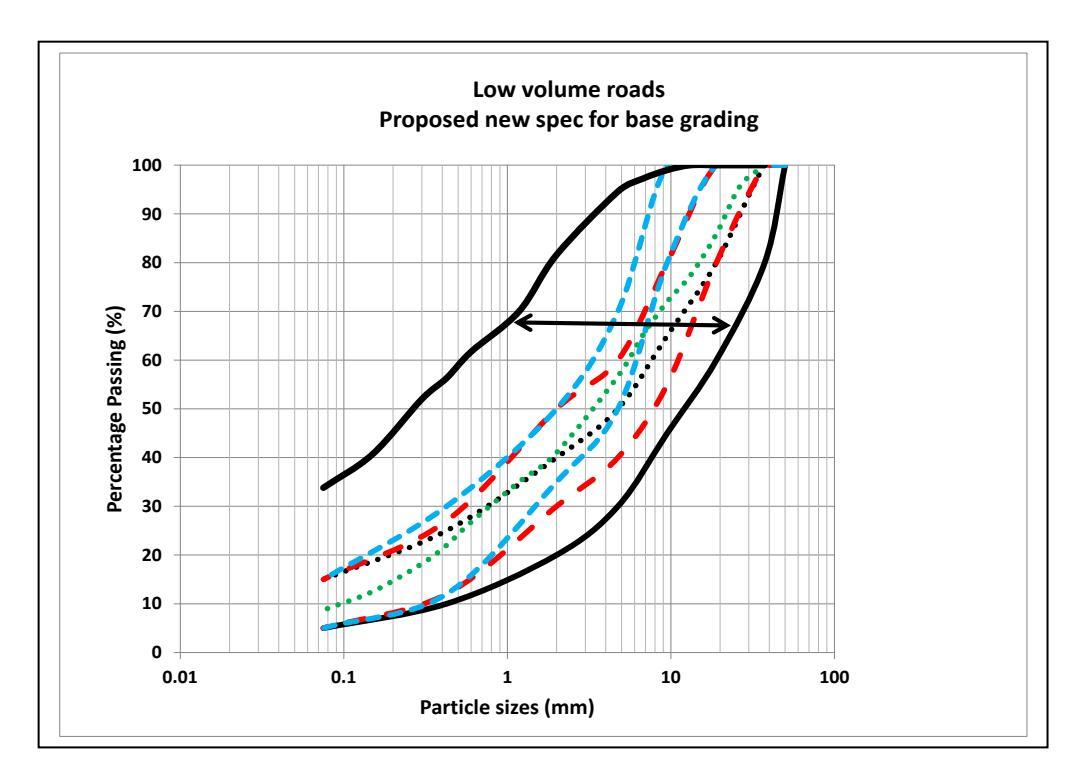
Figure 7-7 Proposed new grading specifications for bases for low volume roads

The natural materials that were used for the construction of the bases were much finer than the standard specifications, (Figure 7-6), yet the sections still performed well. This shows that for low volume roads the grading specifications can be relaxed and envelope given in Figure 7-7 is recommended.
