**MINISTRY OF PUBLIC WORKS AND TRANSPORT**

**PERFORMANCE MONITORING  
OF  
THE NEC-ADB PACKAGE I  
TRIAL AND GRAVEL ROADS**

**SEACAP 17.02**

**FINAL REPORT  
JUNE 2009**

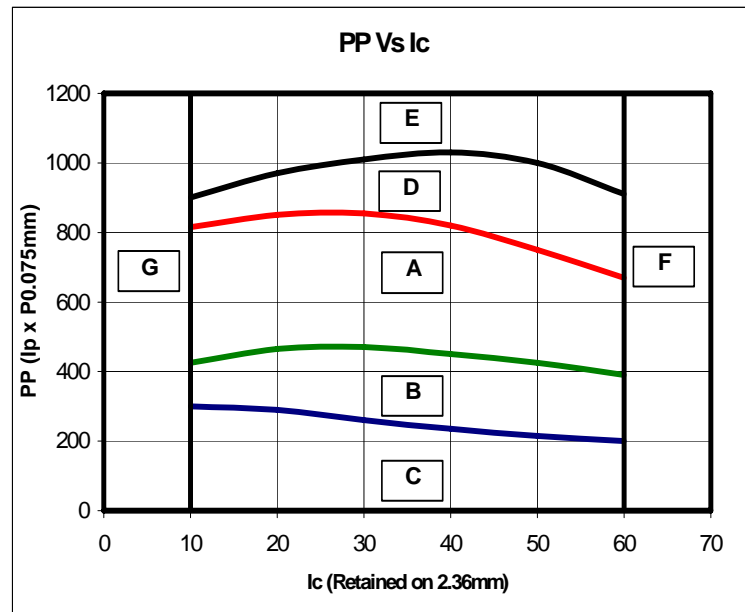
**Figure 3.1 Gravel Suitability Assessment**

The above plot indicates that only 6 out of the 22 approved materials sources fell into “good performance categories” and that the remaining materials could be described as being susceptible to rapid erosion. It should be noted however that figure 3.1 was originally derived for Southern African road environment conditions and may require some re-calibration for the higher and more intense rainfall environments of S E Asia. It nevertheless provides valuable relative comparison for gravel source assessment.

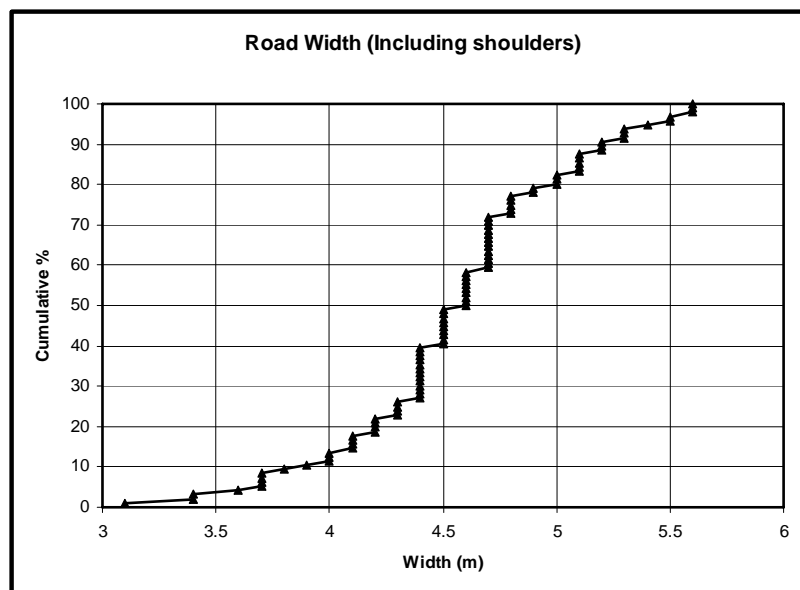
**Figure 5.1 Surveyed Road Widths**

The overall road widths were however below standard at about 40% of the sites, largely due to the narrow shoulders, Figure 5.1. Shoulders below 1.0m are not permitted in the proposed LVRR standards.

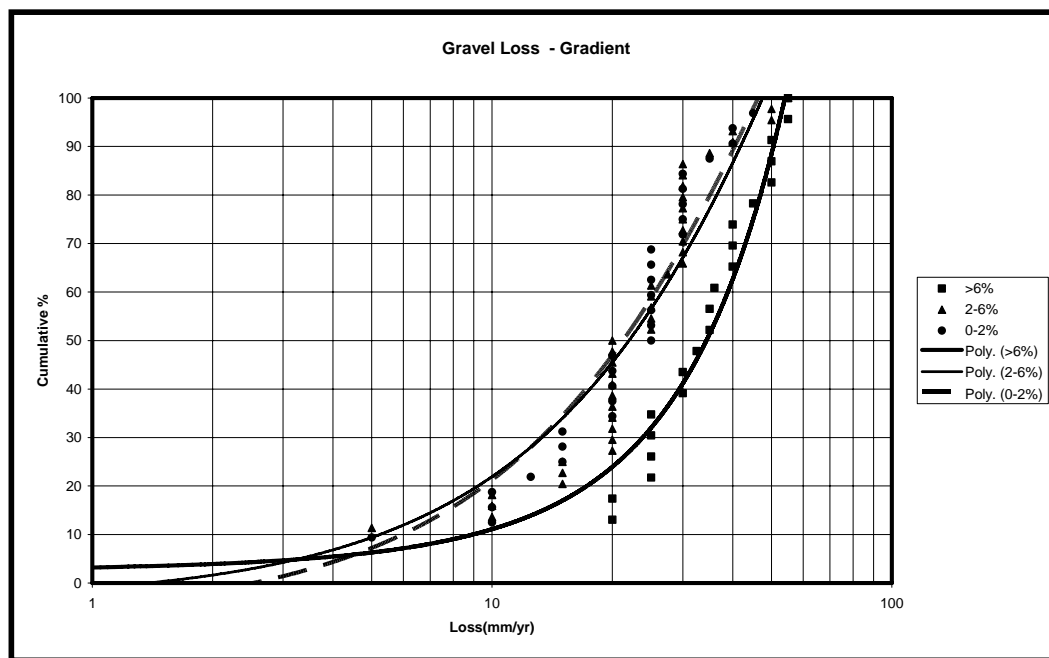
**Figure 5.2 LGAP Gravel Loss**

The gravel losses were calculated for 3 different gradient ranges 0-2%; 2.1-6%; and >6%, as shown in Figure 2.2.

The following key points arise out of this analysis:

1. The gravel loss figures for 0-2 and 2-6% are reasonably similar, with just over 50% having an unsustainable loss of greater than 20mm/yr.
2. However, 70% of roads with less than 6% gradient show gravel losses less than 30mm/yr which would indicate that with at least some effective shape maintenance these roads could be sustainable.
3. Roads with greater than 6% gradient show a significant increase in gravel loss, with around 75% having a loss of greater than 20mm/yr and 60% greater than 30mm/yr. These sections would not be considered sustainable.
