**CASE STUDY OF DAK LAK RRST PAVEMENT AND
SURFACE DETERIORATION**

BUON HO ROAD

SEACAP 24

June 2008

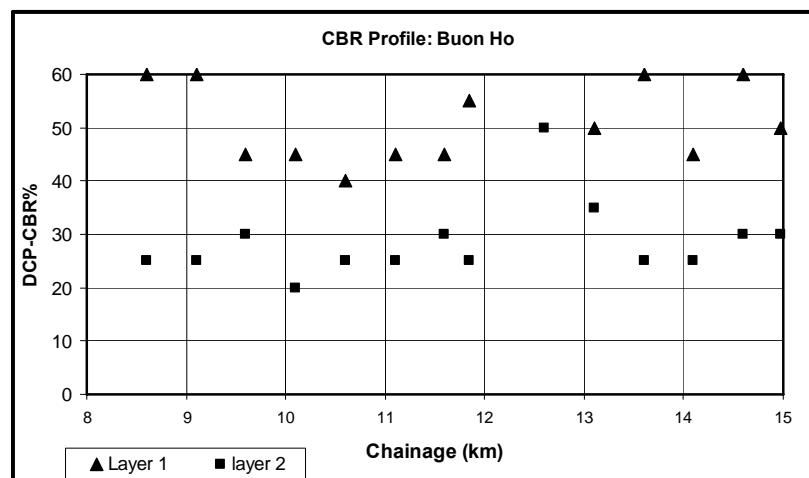
Figure 2 In Situ Strength of Existing Pre-Trial Road

Prior to the trials programme the Buon Ho road was primarily of unsealed gravel construction with some sections of Penetration Macadam. Visits were made by Intech-TRL to Buon Ho as part of the consultation process and relevant information gathered by a walk-over survey in June 2005. This included in situ (DCP) testing evaluation of the existing road surface, (see Figure 2 and Figure 3). The existing surface was seen to be in poor condition and composed of sub-standard quality gravely silty clay.

The original designs are shown in Table 12. Estimates of the likely 'subgrade' strength were made by using DCP measurements in the original old road. The results are shown in Figure 2 where it can be seen that the minimum CBR is greater than 20%. For an assessment of the design of the trial road a value of 10% CBR has been adopted. The AASHTO method was used for estimating the traffic capacity using the assumptions concerning the input variables shown in Table 13.

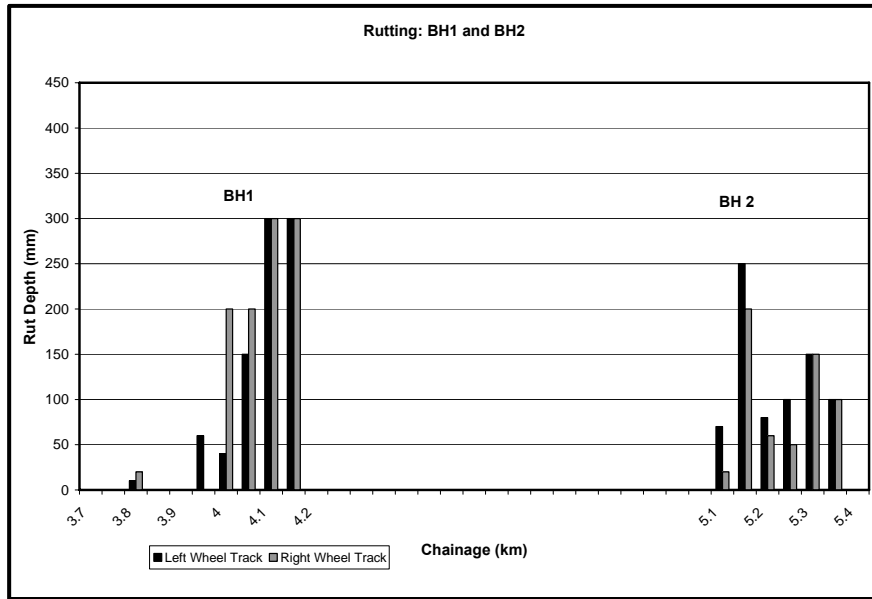
Figure 4. Rut Depths for Sections BH1 and BH2

The coded visual survey sheets are included in Appendix F along with tabulated summary descriptions. Figures 4 to 8 present the wheel-track rut depths measured as part of the visual survey procedure.

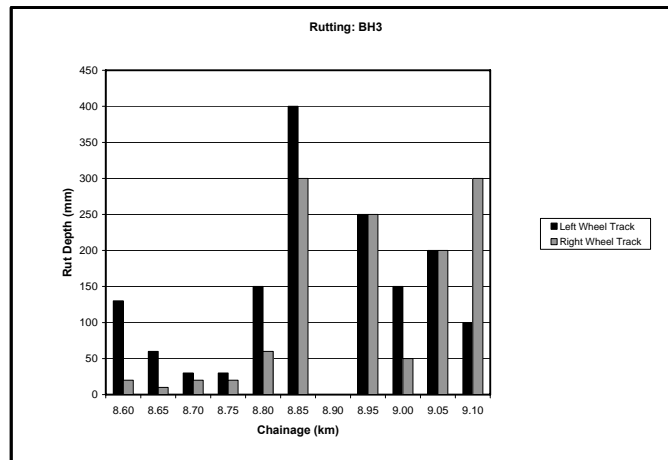
Figure 5. Rut depths for Section BH3

4. Sections with the same contractor but different designs are exhibiting significantly different performance characteristics, for example compare Figure 5 and Figure 6.

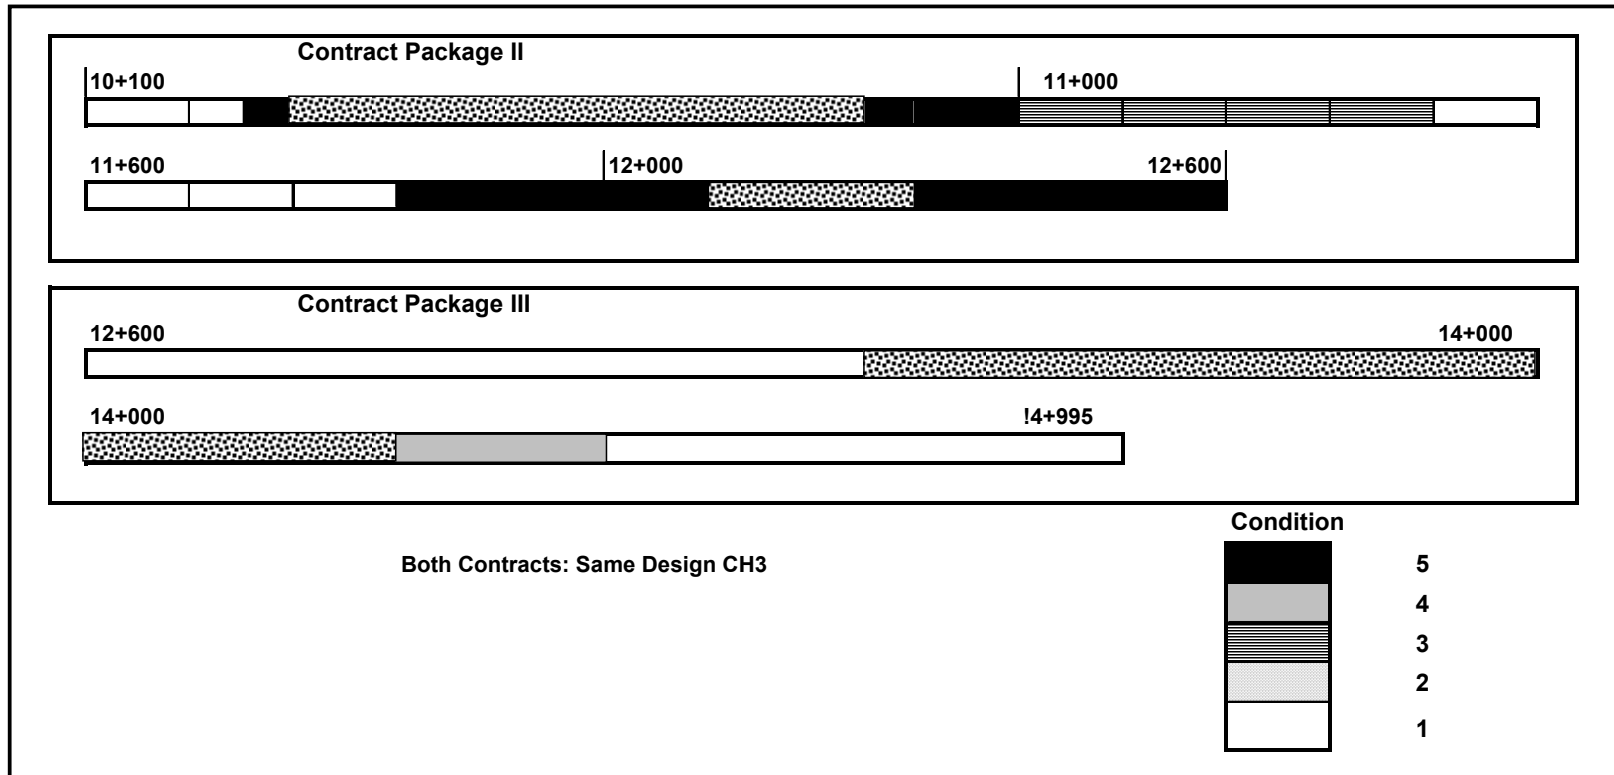
Figure 10. Sections with Same Design but Different Contractors

3. Two sections BH5 and BH6 with the same design, but built by different contractors, are exhibiting markedly different performance characteristics, Figure 10.

In summary, there is significant evidence to indicate that the trial road was, at least in part, constructed with materials that did not meet the specifications and, possibly, to variable compaction standards. The markedly different performance of sections BH5 and BH6, which are nominally the same design but built by different contractors, indicates that the quality of materials and the quality of construction are significant factors.

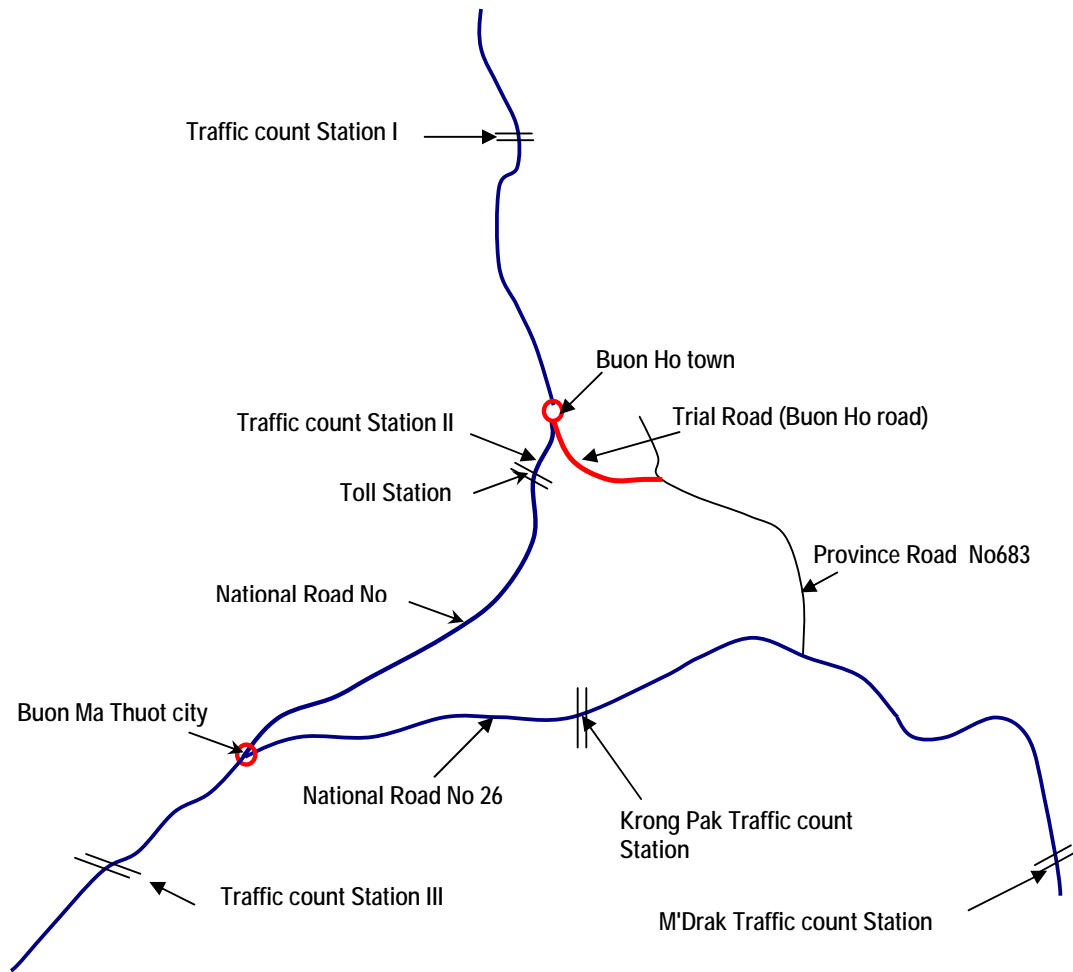
Figure 11 Location of Trial Road and Traffic Counting Stations

Figure 11 shows the location of the road in comparison with the main towns and National Routes Number 14 and 26. Vehicles travelling from the East on RN 26 to the North on RN 14 and vice versa were able to reduce their journey distance by about 70 km by using the trial road as a short cut and this also enabled them to avoid the toll station on NR 14.
