# Evidence of soil instability and erosion along paths and roads in five villages in Central Ghana

CRES/QA/EROSION/1/0401/1.1

Sub-component of DFID project R7575:  
Action research to evaluate the impact on livelihoods of a set of post-harvest interventions in Ghana's off-road settlements: focus on IMTs  
(Dr Gina Porter, University of Durham, UK)

## Report on visit 4-9 February 2001

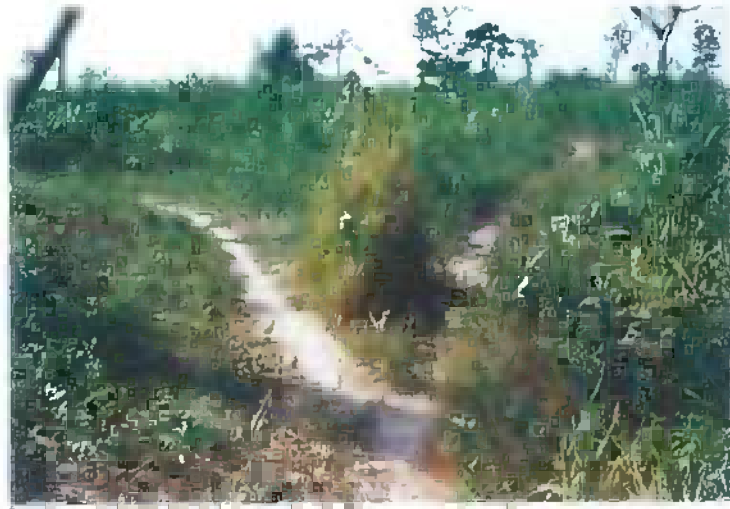
Path 1, which runs West of Adabra towards Okotokwa (Figure 4), is 0.3-0.5 m wide and is covered by sand-textured material (predominantly quartz from weathered granite) (Figure 8). This is no evidence of significant gullying or stream crossings along the first +600 m walked. One section has a depth of loose sand, which may pose difficulties for walking or IMTs, otherwise paths have a compact subsoil. Slopes are relatively shallow ( $<10^\circ$ ), so widening for IMT use should not pose additional 'cut-and-fill' instability problems (Figure 9). There is no evidence of significant gullying in surrounding fields, though some localised slope-wash may be present. Soils by the path appear sandy, but dark, probably as a result of high levels of organic matter (a positive soil binding agent). The soils around Adabra are mapped as Lixisols (locally 'Adawso-Bawjjai / Nta-Ofin Association'; Adu and Asiamah, 1992). Such soils have a higher base saturation than Acrisols, such as those found at Abora, Sampa, Lome and Awurabo, and as a result are expected to have less erodible soil structures (Deckers *et al.*, 1998), though surface slaking can make them prone to local slope-wash (Driessen and Dudal, 1991).

Figure 9. Flat terrain about Path 1, Adabra village

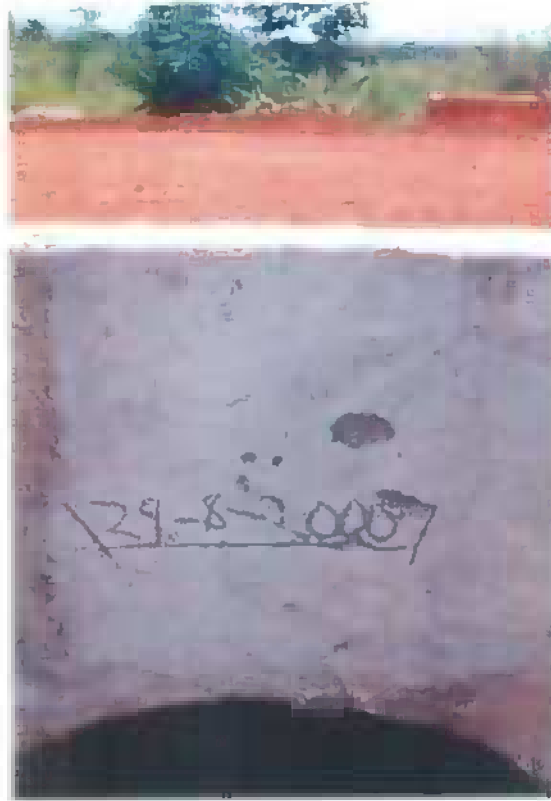
The feeder road connecting Abora village with the market (and source of water) at Ankamu settlement was re-graded in 1997, some culverts were repaired in 2000 (Figure 11), and a section close to Ankamu tarred in early 2001 (Kathrin Blaufuss / Frank Owusu Acheampong, pers comm.).

Figure 11. A road culvert along the new Abora-Ankamu feeder road

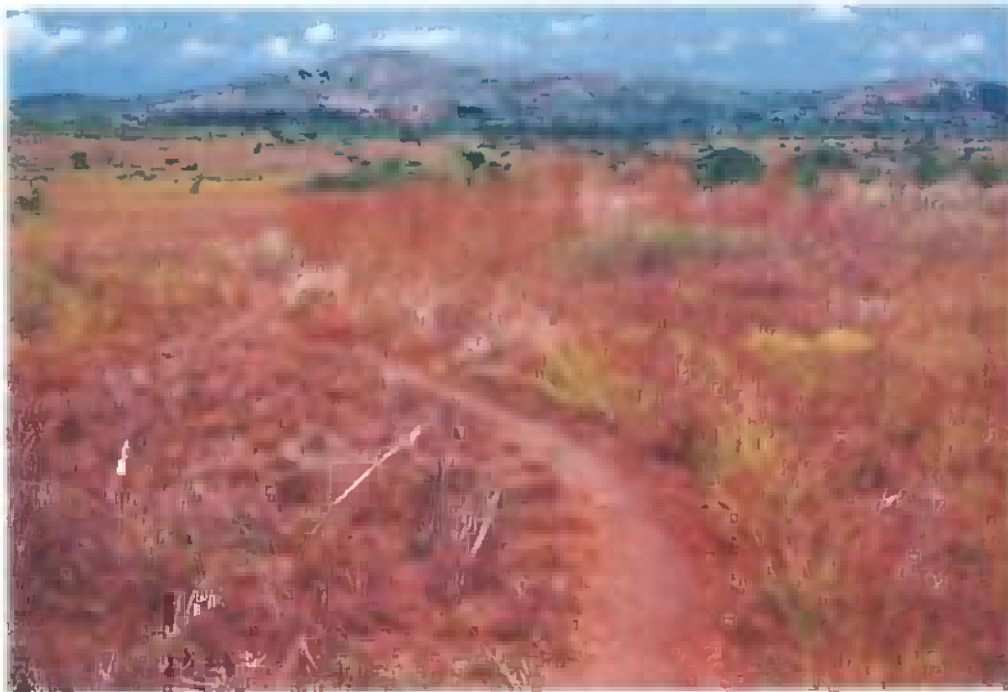
**Figure 14. Abora village is just below the peak of Abora Hill on the horizon. Photograph taken from the depression containing Vertisol soils.**

The dry-season cracking probably indicates the presence of expanding 2:1 lattice clays. These soils are mapped as Vertisol soils (locally 'Osibi-Bumbi Association'; Asamoah, 1968). While there is no evidence of old ruts associated with damage during the wet season, Vertisol soils are likely to become very slippery and waterlogged during the rainy season (once the peds have swollen with the first rains). An elevated causeway (made

from soils other than Vertisols) with subsurface drainage may be necessary for successful IMT use during the wet-season. Such a causeway is planned with the VIP improvements.

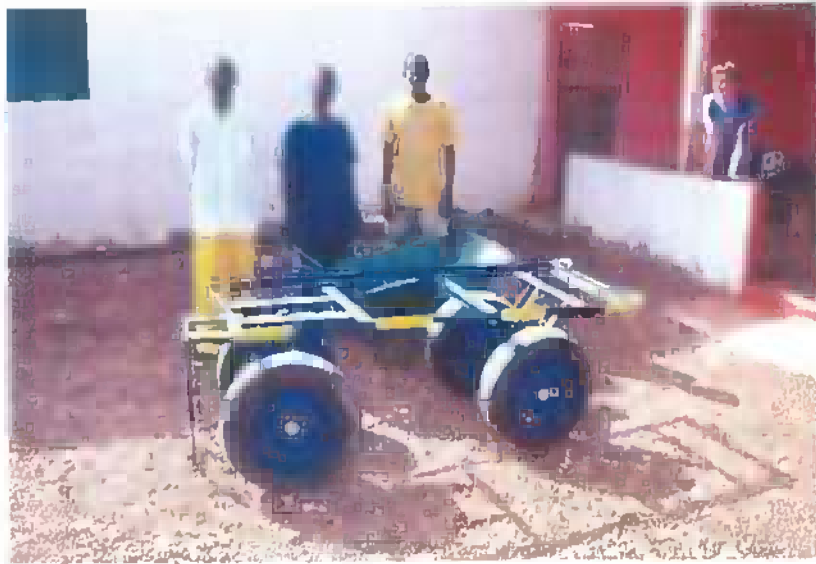
With further development, this gully would affect the passage of IMTs (see Figure 19), though I suspect that the steepness of the slope makes IMT use already hard work on this section of the Sampa-Okya River path. Below this steep section, the path has a modest gradient and is already wide enough for the use of IMTs. The soils are very dry (< 20 % moisture content by volume), with the exception of one flat area half way to the R. Okya (by the plantain plot). The wetness of the soils in this area allowed estimation of the particle texture, which appeared to be a loam. By the River Okya, the soils were, however, sandy (probably alluvial sands).

**Figure 19. A 'push-truck' IMT being delivered at the chief's palace, Sampa village**
