RESEARCH REPORT 381

CONCRETE PAVEMENT TRIALS IN ZIMBABWE

By J D Parry, N C Hewitt and T E Jones

Project title: PC Concrete Pavements

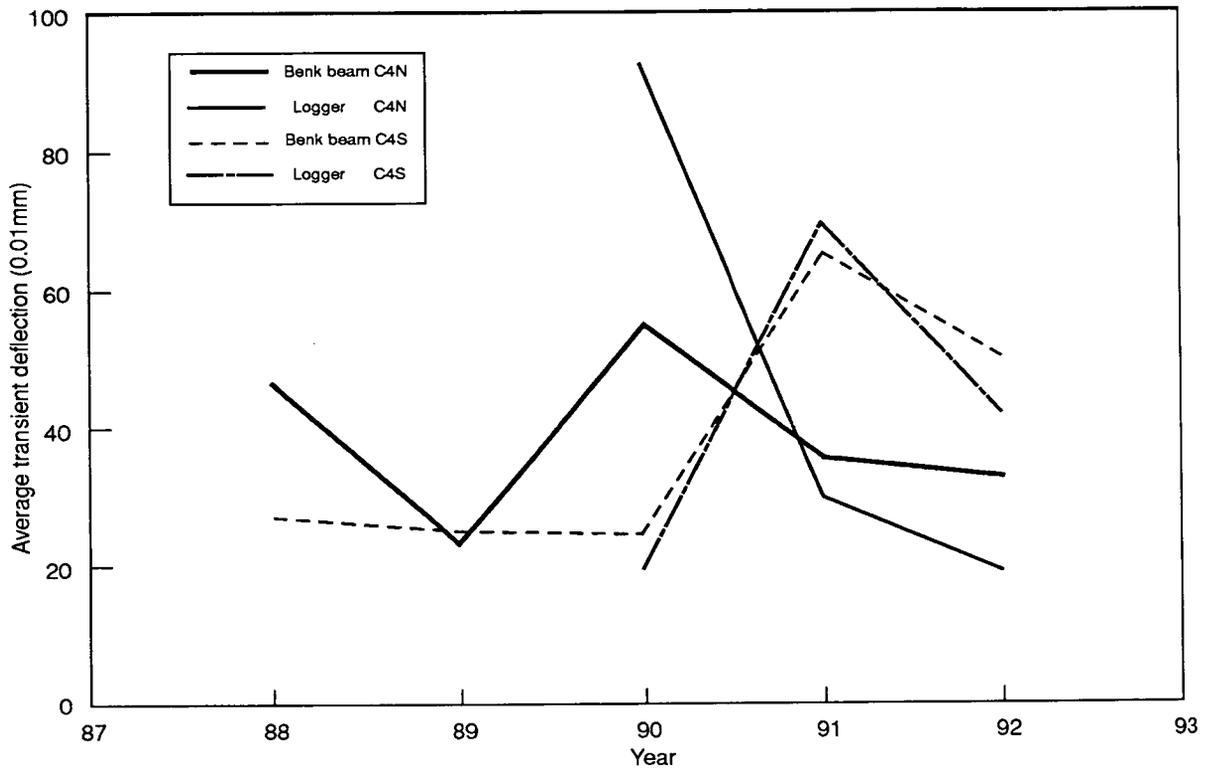
Fig. 7 Average transient deflections - Section C4

A summary of the vertical deflections measured by the Benkelman beams and the logger over successive surveys is shown in Table A15 and plotted in Figure 7 for one section. Figure 8 shows a summary of all the logger readings taken in 1992 on trial section C1 south side. The plot shows maximum minus final values of vertical displacement, V , on both sides of each joint. Where the points V_1 and V_2 are close e.g. at the right side of the graph, interlock is still good. The loss of interlock at the other end may be due to a number of factors, including low temperature at the time of measurement and sub-base erosion. There is also a plot of $V_1 - V_2$ on each logger plot (Figure A6).

There appears to be a correlation in Figure 7 between measurements made by the verge side Benkelman beam and the logger but more data are required before this can be defined with confidence, because the deflection is a combination of bending and rocking which affect the two instruments in different ways. Furthermore, there are both similarities and disparities between repeated measure-

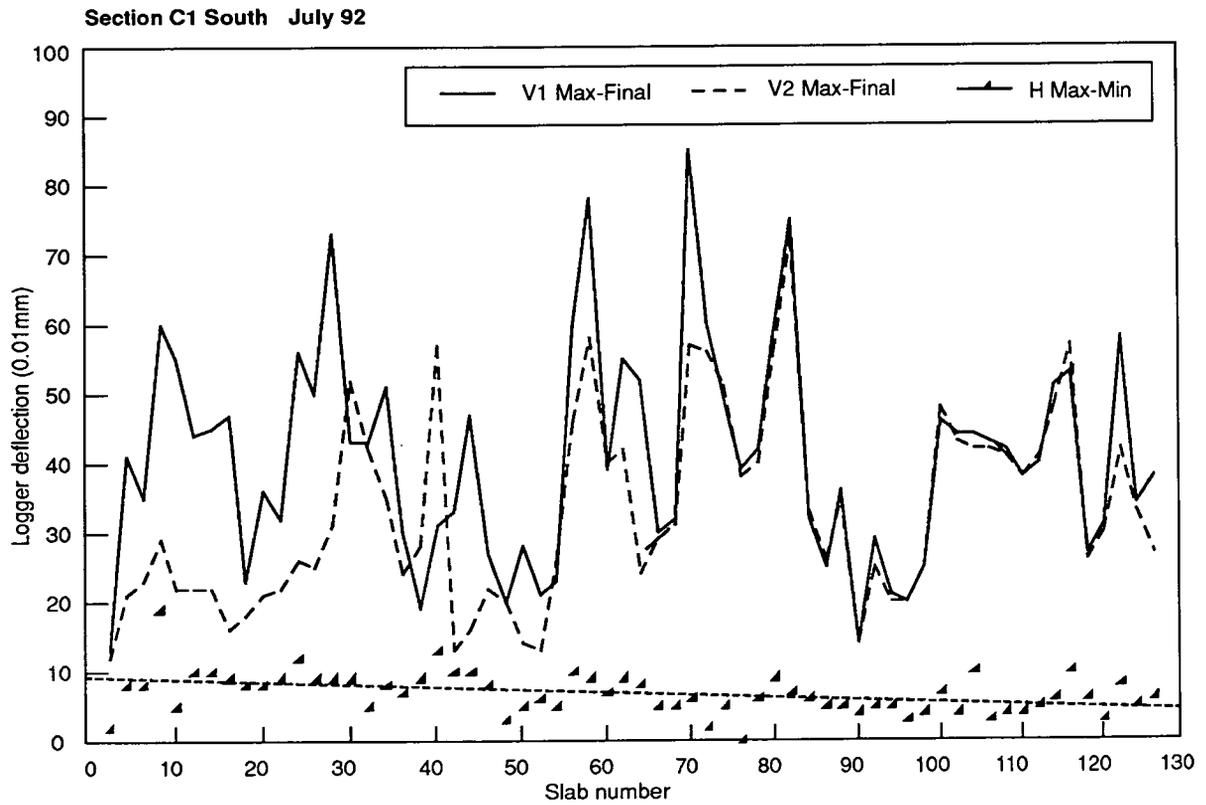
Fig. 8 Deflection logger readings

ments made in 1992 on the same sections using the Benkelman beams (Figures 9 and 10). Examination of Figures 8, 9 and 10 led to the conclusion that weather conditions affect the measurements of deflections more than had been anticipated. This is discussed below in Section 4.7.

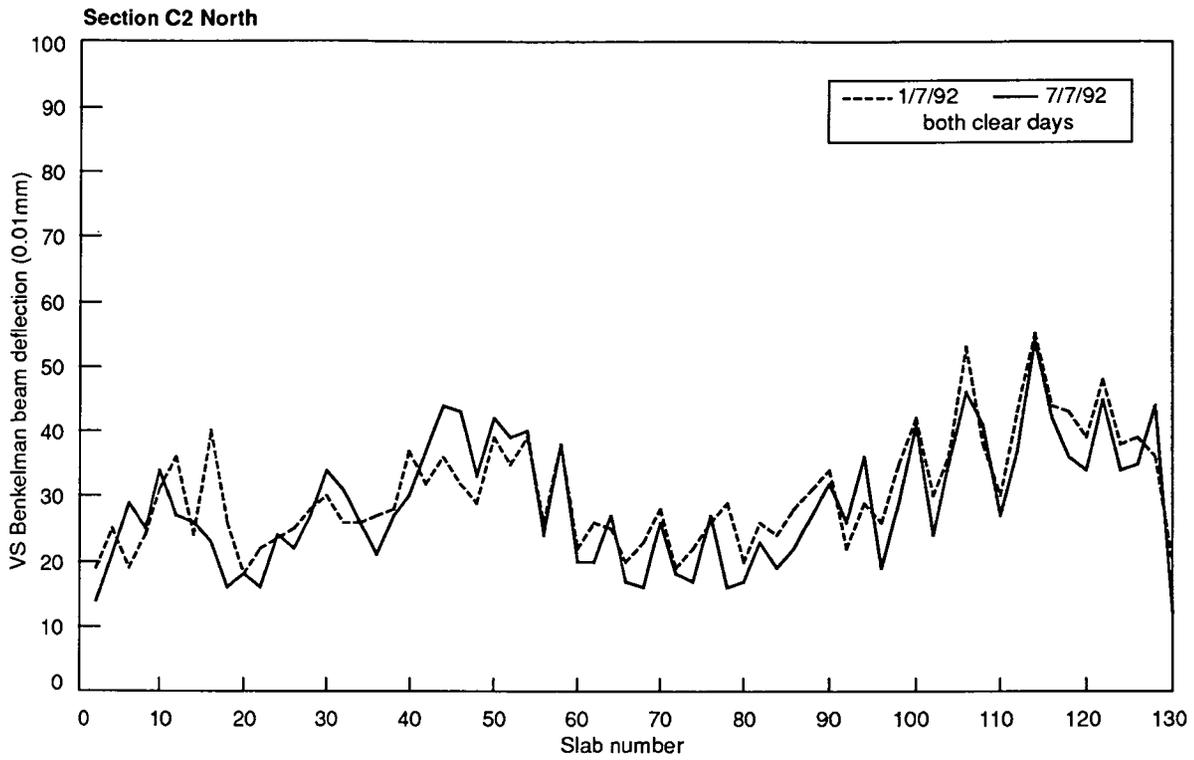
**Fig. 9 Repeat beam deflection measurements
- similar weather conditions**

the same month and hour of the day, have been frustrated by the strong influences of cloud cover and wind. The repeat measurements made in June and July 1992 shown in Table A15 and Figures 9 and 10 illustrate a) that average deflection measurements can be accurately reproduced under similar conditions and b) the disruptive effect on deflections of variations in radiation from the sun. Although it is expected that deflection measurements will increase with time due to erosion of the material beneath the slab edges, the averages of all readings taken each year show little evidence of this to date.

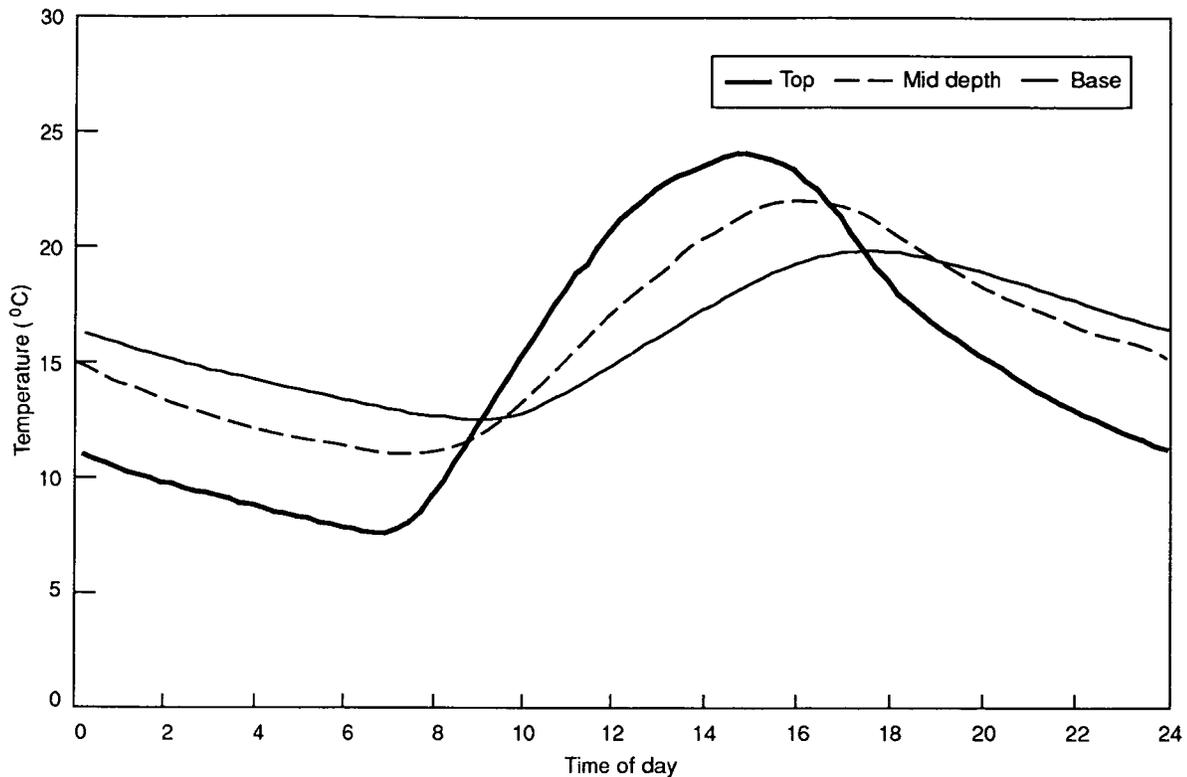
Fig. 12 Clear sky temperatures of slab C4-163

Figure 12 shows that over approximately eight hours during the day, the temperature is higher at the top of the slab than at the base; at night the reverse is true. This variation in the temperature differential causes differential linear expansion between the top and the base surfaces. The effect of this is a tendency towards hogging in the day time and dishing at night, as illustrated in Figure 13.

Figure 12 also shows that the temperature at the top surface is equal to that at the base at about 0900 and 1730 hours on a typically clear day. Whatever the actual shape of the slab surface at these times, for the purpose of analysis the slab could be considered flat; the day-time hogging and night-time dishing would then be relative to the actual shape at 0900 and 1730.

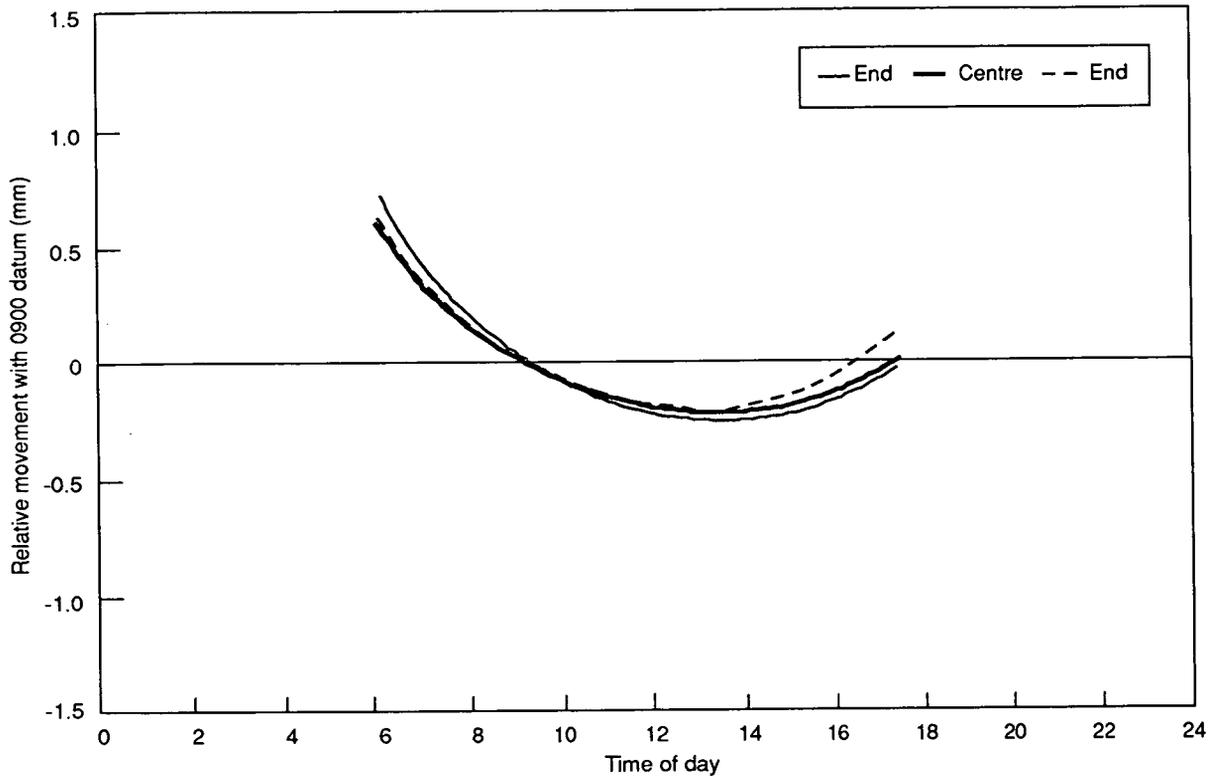
Fig. 14 Transverse warping of slab C1-97

day. However, each concrete slab was cast with a slightly different shape so, in order to compare the different paths, all the heights were measured with respect to the value at 0900, when the temperatures on the top and bottom surfaces were similar. Figure 14 shows that the three transverse paths warp in a similar manner and Figure 15 shows for each of the three longitudinal paths a larger movement, but again all three paths are similar.

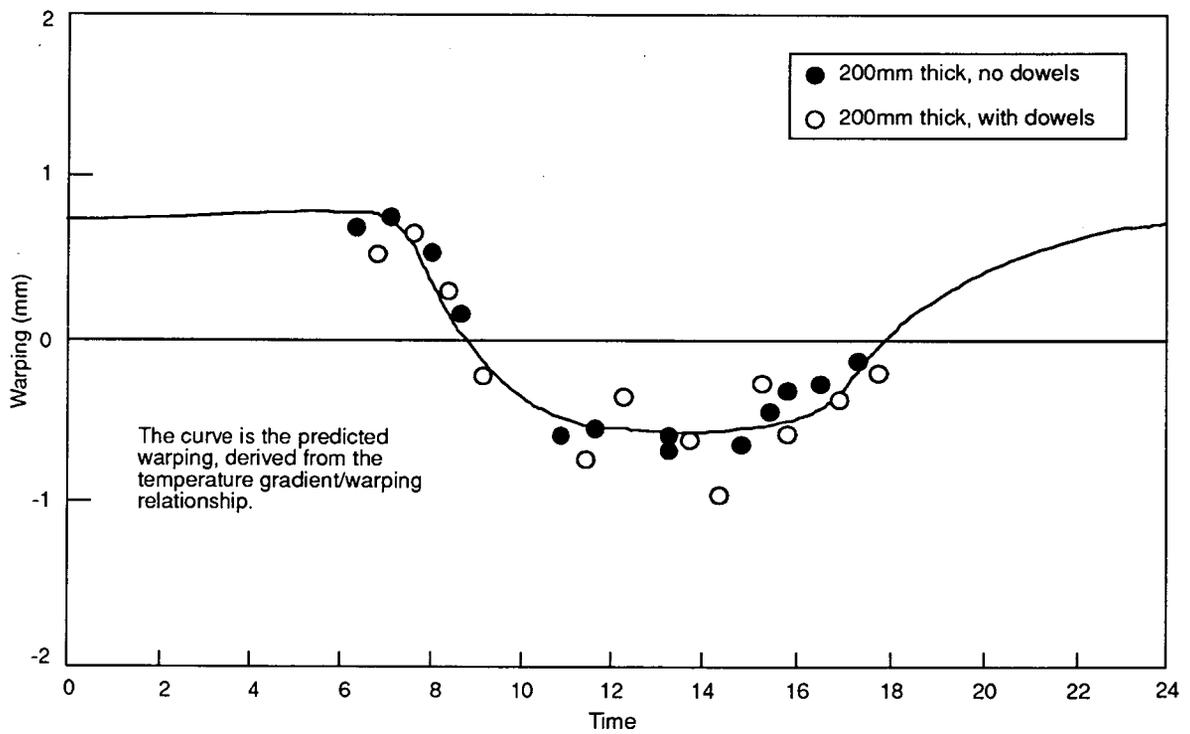
Fig. 21 Longitudinal warping plotted against time (24 hours)

To this point the analysis has considered only day-time movements. In order to calculate night-time effects, the temperature difference between the top and base of the slabs was plotted against longitudinal warping on two slabs 200mm thick, (Figure 20), and the resultant relationship was used to predict longitudinal warping over a 24 hour period. This predicted warping is illustrated in Figure 21 with measured results of day time warping of

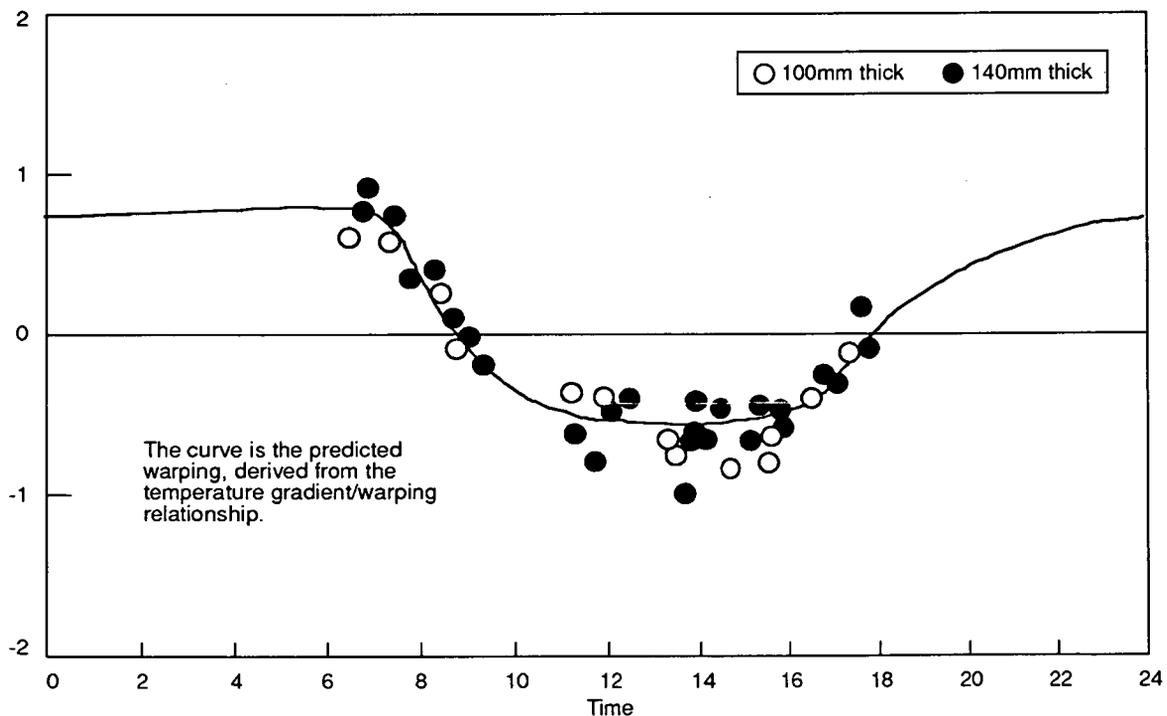
Fig. 22 Longitudinal warping plotted against time (24 hours)

the two slabs, one dowelled at the ends, the other undowelled. Calculations showed the relationship to be similar for slabs of less thickness. Figure 22 shows the same curve with measured results on slabs 100mm, and 140mm thick. Clearly, variations in the weather will affect the magnitude of the warping by causing the temperature differential between the top and base of the concrete slabs to vary. This in turn also affects the deflection measurements as the slabs rock under load.

tries, and indeed in Zimbabwe during most of the year. However, a surface temperature variation in the order of 17°C is shown to cause warping, i.e. a change between day and night shape in excess of 1mm, in road slabs made with granite aggregate. Limited variations in slab length and thickness and the presence of dowels at the joints had no measurable effect on this movement.
