Report on the investigation of a fire  
in the engine room on the  
suction dredger

***Arco Avon***

12 miles off the coast of Great Yarmouth  
resulting in one fatality  
on 18 August 2015

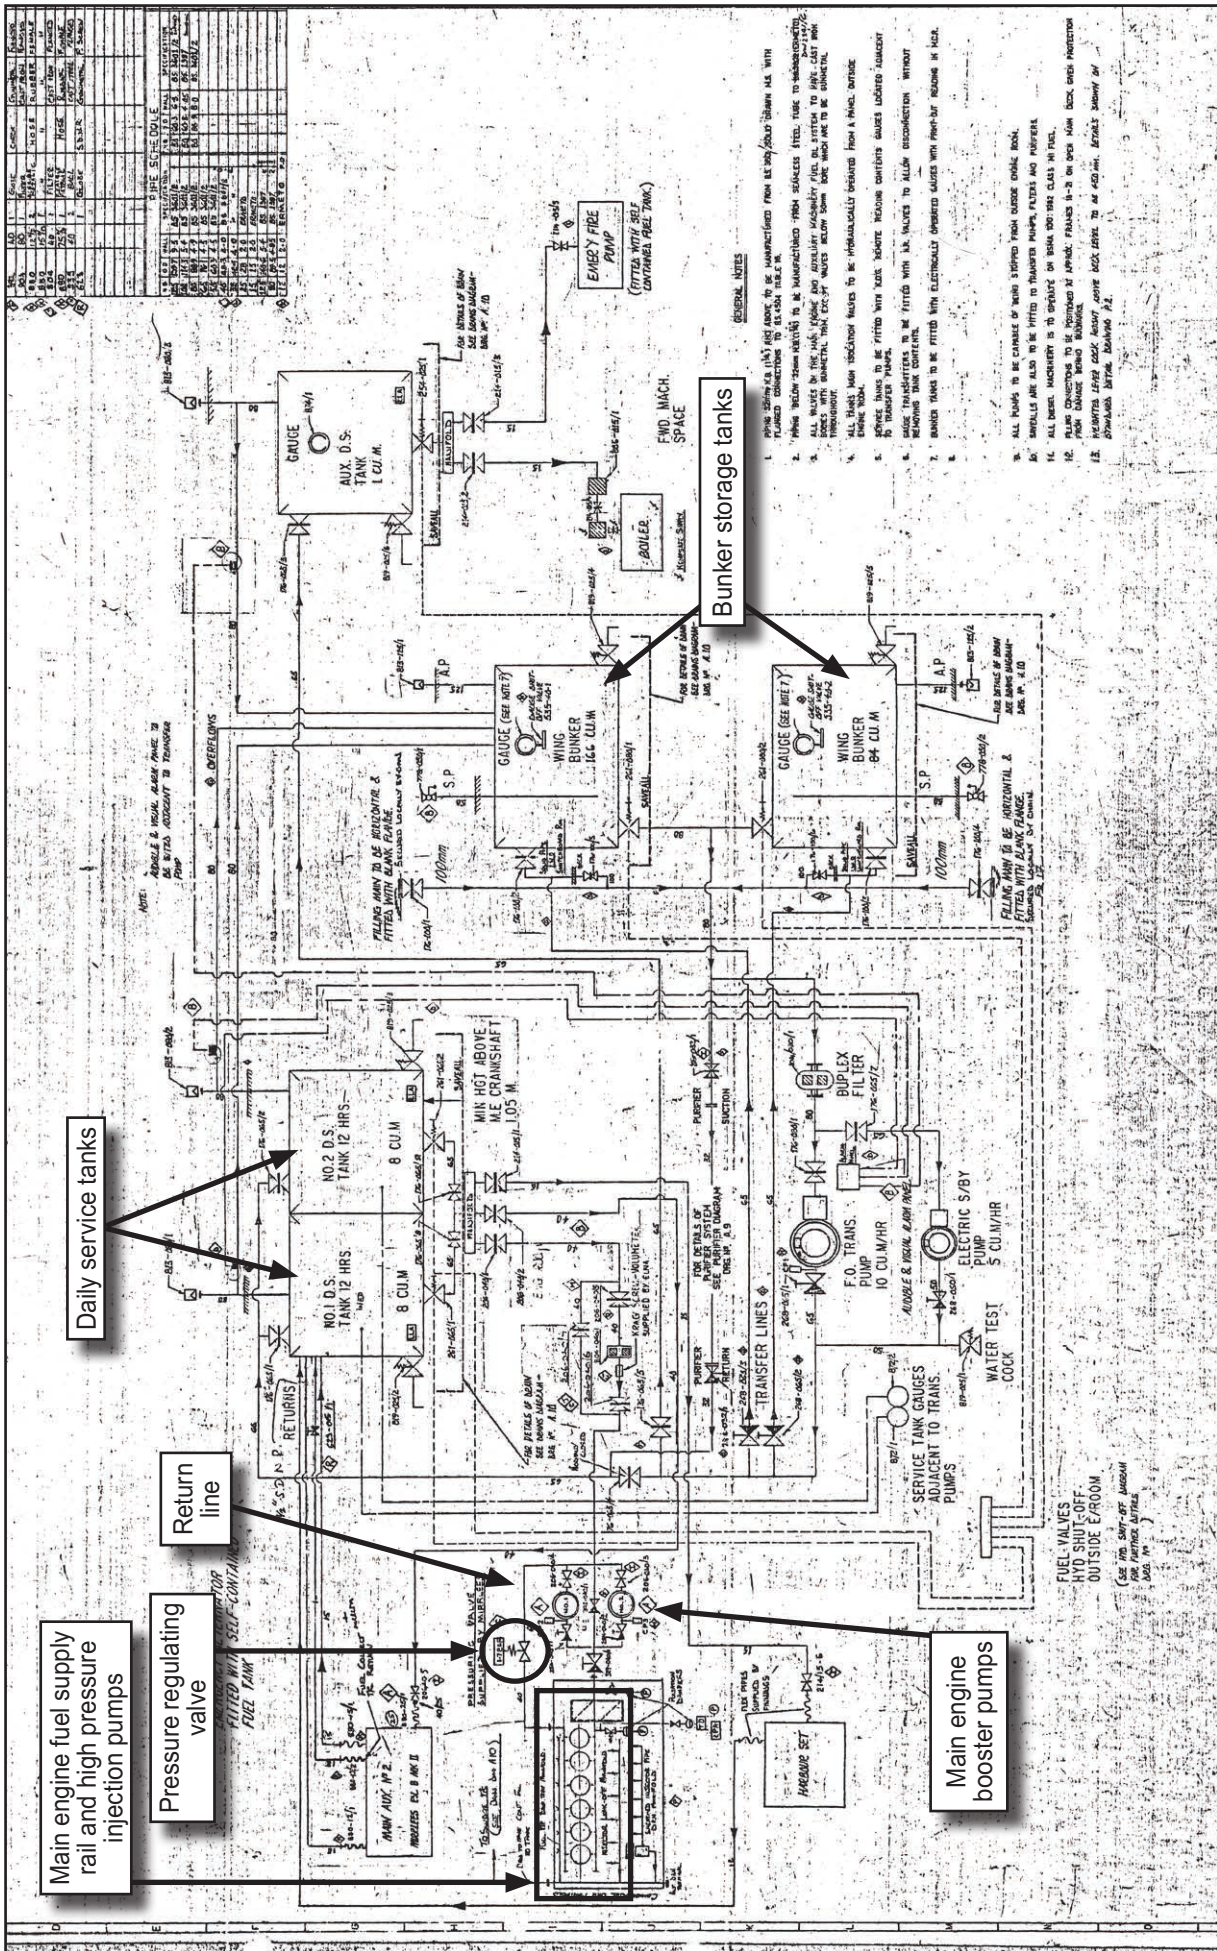
Figure 4: Fuel system

*Arco Avon's* main engine and auxiliary generators ran on marine gas oil (MGO), commonly referred to as diesel. Fuel was stored in two wing bunker tanks, treated directly through a centrifugal purifier, and transferred to two daily service tanks (**Figure 4**).

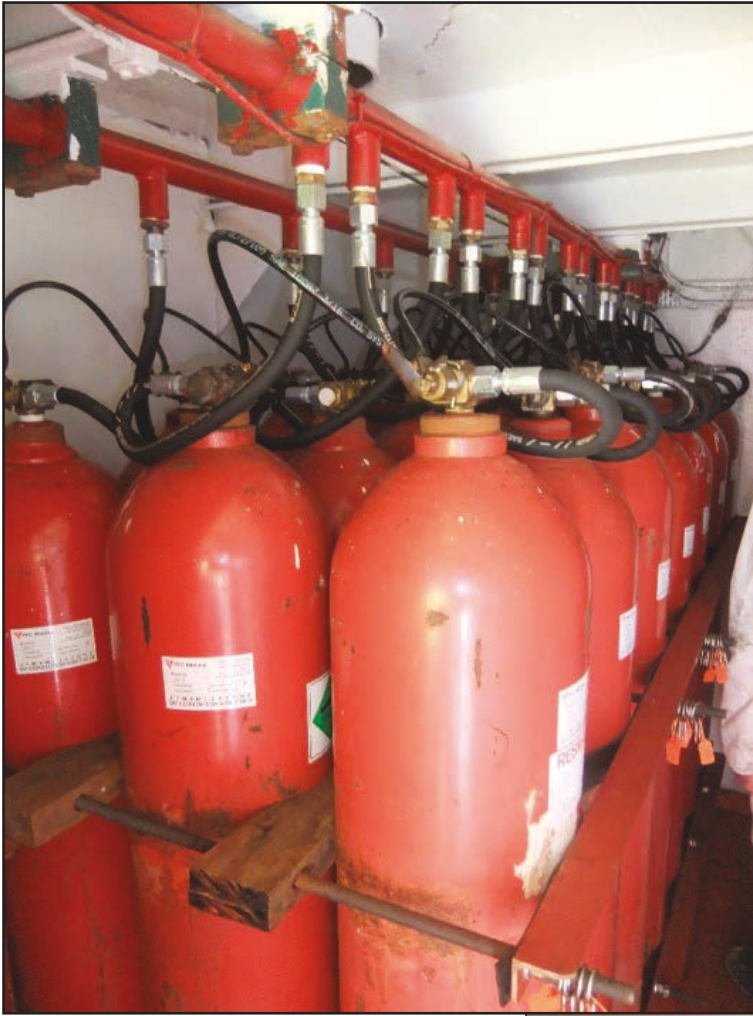
Figure 5: CO<sub>2</sub> cylinder room

The engine room fixed fire-extinguishing arrangements were provided by a Kidde CO<sub>2</sub> smothering system. The system comprised 23 x 45kg CO<sub>2</sub> cylinders arranged for simultaneous release that was designed to achieve a ≥40% by volume concentration of CO<sub>2</sub> in the space. The CO<sub>2</sub> cylinders were located in a dedicated storage room on the starboard side at the aft end of the main deck (**Figure 5**).

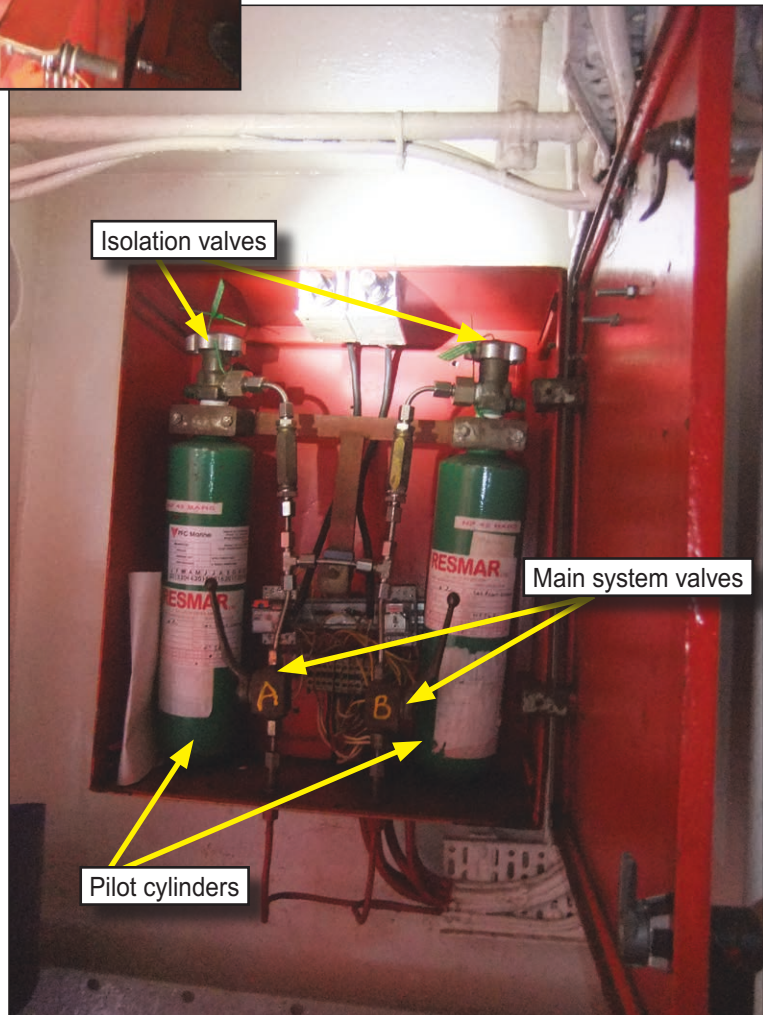
Figure 6: CO<sub>2</sub> system operating control cabinet

The CO<sub>2</sub> system was activated from an operating cabinet located in the access lobby to the engine room at the aft end of the main deck (**Figure 6**). The cabinet door was kept locked with a key available in a 'break glass' box on the front of the cabinet. Opening the cabinet automatically sounded an alarm and stopped the engine room ventilation fans. Inside the cabinet were two pilot cylinders, each with its own isolation valve, and two main system valves. Valve A was operated to open the discharge manifold to the engine room distribution pipework. Valve B was then opened to allow gas pressure from the pilot cylinders to operate a piston in the discharge valve fitted to each of the main cylinders (**Figure 7a**) which, in turn, allowed gas from the main cylinders into the discharge manifold. If the remote operation failed, the discharge manifold valve could be opened locally in the CO<sub>2</sub> cylinder room (**Figure 7b**) and the main CO<sub>2</sub> cylinders could be opened manually.

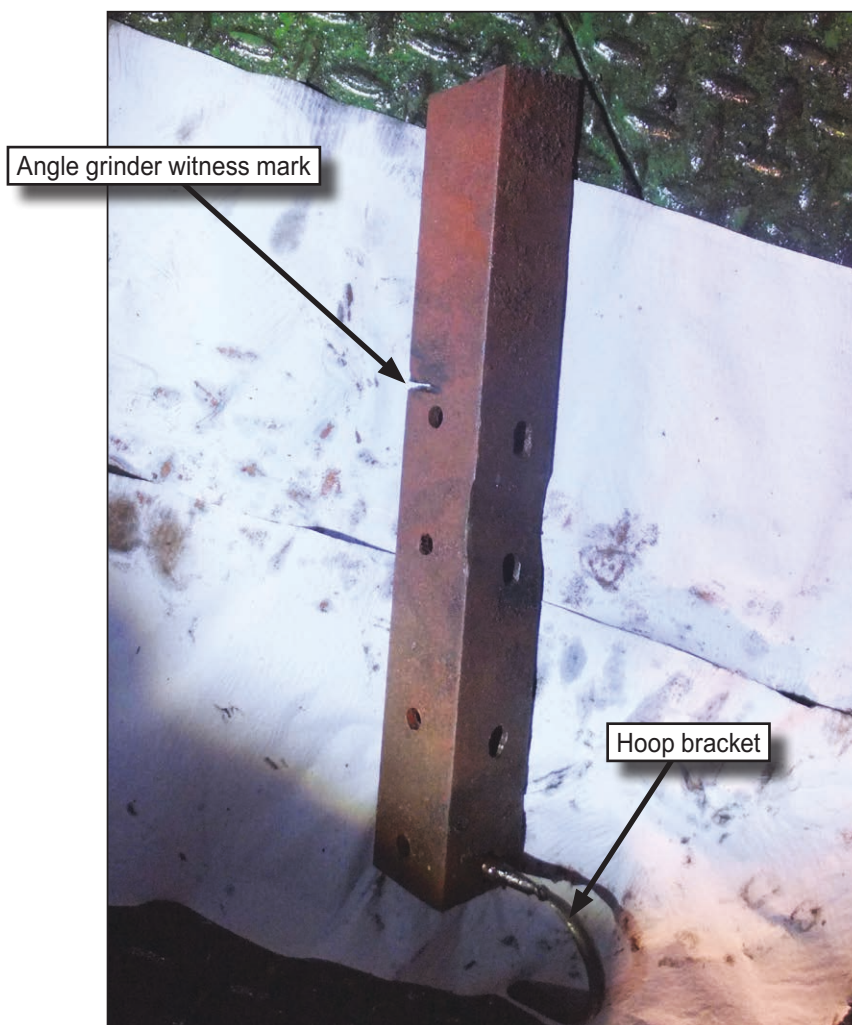
**Figure 13:** Pipe support stanchion

The pipe supporting stanchion in way of the hanging hoop bracket displayed evidence of a cut, the width of which matched the thickness of the angle grinder disc (**Figure 13**).
