INCIDENT

Aircraft Type and Registration:	Boeing 747-436, G-CIVX	
No & Type of Engines:	4 x Rolls-Royce RB211-524G2 turbine engines	
Year of Manufacture:	1998 (Serial no: 28852)	
Date & Time (UTC):	30 January 2016 at 1712 hrs	
Location:	After takeoff from London Heathrow Airport	
Type of Flight:	Commercial Air Transport (Passenger)	
Persons on Board:	Crew - 17	Passengers - 293
Injuries:	Crew - None	Passengers - None
Nature of Damage:	None	
Commander's Licence:	Airline Transport Pilot's Licence	
Commander's Age:	N/A	
Commander's Flying Experience:	N/A hours Last 90 days - N/A hours Last 28 days - N/A hours	
Information Source:	AAIB Field Investigation

Synopsis

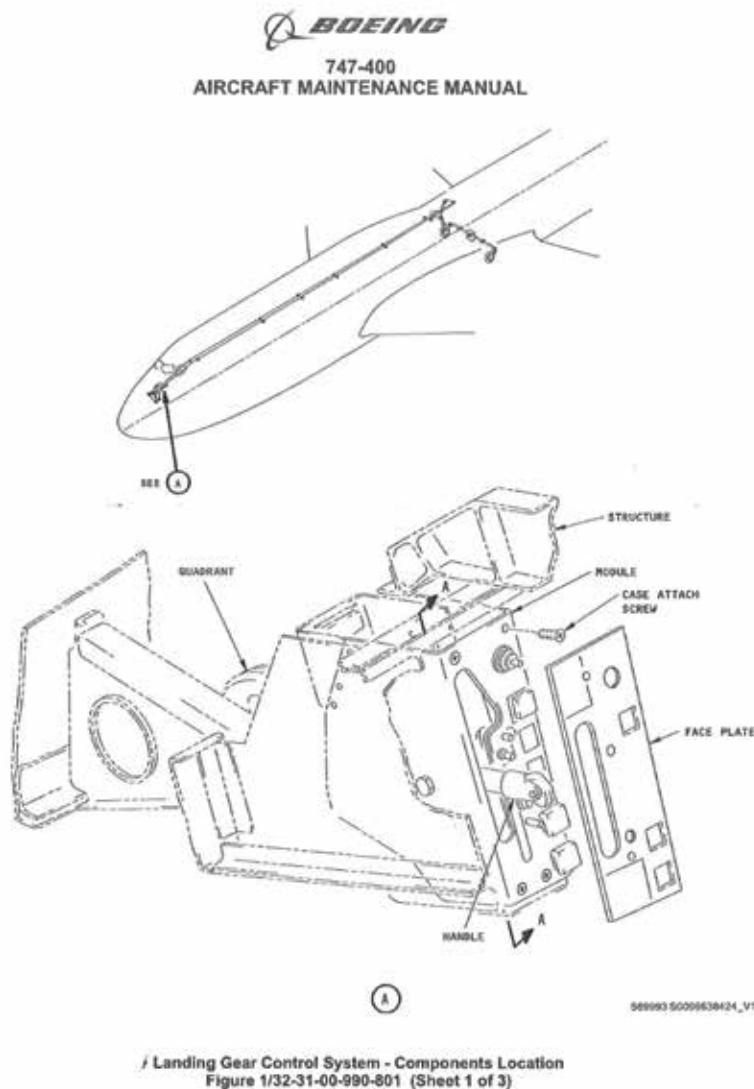
Figure 2
Landing Gear Control Module and cable runs

The handle is connected to a control rod, which in turn is connected to a quadrant, and attached to the quadrant is a cable that runs to the wing gear selector valve quadrant located in the right hand body gear wheel well. Another cable runs from the wing gear selector valve quadrant to the nose/body gear selector valve quadrant located in the left-hand body gear wheel well (Figures 2 and 3).

The quadrant in each wheel well is connected to a selector valve by a mechanical lever. When a replacement LGCM is installed, it is a requirement in the Aircraft Maintenance Manual (AMM) to insert a rig pin in the selector valve quadrant (Figure 3).

One of the engineers, who was positioned near the quadrant in the right-hand wheel well, noticed that the rig pin was not fitted and that the quadrant was moving (by inputs from another engineer in the cockpit). He was concerned that he might be injured, and took a planned break that was overdue. This break caused a distraction, and the fitting of the rig pin was omitted.
