Report on the investigation of a  
fatal man overboard from the fishing vessel

***Aquarius* (BF 89)**

east of Aberdeen

on 17 August 2015

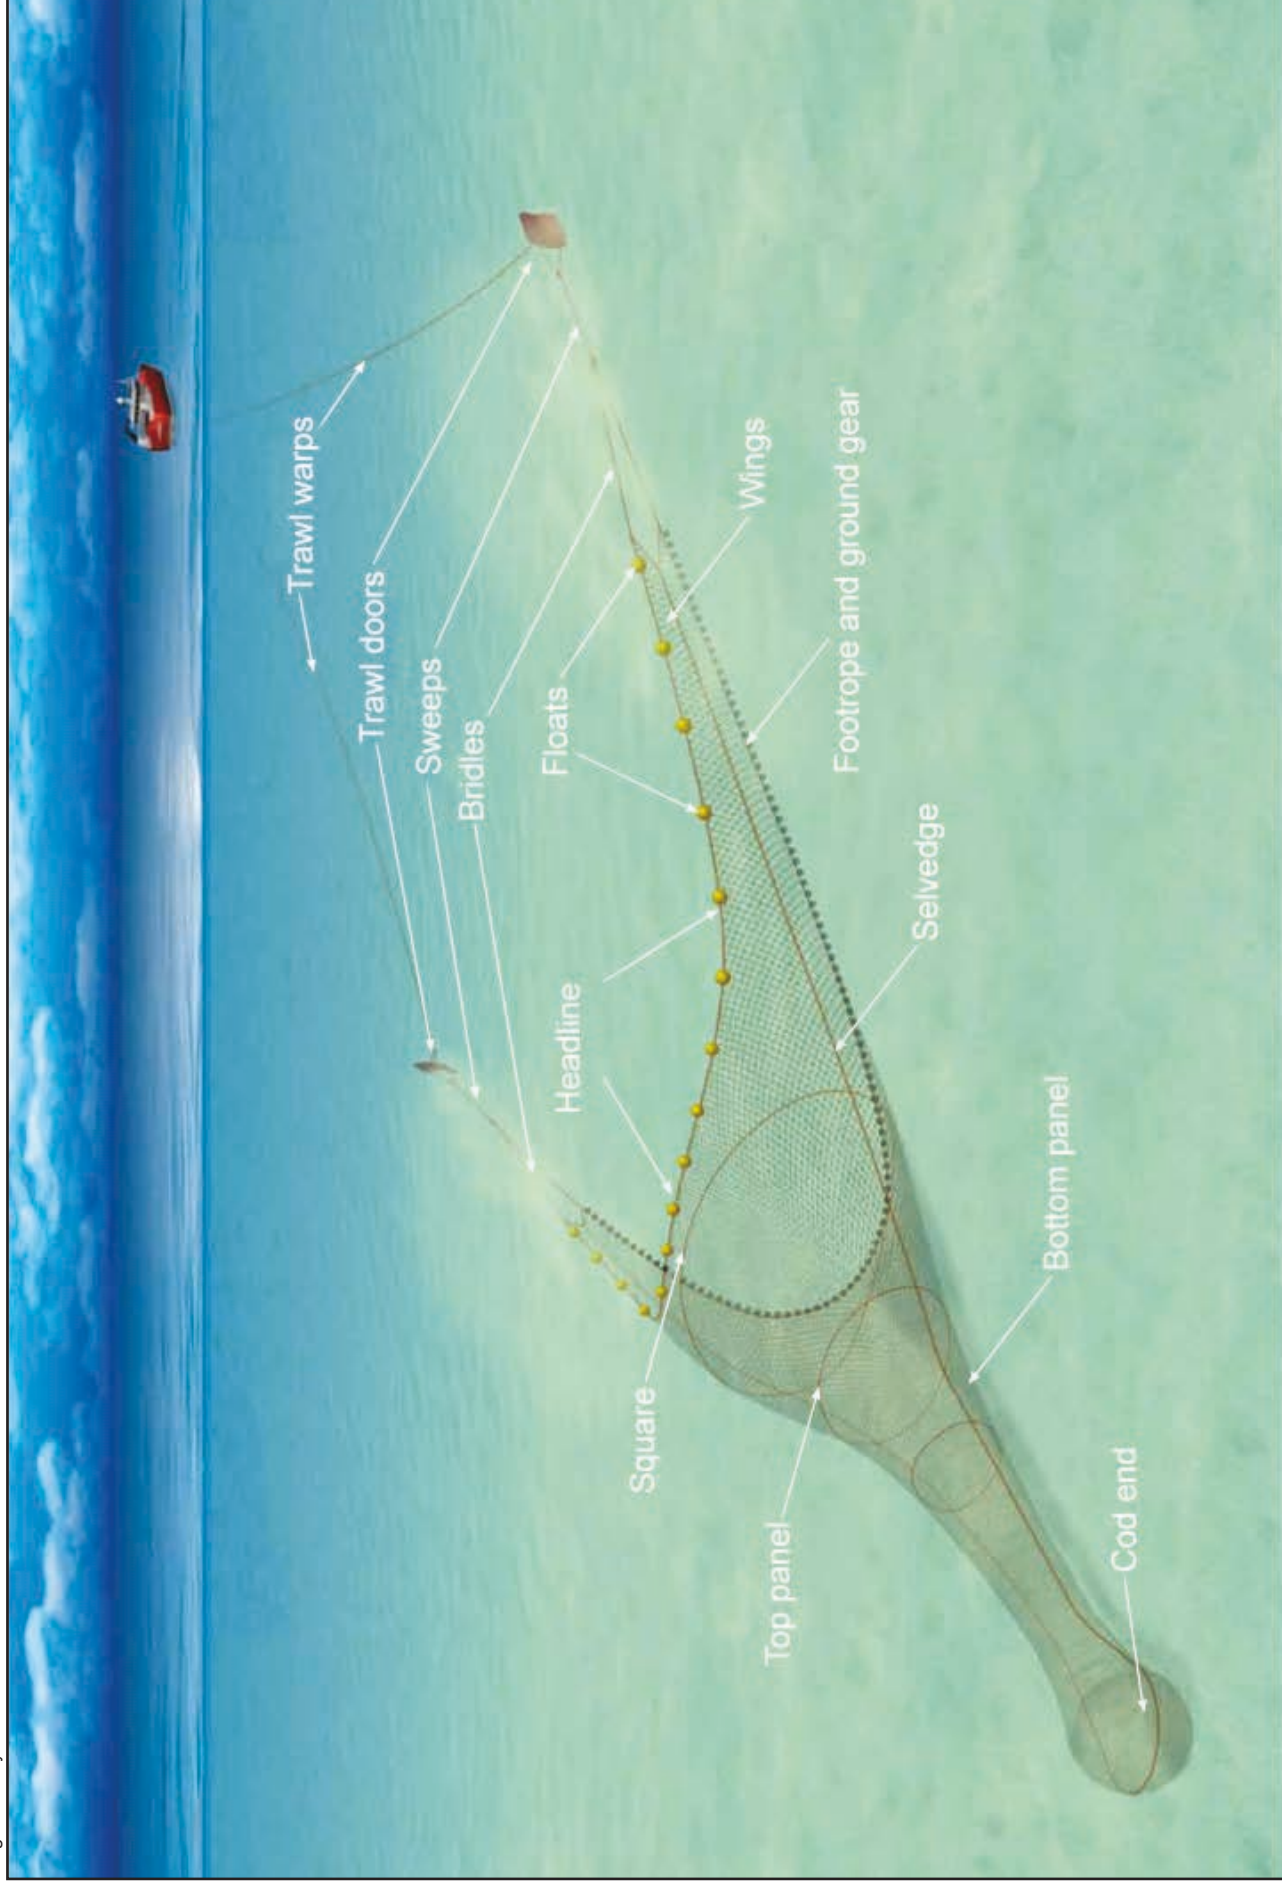
Figure 1: Demersal trawl net arrangement

Before departure from Aberdeen, the skipper gathered his five-man crew together and informed them that he needed to re-mark the vessel's steel wire trawl warps (**Figure 1**). He explained that this would be done once the boat was clear of the harbour, and that he wanted the warps to be marked at 125 fathoms<sup>1</sup>.

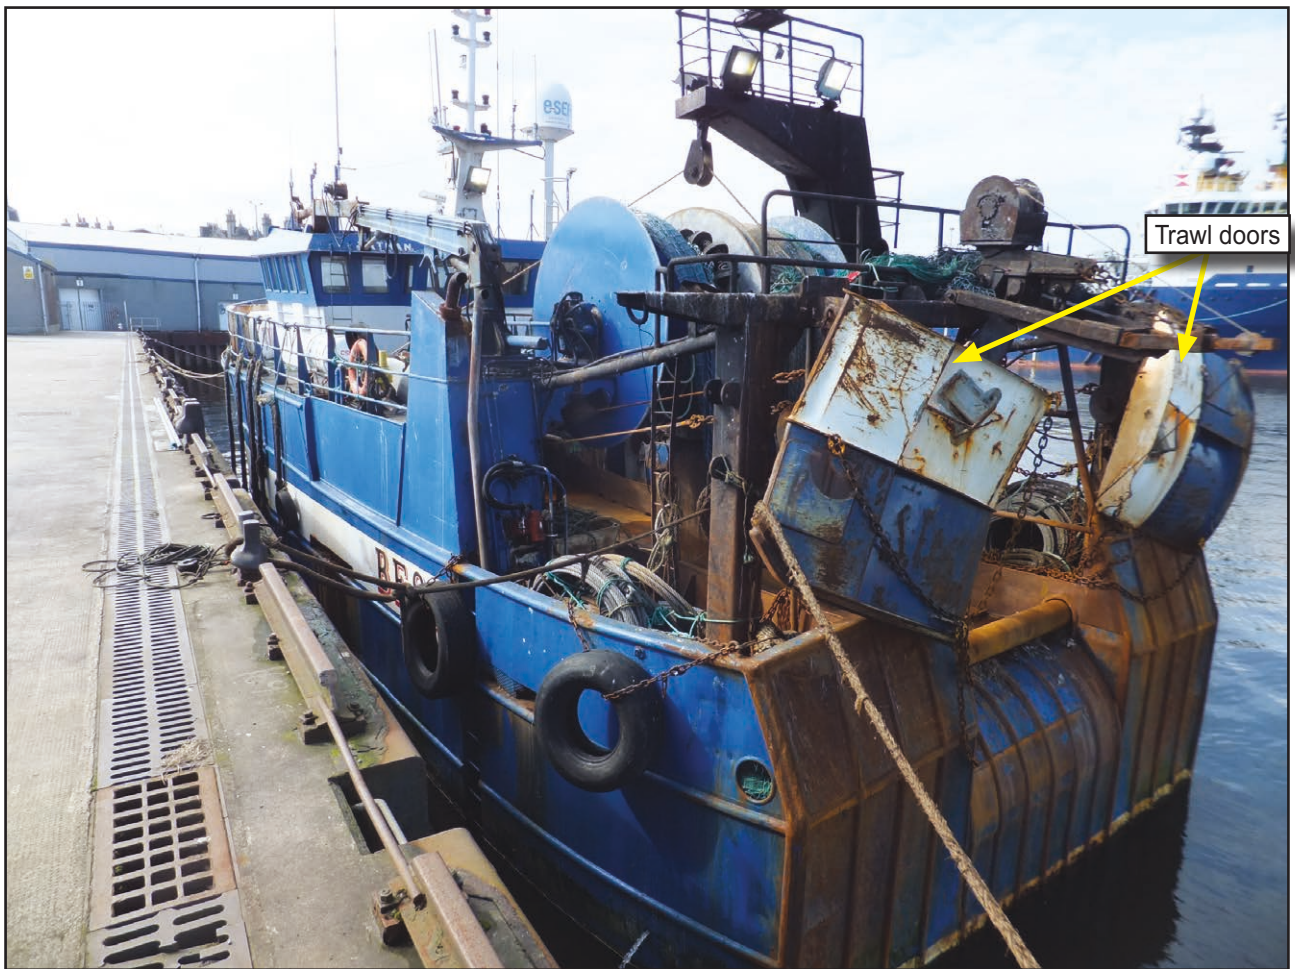
Figure 2a: Stern view of *Aquarius*

At about 0100, the crew let the mooring ropes go and the skipper manoeuvred *Aquarius* away from the quayside. As the boat was manoeuvred out of the harbour the crew secured the trawl doors to the stern gantry and disconnected the port side trawl warp (**Figures 2a** and **2b**).

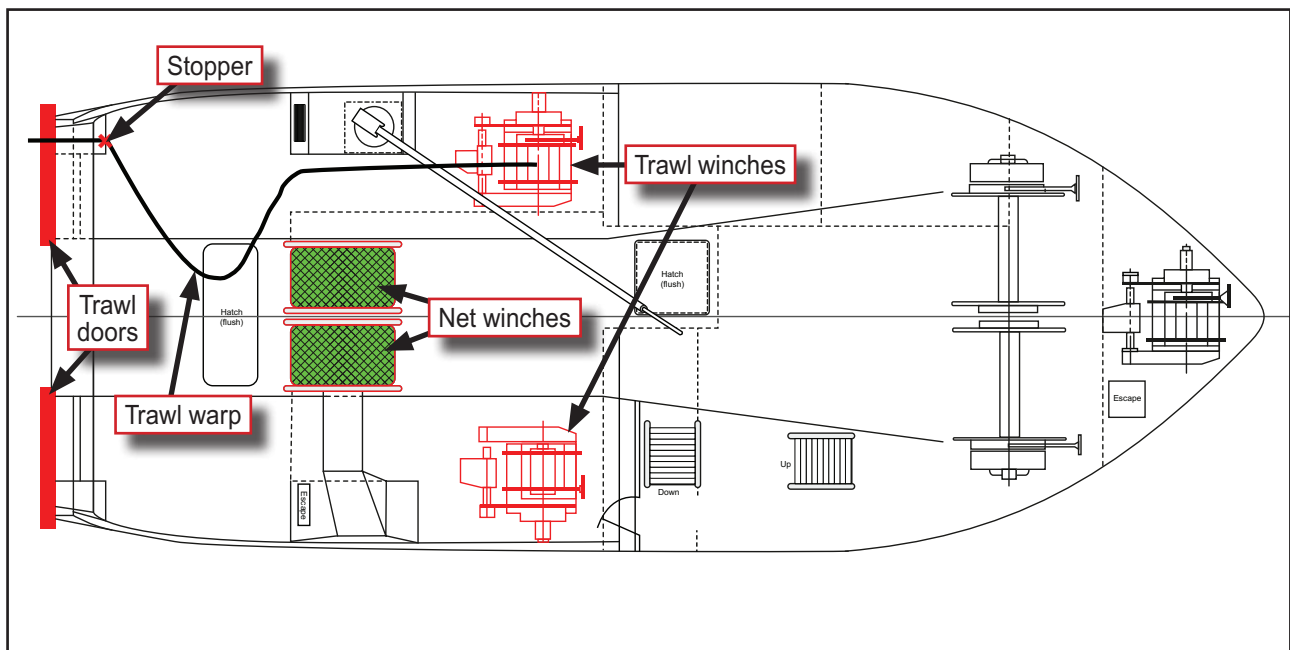
**Figure 4:** Plan view of deck with warp pulled inboard

With the weight of the streamed warp being taken by the rope stopper, the crew pulled the slackened section of warp inboard and laid it on the deck (**Figure 4**). Annang knelt on the deck outboard of the slackened warp and began to open its wire strands with a marlin spike; his intention was to insert a fibre rope marker (**Figure 5**). Another crew member knelt on the opposite side of the warp to assist in holding it securely. The three remaining crew members stood inboard of the warp towards the stern of the boat (**Figure 6**). At the same time, the skipper was gradually altering the vessel's course to head south towards his intended fishing grounds, steaming at a speed over the ground of 5 to 6kts (**Figure 7**).

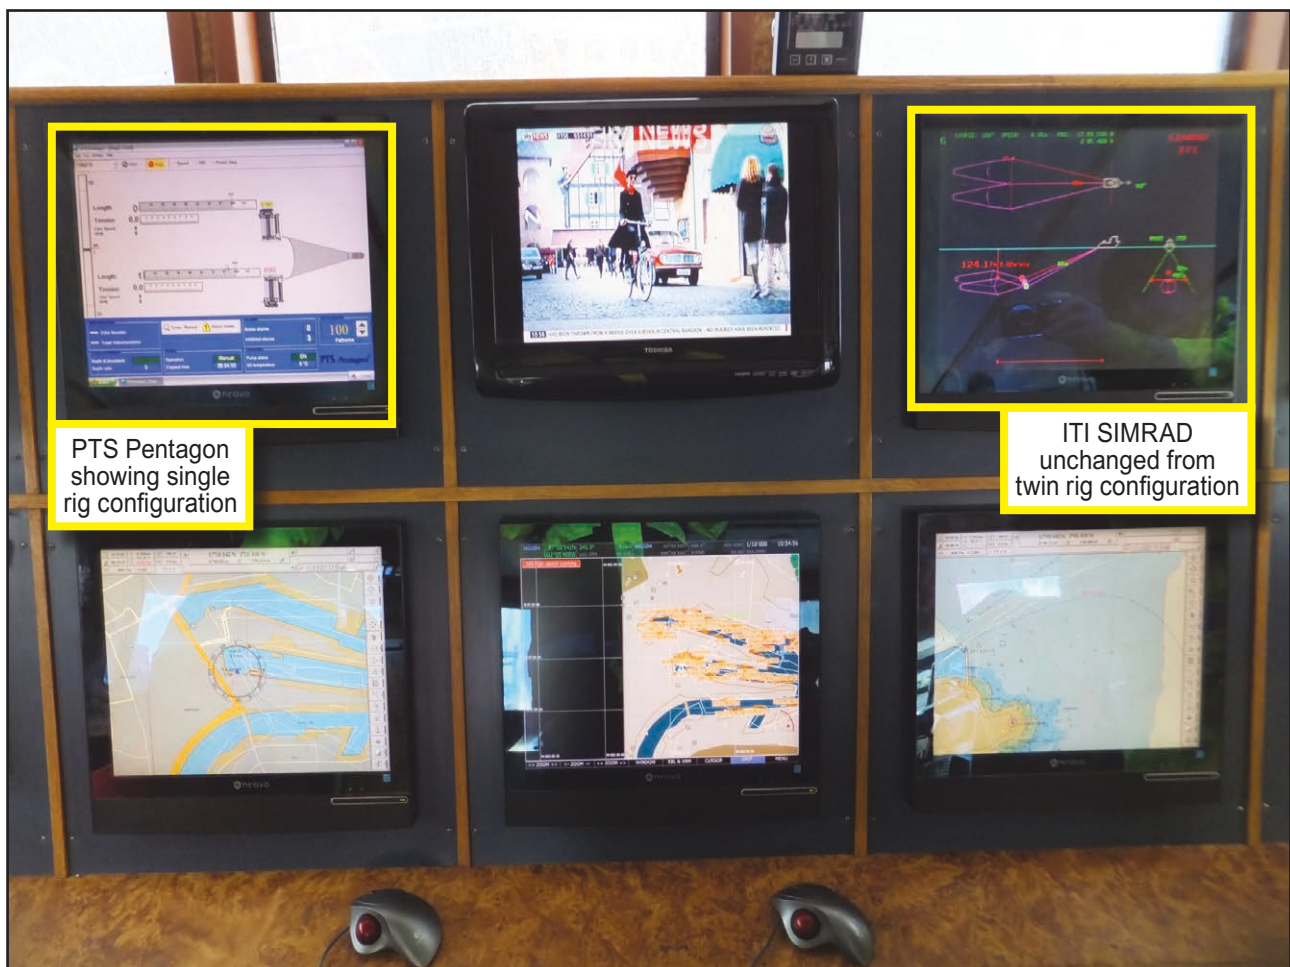
**Figure 8:** Wheelhouse electronic displays

*Aquarius* was fitted with an electronic Rapp Marine PTS Pentagon winch control system and a Simrad ITI acoustic trawl monitoring system. Both systems provided computer display readouts in the wheelhouse (**Figure 8**). The skipper had limited confidence in his vessel's electronic systems and preferred to physically mark his warps to give a visual reference of how much wire had been payed out. The skipper used strands of man-made fibre rope to mark his warps. To do this, the crew used marlin spikes to open up the steel wire warps and wove the markers between the warps' steel wire strands.

The marking of *Aquarius*'s trawl warps, by opening up the steel wire strands and inserting lengths of man-made fibre rope, was an activity that the skipper and his crew carried out on a regular basis. The task was typically undertaken on the quayside when the vessel was in port. The reason for marking the warps was to allow the skipper to place the net on or near the sea bed, and also by varying the amount of wire veered to maintain the mouth of his net at its optimum width to catch fish. The electronic winch control and acoustic trawl monitoring systems fitted to *Aquarius* should have removed the need to mark the warps manually. However, the skipper had little confidence in the technology and it was apparent that the trawl monitoring system had not been set up for single net trawling (**Figure 8**).
