Report on the investigation of the collision
between the stern trawler
Karen (B317)
and a dived
Royal Navy submarine
in the Irish Sea
on 15 April 2015

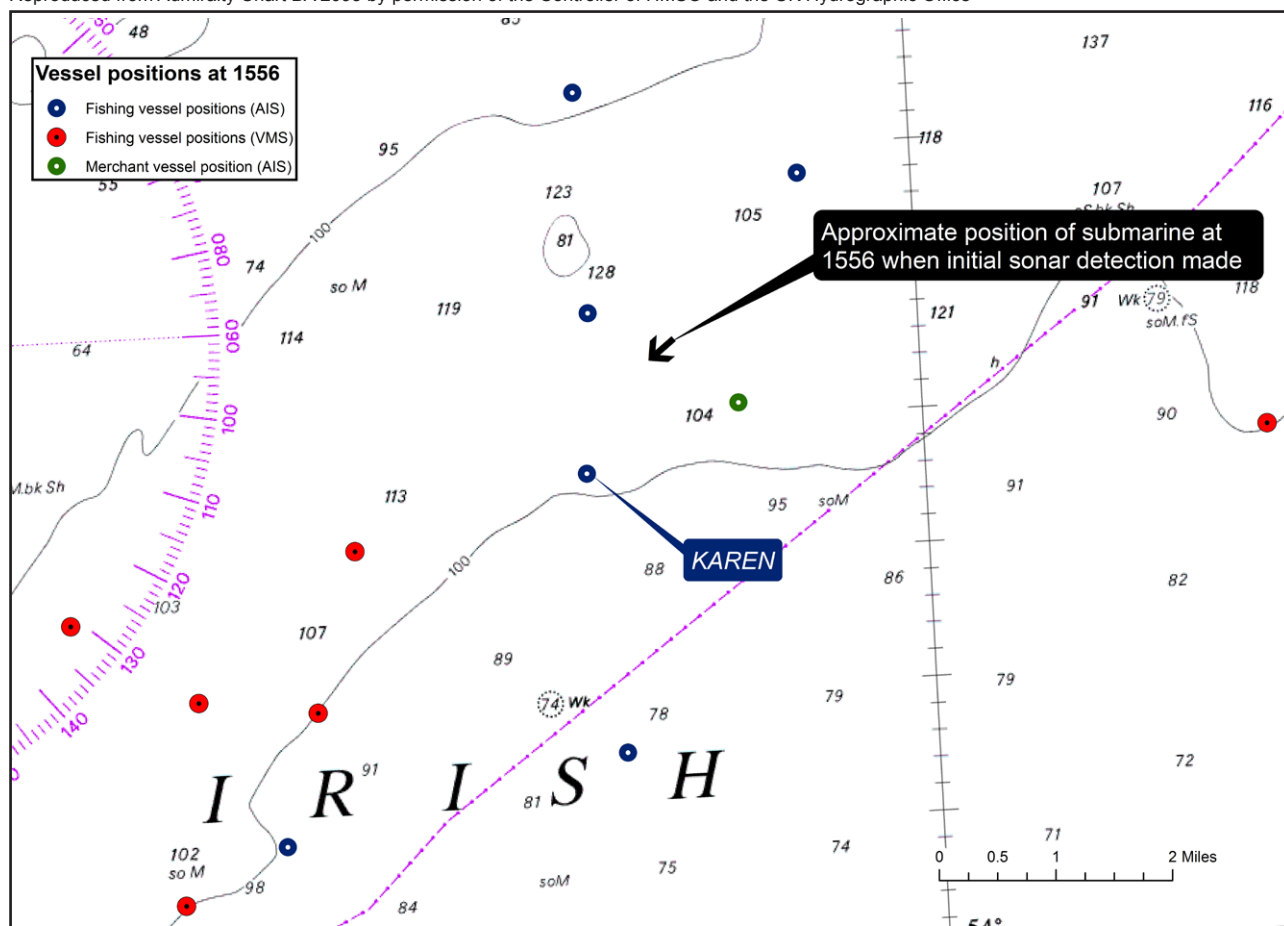
At 1556, the submarine was on a south-westerly heading at 10kts and the sonar operators identified a new contact, fine on the port bow, that had previously been masked by several other vessels (**Figure 2**); this was *Karen*. In order to determine the contact's range, the submarine's heading was altered 15° to starboard⁴. The sonar operators listened to *Karen* and analysed the acoustic information; this included an assessment of its shaft revolutions per minute (rpm), propeller configuration and aural characteristics. Based on this information and the absence of trawl noise, the submarine's command team assessed that *Karen* was a small merchant vessel. The submarine's heading was then altered to port onto a south-easterly course in order to determine the ranges of other passive sonar contacts.

Figure 2: Plot showing the approximate position of the submarine and adjacent shipping at 1556, based on AIS and VMS data

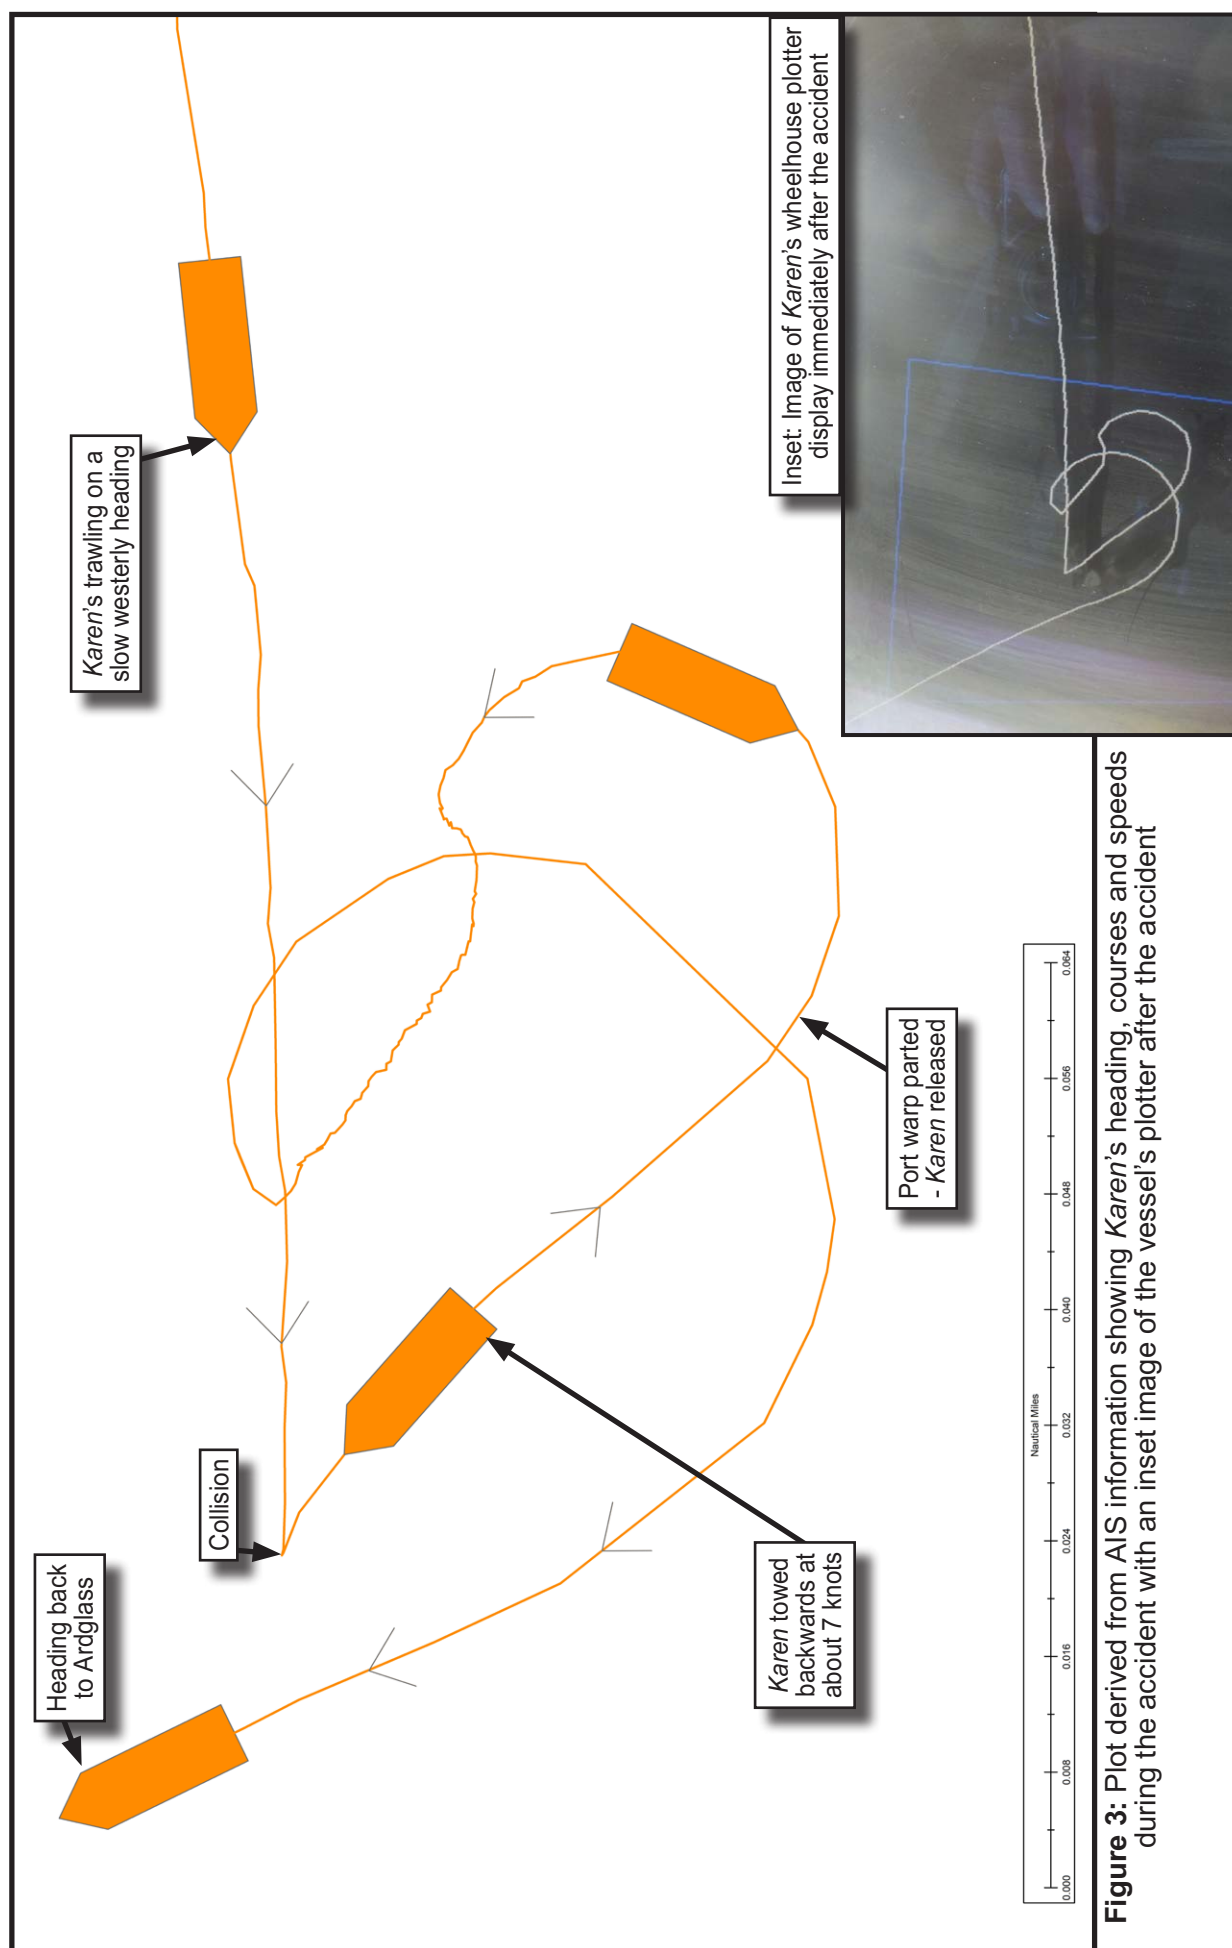
Figure 3: Plot derived from AIS information showing *Karen's* heading, courses and speeds during the accident with an inset image of the vessel's plotter after the accident

At 1615, *Karen's* skipper called Belfast Coastguard and explained that his vessel had been uncontrollably towed backwards and that all his fishing gear was lost. He also advised the coastguard that his assessment was that the cause of the incident must have been a submarine. Having regained control of his vessel and completed his report to the coastguard, the skipper started to head *Karen* back to Ardglass (**Figure 3**).

A plot showing *Karen*'s AIS track during the accident and an image of the wheelhouse plotter taken just after the accident is at **Figure 3**.

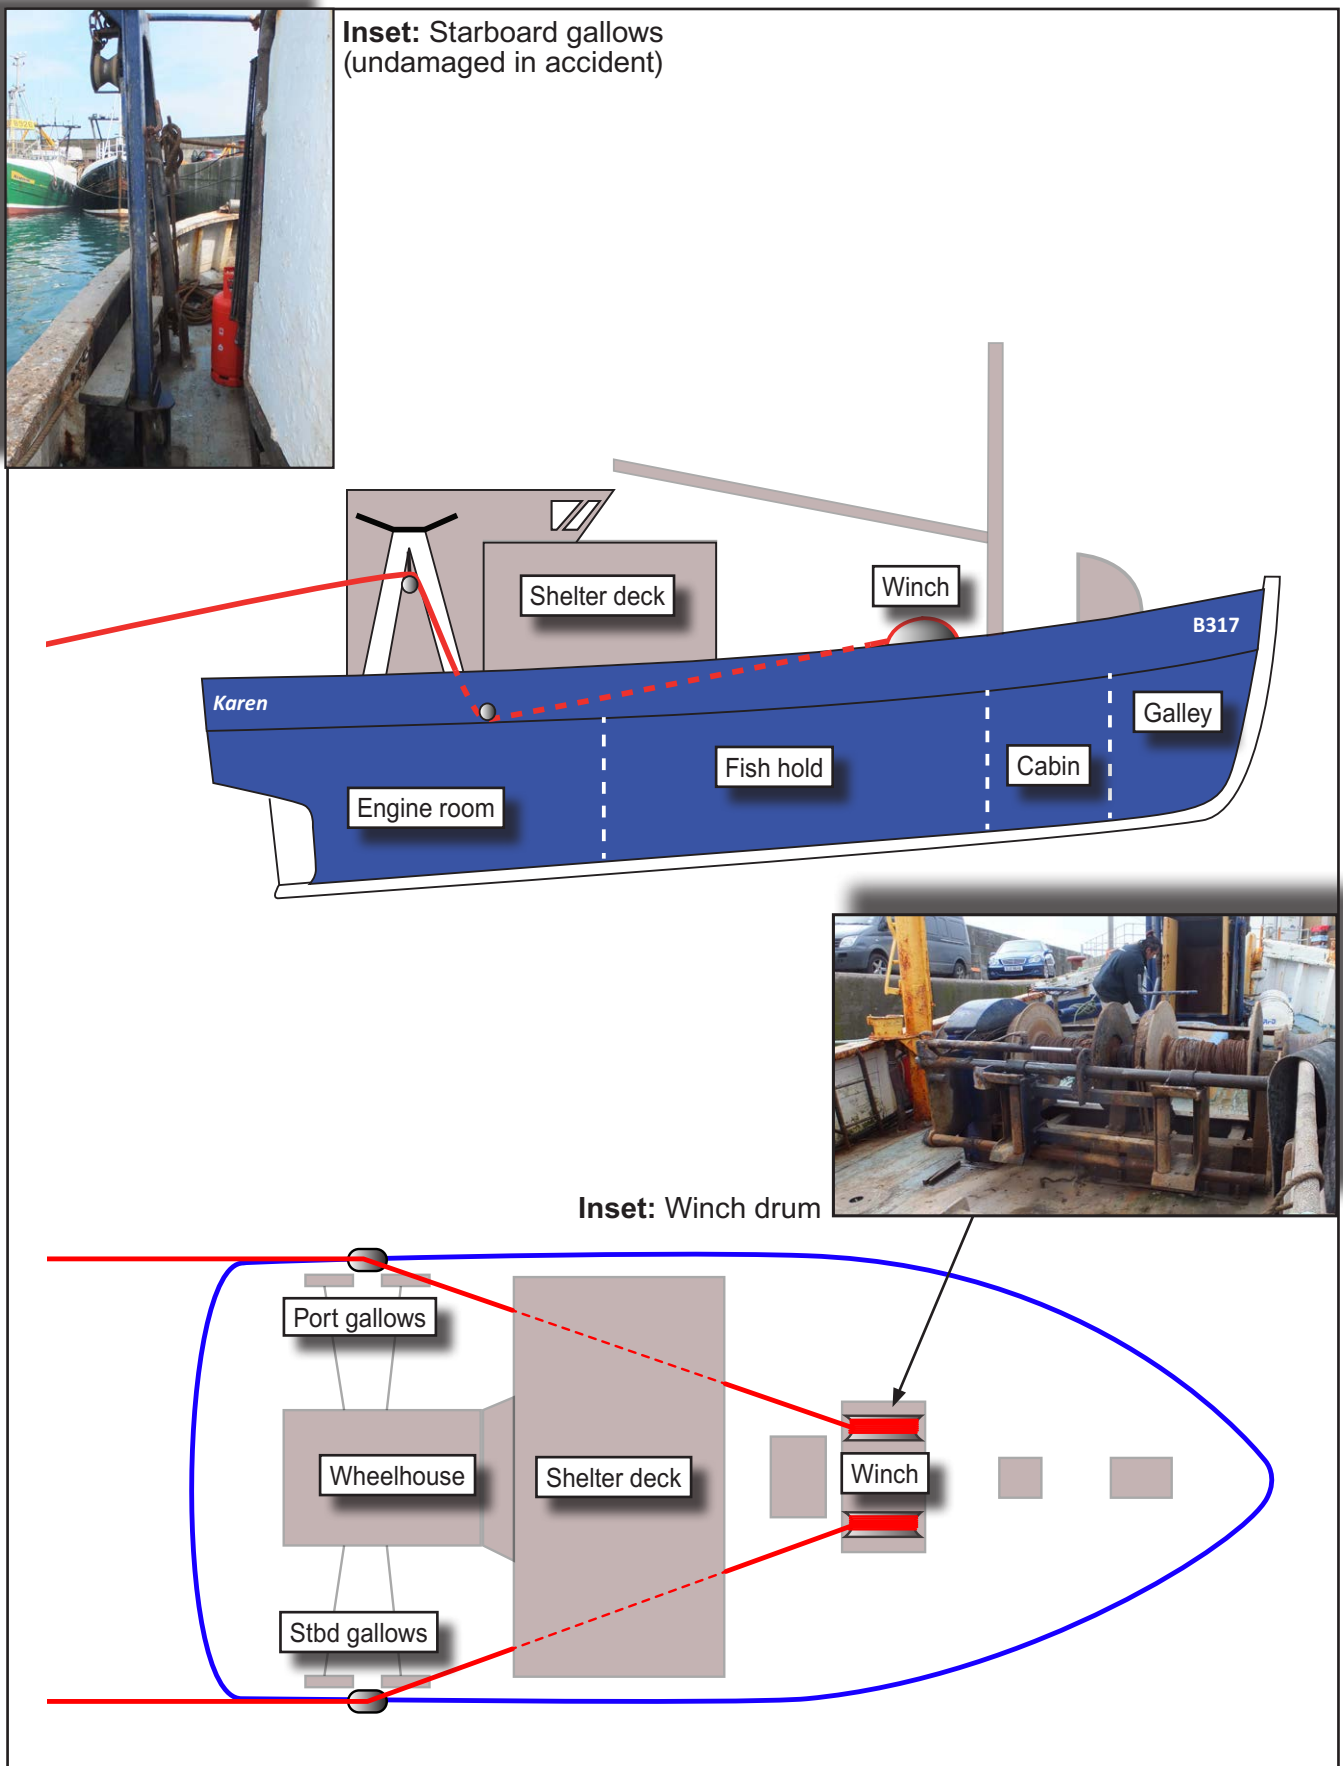
shelterdeck to gallows on each side of the wheelhouse then over the stern into the water (**Figure 5**). The warp length was typically four times the depth of water; at the time of the accident, the total length of *Karen*'s tow, including the net, was 457m.

Figure 5: *Karen* – layout showing rigging of trawl warps

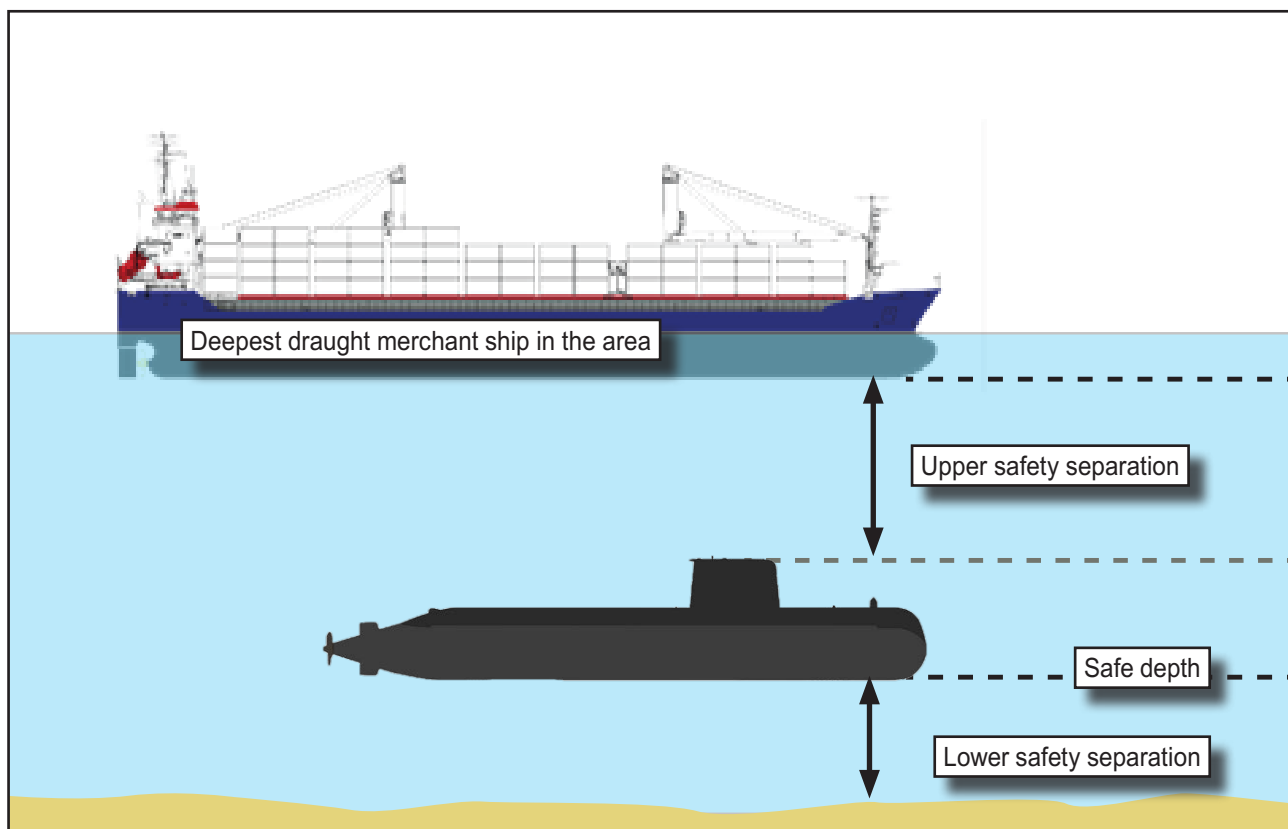
When surfaced, submarines comply with the International Regulations for the Prevention of Collisions at Sea (COLREGs), including showing appropriate lights and shapes. There is no provision in the COLREGs for dived submarines; this means that responsibility for collision avoidance rests entirely with its commanding officer once a submarine has dived. When deep, submarines operate at a depth where there is no risk of collision with any merchant vessel that could be encountered; this is known as 'safe depth' (**Figure 14**).

Figure 14: Illustration (not to scale) of a submarine at safe depth

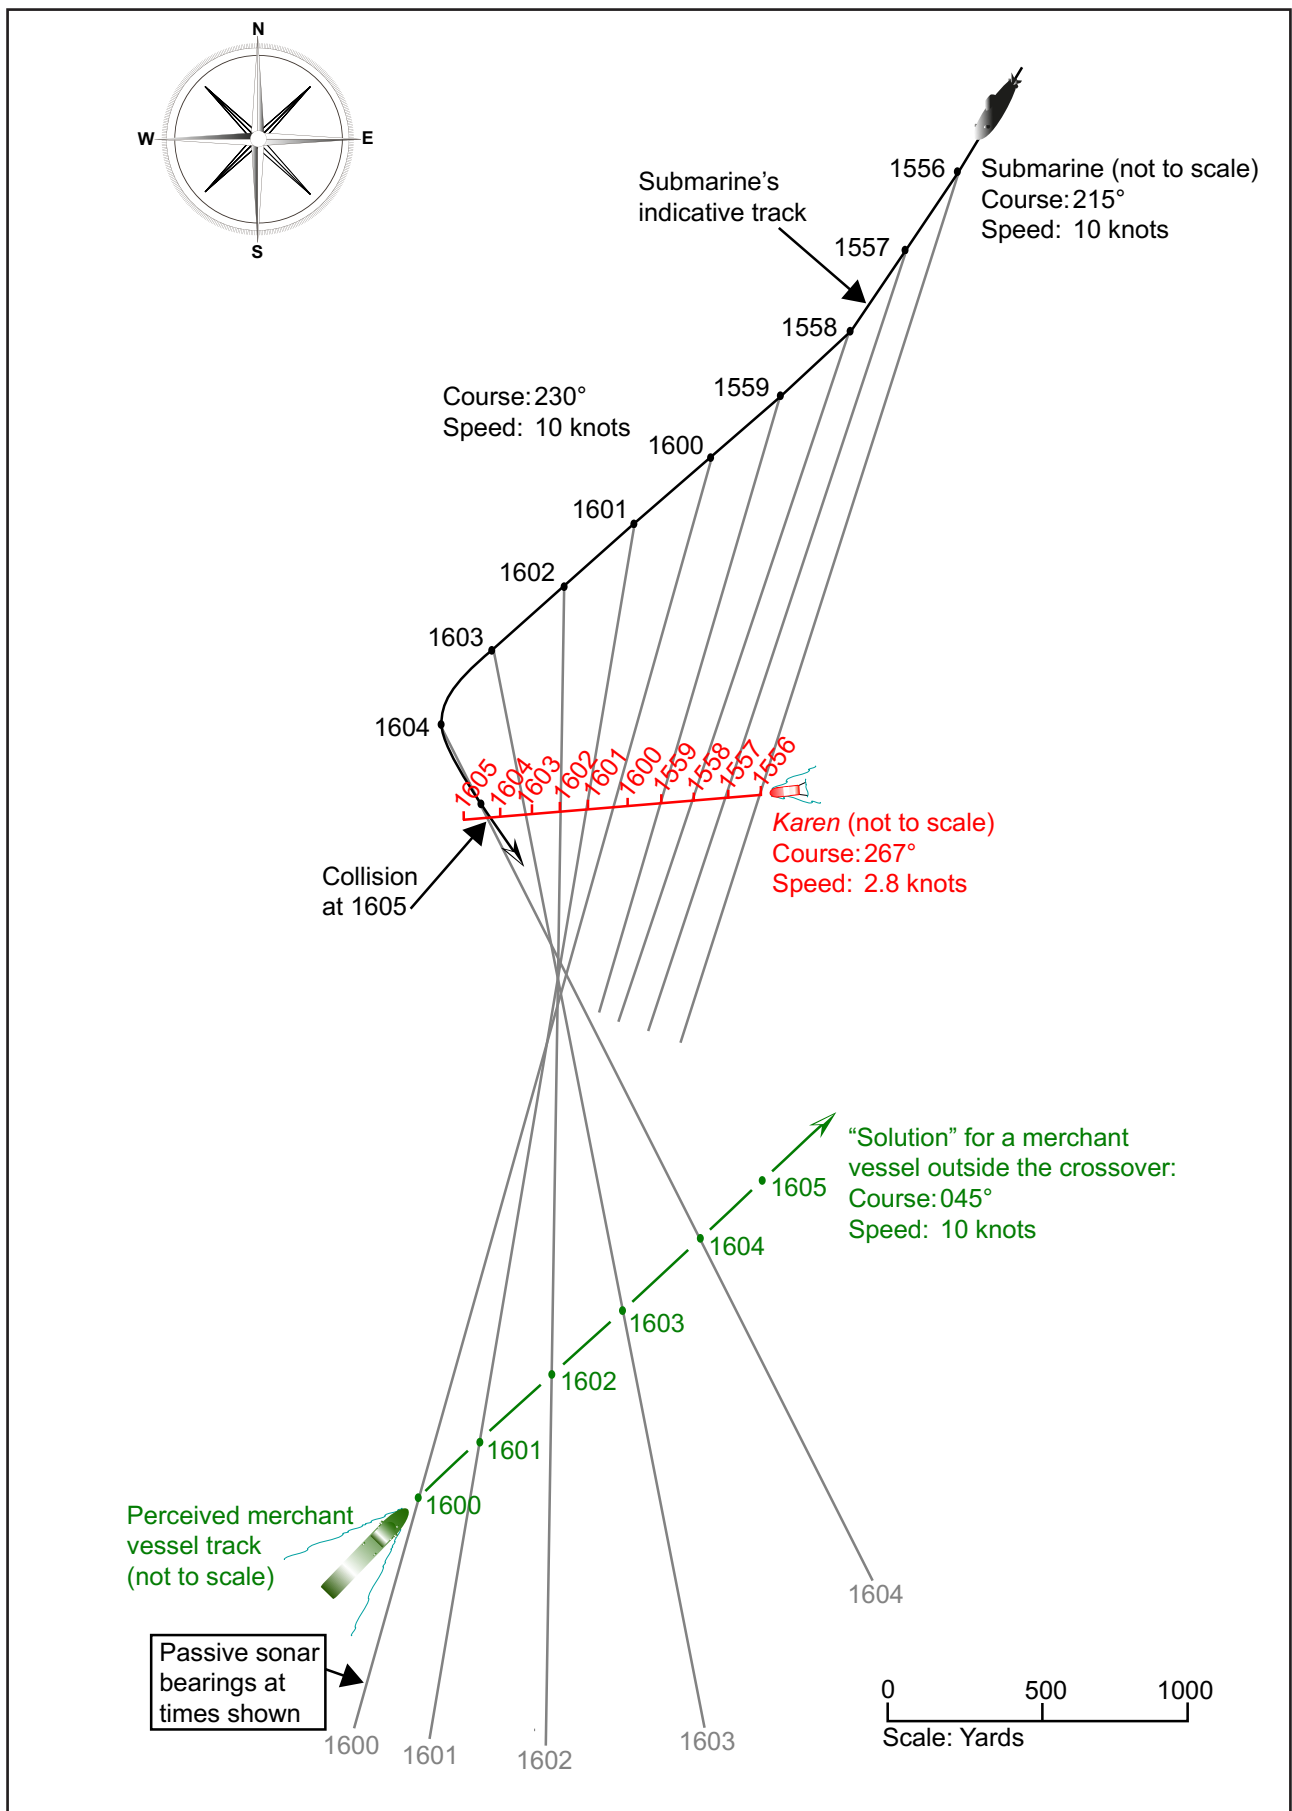
Figure 15 illustrates the passive TMA process prior to the collision. The submarine's track, including the ranging manoeuvre, is shown in black and two possible TMA solutions are also shown. The more distant contact (shown in green) is a solution using a typical merchant vessel speed of 10kts, and the closer contact (shown in red) is a solution for a vessel speed of 2.8kts, representative of *Karen's* actual relative movement.

Figure 15: Illustration of TMA process showing potential solutions for vessels at 2.8kts and 10kts

The misidentification of *Karen* as a merchant vessel also led directly to the TMA process over-estimating the fishing vessel's speed and, therefore, its range (**Figure 15**). The close pass with *Karen* shortly after the submarine had altered course to

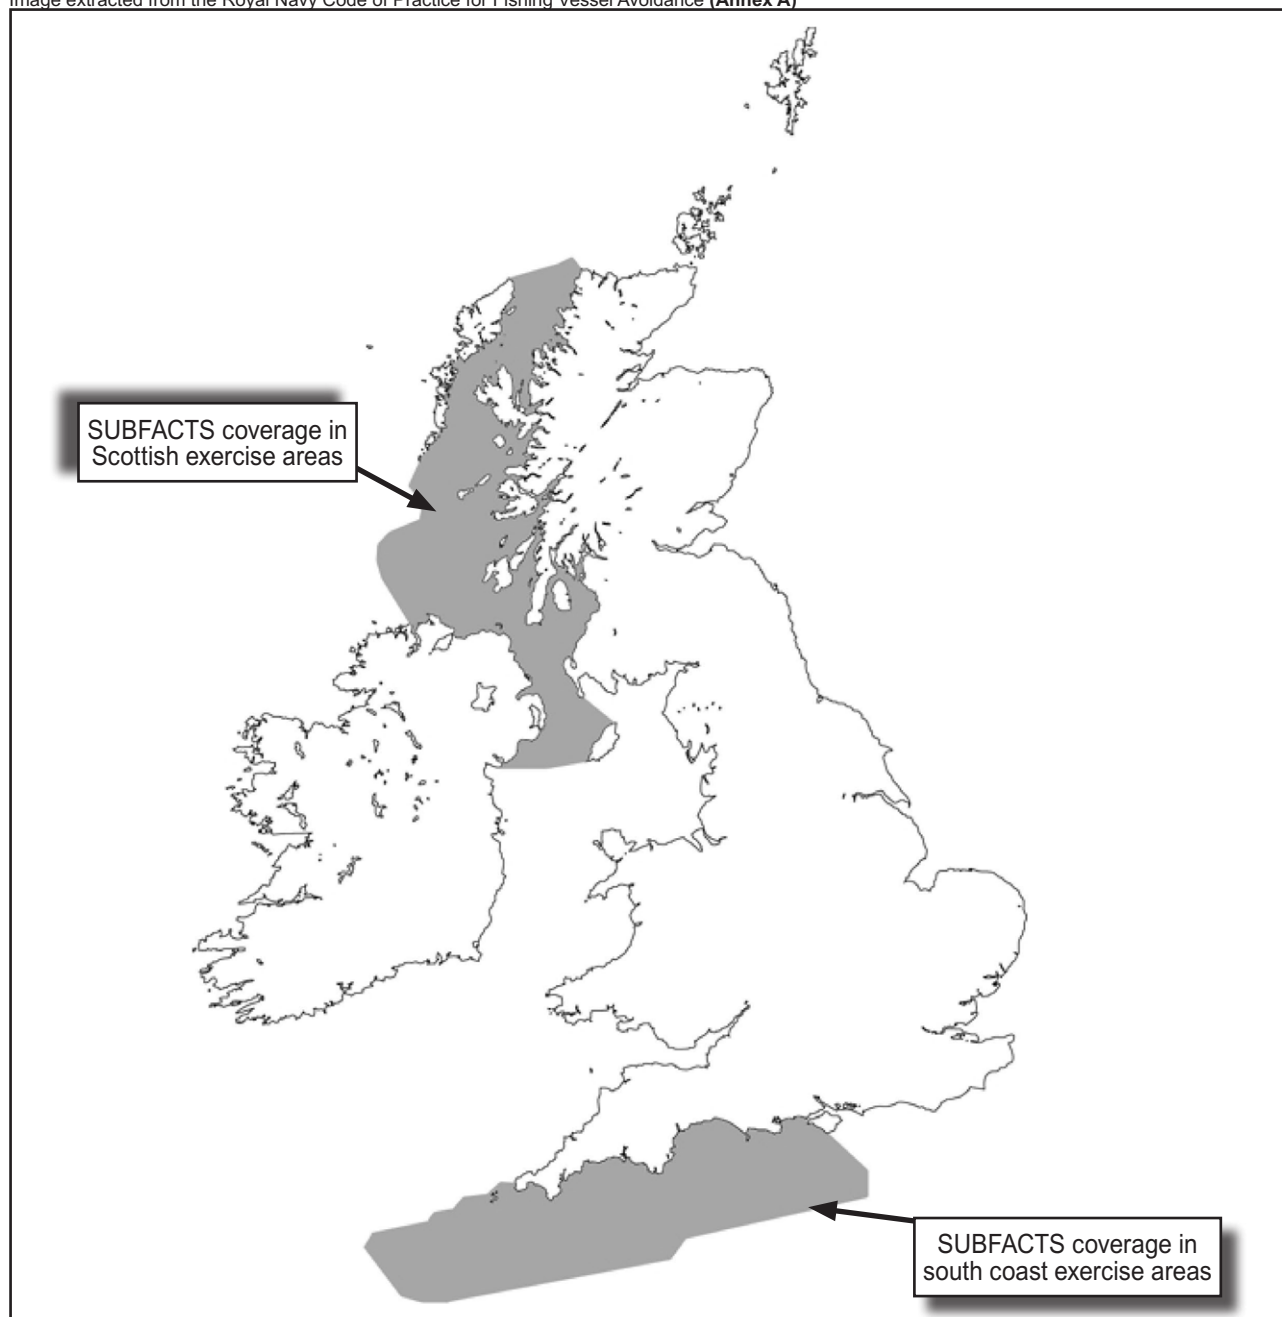
The Royal Navy operated a warning system, referred to as SUBFACTS¹⁷, intended to notify mariners of the presence of dived submarines operating in designated exercise areas (**Figure 16**). SUBFACTS information was compiled by the duty submarine controller at the Fleet Operations Division in Northwood. It was then broadcast at 0620 UTC and 1820 UTC daily via the coastguard on VHF radio and also using the Navigational and Meteorological Warning Broadcast Service (NAVTEX).

Figure 16: SUBFACTS area coverage diagram

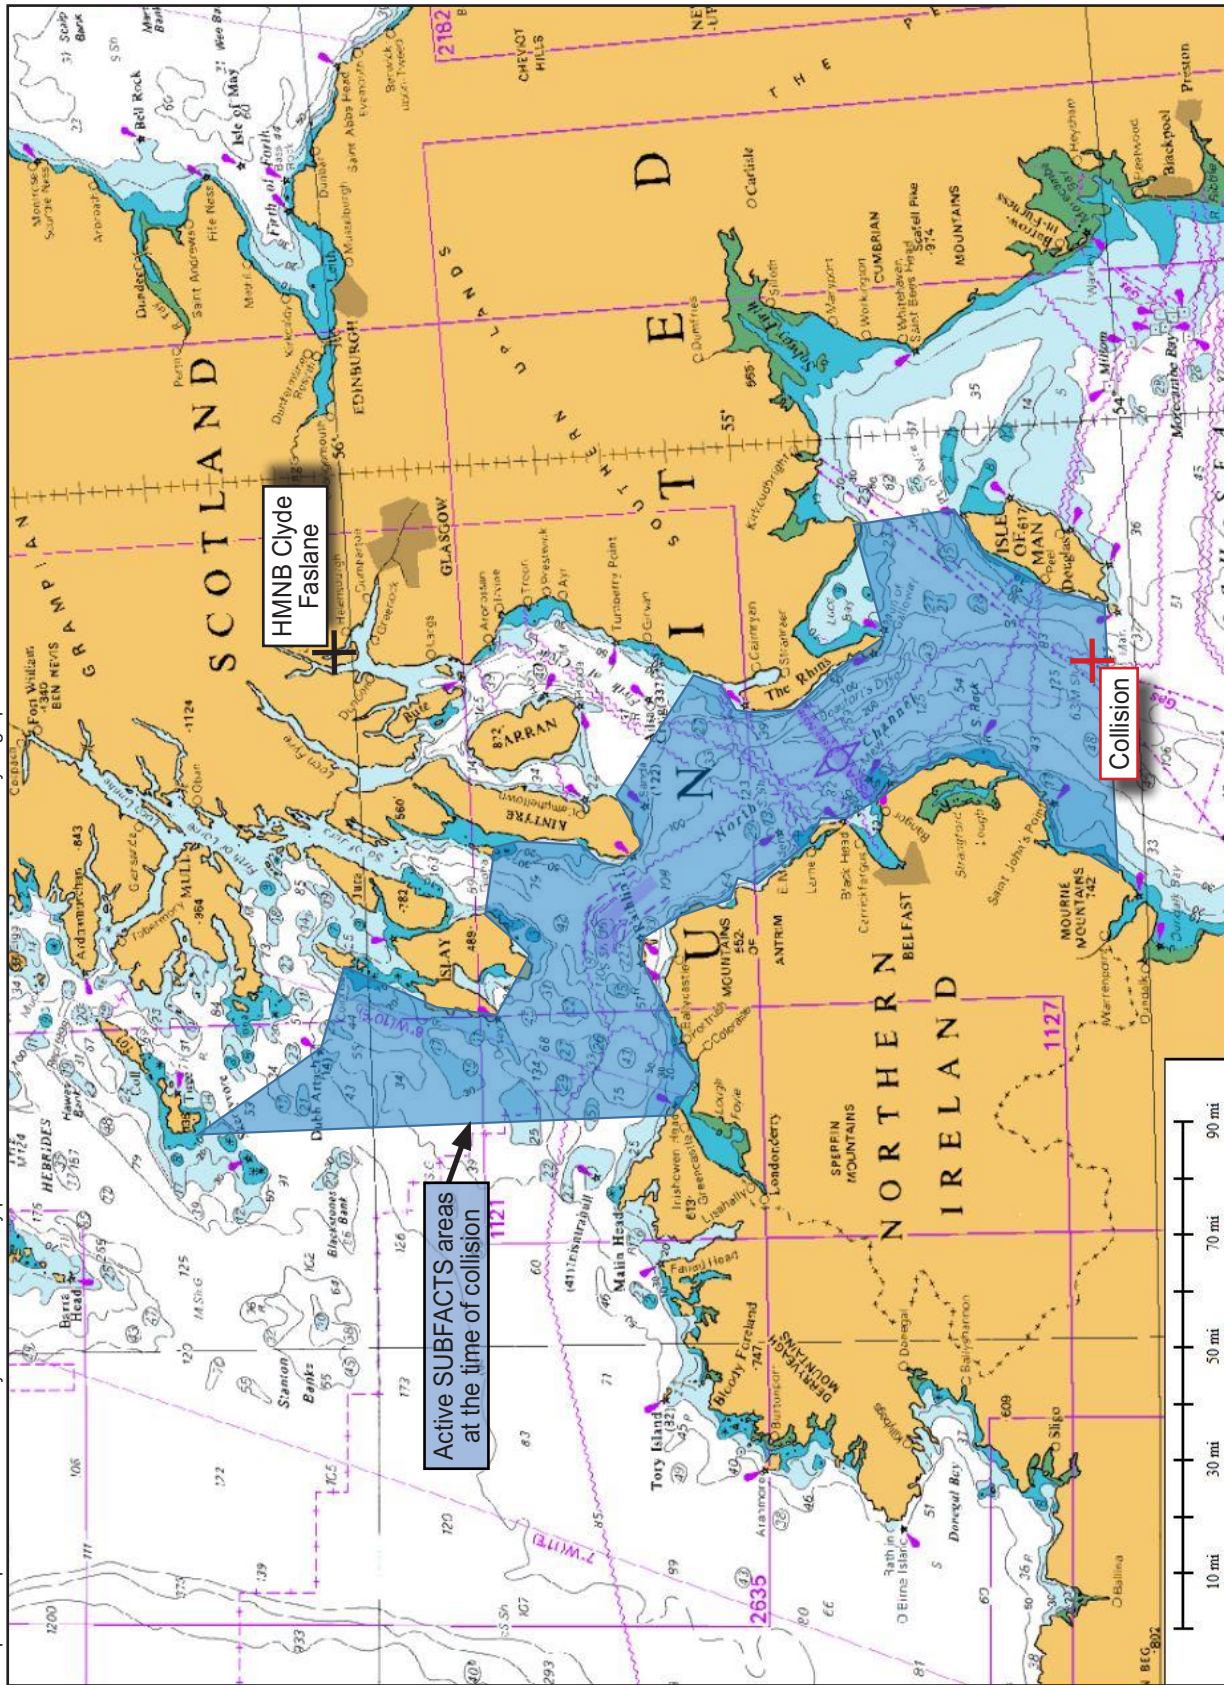
At 0720 on 15 April 2015, the following SUBFACTS warning message was issued (**Figure 17**):

¹⁸ The SUBFACTS area described in the broadcast message promulgated on the day of the accident was not in accordance with the pre-designated submarine exercise areas described in ALRS or MGN 12(F) (**Annex B** to this report).

Figure 17: Active SUBFACTS areas at the time of the accident

The accident location was about 1 mile inside the southern boundary of this SUBFACTS promulgated area.

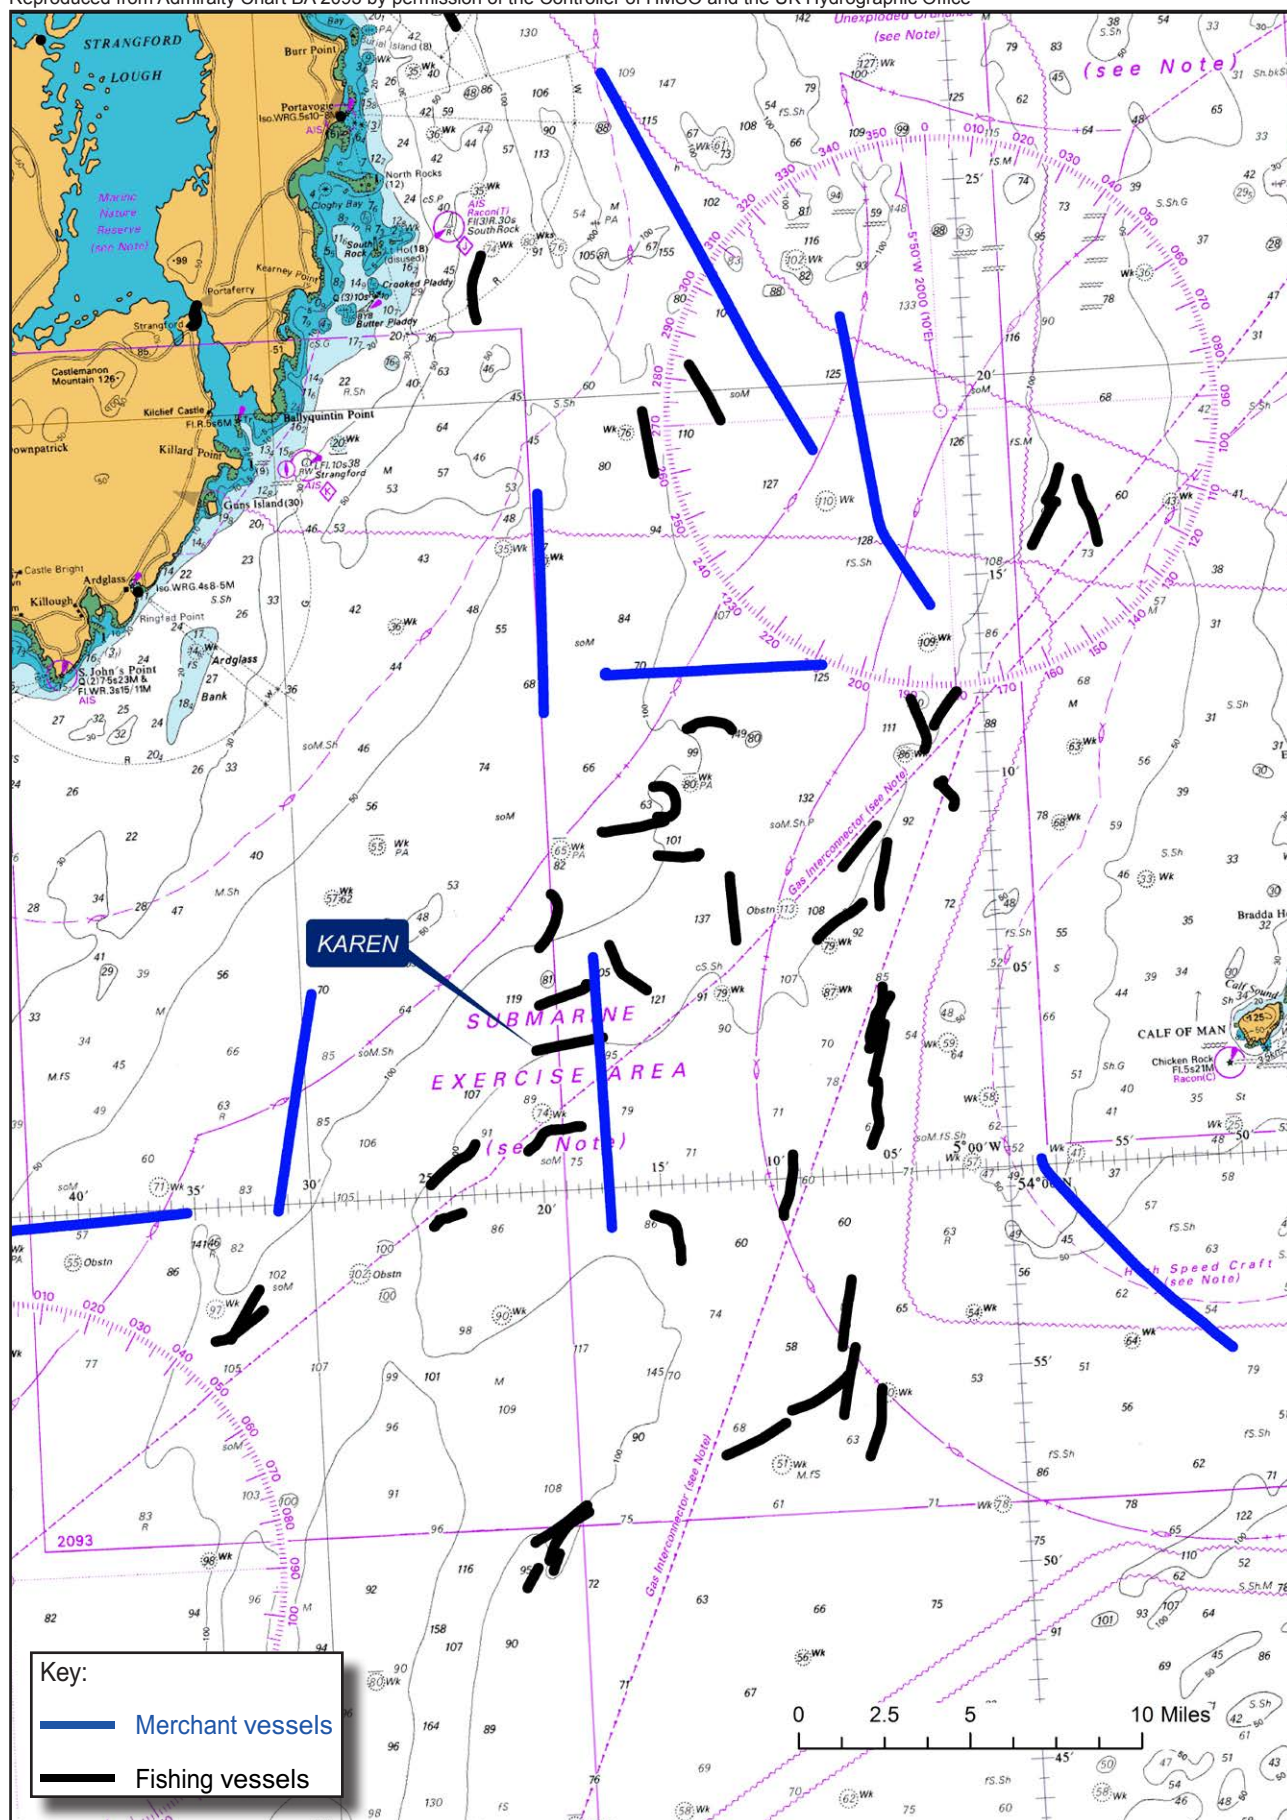
AIS data for 30 minutes prior to the accident, in *Karen*'s vicinity, (**Figure 18**) shows:

Figure 18: Plot of all AIS tracks in the area for 30 minutes prior to the accident

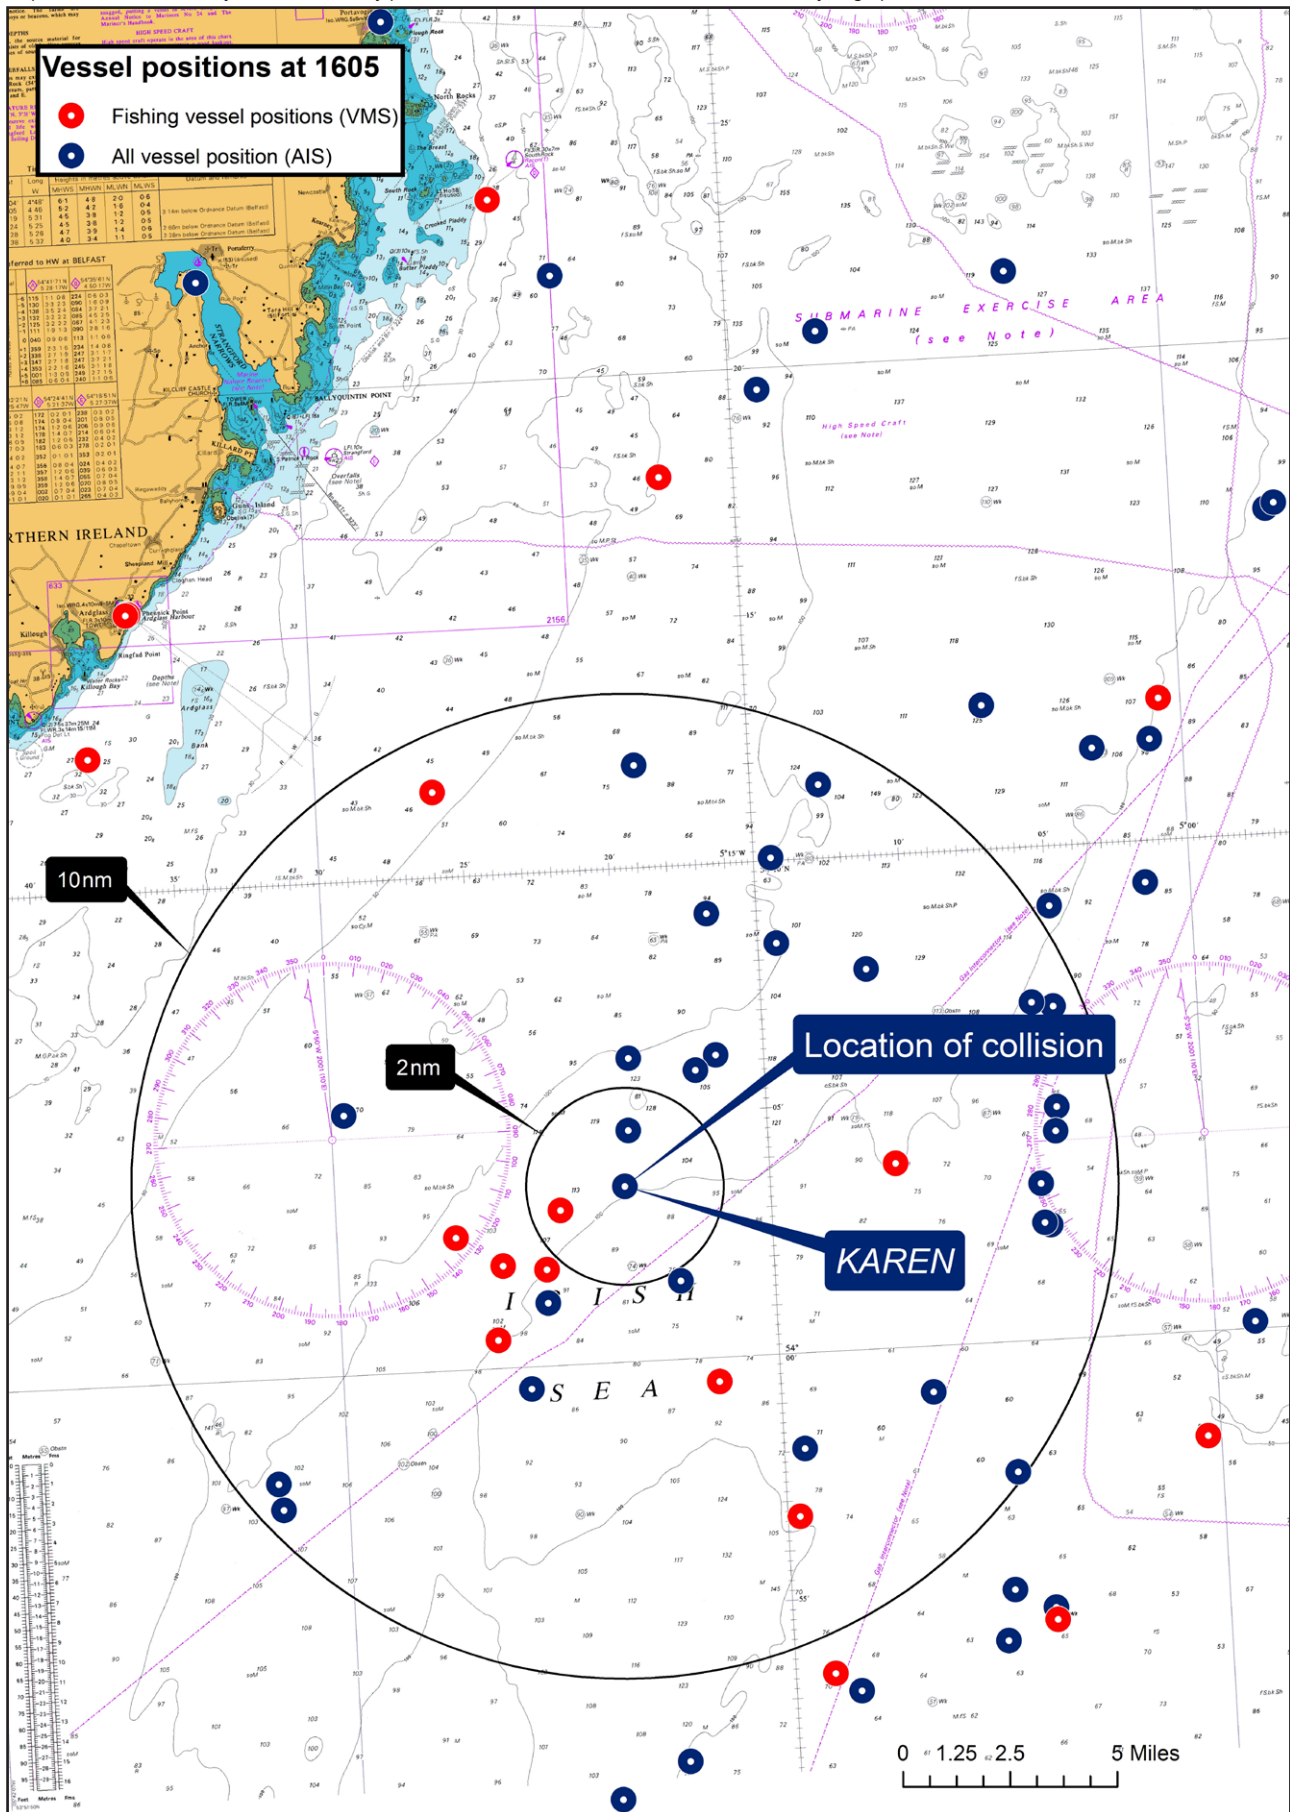
The submarine collided with *Karen*'s fishing gear because its sonar contact was assessed to be that of a small merchant vessel, and earlier the Commanding Officer had suspended the requirement for close quarters procedures, the effect of which was to normalise close passes with merchant vessel contacts. At the time of the collision there were 36 other vessels operating within a 10-mile radius of the submarine; most were fishing vessels and at least two²⁷ of those, including *Karen*, were within 4000yds (**Figure 19**).

²⁷ On **Figure 19**, three fishing vessels are shown within 4000 yards (2nm) of the accident location. The two positions (shown in blue) derived from AIS, including *Karen*, are timed at 1605. The position of the third fishing vessel (shown in red) also inside 4000yds of the accident location, was derived from VMS and timed at 1622 (see Section 1.11.1).

Figure 19: Plot of all vessels operating within 10nm of the accident location

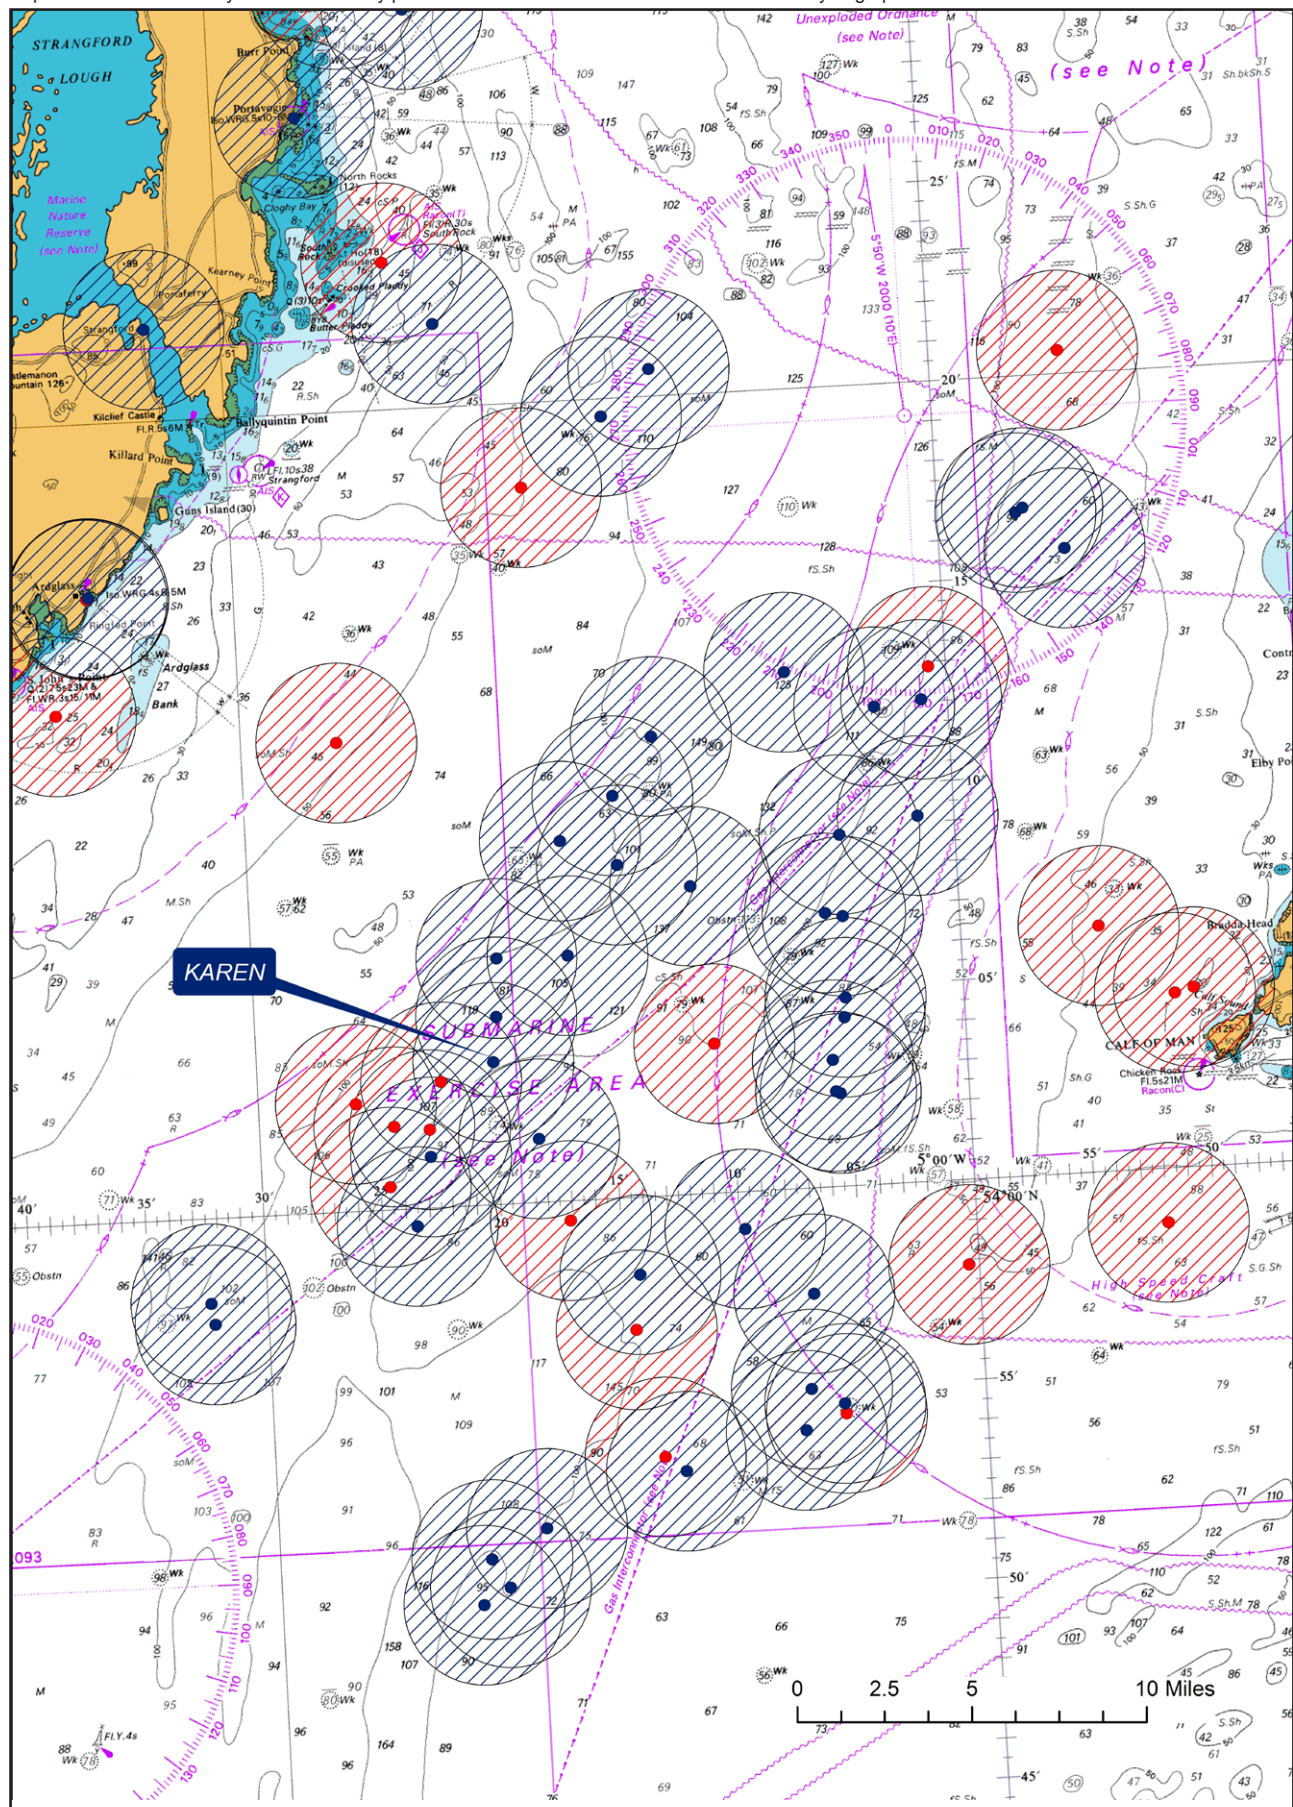
Figure 20 shows the positions of all the 61 fishing vessels²⁹ in the area, based on AIS and VMS data, at or near to the time of the accident³⁰; the circles shown around each contact are at 4000yds. It is apparent from this analysis that the area was impassable to a deep submarine operating in compliance with BR0095. It is also apparent that the submarine must have passed within 4000yds of several other fishing vessels both prior to and after the collision.

³⁰ On Figure 20, fishing vessel AIS positions (shown in blue) are at the time of the accident. Given that the VMS system only transmits a fishing vessel's position approximately every 2 hours, then the fishing vessel positions derived from VMS (shown in red) are at the time nearest to 1605 that a VMS transmission was made.

Figure 20: Plot of all fishing vessels in the area with 4000 yard separation circles
