Rail Accident Investigation Branch

Rail Accident Report

Collision at Knockmore Junction, Northern Ireland 4 February 2016

Report 20/2016
October 2016

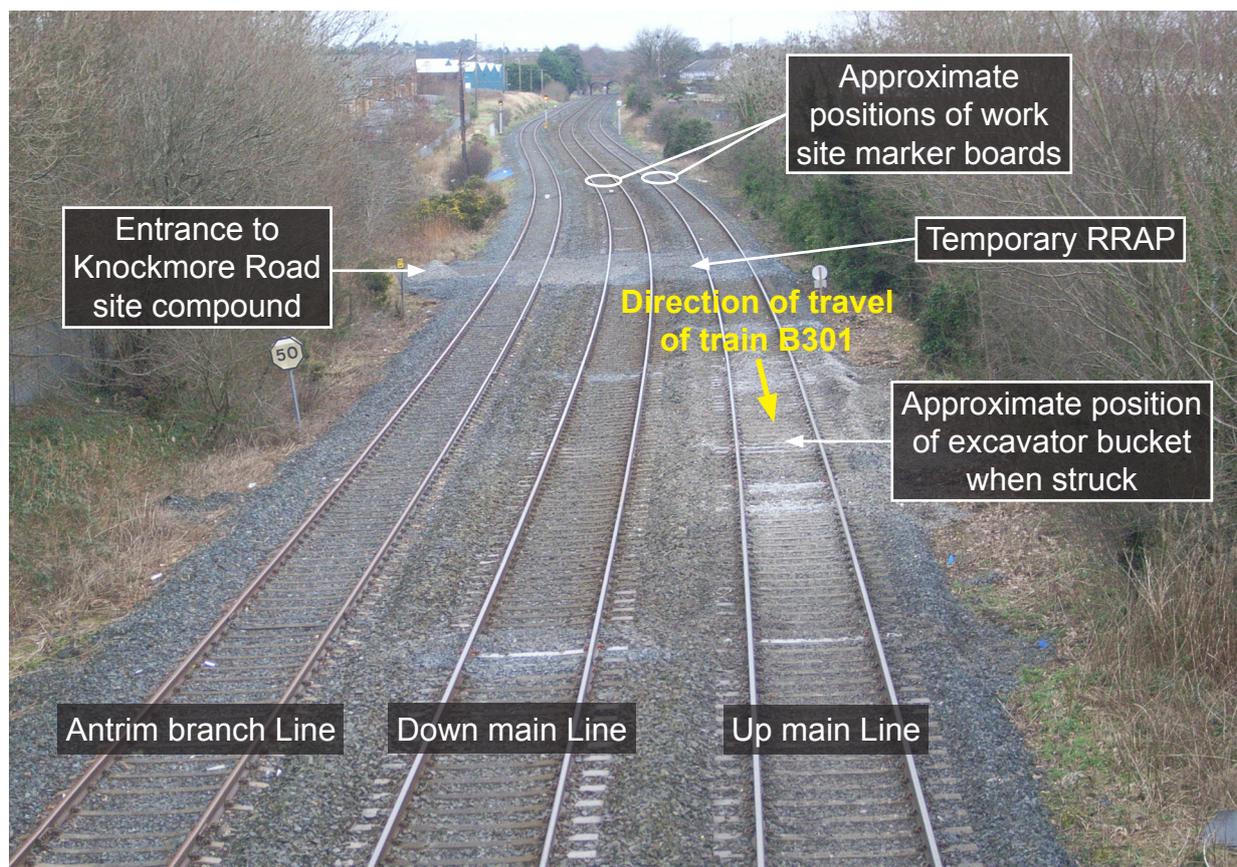
- 8 The Knockmore Road site compound was one of several created along the railway corridor to facilitate engineering work undertaken as part of the Belfast to Lurgan track rehabilitation works. A temporary *road/rail access point* (RRAP) had been constructed on the railway adjacent to the site compound entrance. This RRAP consisted of railway *ballast* placed up to rail level (figure 2).

Figure 2: RRAP and worksite marker board location near Knockmore Road site compound

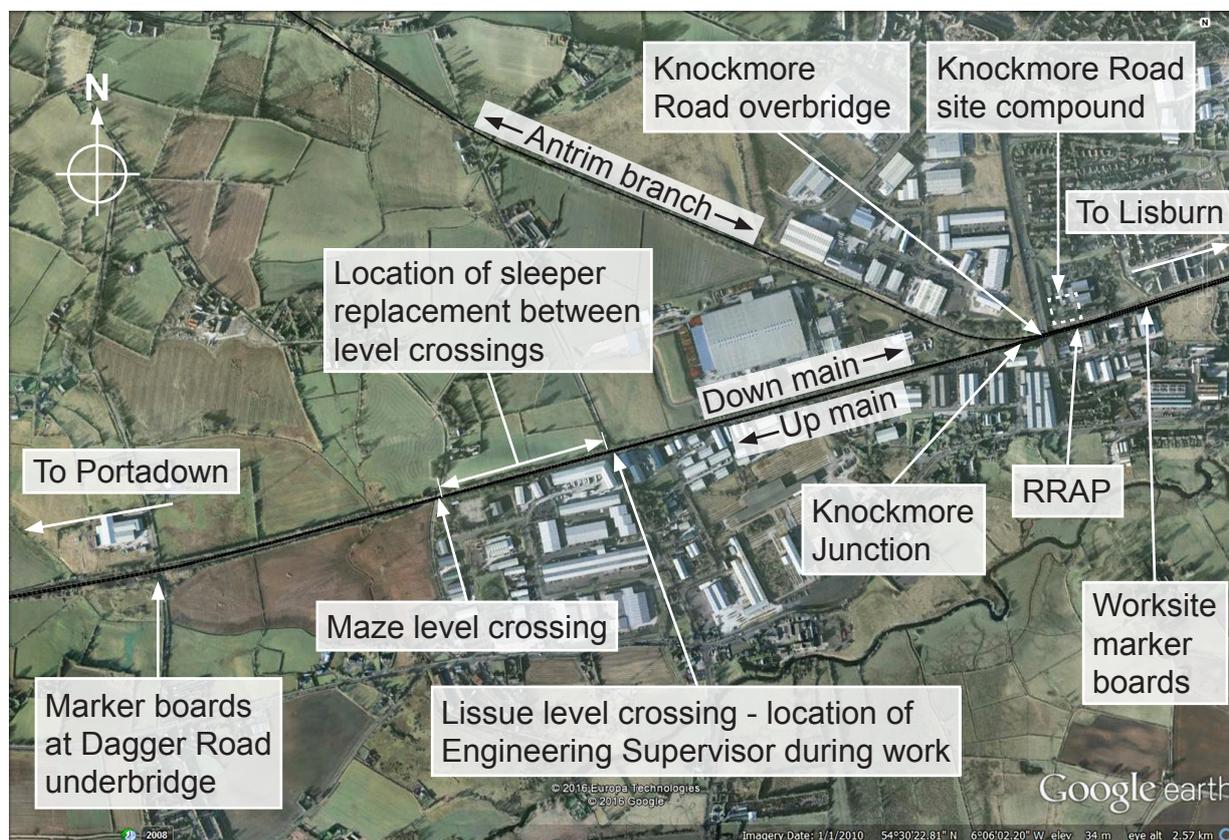
- 9 During the night before the accident a work group was replacing *sleepers* between Lissue and Maze level crossings, respectively 1.2 km and 1.7 km west of the RRAP. This work was done in a *worksite* extending from about 50 metres east of the RRAP to Dagger Road underbridge, about 0.6 km west of Maze level crossing (figure 3). The total length of the worksite was about 2.3 km. It was within a possession extending from Lisburn to Portadown, a distance of approximately 28 km.

Figure 3: Google Earth image showing a plan of the site

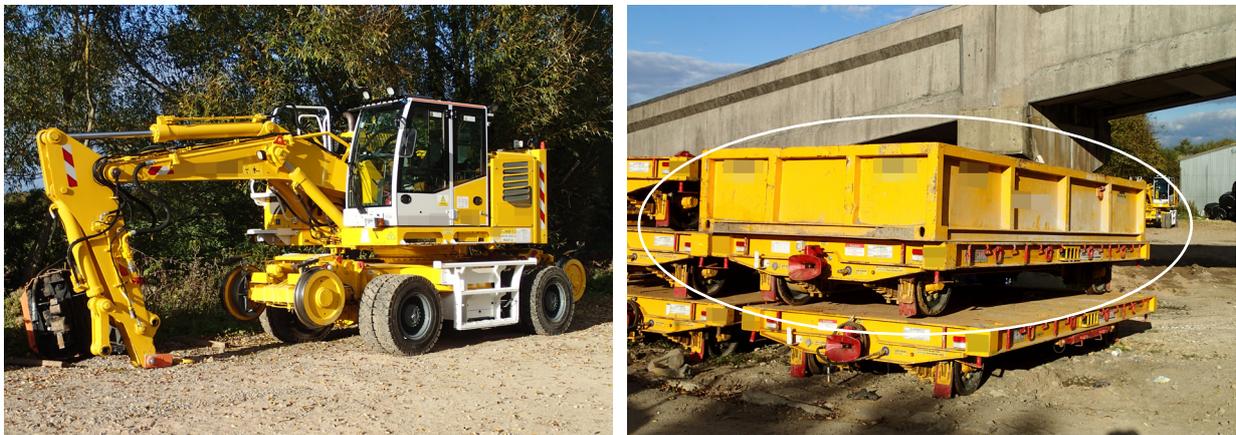
- 17 The work group also used a five metre *flatbed* trailer with a large open box container, known as a ballast box, to transport ballast to site. This was attached to the road/rail machine on the up main line. A road/rail machine and trailer with ballast box, similar to those being used by the work group on the night before the accident, are shown in figure 4.

Figure 4: Example of a road/rail machine (left) and trailer and ballast box combination (circled right) similar to that used by the work group but not involved with the incident.
