AAIB Bulletin: 11/2016	N186CB	EW/C2015/11/01
ACCIDENT		
Aircraft Type and Registration:	Piper PA-46-350P Malibu Mirage, N186CB	
No & Type of Engines:	1 Lycoming TIO-540-AE2A piston engine	
Year of Manufacture:	1990 (Serial no: 46-22085)	
Date & Time (UTC):	14 November 2015 at 1134 hrs	
Location:	Buttles Farm, Churchinford, Somerset	
Type of Flight:	Private	
Persons on Board:	Crew - 1	Passengers - 3
Injuries:	Crew - 1 (Fatal)	Passengers - 3 (Fatal)
Nature of Damage:	Aircraft destroyed	
Commander's Licence:	Private Pilot's Licence	
Commander's Age:	56 years	
Commander's Flying Experience:	600 hours (of which 260 were on type) Last 90 days - 17 hours Last 28 days - 4 hours	
Information Source:	AAIB Field Investigation

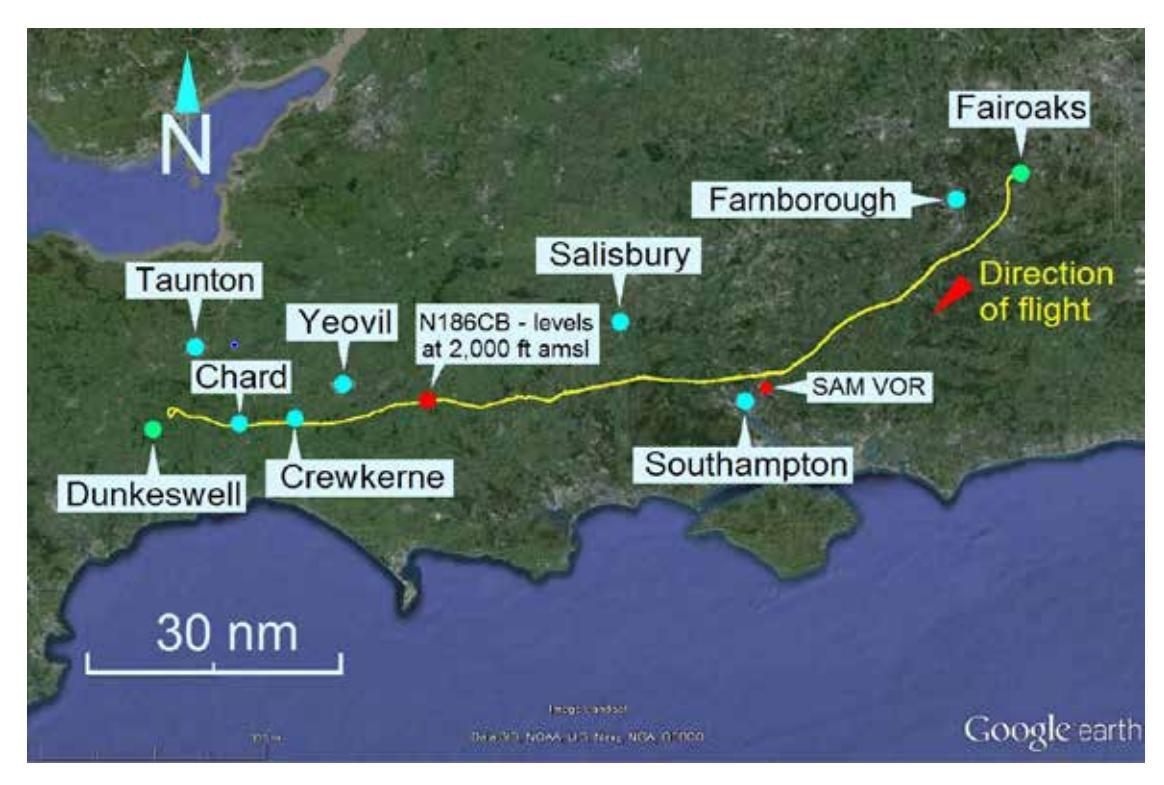
# Figure 2

Combined radar track of the flight from Fairoaks

At 1120 hrs, 32 nm to the east of Dunkeswell, the aircraft was flying level at about 2,000 ft amsl and at a groundspeed of 130 kt (Figure 2). It maintained an altitude of between 1,900 ft and 2,000 ft amsl whilst following a course towards Dunkeswell, consistent with

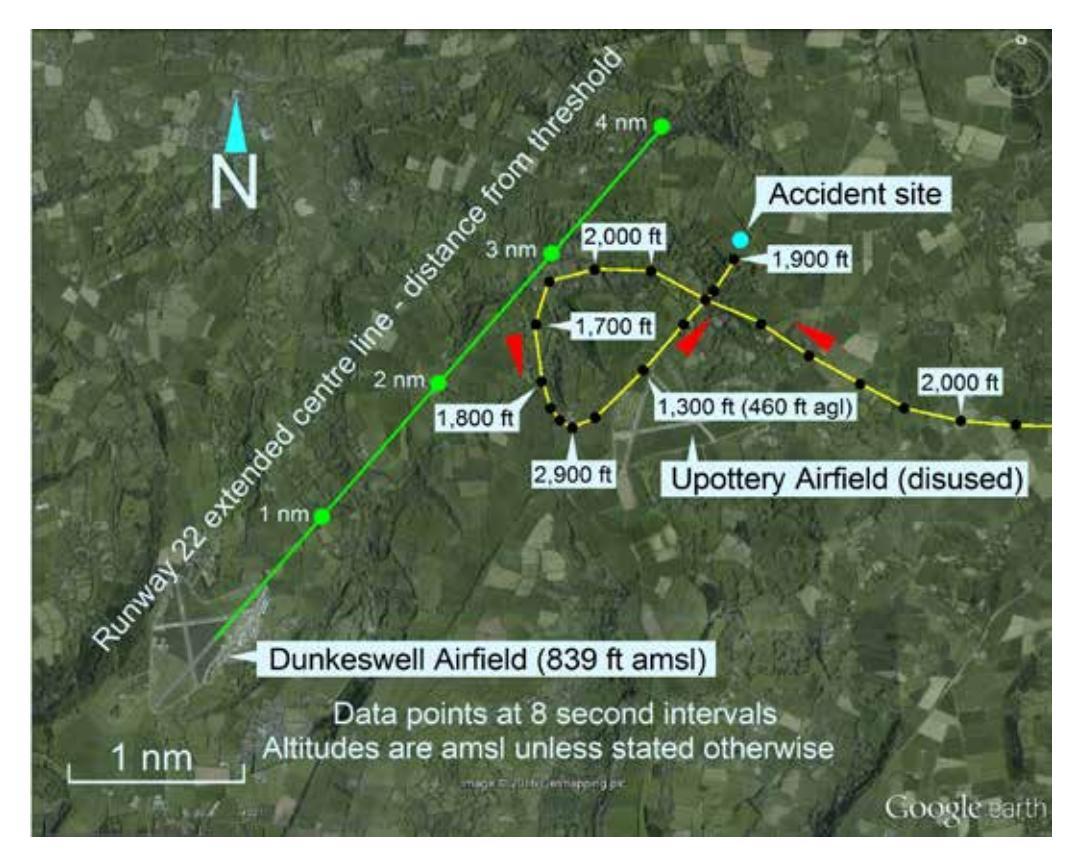
# Figure 4

At an altitude of about 2,000 ft amsl<sup>11</sup> (about 1,375 ft agl) and a range of 3 nm from the runway threshold (consistent with a vertical approach path of  $3.5^{\circ}$ ), the aircraft proceeded to close to within approximately 150 m of the extended centreline (Figures 3, 4 and 5). However, rather than establishing onto the final approach, the aircraft continued to turn to the left whilst also descending The aircraft's groundspeed at this point was 144 kt and its estimated airspeed was 153 KIAS, based on the reported wind of 220° at 16 kt. During the turn towards the extended centreline, the turn rate progressively increased from 0.25°/sec to 1.8°/sec over a 24 second period.

Approach to Dunkeswell (Burrington Comb radar) - plan view
