# Rail Accident Report

## **Derailment of a passenger train at Ealing Broadway 2 March 2016**

Report 24/2016  
December 2016

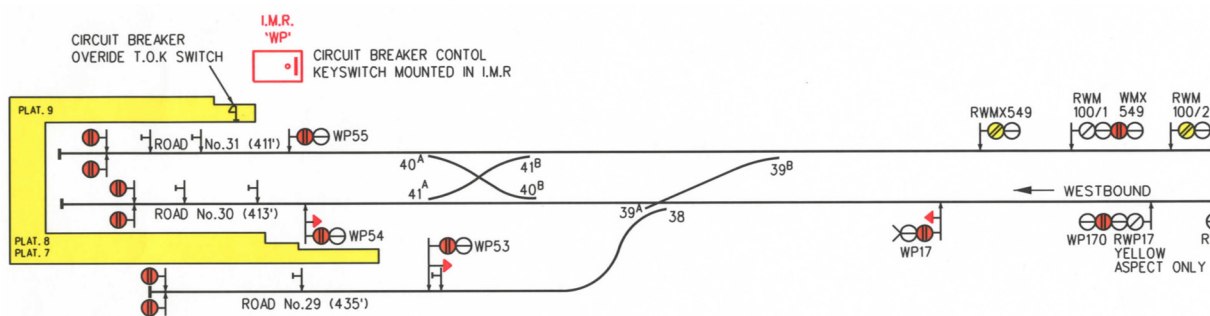
Figure 3: Extract from the Traffic Controller's Diagram showing the track layout at Ealing Broadway

- 41 The service controller contacted the train operator of train 011 to inform him that there had been a signal failure and train 011 might be held at signal WP17 (see figure 3) for a while. The service controller contacted the train operator four times over the next ten minutes in connection with making arrangements for the Ealing Broadway station supervisor to secure 38 points in order to permit the train to travel to the platform.

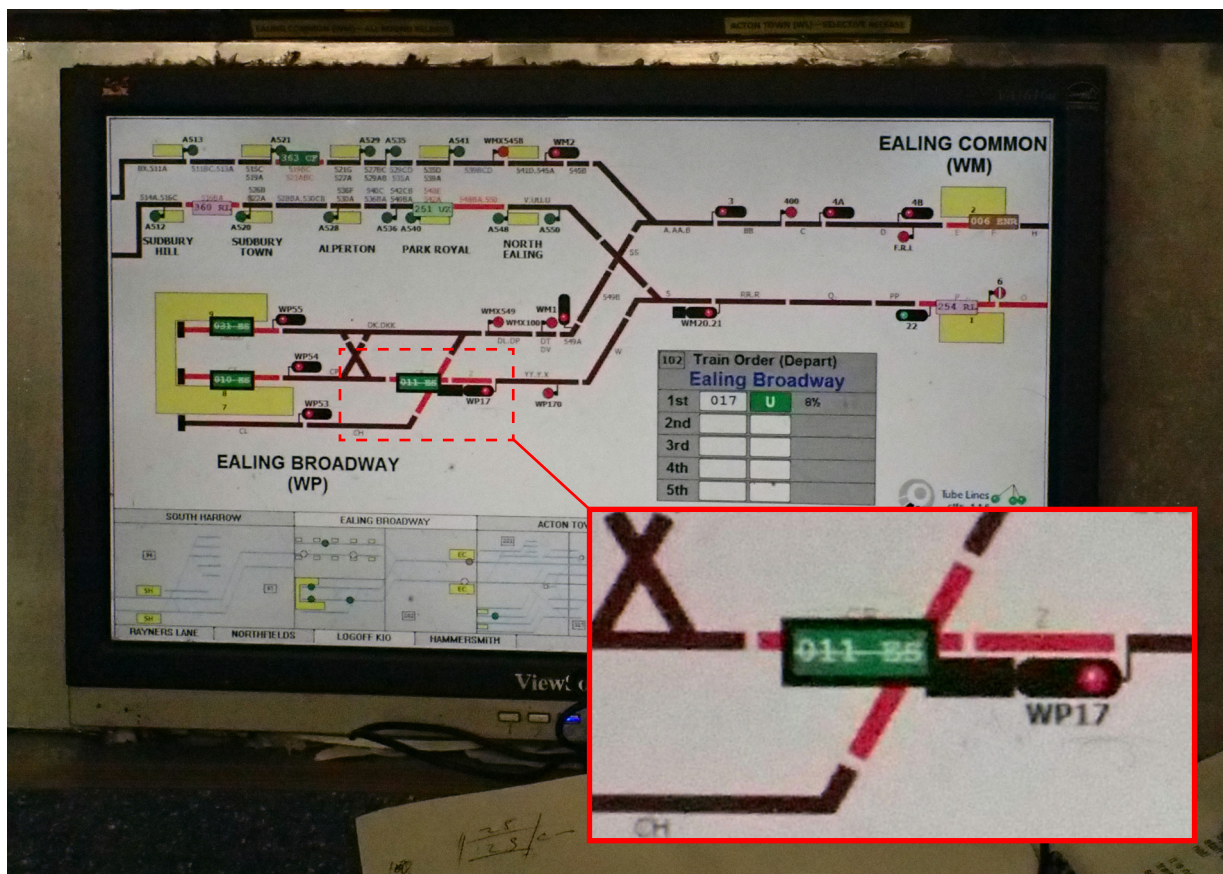
83 The signaller had the overview panel (figure 8), the centralised train following system screen (figure 9) and an out of date A4 version of the Traffic Controller's Diagram (figure 10) available to assist him with understanding the track layout at Ealing Broadway. Neither of the first two gave any indication of the position the points were in, and only the Traffic Controller's Diagram gave any information about which point positions were normal and which reverse. There was an up to date version of the Traffic Controller's Diagram at the front of the signaller's log book, but he was not aware of its presence.

Figure 9: Signaller's centralised train following system screen with insert showing the detail of train 011 on the crossover

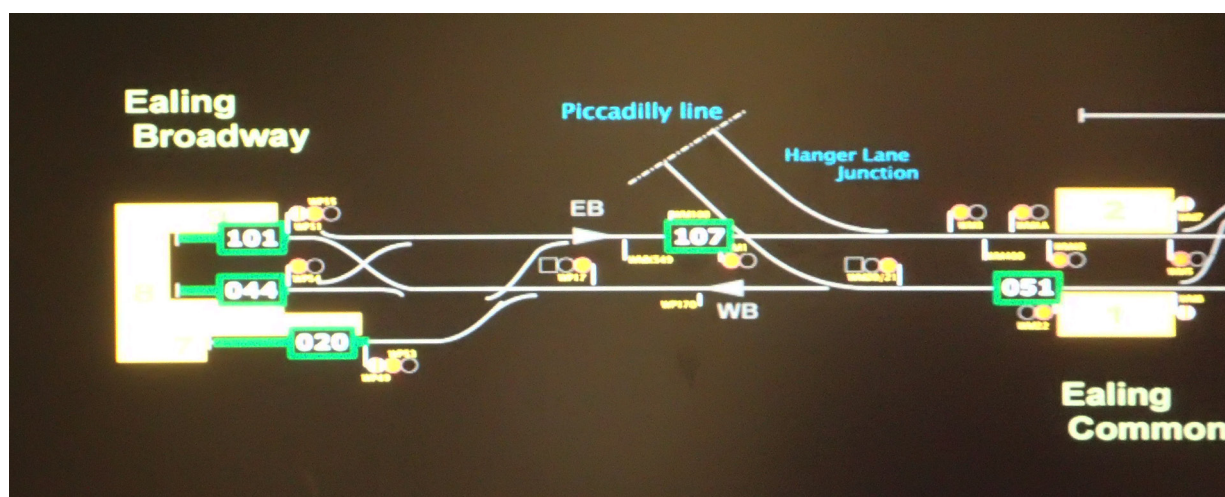
- 86 The District line service controllers had a later version of the diagram (figure 11) and *Tracknet* (figure 12) to inform their decision making (although LUL company standards state that the Tracknet system must not be used as the basis of safety critical decisions).

Figure 12: Tracknet overview available to the service controllers
