SERIOUS INCIDENT

Aircraft Type and Registration:	Airbus A319-111, G-EZFJ	
No & Type of Engines:	2 CFM CFM56-5B5/3 turbofan engines	
Year of Manufacture:	2009 (Serial no: 4040)	
Date & Time (UTC):	14 April 2016 at 0847 hrs	
Location:	Malaga Airport, Spain	
Type of Flight:	Commercial Air Transport (Passenger)	
Persons on Board:	Crew - 6	Passengers - 157
Injuries:	Crew - None	Passengers - None
Nature of Damage:	None	
Commander's Licence:	Airline Transport Pilot's Licence	
Commander's Age:	57 years	
Commander's Flying Experience:	21,000 hours (of which 4,000 were on type) Last 90 days - 200 hours Last 28 days - 78 hours	
Information Source:	AAIB Field Investigation

Synopsis

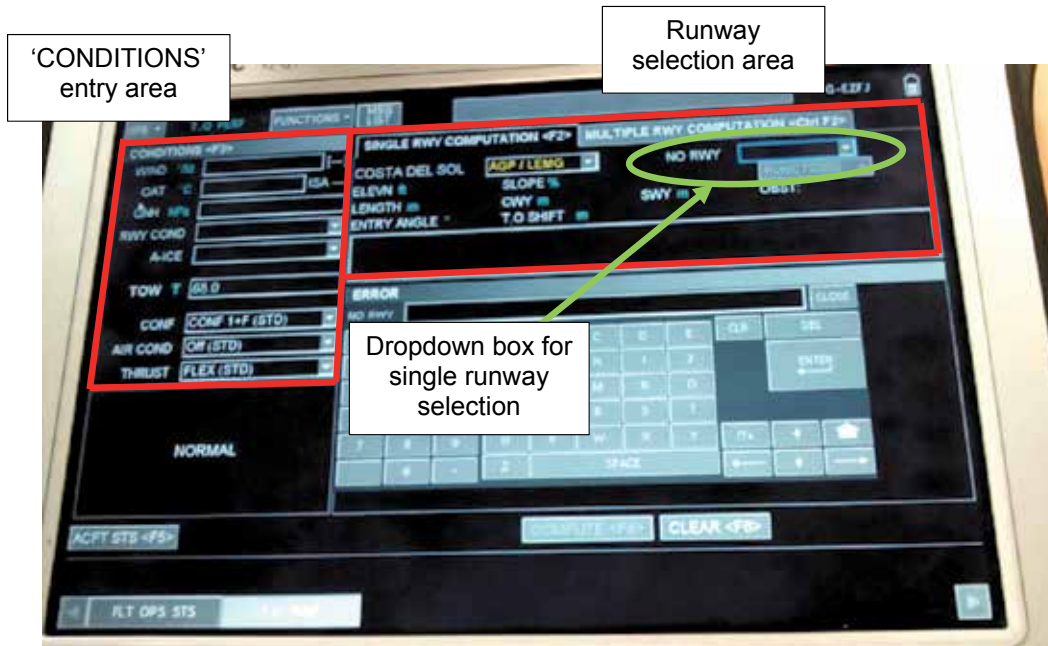
Figure 1

To calculate takeoff performance data, the crew enter aircraft and environmental information into the 'CONDITIONS' area and then select the runway they wish to use at the chosen airport (Figure 1). There are two options for runway selection; single and multiple. The operator indicated that most takeoff performance calculations were performed using the single runway option. The multiple runway option calculates takeoff performance data for all the selected runways to allow comparison and also a ranking of the runways in order of the highest thrust derate.

FlySmart takeoff performance screen

For single runway computations, the runway number is selected using a single drop-down menu at the top right (Figure 1). For the Multiple Runways selection, the operator described a typical usage:
