Report on the investigation of
the fatal man overboard from the
ocean rowing boat

Toby Wallace

North Atlantic Ocean

14 February 2016

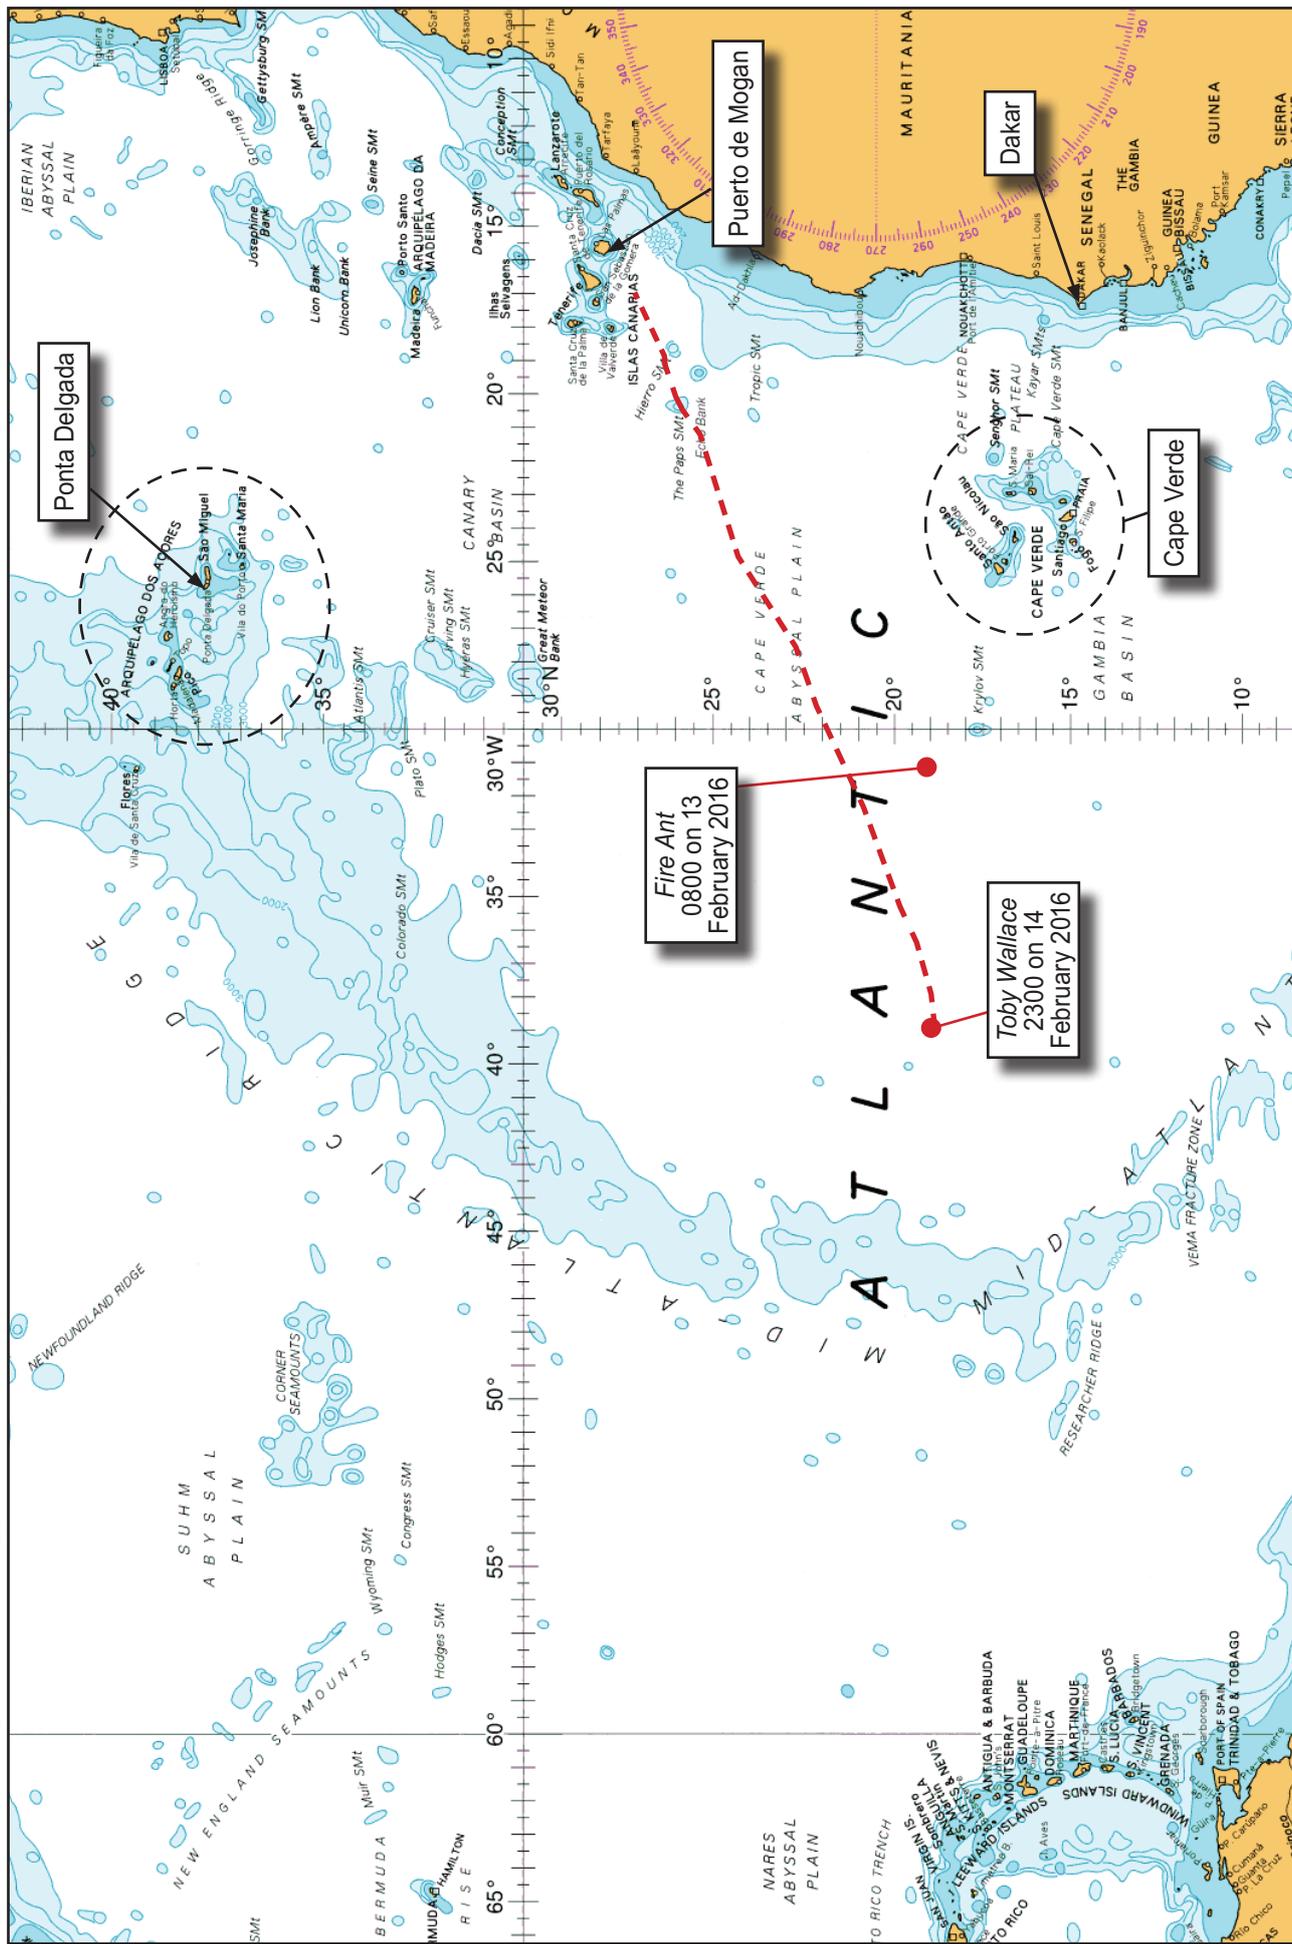
Figure 1: Toby Wallace – position on 14 February

On 28 January 2016, the 10.8m ocean rowing boat *Toby Wallace* departed from Puerto De Mogan, Gran Canaria for passage to Barbados, West Indies (**Figure 1**). On board were eight rowers who aimed to complete the voyage in less than 31 days.

As *Toby Wallace* was in the Portuguese search and rescue (SAR) region, MRCC Falmouth passed responsibility for co-ordination of the incident response to MRCC Ponta Delgada, Azores (**Figure 1**). MRCC Ponta Delgada arranged for a French Falcon aircraft from Dakar, Senegal, and a Portuguese P3C Orion aircraft from Portugal to search for the missing rower. The Bahamas registered cargo ship *Sea Pearl*, which was about 113nm to the east of *Toby Wallace*, was also diverted.
