Report on the investigation of the collision

City of Rotterdam

Primula Seaways

3 December 2015

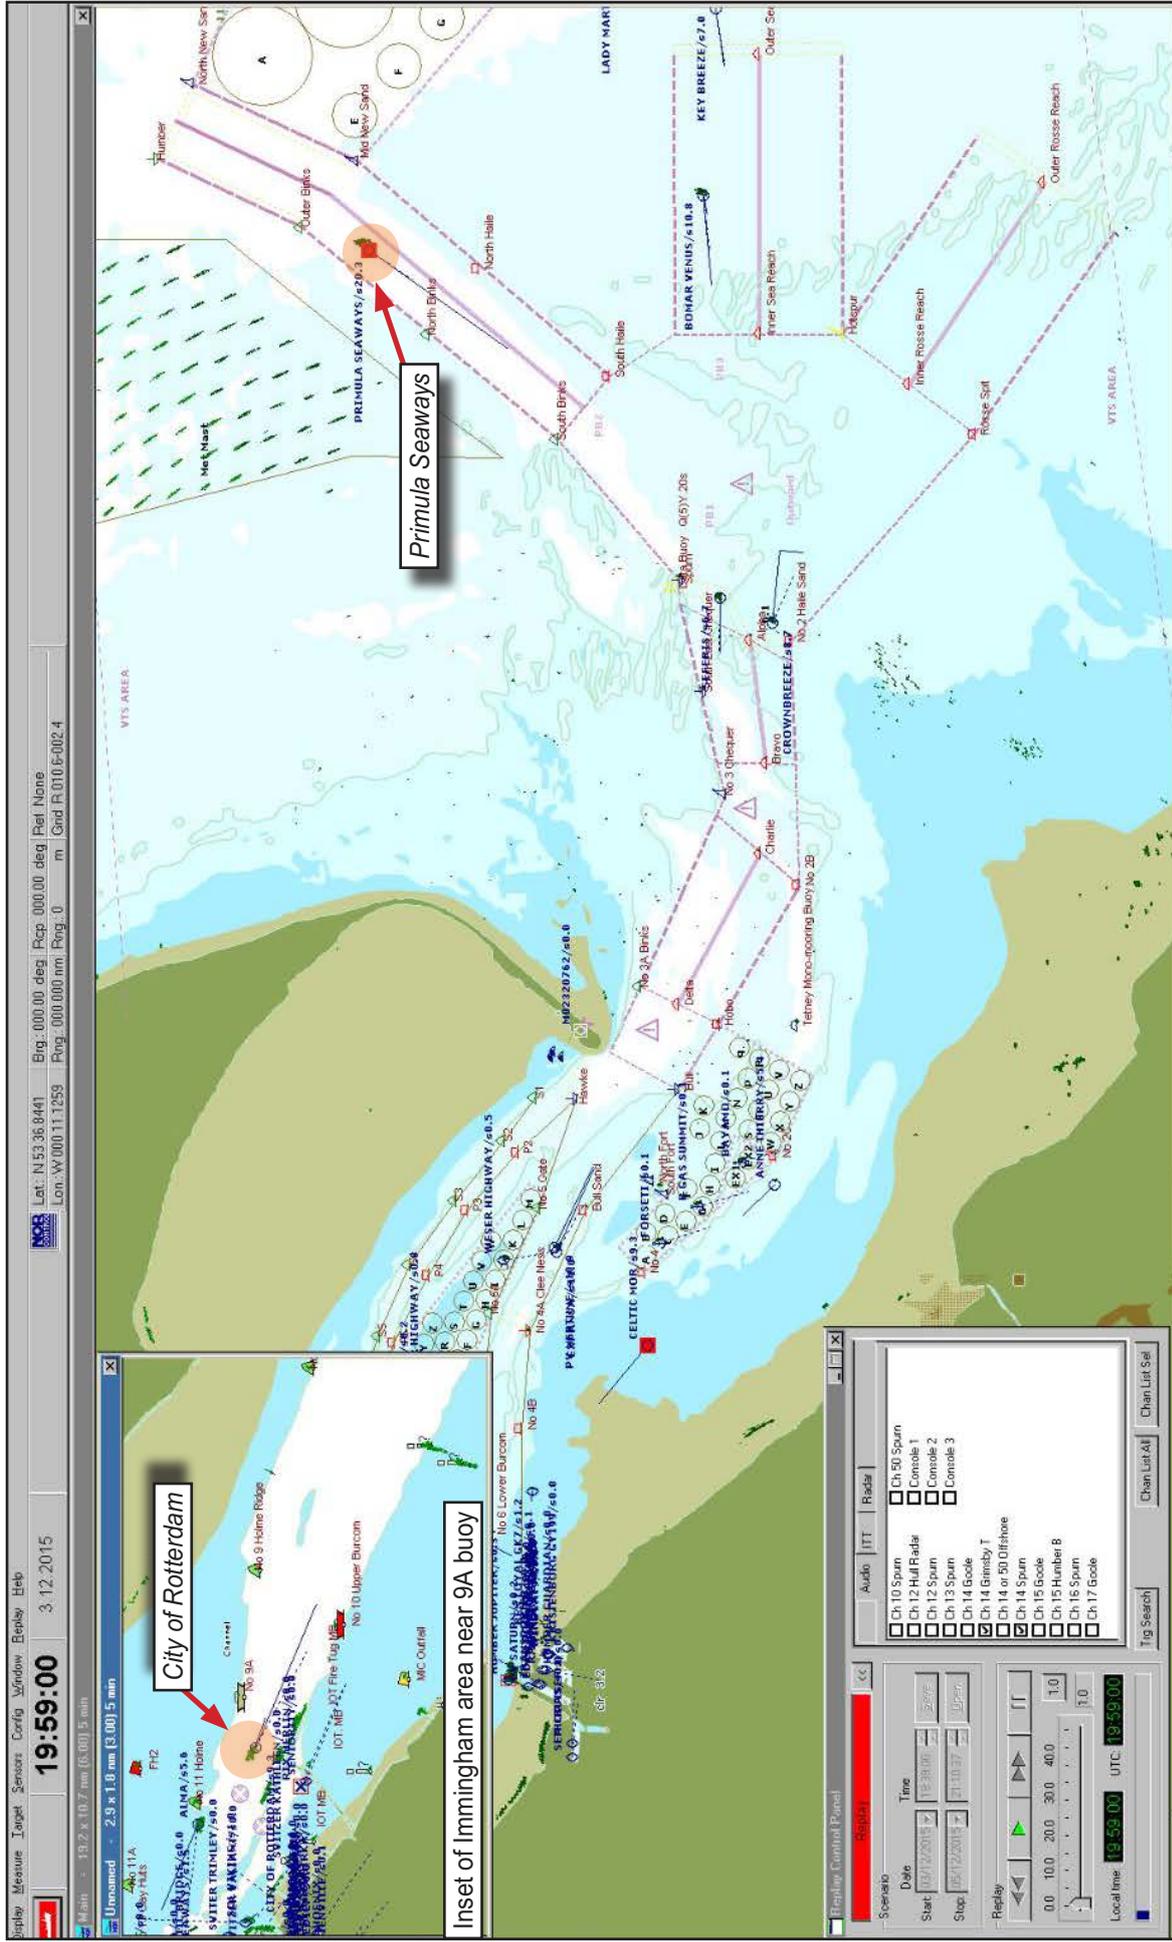
Figure 3: Vessels' position at 1959

At 1858, *City of Rotterdam* sailed from its berth and the pilot conned the vessel in to Immingham lock. By 1959, the vessel had cleared the lock, released the attending tugs and was passing 9A buoy in the main navigation channel in the River Humber (**Figure 3**). The vessel was on a south-easterly heading in manual steering at a

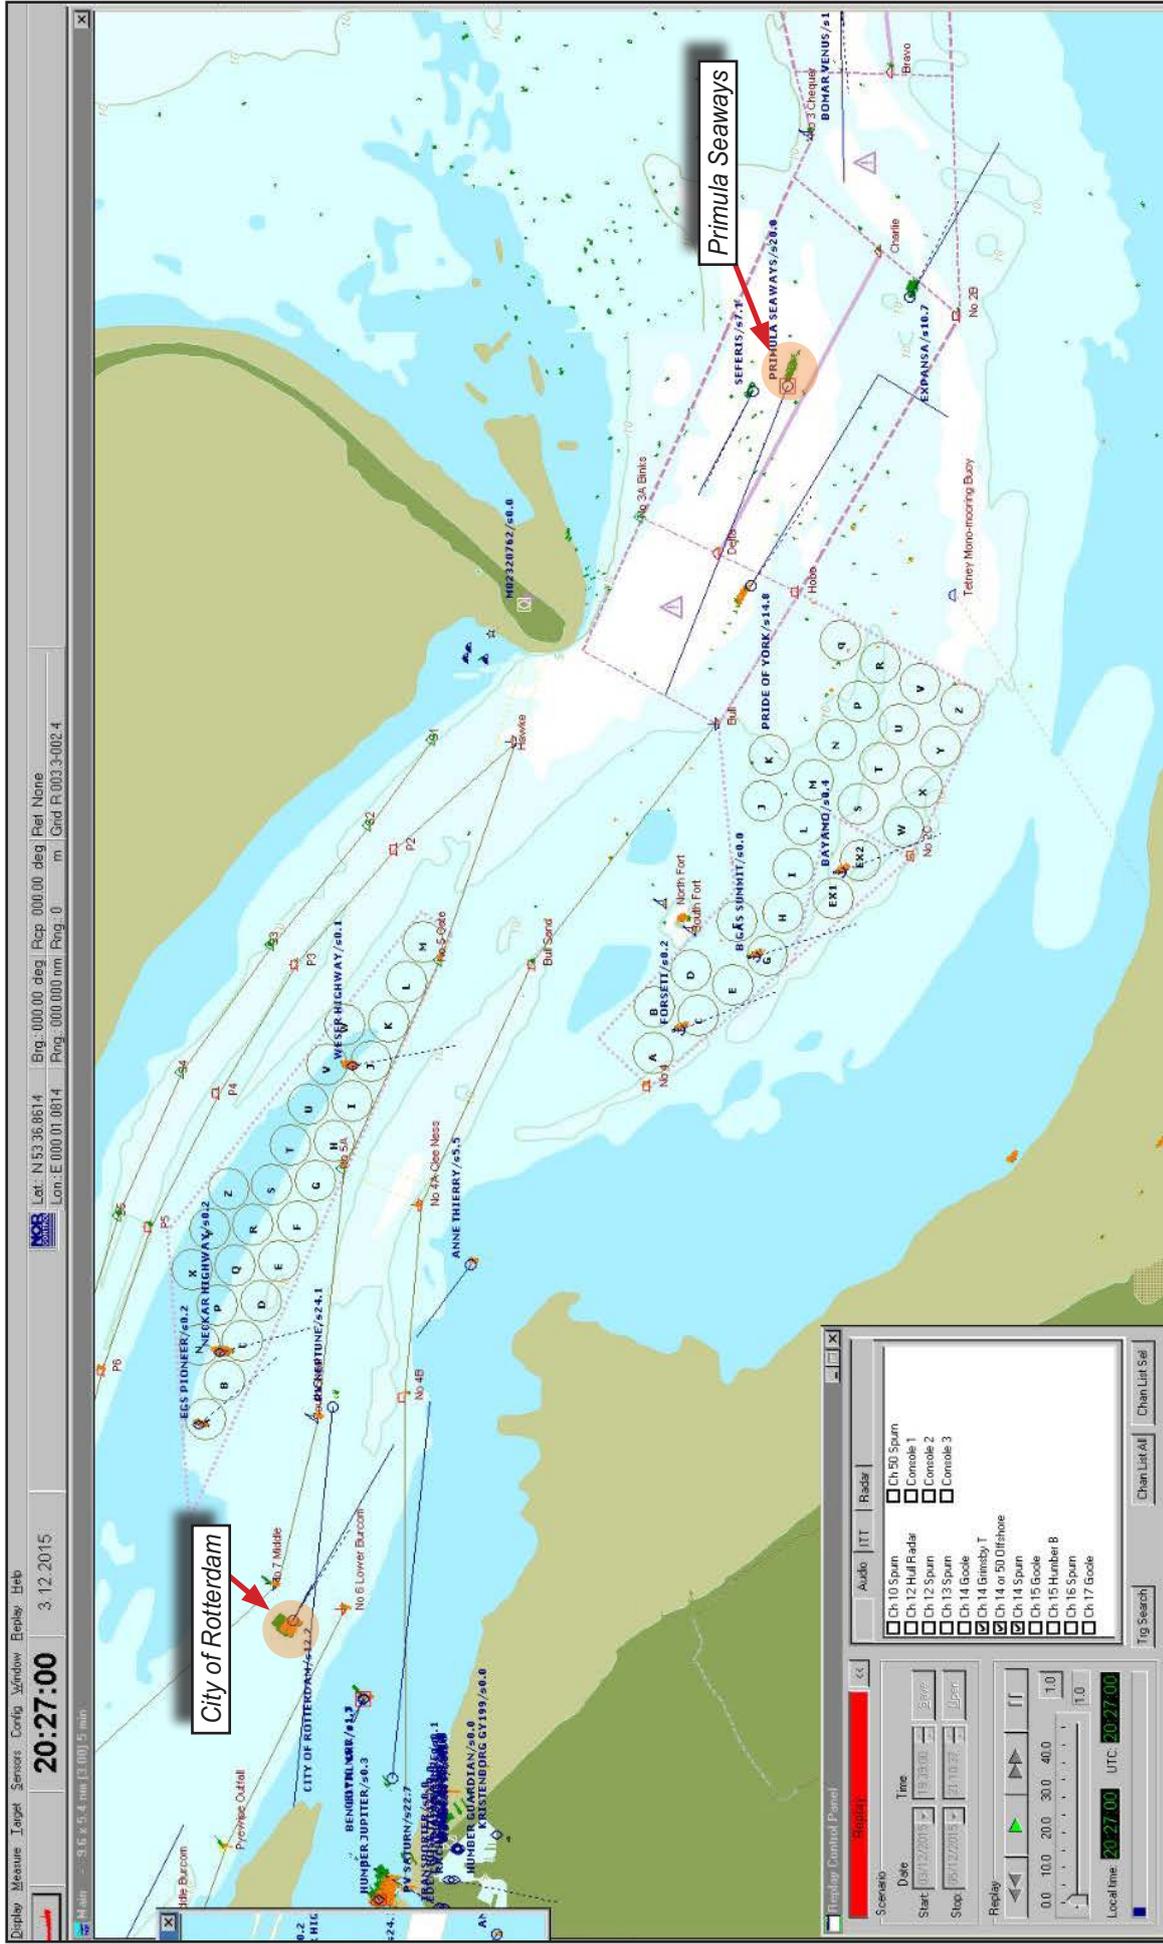
Figure 4: Vessels' position at 2027

At 2027, *City of Rotterdam* passed the Grimsby Middle buoy on a heading of 125° (**Figure 4**). At that time, the Denmark registered ro-ro freight ferry *Primula Seaways* was in the outer approaches of the River Humber, inbound for Immingham. The ferry was on a trackpilot controlled heading of 291° at 20kts and was overtaking the Malta registered bulk carrier *Seferis*. On the ferry's bridge were the master, second officer and an AB. The second officer was seated in the chair to starboard of the central conning station (**Figure 5**). He was monitoring the ferry's position on the Electronic Chart Display and Information System (ECDIS) and by radar. The master had the control of navigation and was seated in the chair on the central console's port side.

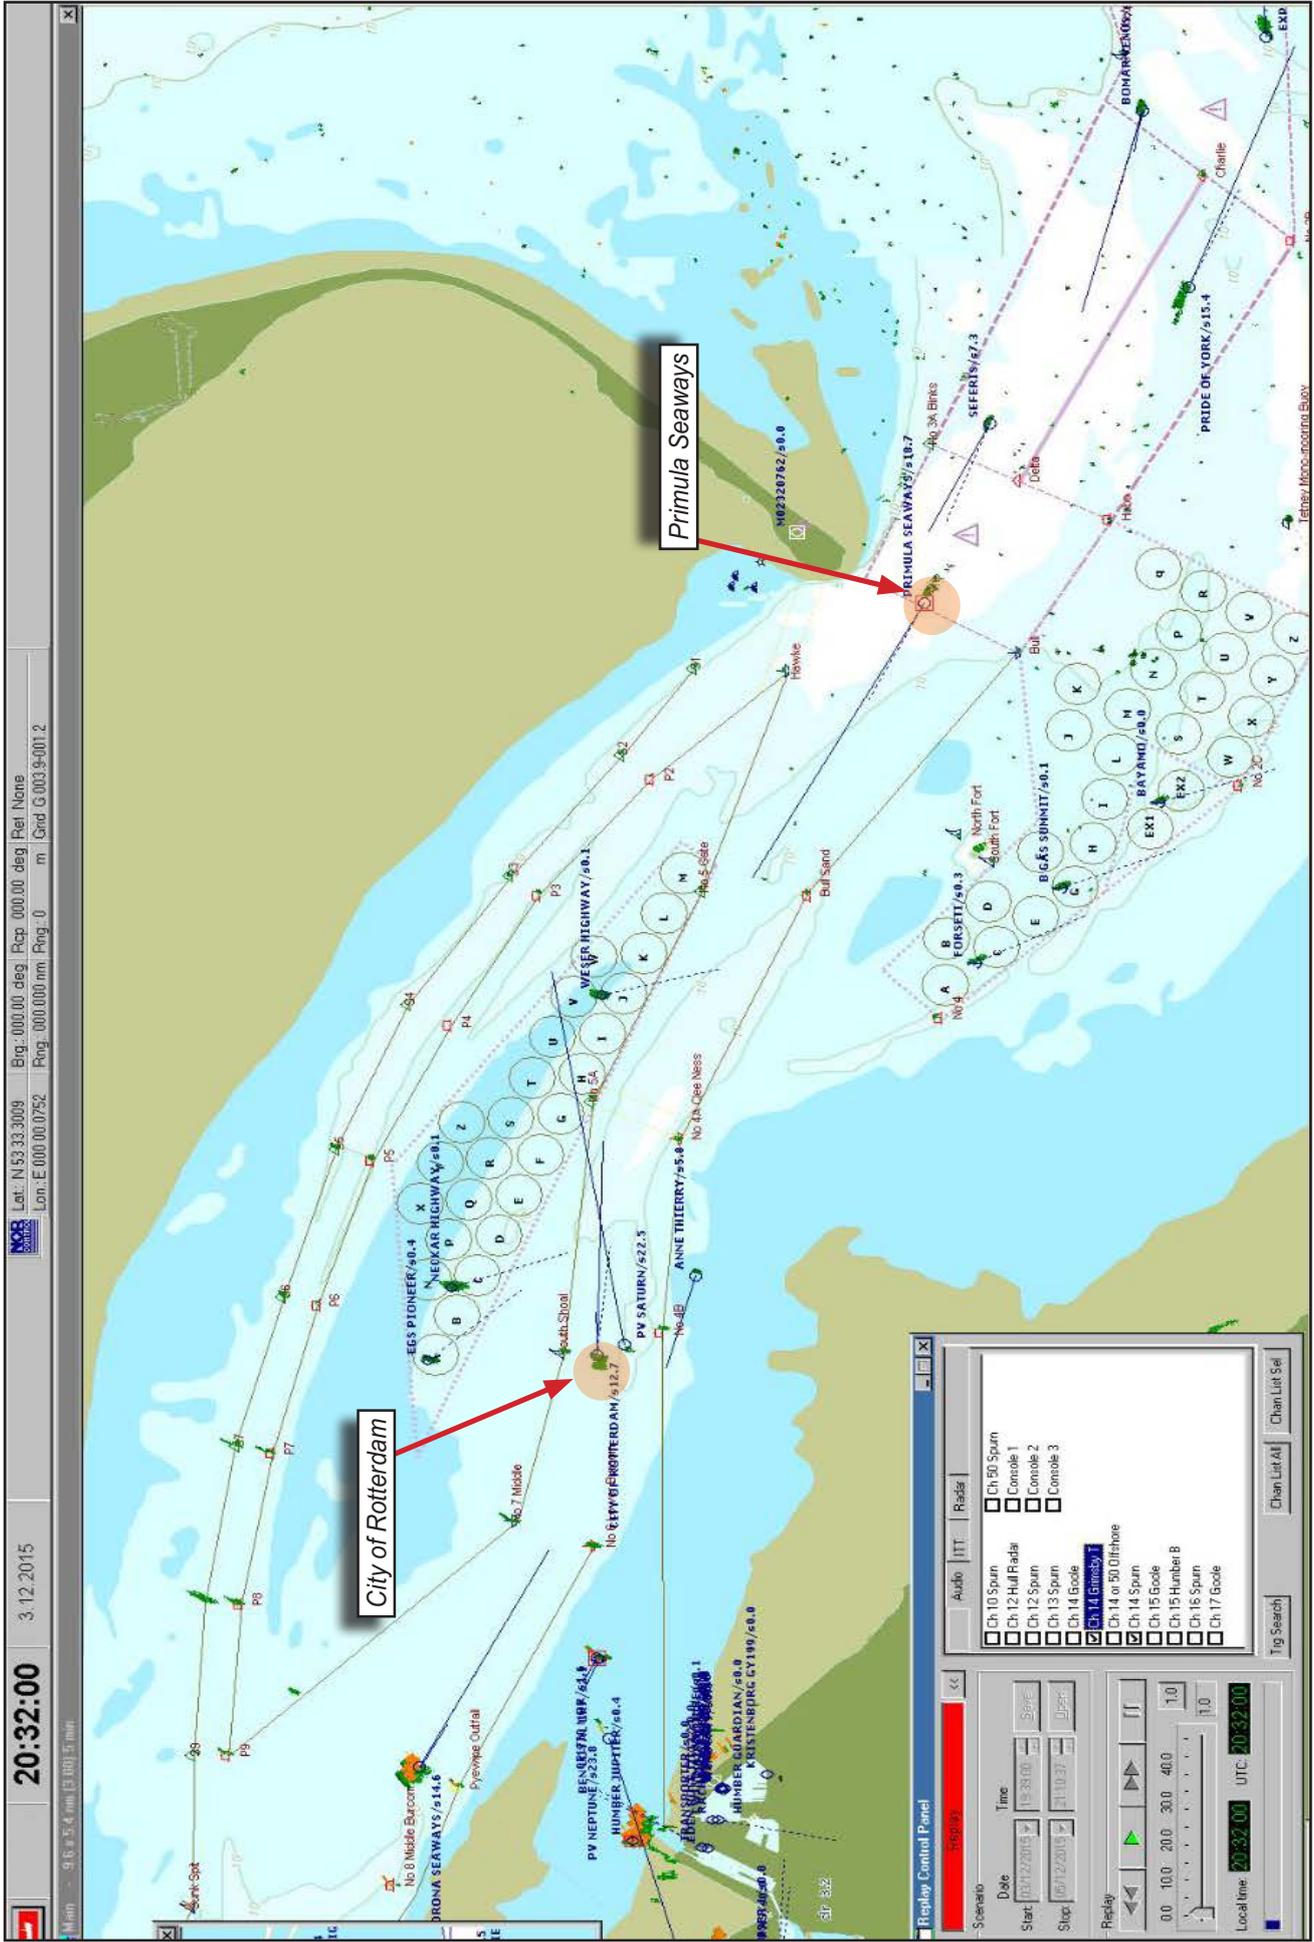
Figure 6: Vessels' positions at 2032

Between 2027 and 2032, *City of Rotterdam's* pilot altered the vessel's heading from 125° to 095° in 5° increments (**Figure 6**). The vessel was to the north of the intended track and the pilot informed the master that he would try and manoeuvre the ship further to the south. By that time, *Primula Seaways* was in clear sight and the pilot informed the master that the vessels would pass port to port.

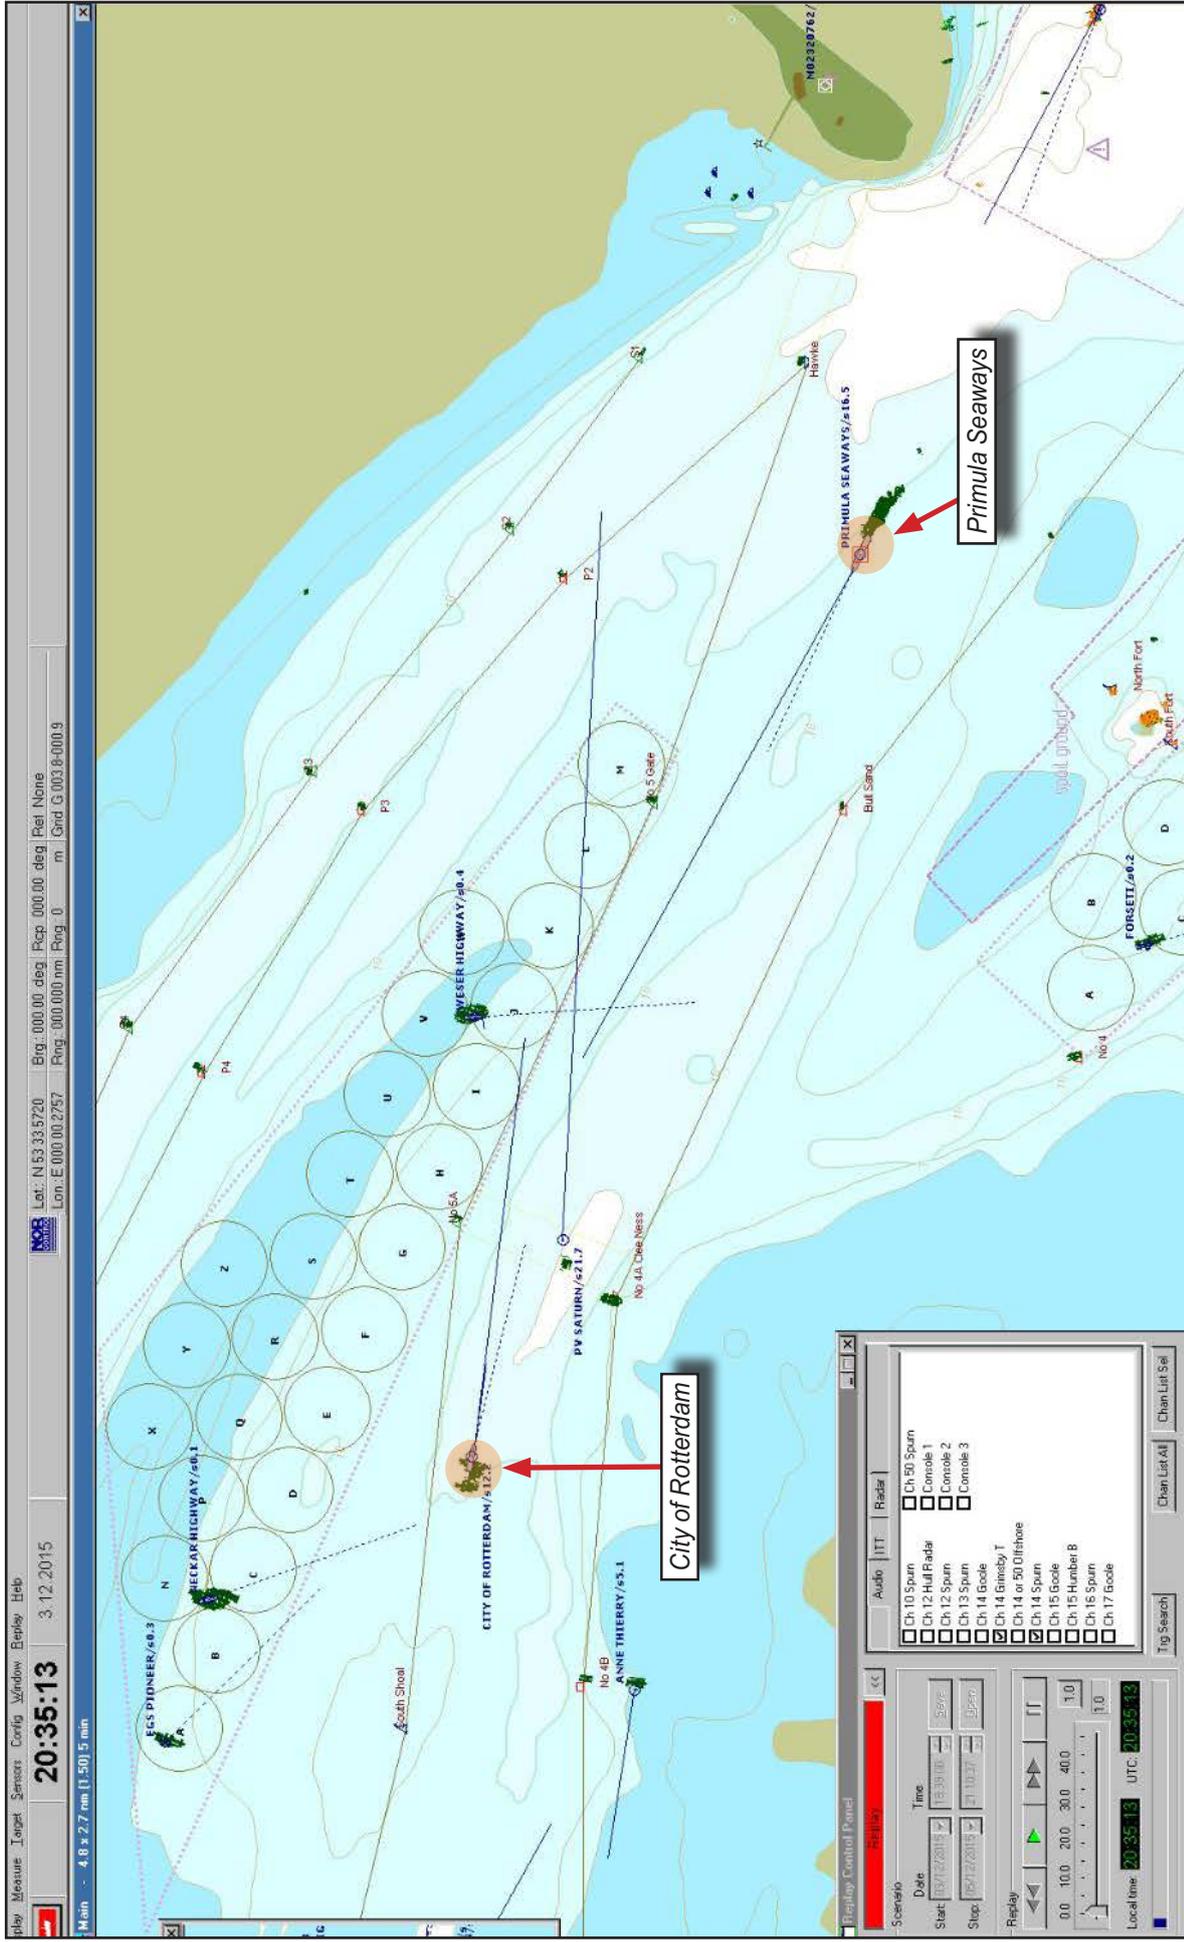
Figure 7: Vessels' positions at 2035

Primula Seaways' master and second officer continued to be concerned that *City of Rotterdam* remained on the northern side of the channel and did not appear to be altering course. The VTS watch manager was now also concerned, and he and *Primula Seaways*' second officer called the car carrier in quick succession on VHF channel 14 at 2037 (**Table 3**). The pilot replied, again using the VHF radio on the starboard side of the bridge front.

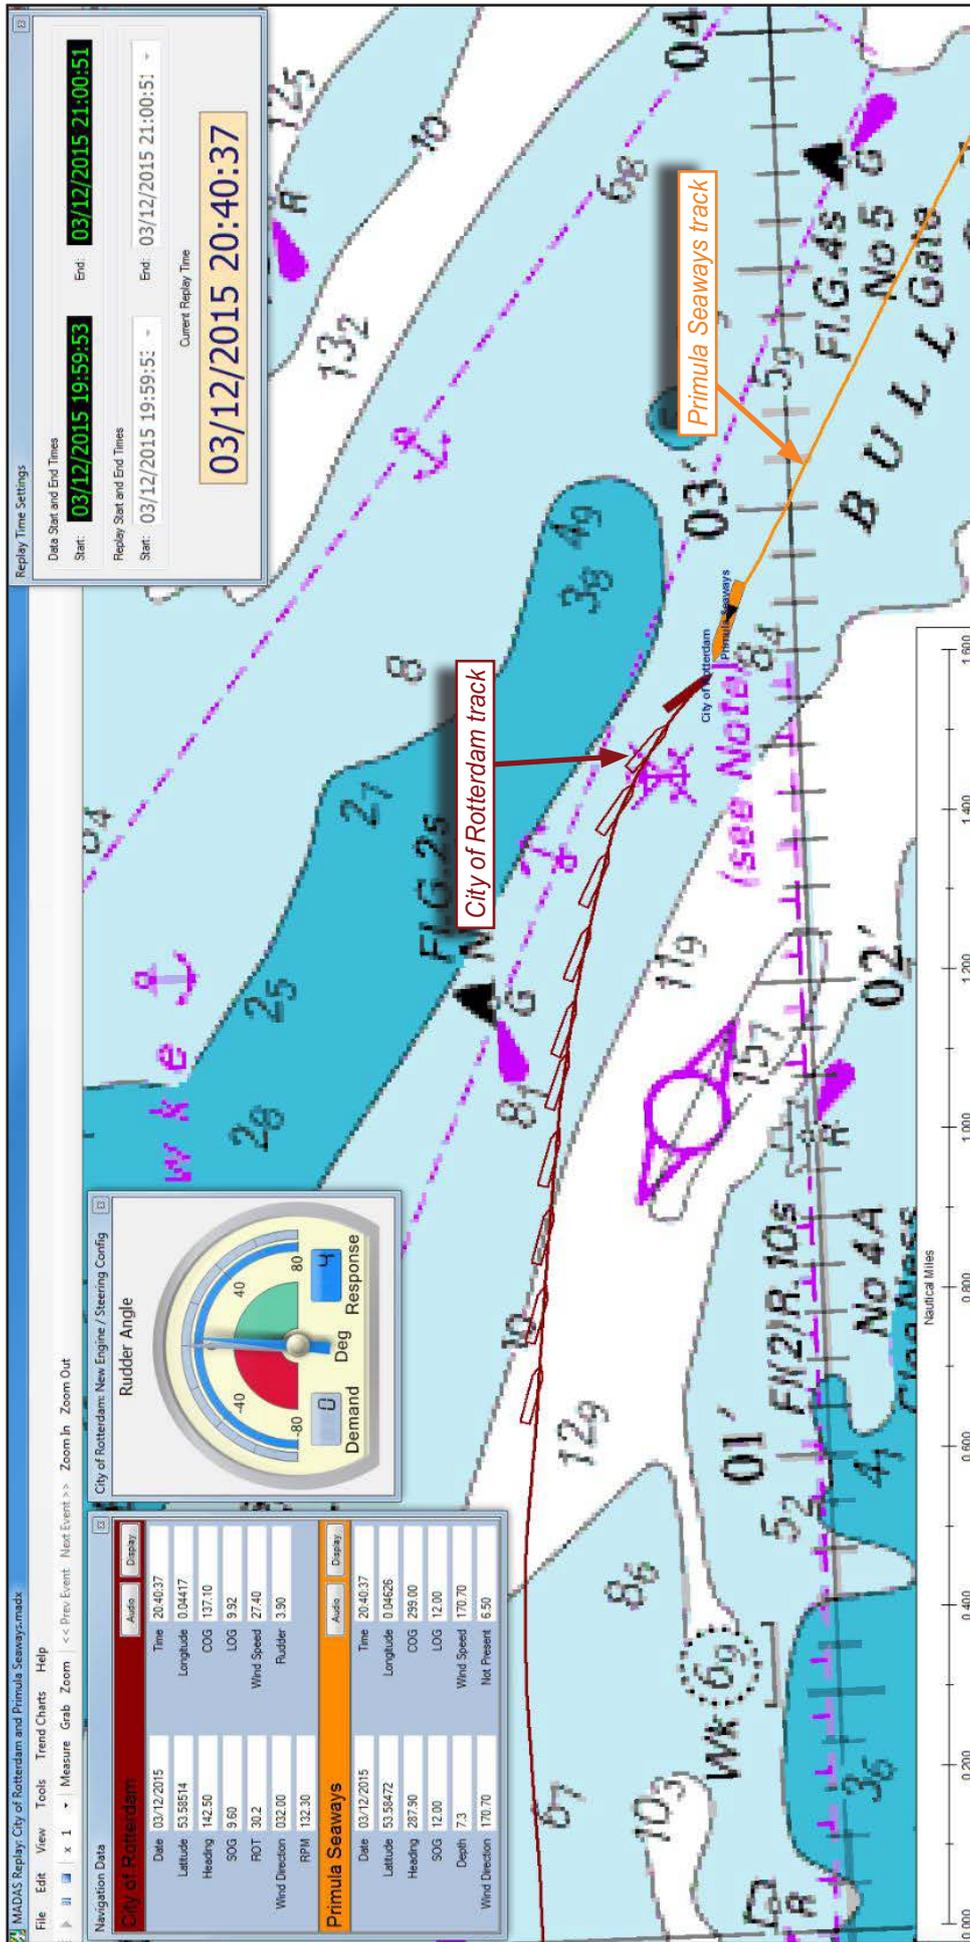
Figure 9: Vessels' positions at 2040

On impact, *City of Rotterdam* heeled to starboard. The master and pilot fell to the deck but they were not injured. The pilot reported the collision to the VTS and the car carrier was manoeuvred towards the Bull anchorage at slow speed. The general alarm was not sounded. The chief and second officers went to the bridge immediately. The chief officer then went forward to assess the damage while the on-watch engineers checked for damage in the machinery spaces.

City of Rotterdam's forward hydraulic system was badly damaged so the vessel was unable to anchor. As soon as it was confirmed that there had been no breach in the car carrier's watertight integrity, the VTS authorised the vessel to return to Immingham. The VDR data was saved, but no radar information was recorded due to the starboard radar display being on standby.

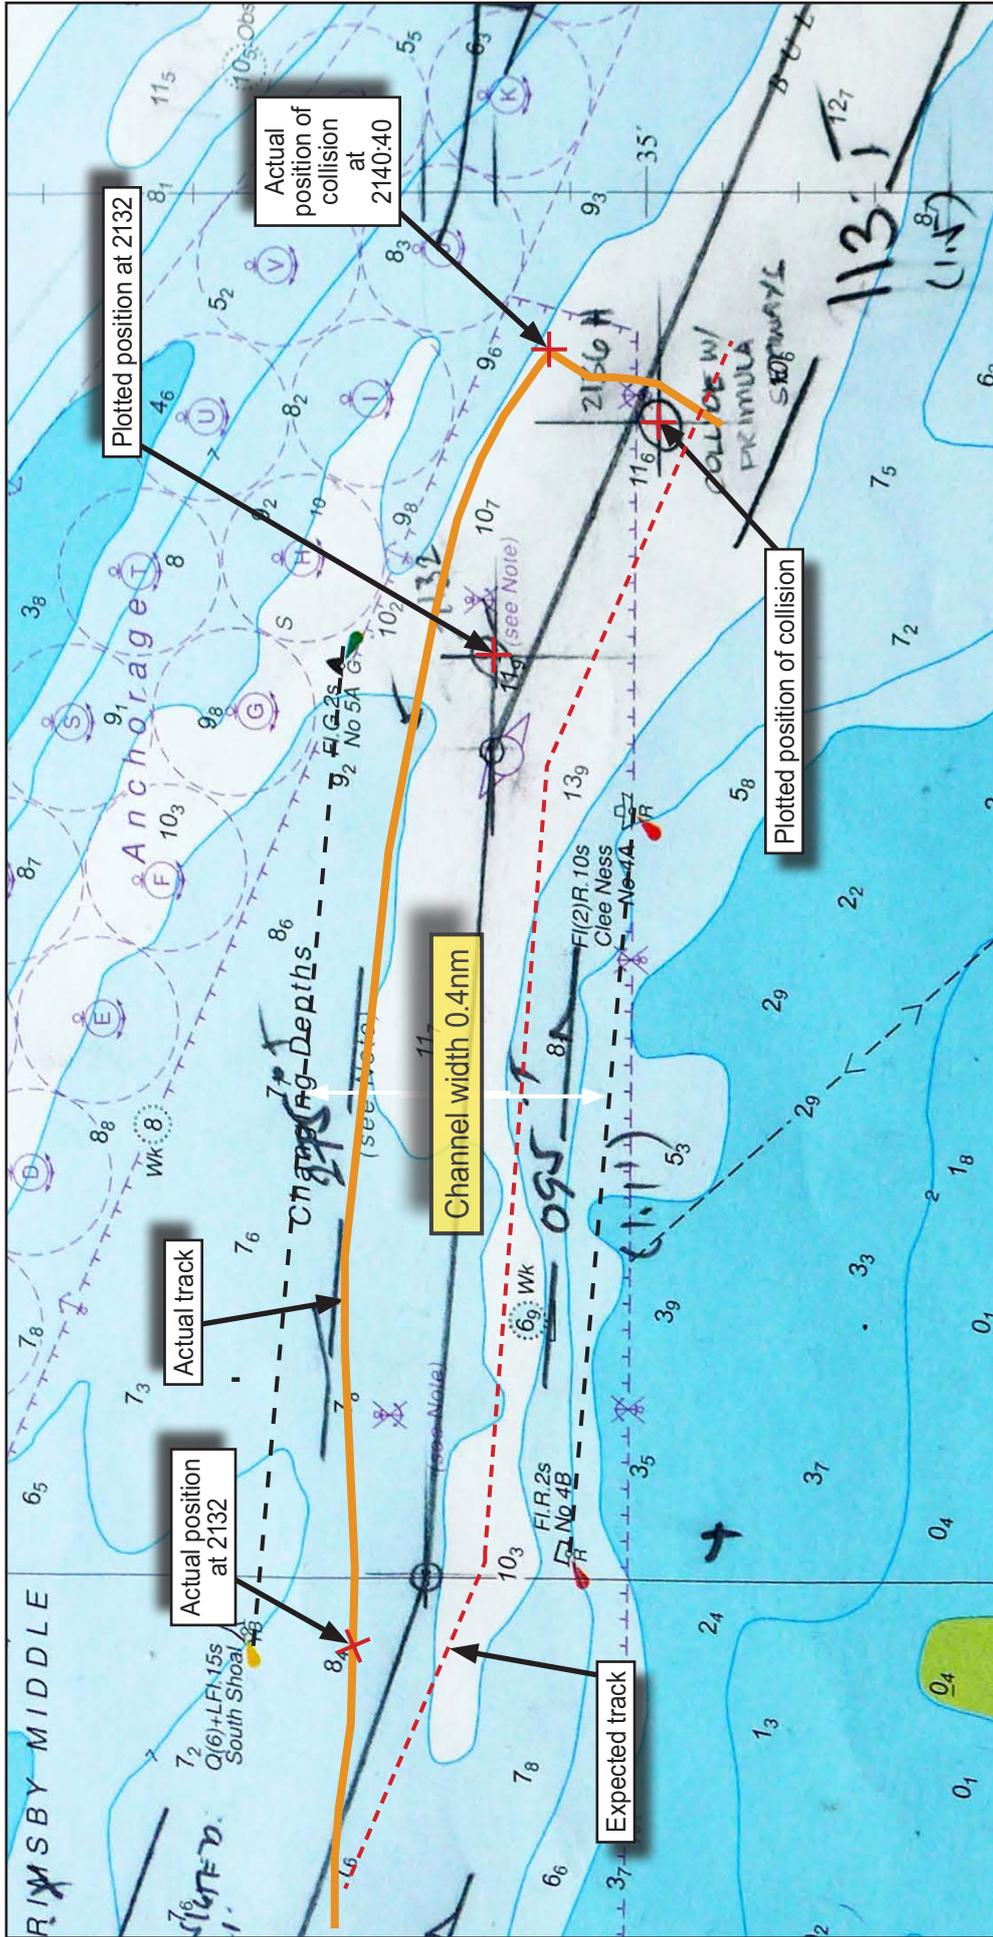
Figure 12: City of Rotterdam - extract of chart in use (with overlays)
Note: times on this chart are UTC (+1)

City of Rotterdam's primary means of navigation was paper charts, but the intended tracks for the vessel's departure from Immingham had also been input into the ECS. The tracks followed the axis of the buoyed channel and were generally equidistant from the port and starboard marks. During the passage in the Bull Channel, the third officer monitored the vessel's position on the ECS, but he had also periodically plotted positions on the chart (**Figure 12**).

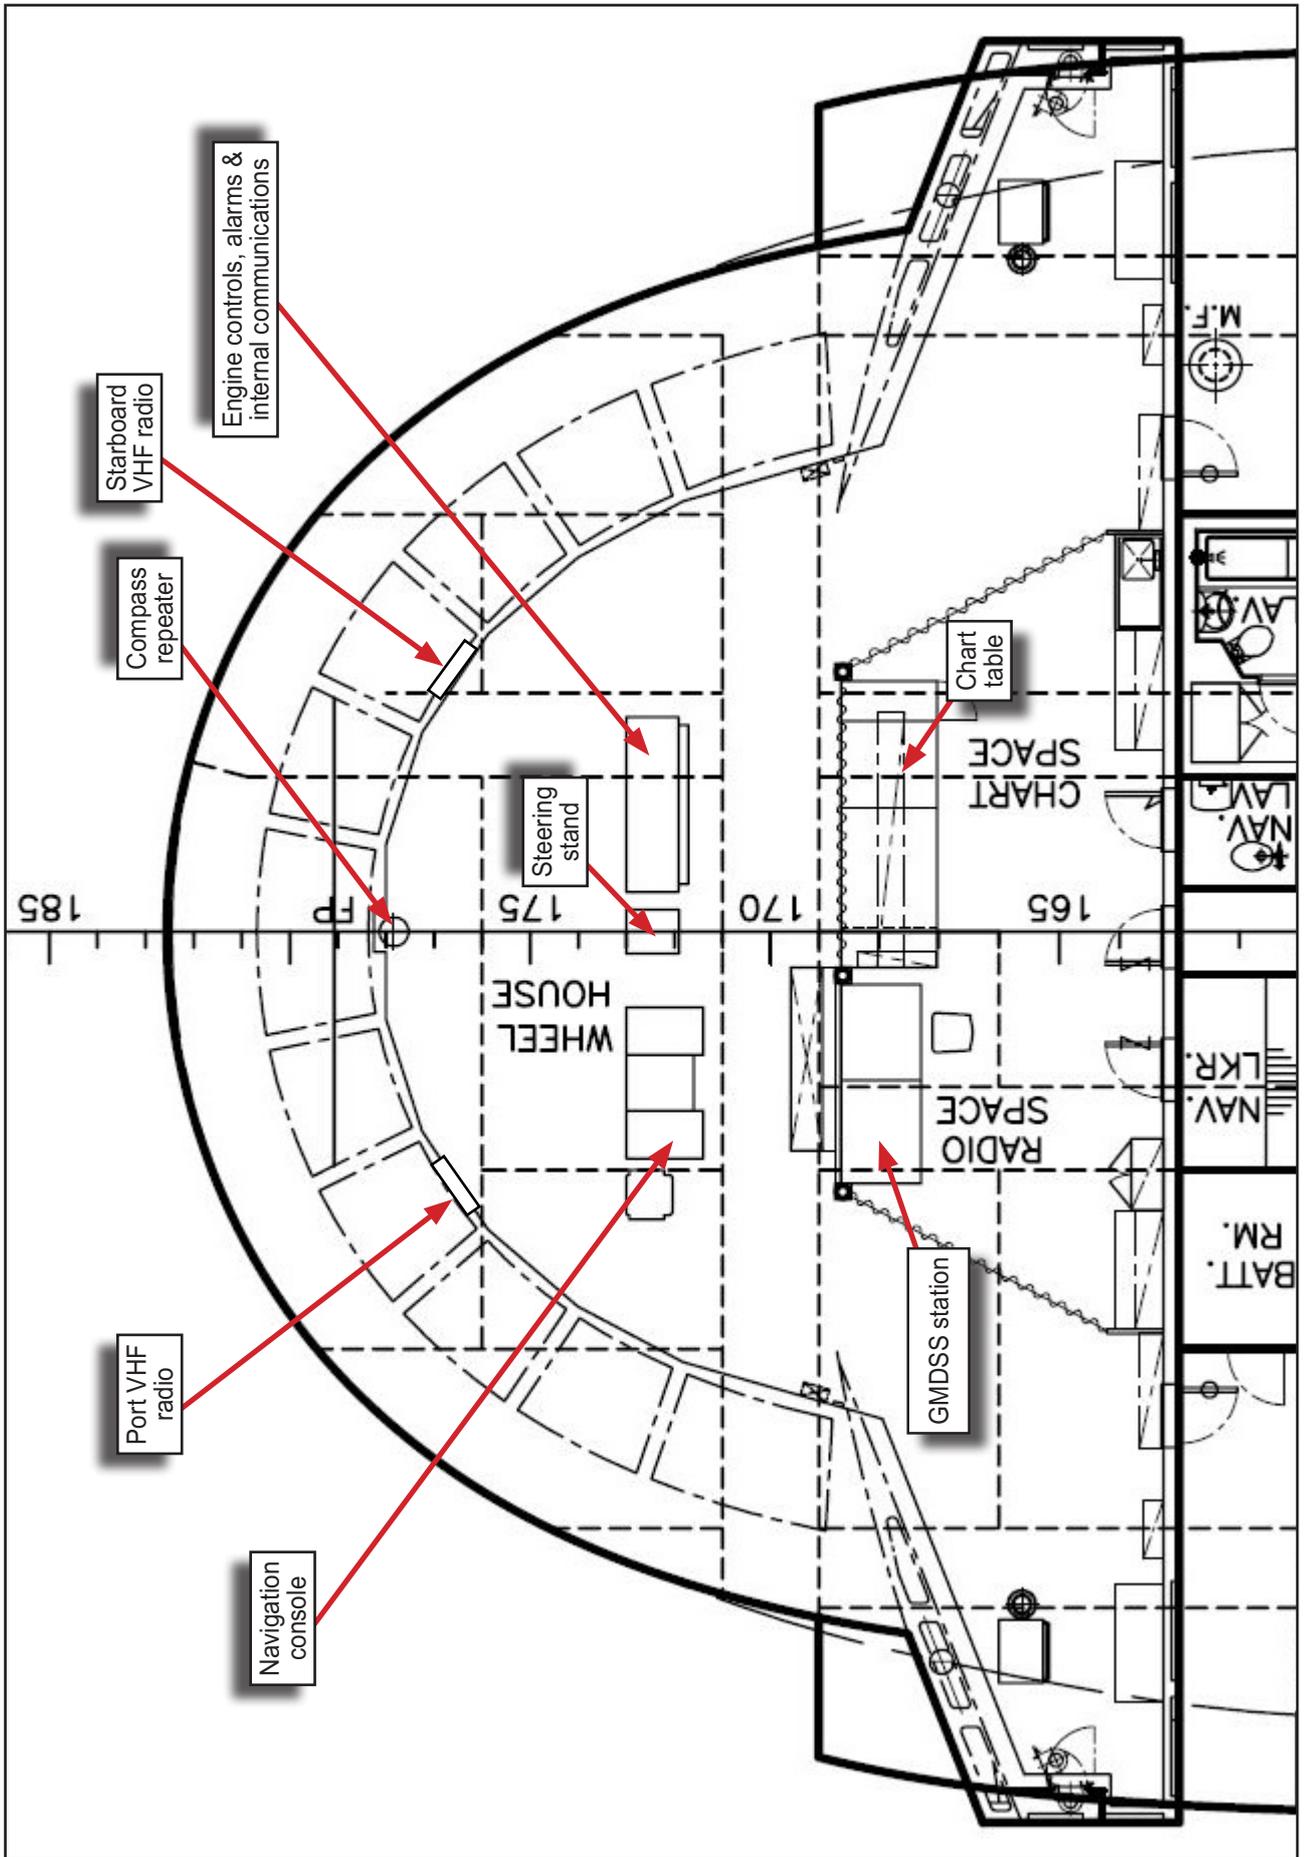
Figure 13: City of Rotterdam - Bridge arrangement

City of Rotterdam's hemispherical bow (**Figure 11**) was designed to reduce wind resistance and carbon emissions and to provide better fuel economy. A consequence of the bow's shape was that the vessel's bridge was of unconventional design (**Figure 13**). Only the front window on the centreline was perpendicular to the vessel's fore and aft axis. The angular difference between the centre window and the off-axis windows⁹ above the VHF radios mounted on the forward bulkhead was 33° (**Figures 14 and 15**). The windows also sloped inwards from the bottom at an angle of 55°.

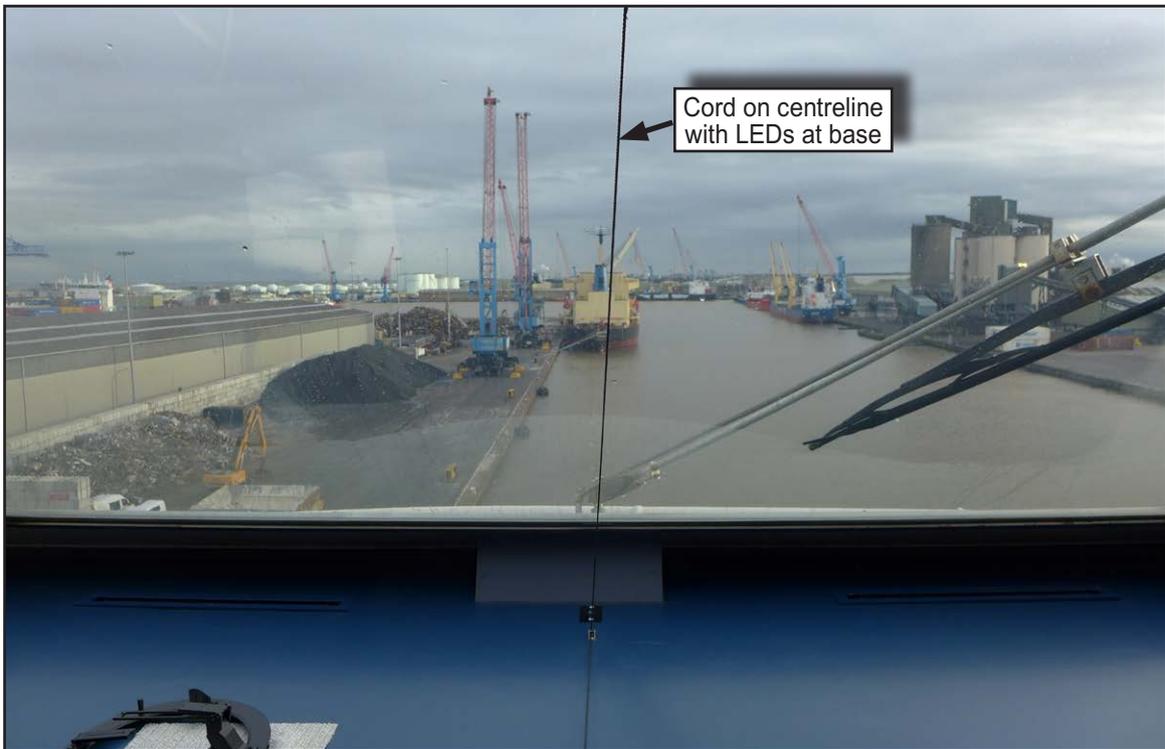
Figure 14: *City of Rotterdam* - view from centre window

None of the vessel's bow canopy was visible from the bridge, so to provide a visual reference of the vessel's centreline a length of black cord had been positioned down the middle of the centre window (**Figure 14**) with two green light emitting diodes (LEDs) at its base. A compass repeater, an automatic identification system (AIS) transceiver and a pilot plug were positioned by the centreline window (**Figures 2, 13 and 16**).

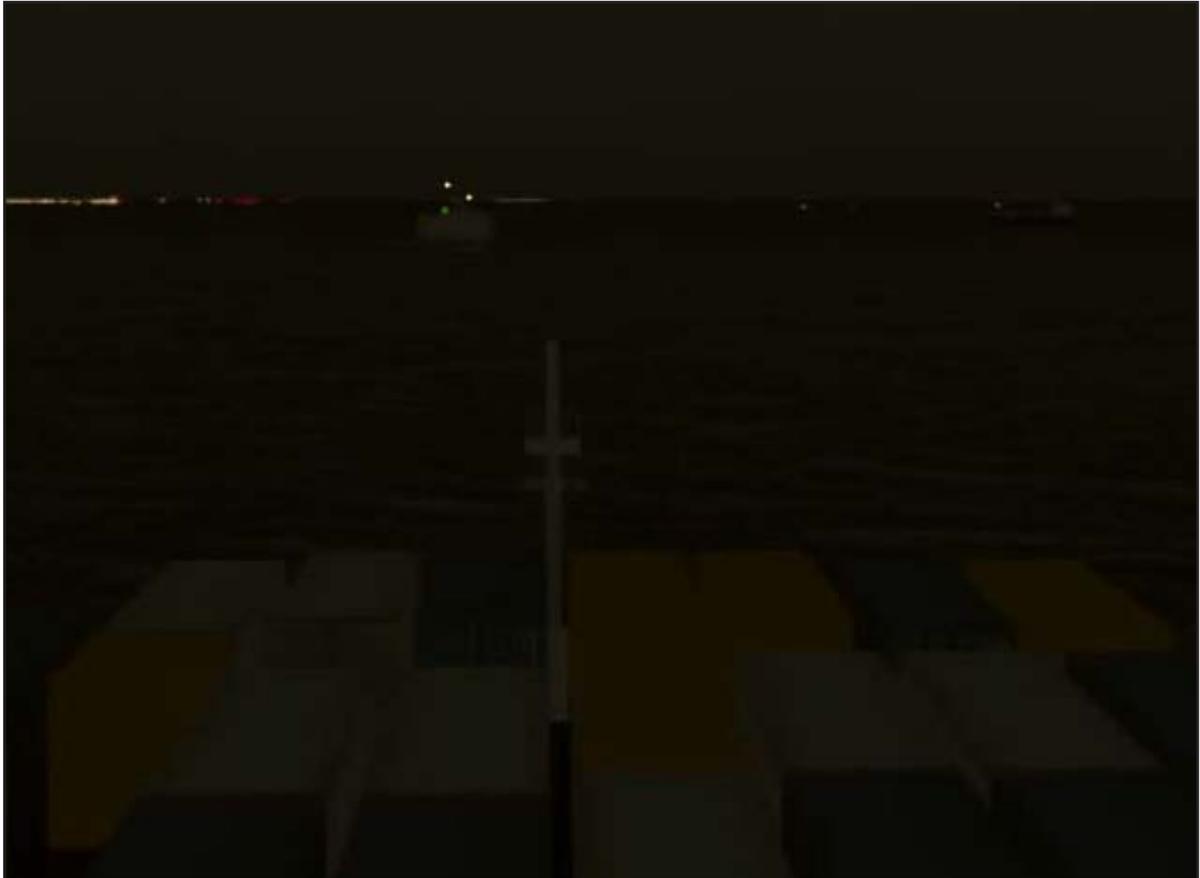
Figure 18: Simulated night-time view from *Primula Seaways* at 2038:25, *City of Rotterdam* is showing its two masthead lights and green sidelight

- When *Primula Seaways* started to reduce speed to ‘half ahead’ at 2038:25, *City of Rotterdam* was within 1nm (**Figure 18**). The car carrier’s pilot had informed the ferry’s master several times that he was manoeuvring to the south, yet there was no sign of the vessel doing so. From the simulations, it was evident that a course alteration to starboard would have caused the ferry to cross *City of Rotterdam*’s bow while an alteration to port would have exacerbated the close quarters situation that was developing if the car carrier did turn more to the south as the pilot had indicated.
