Rail Accident Investigation: Interim Report 2

**Fatal accident involving the derailment of a tram
at Sandilands Junction, Croydon
9 November 2016**

Report IR1/2017
February 2017

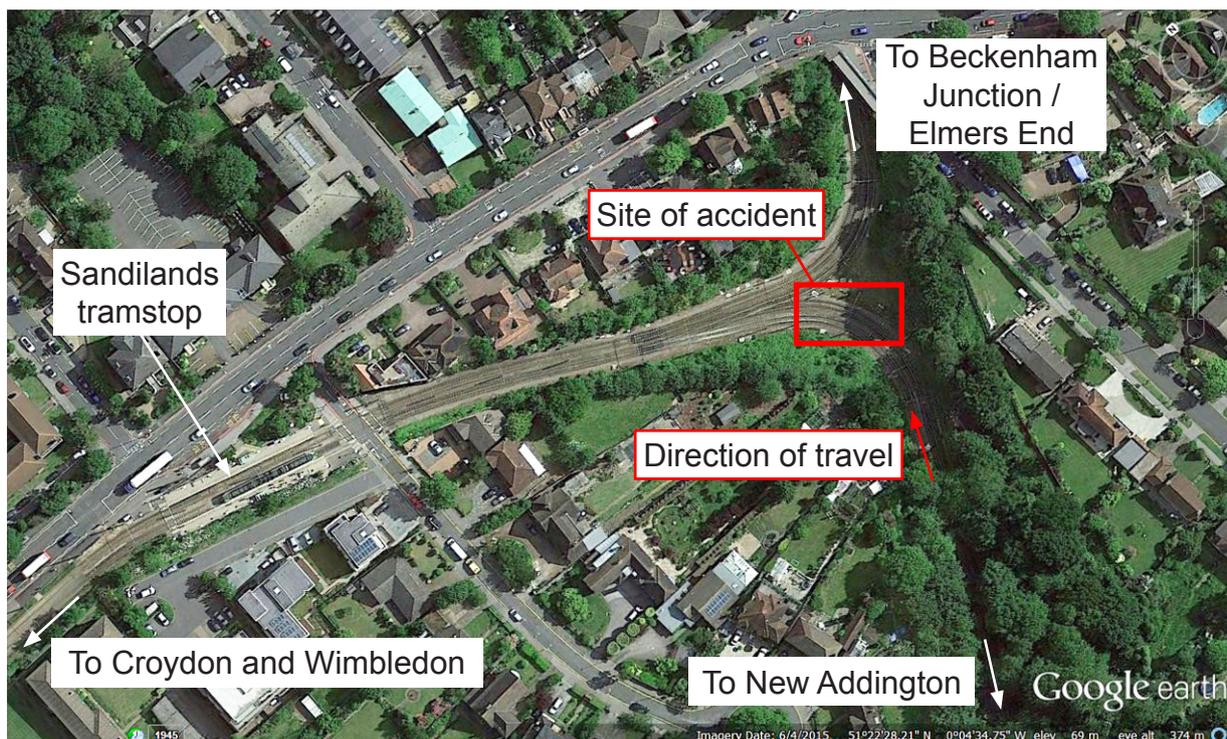
Figure 1: Google Earth image showing area where accident occurred

- 1 At about 06:07 hrs on Wednesday 9 November 2016, a tram running between New Addington and Wimbledon derailed and overturned on a curve as it approached Sandilands Junction, in Croydon (figure 1). The tram travelled for a short distance on its side before stopping in the vicinity of the junction.
- 2 Seven people lost their lives in the accident and 51 people were taken to hospital, 16 of them from suffering serious injuries¹.
- 3 The Rail Accident Investigation Branch's (RAIB) analysis of the on-tram data recorder (OTDR) shows that the tram was travelling at a speed of approximately 73 km/h (46 mph) as it entered the curve, which had a maximum permitted speed of 20 km/h (13 mph).
