ACCIDENT

Aircraft Type and Registration:	Schleicher ASW 27-18E (ASG 29E) glider, G-VLCC	
No & Type of Engines:	1 Solo Type 2350 two-stroke engine	
Year of Manufacture:	2007 (Serial no: 29511)	
Date & Time (UTC):	21 July 2016 at 1043 hrs	
Location:	Moundsmere, near Basingstoke, Hampshire	
Type of Flight:	Private	
Persons on Board:	Crew - 1	Passengers - None
Injuries:	Crew - 1 (Fatal)	Passengers - N/A
Nature of Damage:	Glider destroyed	
Commander's Licence:	British Gliding Association Gliding Certificate	
Commander's Age:	60 years	
Commander's Flying Experience:	1,800 hours gliding (of which 3 were on type) Last 90 days - 16 hours Last 28 days - 0 hours	
Information Source:	AAIB Field Investigation

Synopsis

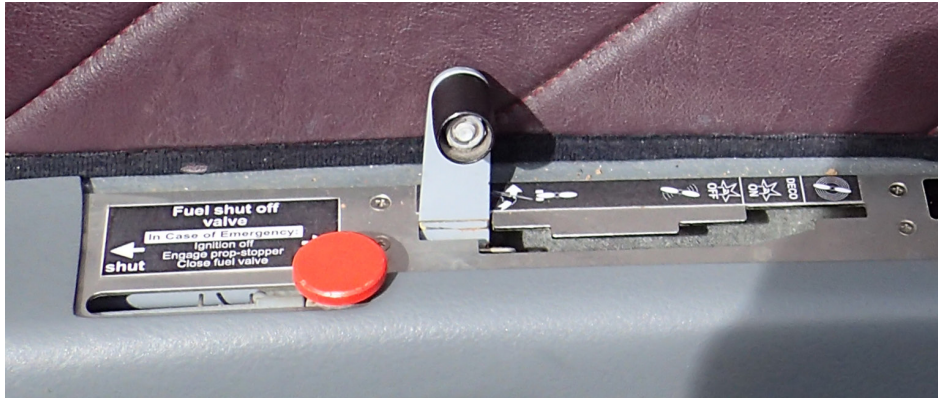
Figure 6

A fuel tank located just behind the pilot contains 10.5 litres of fuel, which is sufficient for approximately one hour of powered flight. The fuel shutoff valve is operated by a lever in the cockpit (Figure 6) and, if inadvertently left closed, is automatically opened by the action of moving the engine control lever to the ignition position.

Fuel shutoff and engine control levers

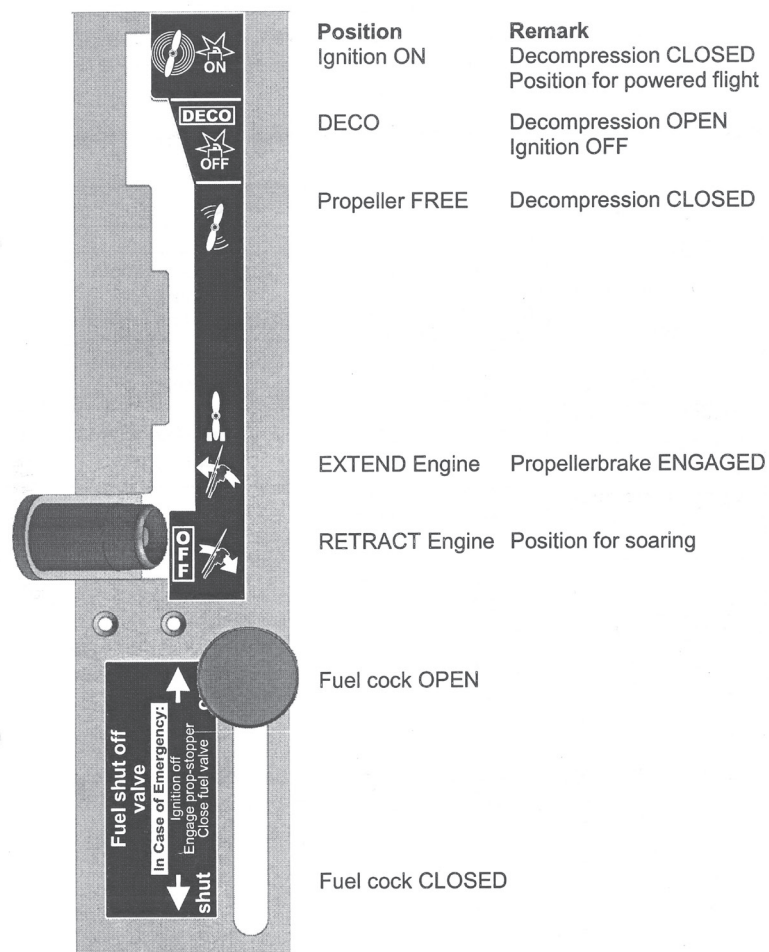
Figure 7

There are five detented lever positions for the engine control (Figure 7).

Engine control lever positions
