Rail Accident Report

**Near miss between a train and a track worker at
Shawford
24 June 2016**

Report 05/2017
March 2017

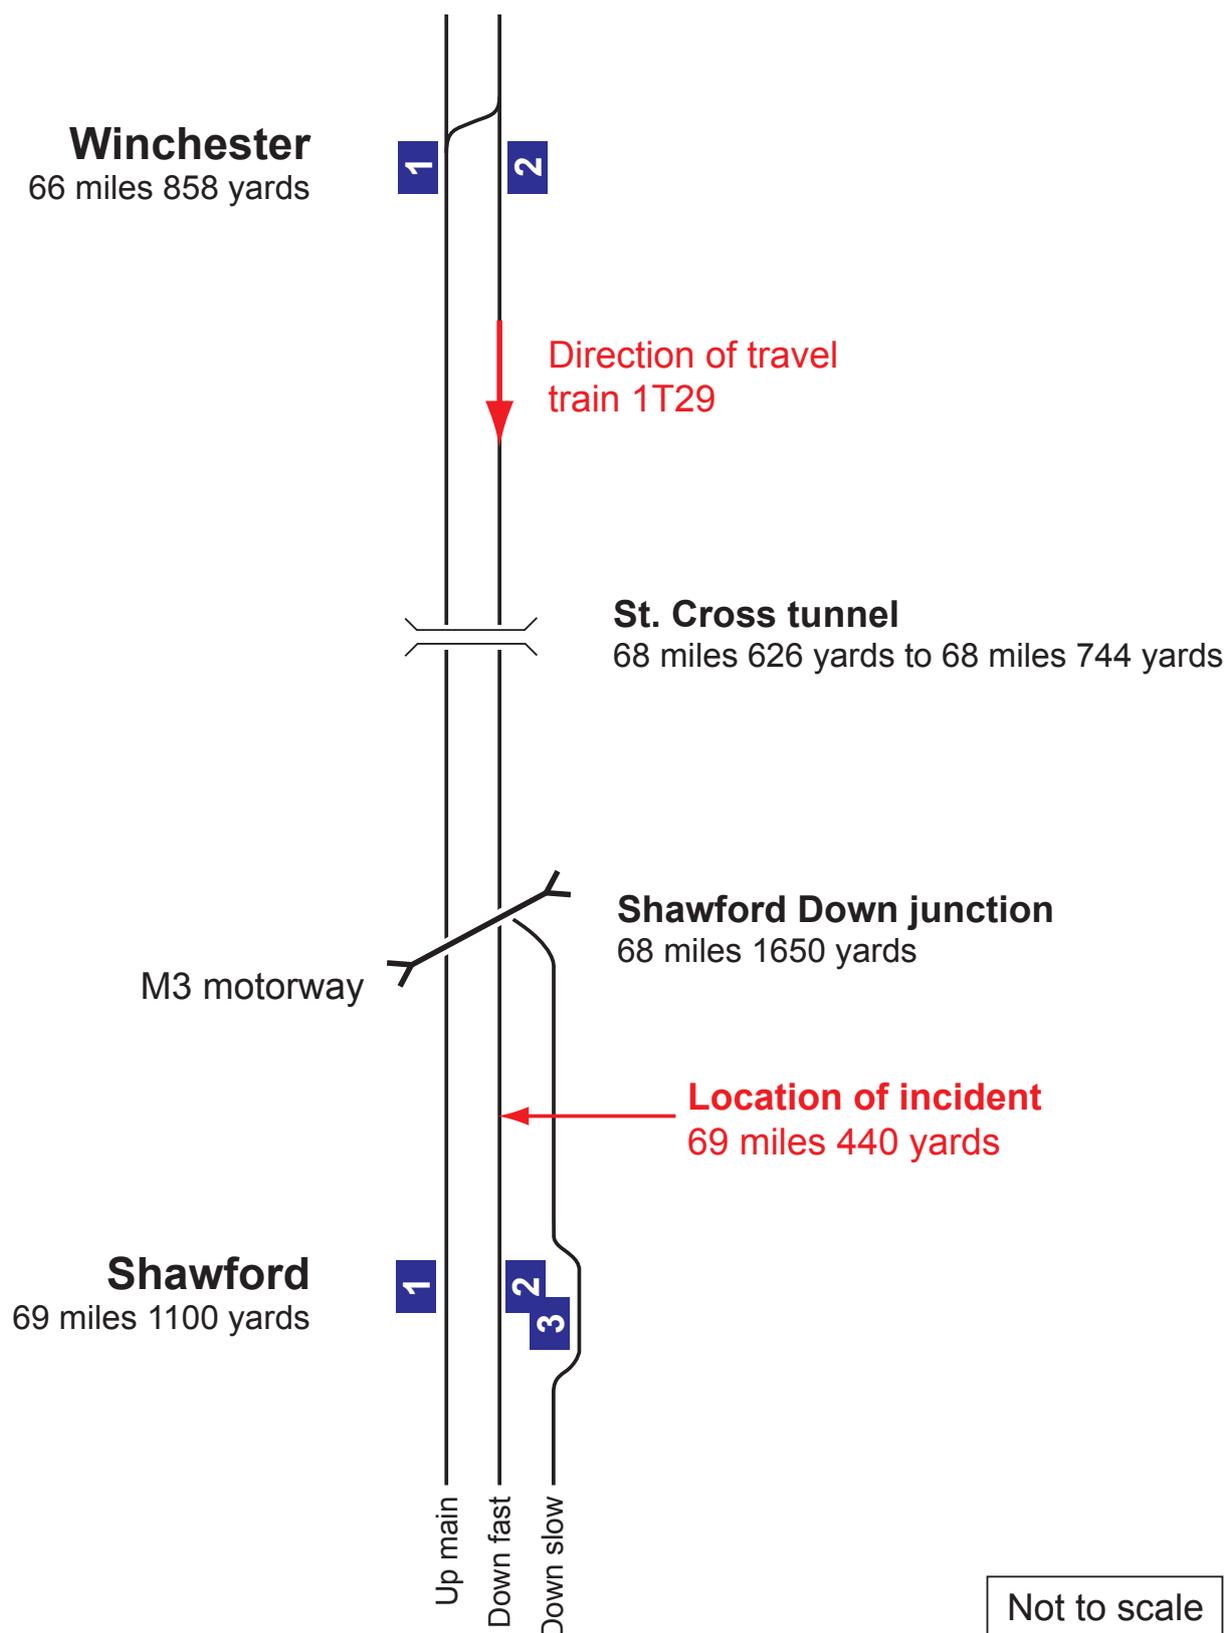
Figure 3: The track layout at Shawford

- 5 The incident occurred to the north of Shawford station on the *down fast* line between Winchester and Eastleigh (figure 2), at about 69 miles 440 yards (from a zero datum at London Waterloo station). The line is part of Network Rail's *Wessex Route* and at this location the railway comprises three tracks: the *up main*, *down fast* and *down slow* lines (figure 3).

- 25 Just as the track worker stepped into the down fast line, the handheld GPS unit beeped. The track worker stopped to look at it. At this time train 1T29 was approaching on the down fast line at about 85 mph (137 km/h). As the train passed Shawford Down junction (figure 3), the driver saw the track worker and sounded the train's horn. The track worker did not acknowledge the warning (normally done by raising an arm) or begin to move, so the driver used the train's horn to give an urgent warning (a series of short, sharp blasts) and made an *emergency brake application*.

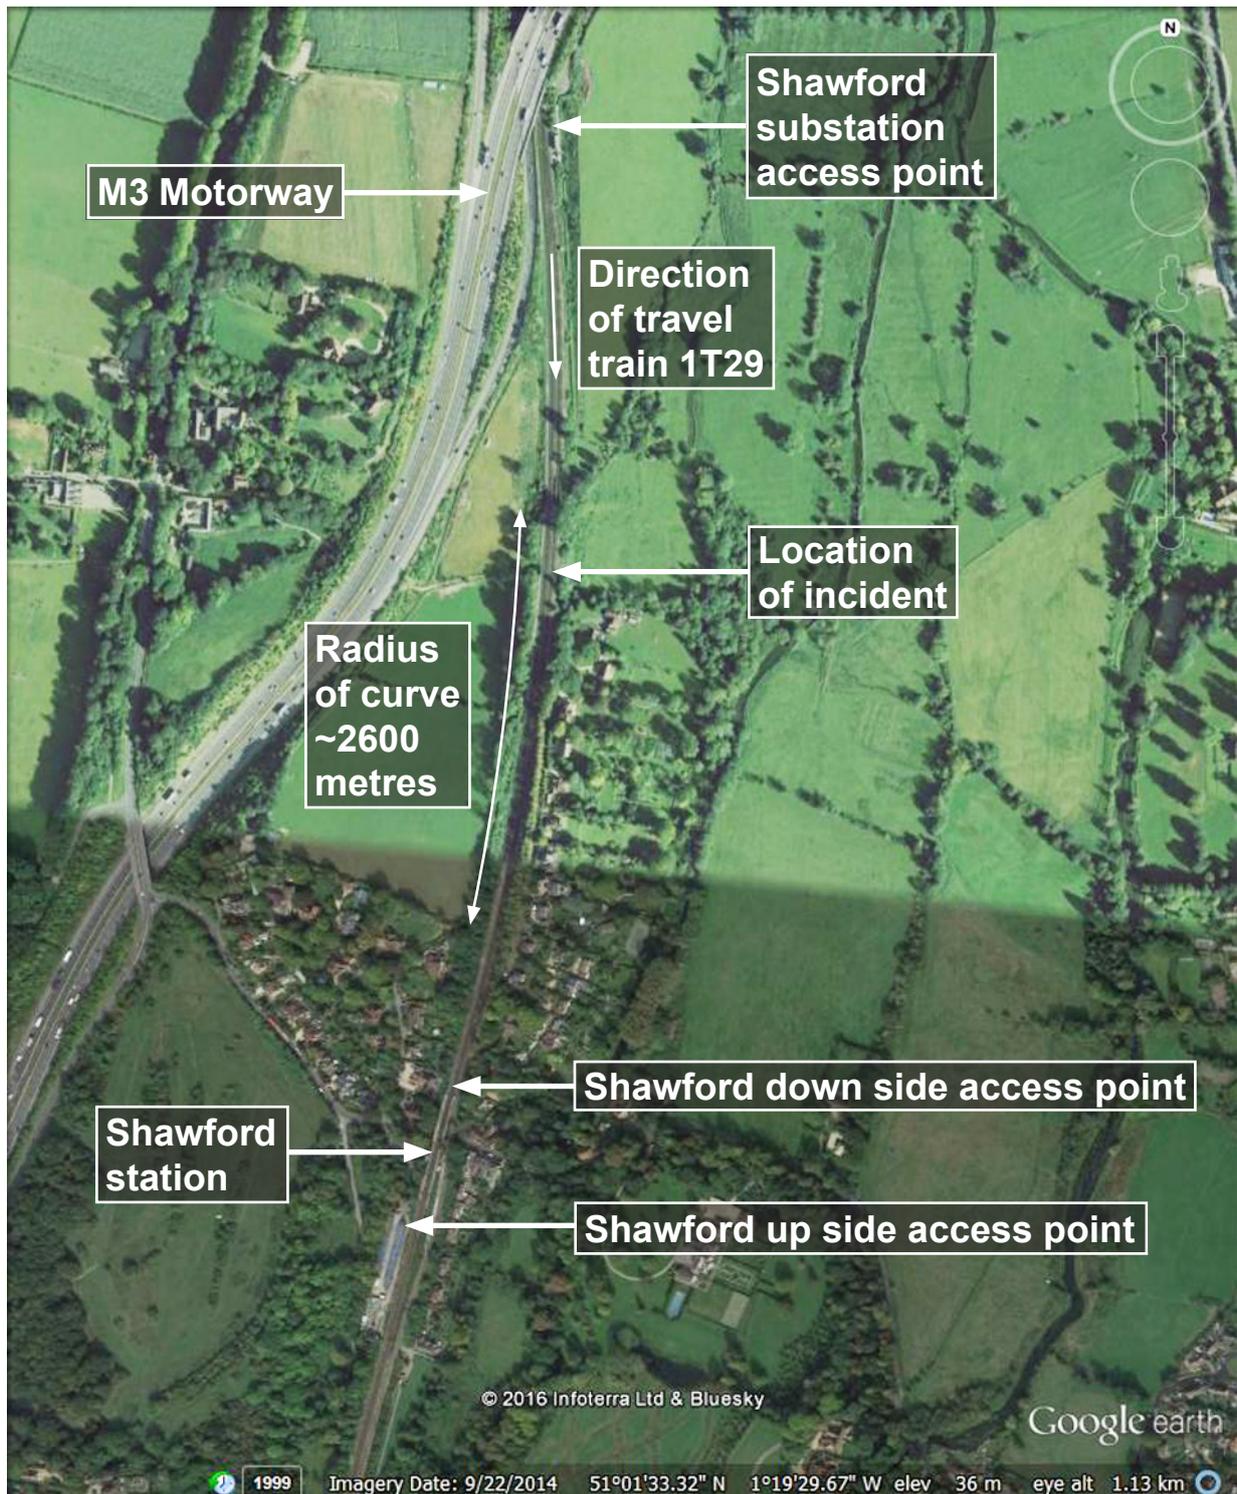
Figure 4: Google Earth view of incident site

- 7 The incident occurred on a right-hand curve (in the train's direction of travel) of about 2600 metres radius (figure 4) and on a falling gradient of 1 in 258 (0.39%). Signalling in the area is controlled from the Eastleigh Area signalling centre. *Third rail electrification* is present throughout.

- 77 Just after passing over Shawford Down junction, the driver saw the track worker and sounded the train's horn. At this point the driver was not sure exactly which line the track worker was standing on due to the track's curvature (figure 4). As the train got closer, the driver realised the track worker was standing on his line so he gave an urgent warning on the train's horn (paragraph 25) and made an emergency brake application. It was this urgent warning that caught the track worker's attention (paragraph 26) and gave the track worker just enough time to move clear.

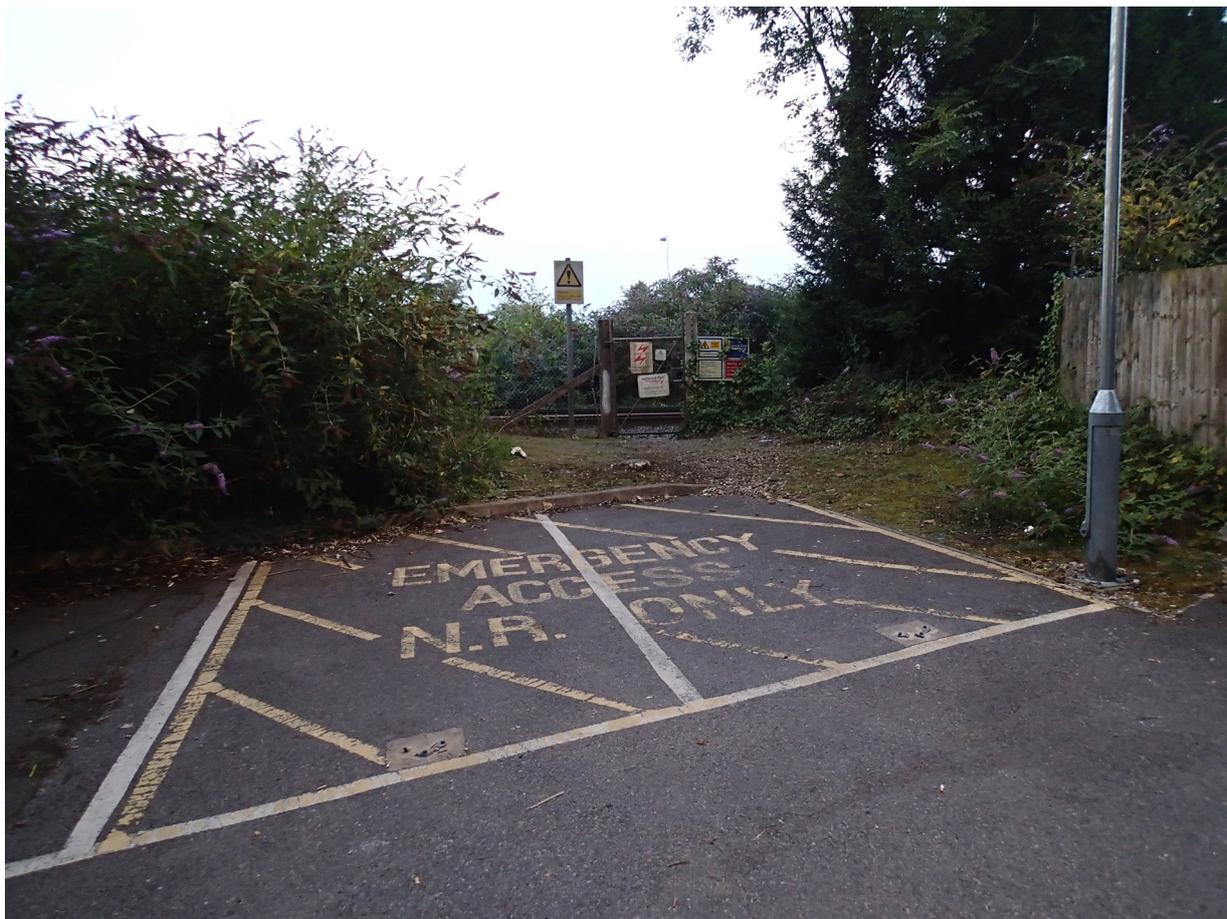
Figure 5: Car parking by access gate on up side at Shawford station

- 20 The team arrived at Shawford station car park at about 12:00 hrs and went to park both vehicles in the allocated spaces located by the access gate on the up side of the railway (figure 5). However, other cars were parked too close to these spaces, leaving insufficient space to fit in both vehicles. Consequently they drove to an alternative *access point* on the down side (figure 6), planning to park in a nearby car park for a public house (figure 6). Once there, they found it had recently changed to a pay and display car park. To avoid paying to park, they left both vehicles in the lane next to the access point while the COSS and track worker went onto the railway intending to quickly determine the exact location of the suspect rail defect. The COSS and track worker could then decide whether to find somewhere else to park in Shawford or drive to another access point to the north at Shawford substation (figure 4). The contractor remained with the vehicles so he could move them if another vehicle was unable to get past.

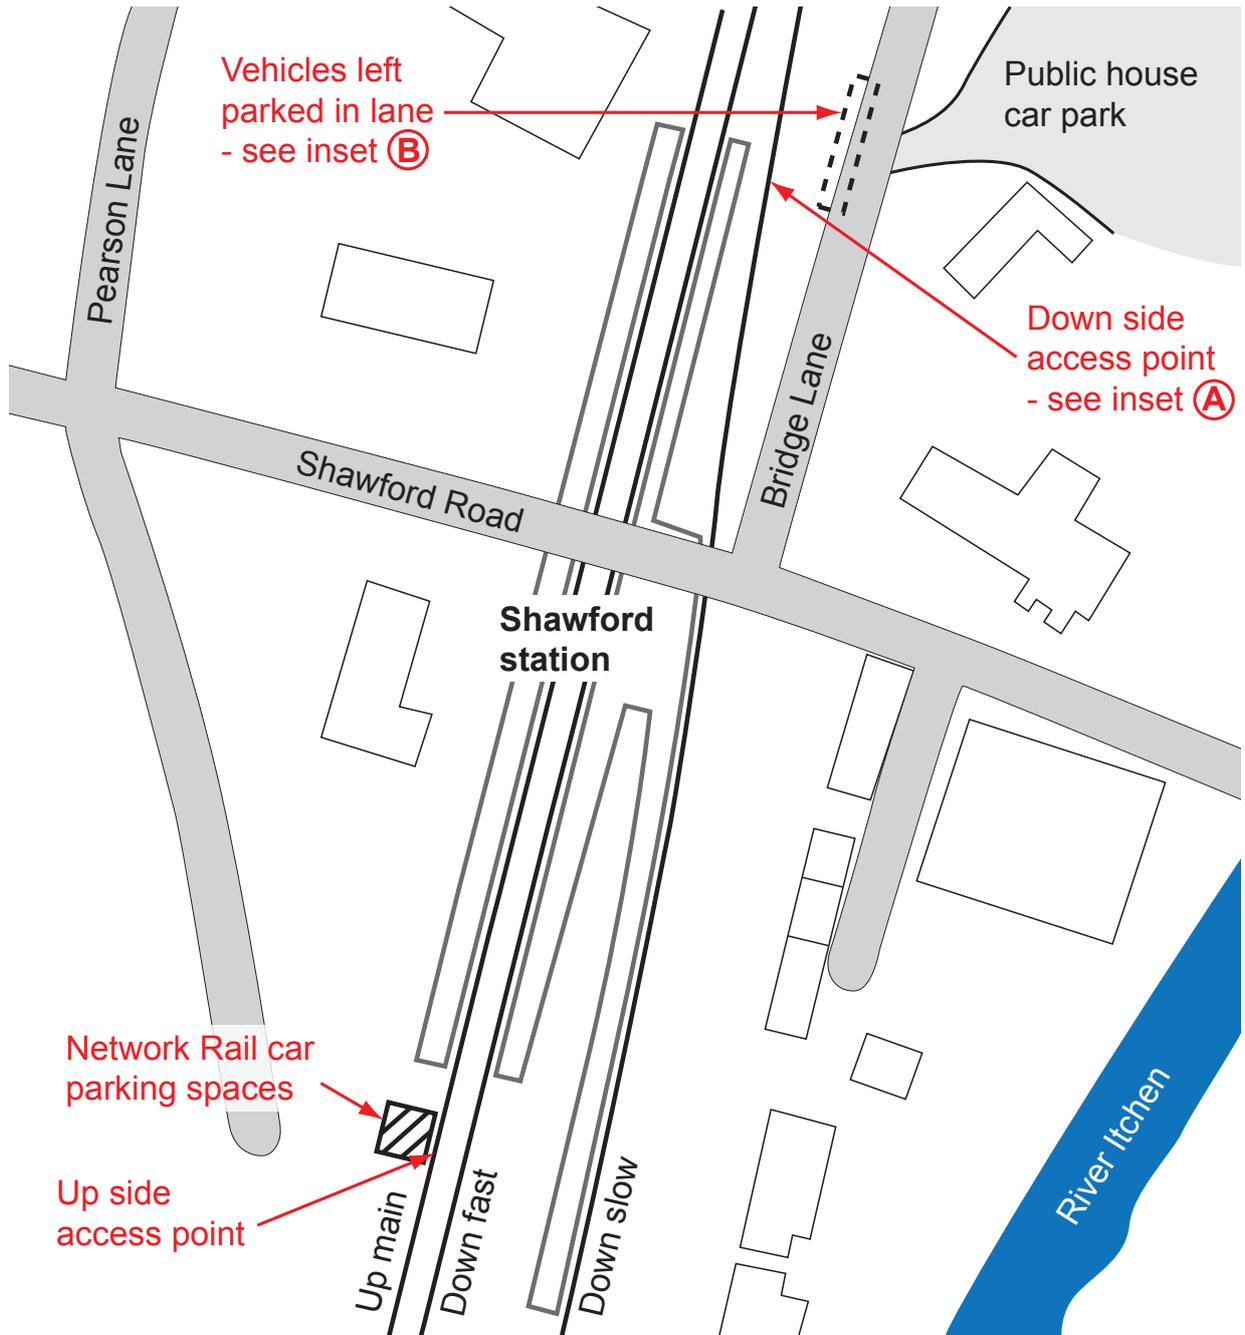
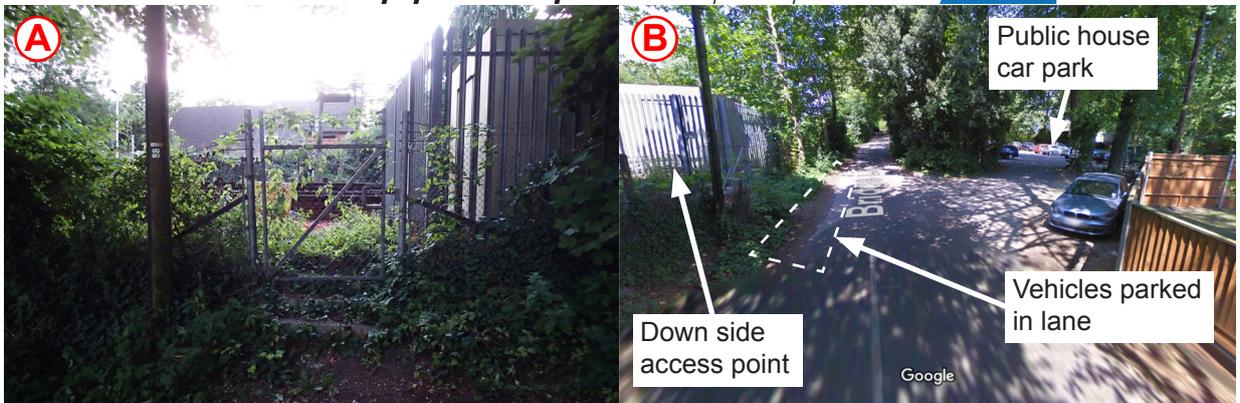
Figure 6: Access points in Shawford station area

- 21 As the COSS and track worker went through the down side access gate (figure 6), they agreed to stay in the down cess as they walked. The COSS locked the gate behind him but then became distracted by checking that no other vehicles were coming along the lane. Meanwhile the track worker set off on his own, walking north along the cess, taking with him the global positioning system (GPS) coordinates for the reported rail defect and a handheld GPS unit.
