# Rail Accident Report

## Fatal accident near David Lane tram stop 15 August 2016

Report 06/2017  
April 2017

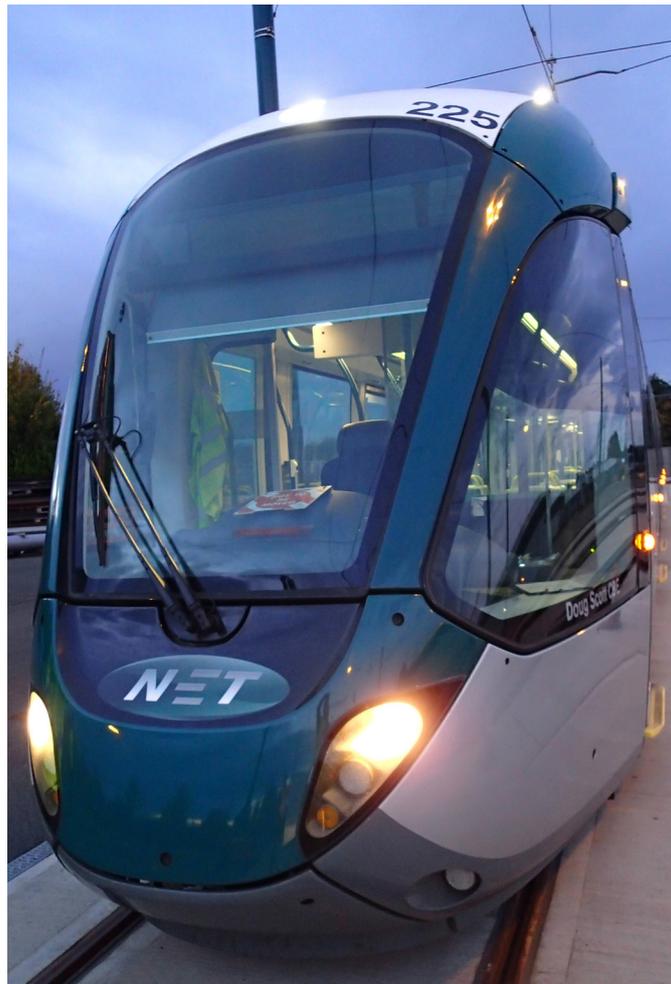
Figure 4: Tram 225

- 8 The tram involved, number 225, was manufactured and supplied by Alstom as part of the network extension (figure 4). It is a derivative of Alstom's Citadis brand. Tram 225 entered service in summer 2015.

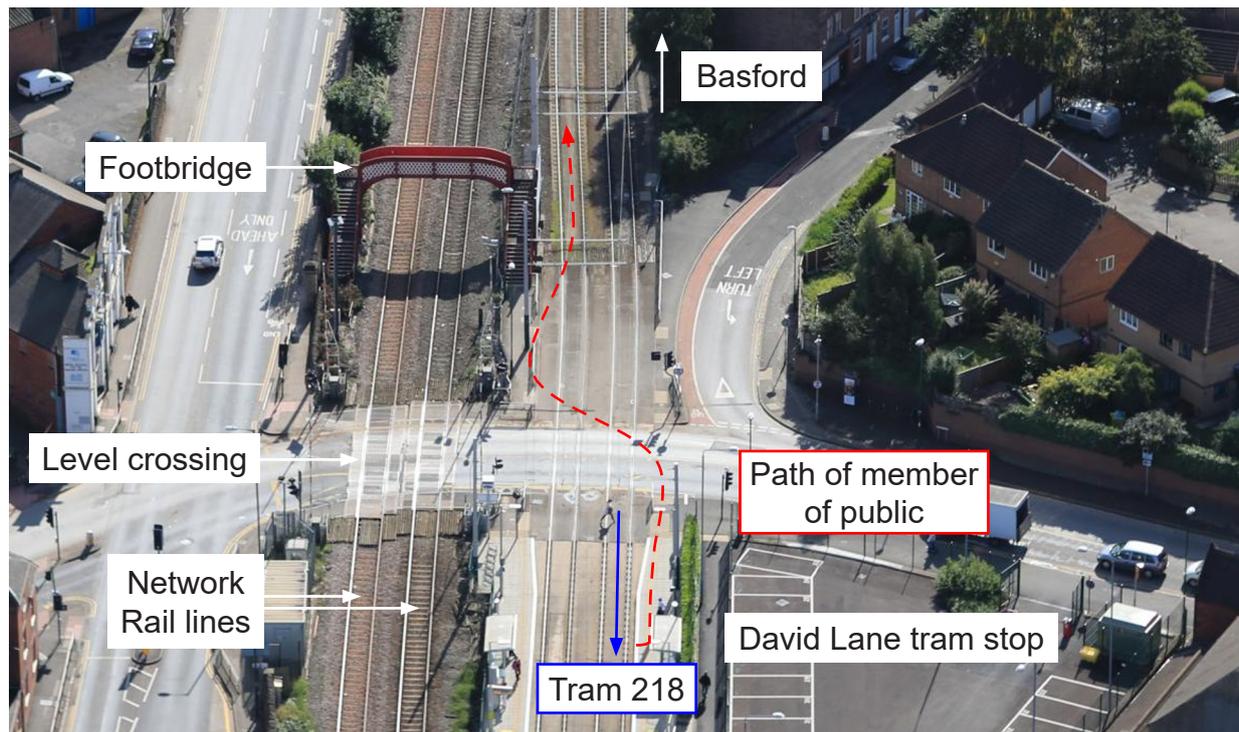
Figure 6: Location overview (courtesy of Network Rail)

- 18 At 22:42:45 hrs, the member of the public alighted from tram 218 at David Lane tram stop. At 22:44:37 hrs, he entered the tramway next to the footbridge that goes over the Network Rail lines, having negotiated the anti-pedestrian guards fitted at this location (figure 6 shows the path he followed). He appeared to be heading back towards Basford tram stop by walking along the tramway.
