Rail Accident Investigation Branch

# Rail Accident Report

**Collision between a train and tractor at  
Hockham Road user worked crossing, near  
Thetford  
10 April 2016**

Report 04/2017  
March 2017

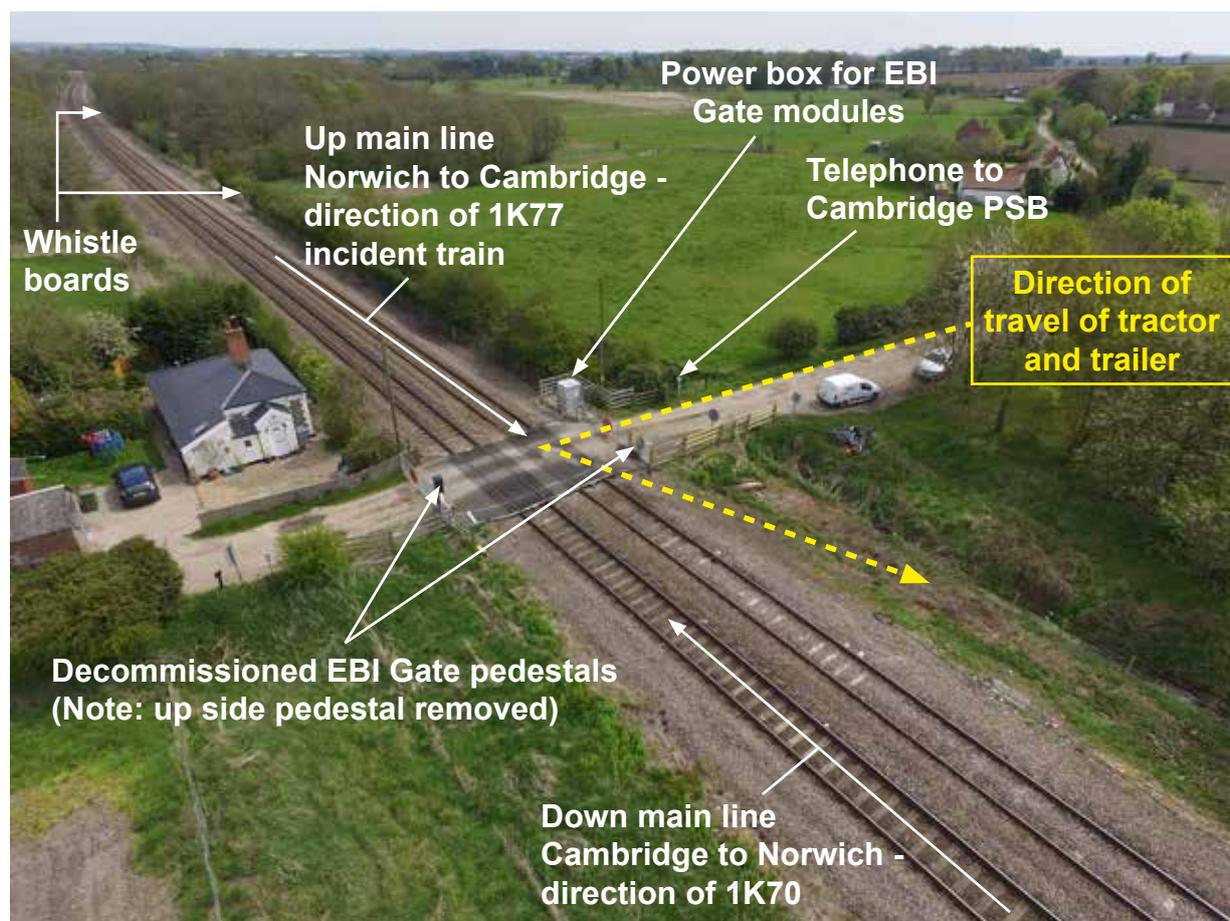
- 6 Hockham Road UWC (figure 3) is located at 99 miles 67chains on the double track railway between Ely and Norwich, which is known as the Thetford line. The signalling system, which is controlled from Cambridge *Power Signal Box* (PSB), is operated under the regulations for *track circuit block* with train detection by means of *axle counters*.
- 7 The road which crosses the railway at this point is classed as a restricted byway<sup>2</sup>. The level crossing has one *authorised user*<sup>3</sup>, who is permitted to use the crossing with farm vehicles, horses and pedestrians. The road also serves fields and one house. It is also used as an unauthorised access route to and from the A11, the main road between Thetford and Norwich, and a paintballing outdoor activity centre (see paragraph 42). There is a public footpath level crossing alongside the road crossing.

Figure 3: Hockham Road UWC from the north-west

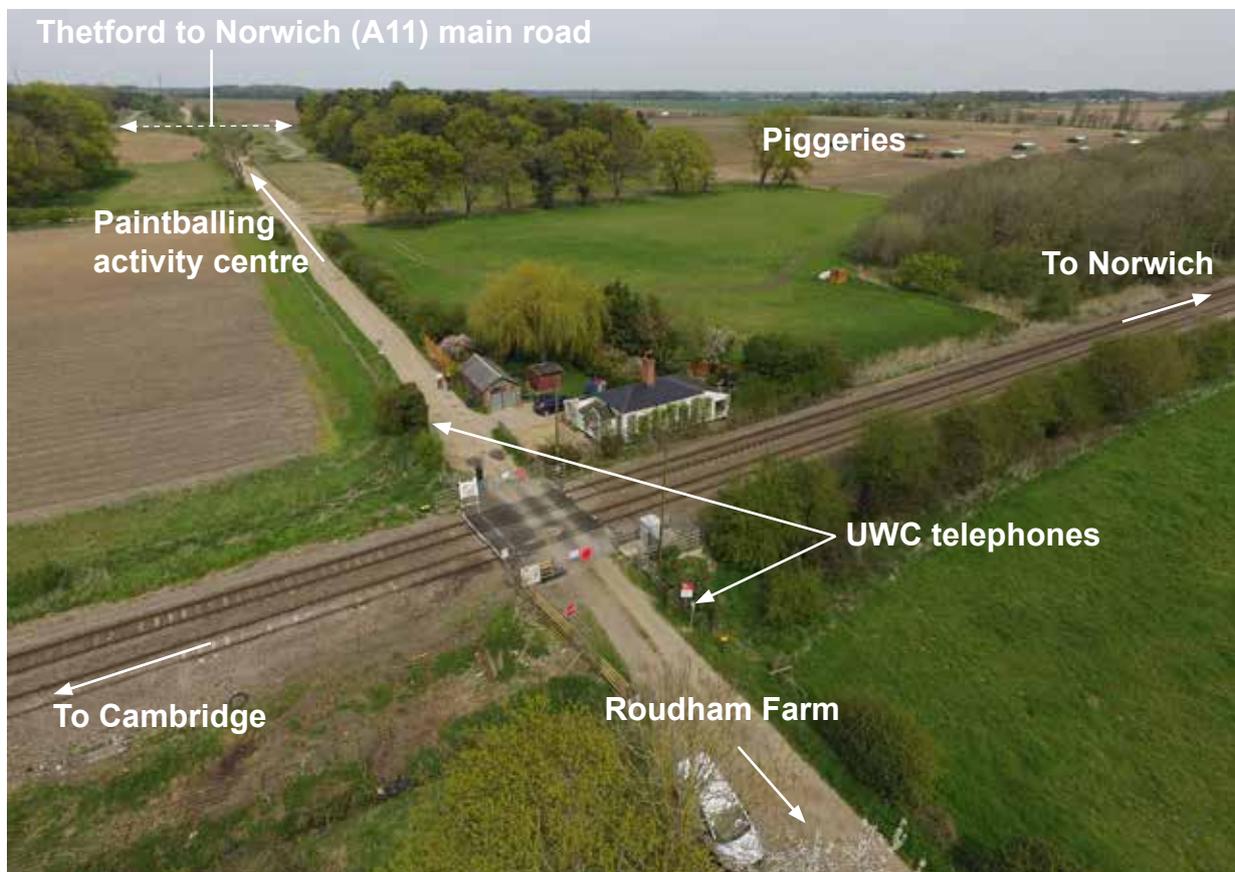
- 14 Hockham Road UWC is fitted with telephones on each side, connected to the Thetford workstation at Cambridge PSB. The telephones enable a person who wishes to use the crossing to contact the signaller (figure 4). Signs on both sides of the crossing tell users with vehicles or animals that they must obtain permission to cross. There are two 'whistle' boards in each direction on the approach to the crossing, instructing train drivers to sound the train horn to warn footpath users at both Hockham Road and nearby Drove Road (Drove Road UWC was closed in 2010, but the adjacent footpath crossing remained in use).

Figure 4: Hockham Road UWC from the south-west

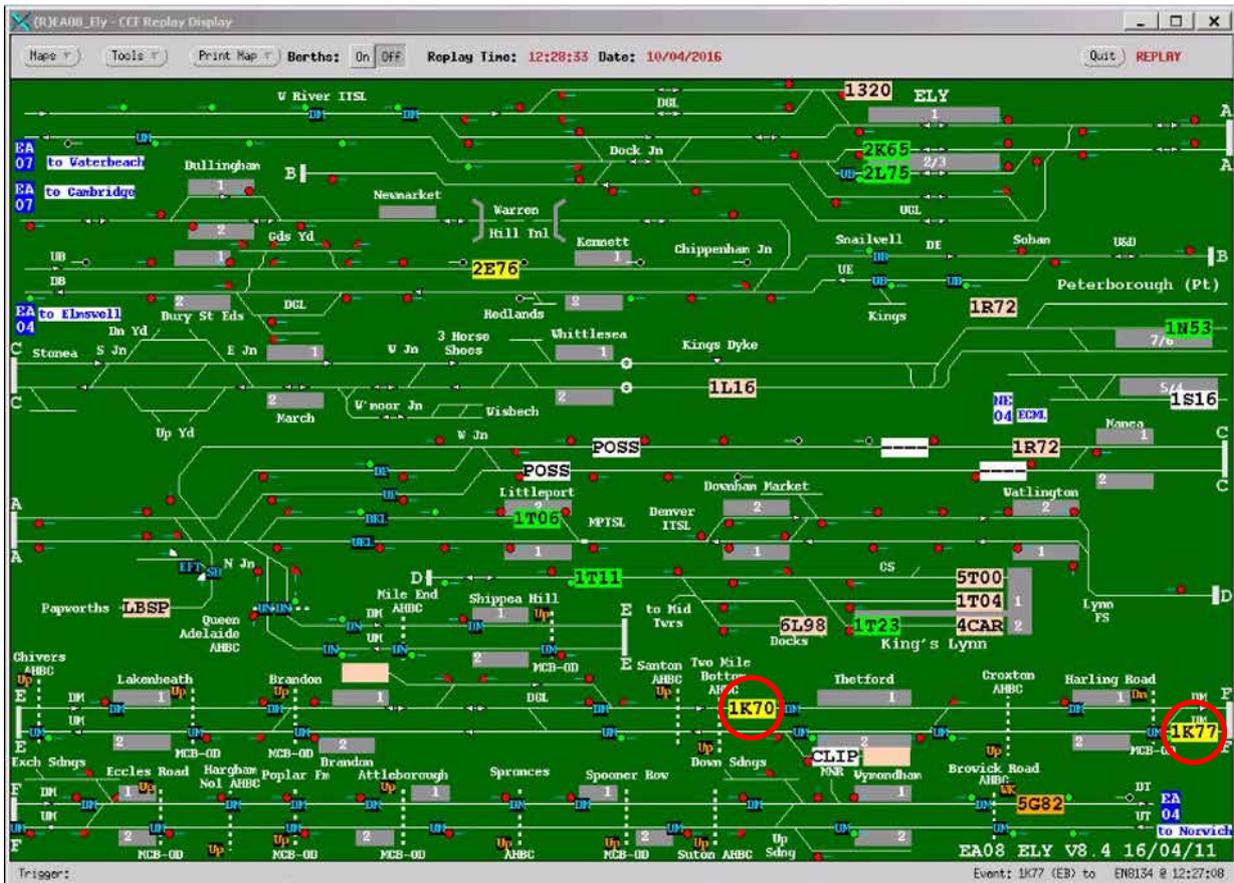
- 24 At about this time, train 1K77, which was later involved in the accident, departed from Norwich on time. The signaller became aware that train 1K77 had entered the area of railway controlled by the Thetford workstation (see figure 2). The signaller received no further telephone calls until a user at Hockham Road UWC called at 12:28:33 hrs to ask for permission to cross with a tractor (figure 7).

Figure 7: CCF screen shot at 12:28:33 seconds showing the positions of trains 1K77 and 1K70 (see also figures 22a to 22h). This system records train movements, and is not visible to signallers in real time.

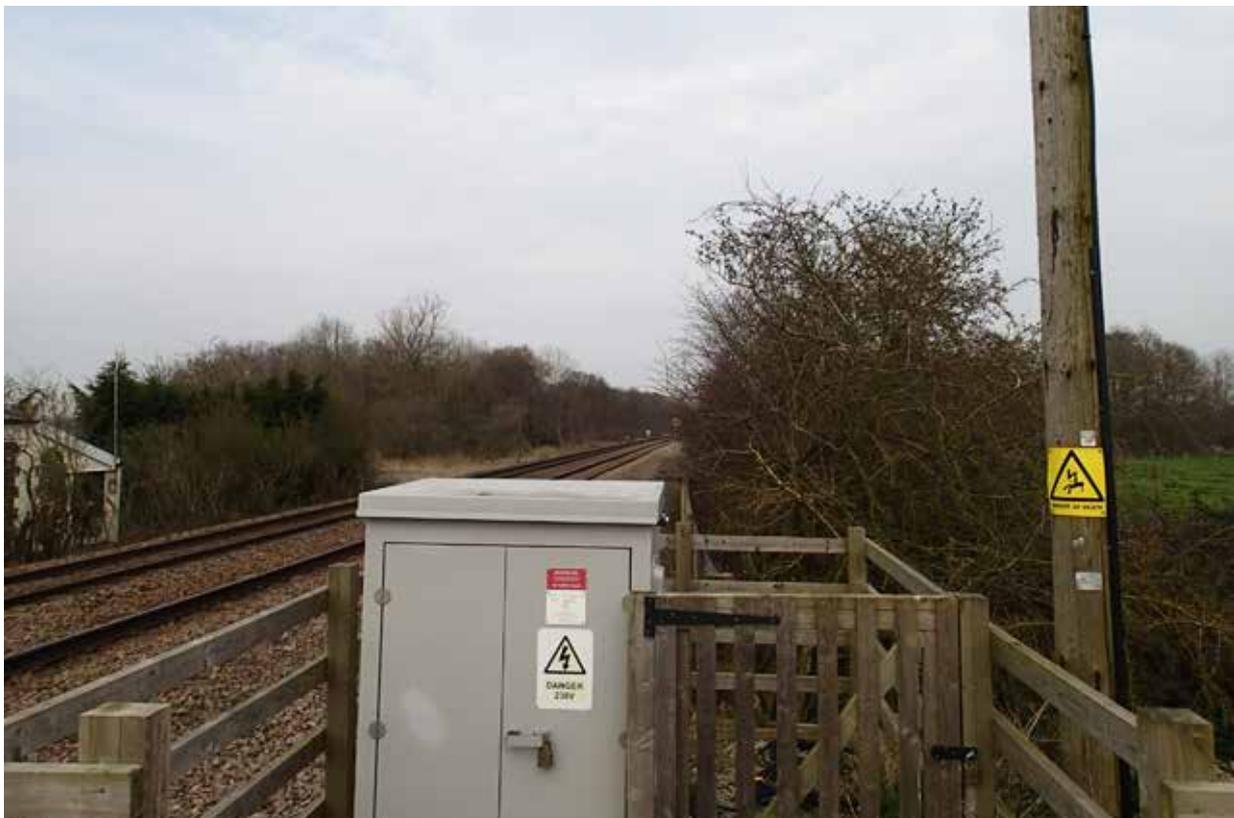
Figure 8: View from Hockham Road UWC looking in the direction from which the up train approached

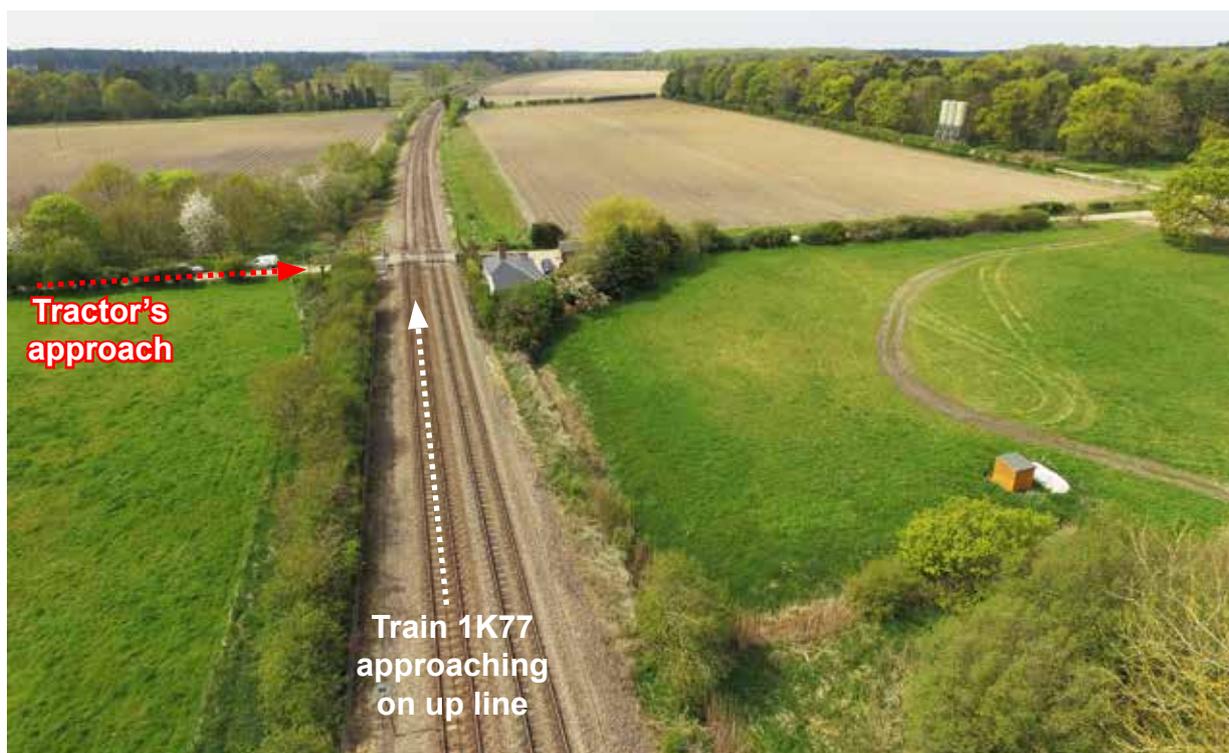
- 29 At 12.29.56 hrs the driver of train 1K77, which was approaching Hockham Road, travelling at 87 mph (140 km/h), sounded his horn once on the approach to the whistle boards for Hockham Road and Drove Road footpath crossing (which is 318 metres beyond Hockham Road). The train driver then saw the raised bucket attachment of a tractor on the left (Roudham Farm) side of Hockham Road crossing, but due to the vegetation and left-hand curvature of the track he could not see the tractor itself, or tell if the gates of the crossing had been opened. The train driver then saw the raised bucket attachment of the tractor continue to move slowly forward towards the crossing.

Figure 9: View looking towards Hockham Road UWC for trains approaching in the up direction

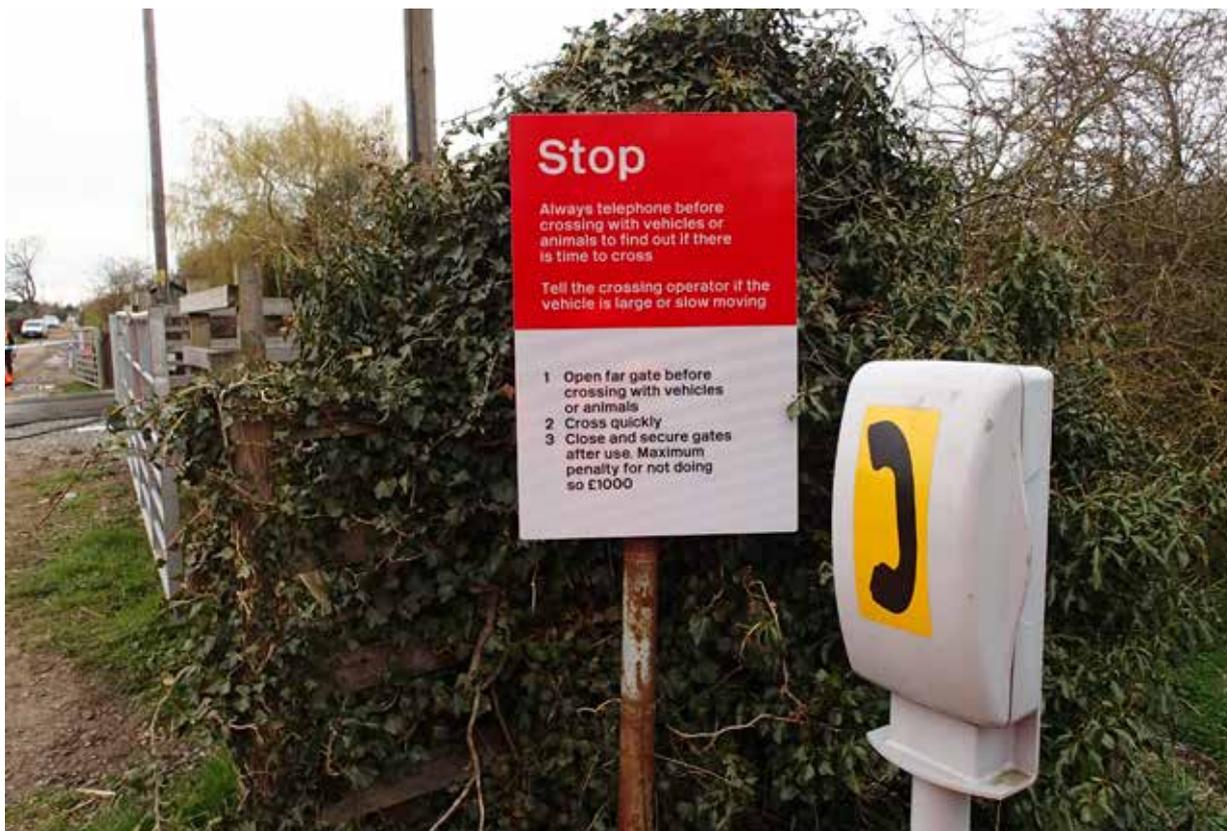
Figure 18: Signage and telephone on the up side at Hockham Road UWC

- 40 Hockham Road crossing has existed since the opening of the Ely to Norwich railway in 1845, when it was provided for the use of occupiers of Roudham Farm. It currently has metal five-bar gates for vehicle access, and separate smaller gates for the adjacent public footpath and restricted byway crossing. As a result of the line speed of 90 mph (144 km/h) and the curvature of the track, the distance at which approaching trains come into sight gives limited warning time, and whistle boards are provided to warn pedestrians of the imminent arrival of a train. Notices instruct people using the crossing with a vehicle or animals to use the telephones either side of the crossing (which were first installed in 1963) to contact the signaller to obtain permission to cross. The user should tell the signaller if they are crossing with a large or slow moving vehicle (although no definition of this is provided). The signage instructs the user to open the far gate before crossing with a vehicle or animals, cross quickly and then to close and secure the gates after use (figure 18).

120 The signs at a UWC do not specify whether a user should open the gates before or after getting permission to cross from the signaller (figure 18). As there is neither a requirement for the user to tell the signaller whether the gates are already open, nor for the signaller required to ask if they are, the user's estimation of the time required to cross, and the signaller's perception of the situation can vary significantly. It is therefore vital that the user and the signaller come to a clear understanding. This can be difficult, as the user, a member of the public, may not fully understand the limitations of the information available to the signaller.

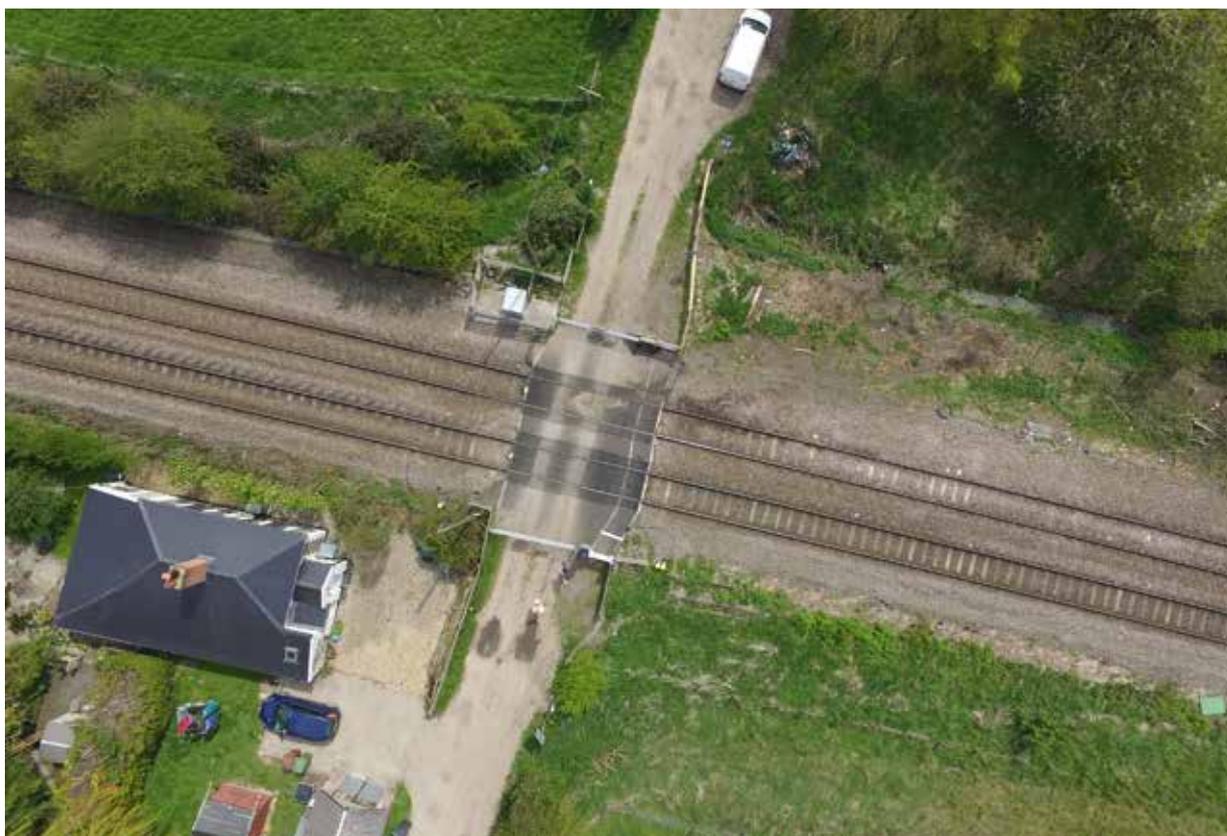
Figure 20: Layout of Hockham Road UWC
