Report on the investigation into  
carbon monoxide poisoning  
on board the motor cruiser

***Love for Lydia***

on Wroxham Broad, United Kingdom

between 7 and 9 June 2016

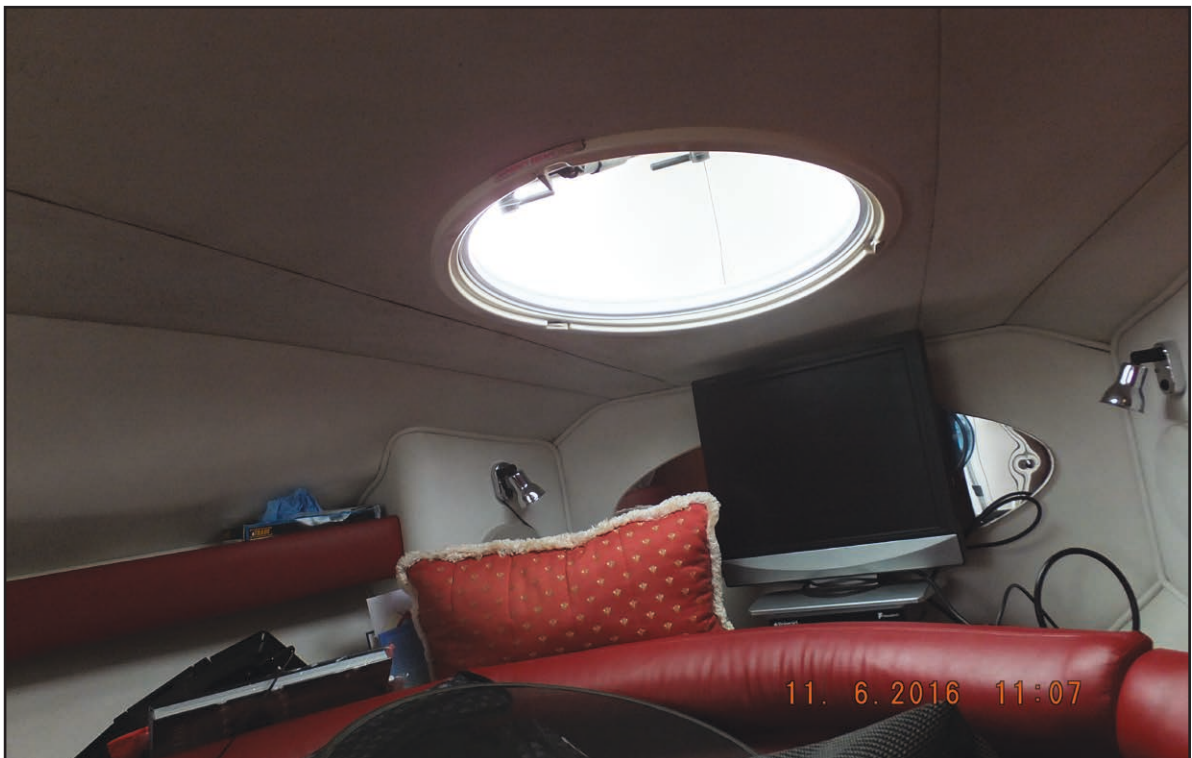
**Figure 5:** Forepeak cabin hatch/vent

*Love for Lydia*'s length overall was 7.62m and the boat was divided into four underdeck compartments: an engine bay aft, a small aft cabin, heads and a forepeak cabin (**Figure 4**). The forepeak cabin could be ventilated by a small oval shaped porthole on each side and a skylight/escape hatch leading to the foredeck (**Figure 5**).

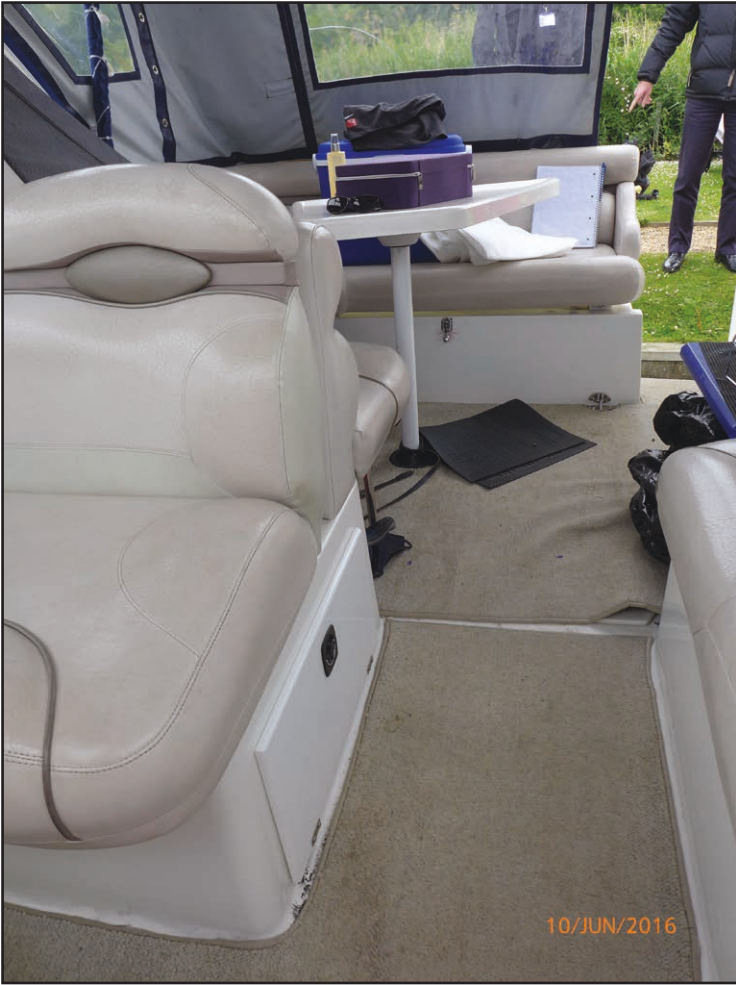
**Figure 6:** Aft deck area

The aft deck and helm area, which was above the engine bay and aft cabin, was fitted with seating and a table (**Figure 6**). A movable bench seat was fitted at the aft end of the deck. The gap between the underneath of the seat and the top of the transom was approximately 5cm (**Figure 7**). In common with many sports motor cruisers, the aft deck and helm area was fitted with a canvas canopy (**Figure 3**) that was attached to the superstructure with press studs. The canopy's configuration was adjusted by zips and twist lock fastenings. The canopy was last replaced in 2011 by a Broads-based supplier at a cost of £2200. No warnings on the dangers of CO poisoning accompanied the canopy.

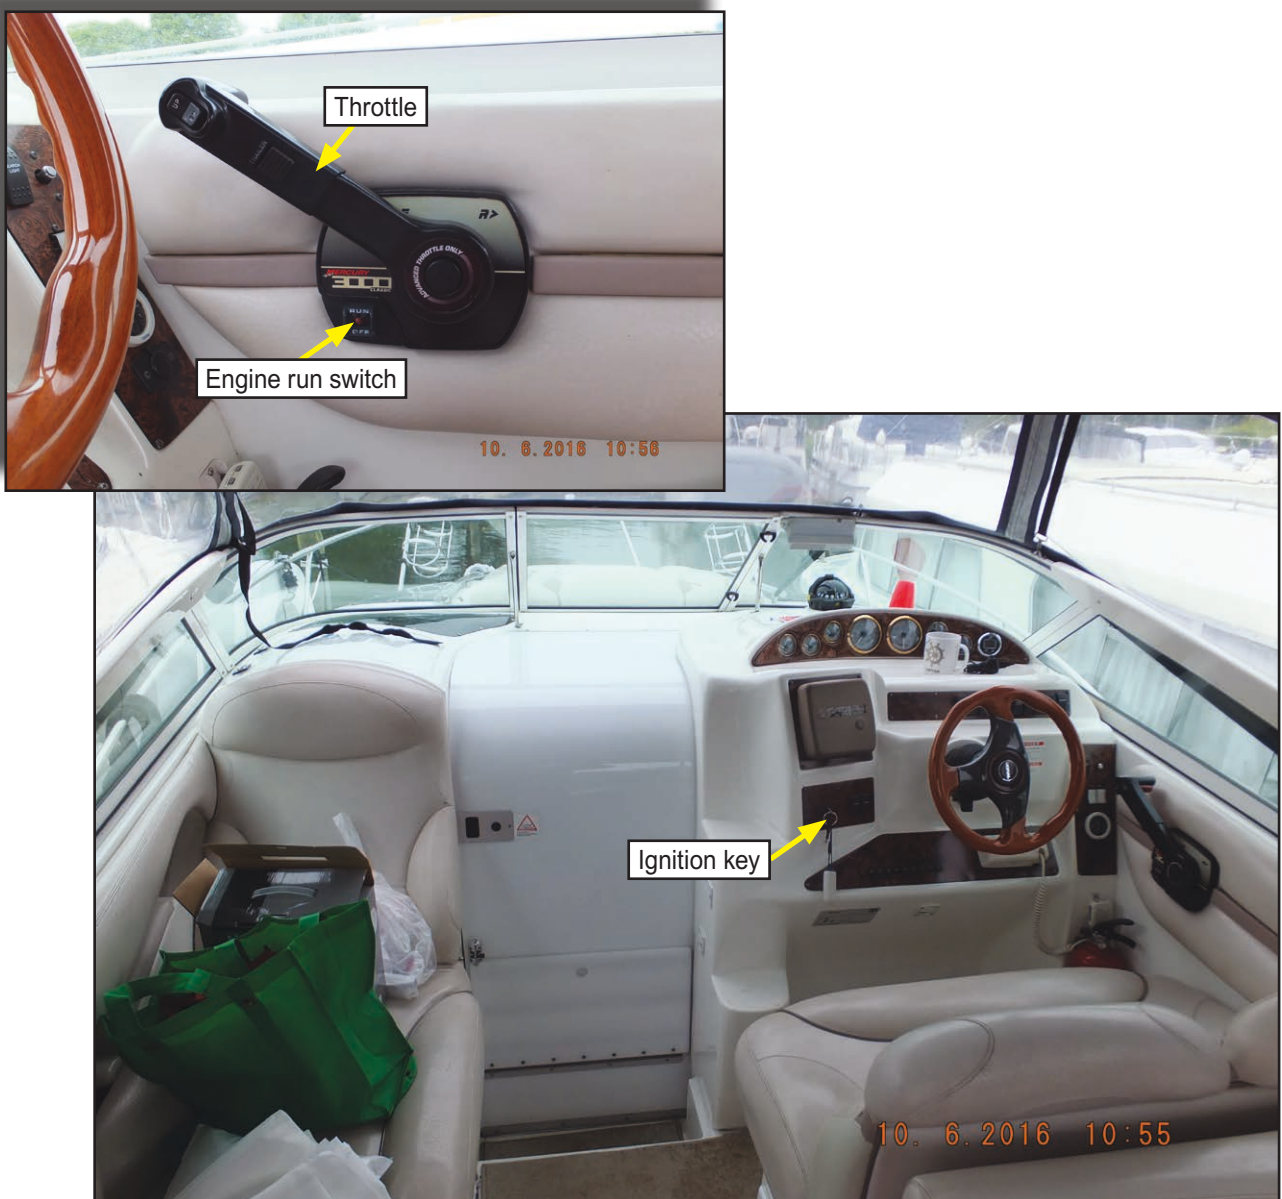
**Figure 9:** Helm position

- The ignition key was in the ignition and engine run switch was in the 'run' position (**Figure 9**).
- The engine throttle was set to between 2400 and 3000 revolutions per minute (rpm)<sup>4</sup> (**Figure 9**).
- The fuel tank was empty.

<sup>4</sup> *Love for Lydia*'s throttle lever had a degree of 'play' in its movement. Consequently, when it was positioned 'as found' the engine speed varied between 2400 and 3000rpm.

*Love for Lydia's* empty fuel tank and the positions in which its engine ignition key, engine run switch and throttle were found, indicates that the engine had been running at between 2400rpm and 3000rpm until it ran out of fuel. With the forepeak cabin port holes and hatch closed and the aft deck covered by its canopy (**Figure 3**), the engine emissions from the 'wet' exhaust were able to propagate through the gap under the bench seat and the open section of the canvas canopy on the port quarter. They then quickly spread through the aft deck to the helm area and into the forepeak cabin (**Figure 13**). During the MAIB tests, a CO concentration of at least 2000ppm accumulated in the forepeak cabin within 8 minutes. In such conditions, it is likely that the deceased would have been quickly overcome (**Figure 15**).

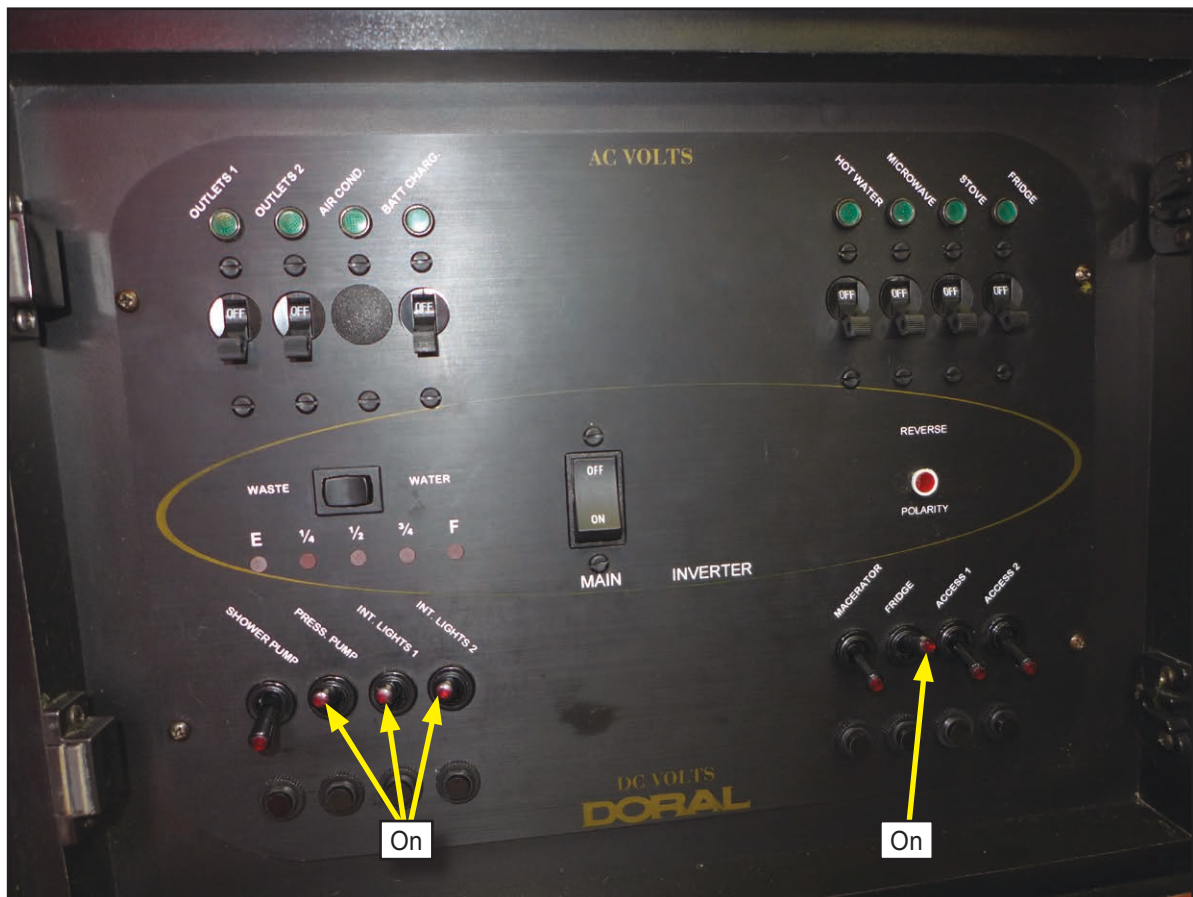
Figure 11: Power distribution panel

- The fuel filler cap located on the starboard side had been unscrewed (**Figure 10**).
- A 'shore power' lead was coiled on the port side of the aft seating area. The 'inboard' end of the lead was plugged into the boat's supply socket (**Figure 10**).
- The switches on the electrical distribution panel in the galley for the fridge, internal lights and domestic water pressure pump were in the 'on' position (**Figure 11**).
- The boat's batteries were in a discharged condition.
- There were no carbon monoxide alarms on board.

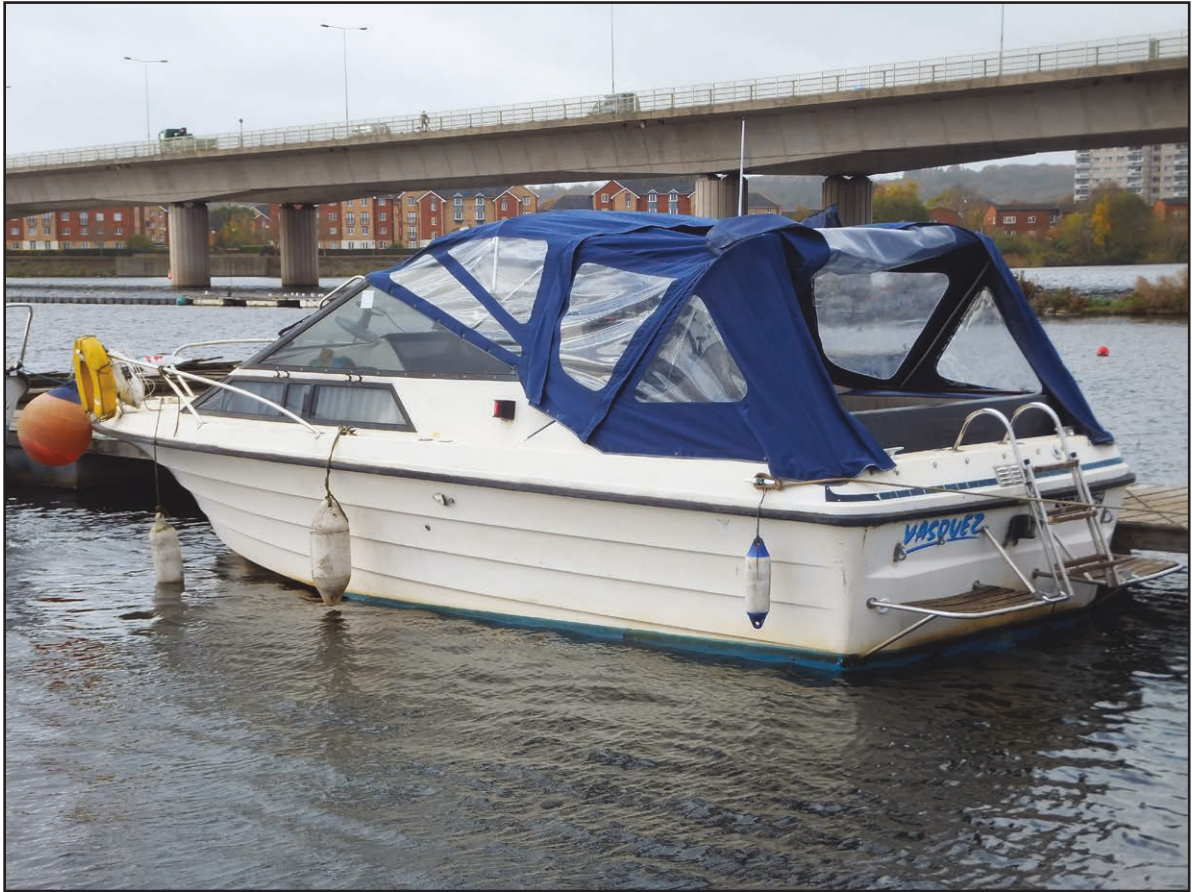
**Figure 17:** *Vasquez*

The MAIB is conducting an investigation of a fatal accident that occurred on the privately owned cabin cruiser *Vasquez* (**Figure 17**) at Cardiff Yacht Club on 12 November 2016. Shortly after midday the boat's owner was found collapsed on the boat and, despite the efforts of fellow club members and emergency services, he did not regain consciousness.

The boat was secured to a club pontoon, the inboard petrol engine was running and the canvas cockpit canopy was fully closed except for one zip that was not fastened. Approximately 45 minutes after the owner had started the engine, he was discovered collapsed in the cabin. Two club members boarded the boat and began to administer cardio-pulmonary resuscitation (CPR). Paramedics arrived and immediately recognised that the rescuers were displaying symptoms consistent with CO poisoning. The paramedics removed the canopy and continued to administer CPR to the owner.
